Re: **Closure Request**
Delaware Ranch 11 W2NC Fee #1H Battery
Tracking #: NAPP2201859426

Trinity Oilfield Services (Trinity), on behalf of Mewbourne Oil Co. (Mewbourne), hereby submits the following Closure Request in response to a release that occurred at the above referenced location, and further described below.

Site Information	
Incident ID	NAPP2201859426
Site Name	Delaware Ranch 11 W2NC Fee #1H Battery
Company	Mewbourne Oil Co.
County	Eddy County, NM
ULSTR	N-11-26S-28E
GPS Coordinates (NAD 83)	32.050382, -104.06142
Landowner	Private

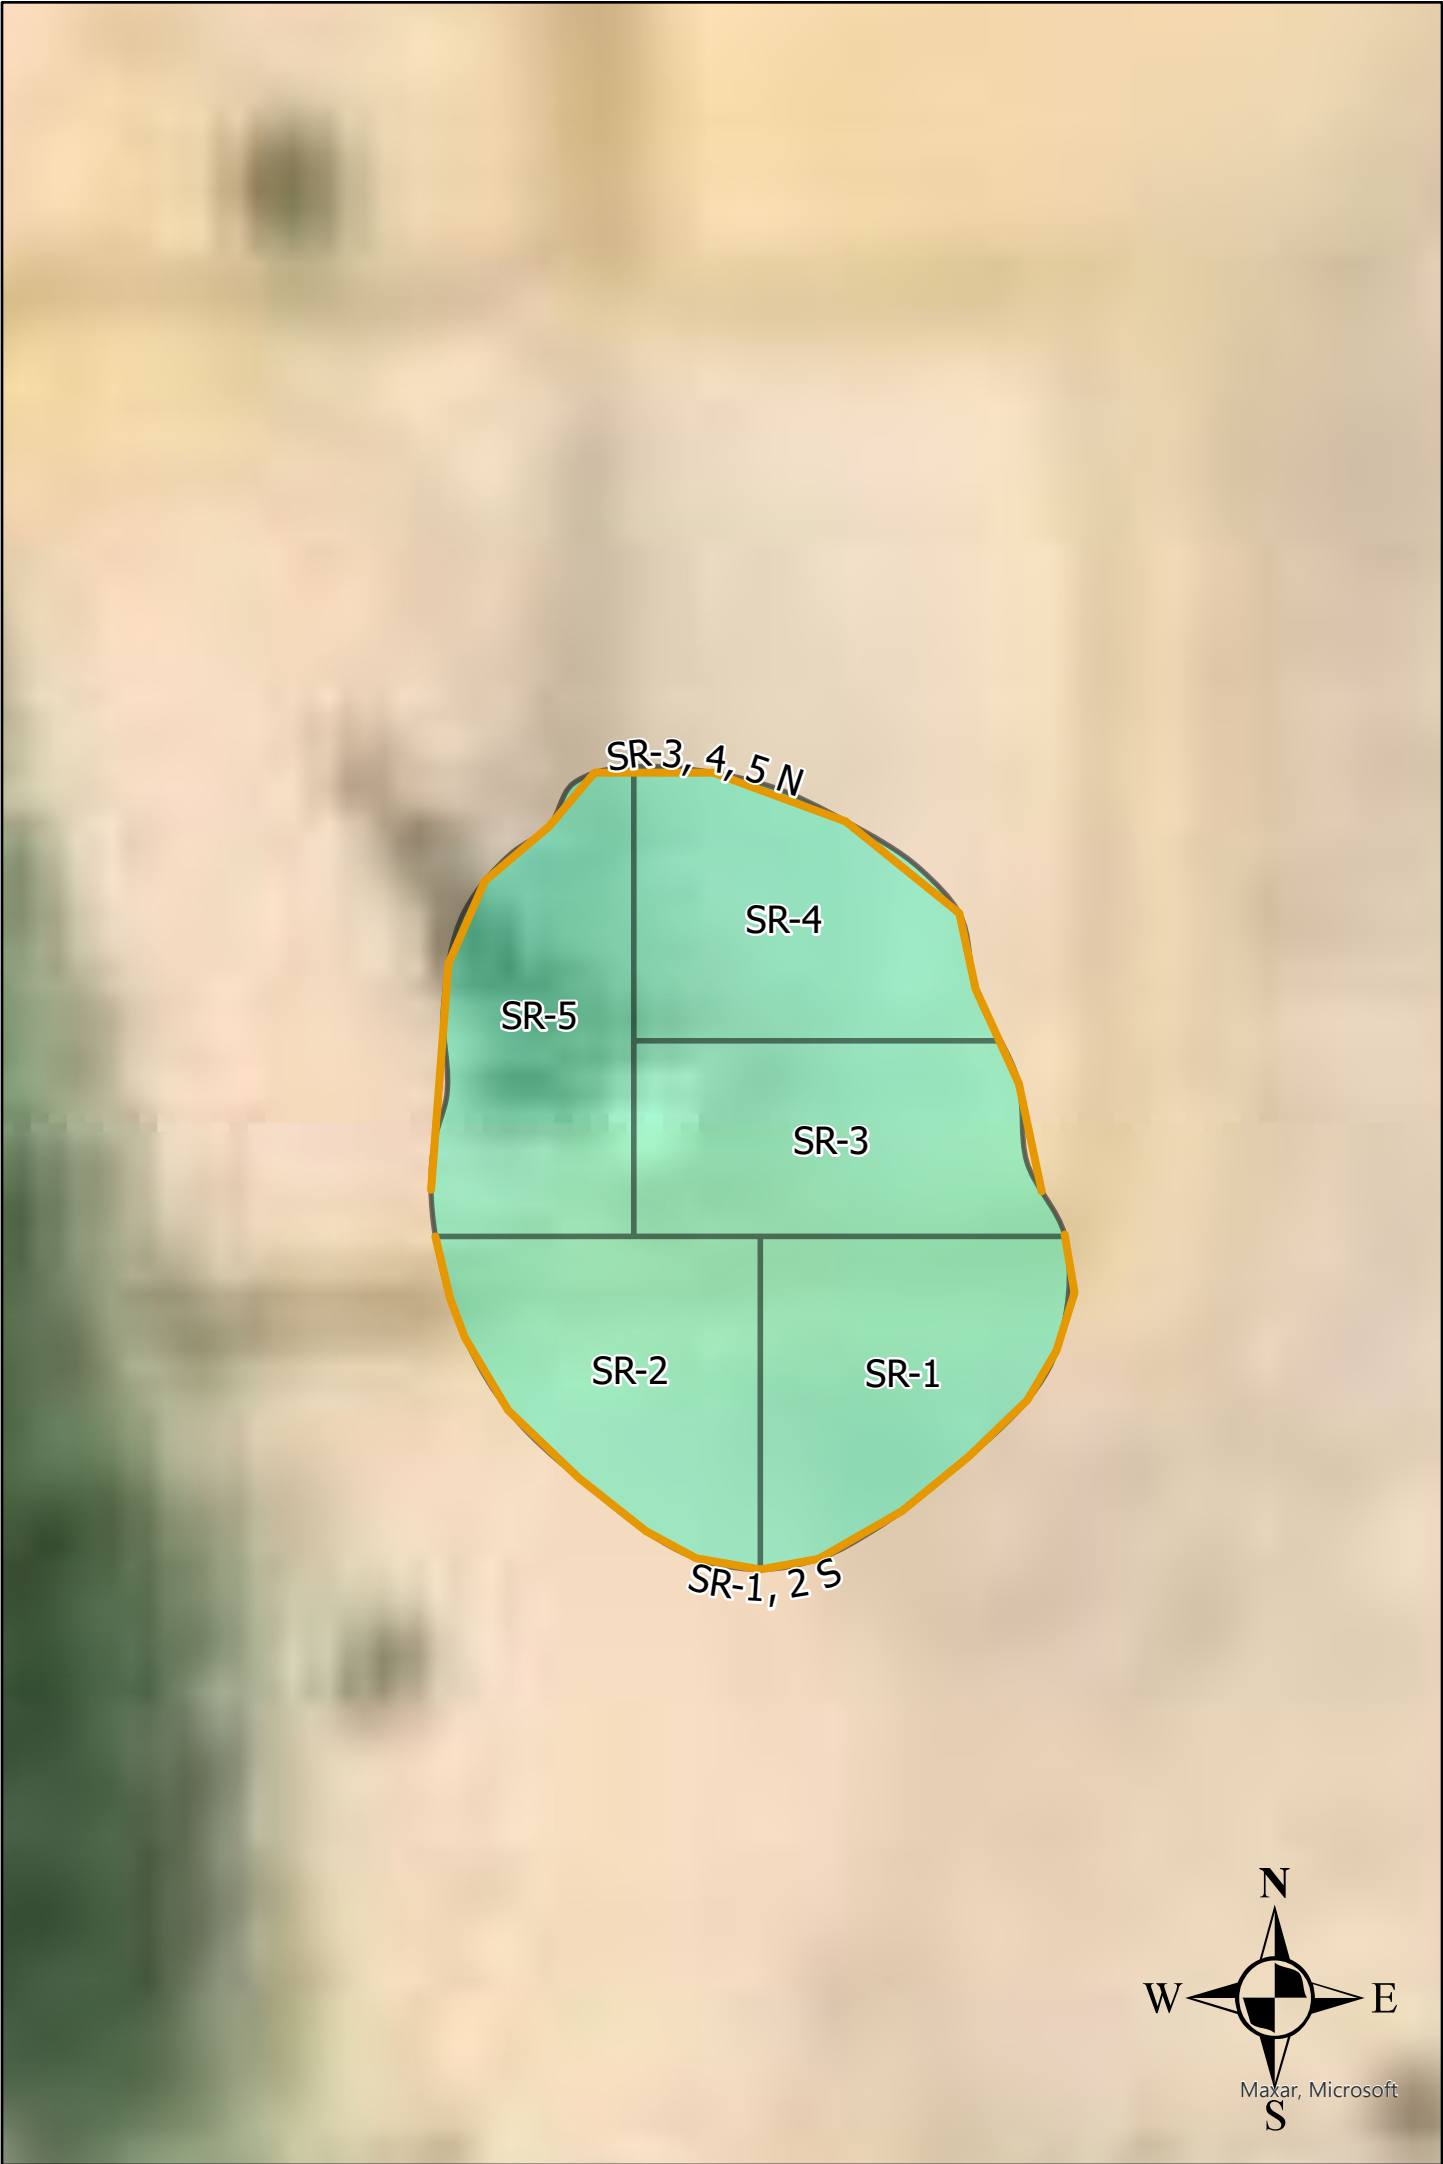
Figure 2
Site Delineation Map
Mewbourne Oil Co.
Delaware Ranch 11 W2NC #1H
Eddy County, New Mexico
NMOCD Reference #
NAPP2201859426

- Remediation Walls
- Remediation Floors - 200 sqFt.
- Release Area

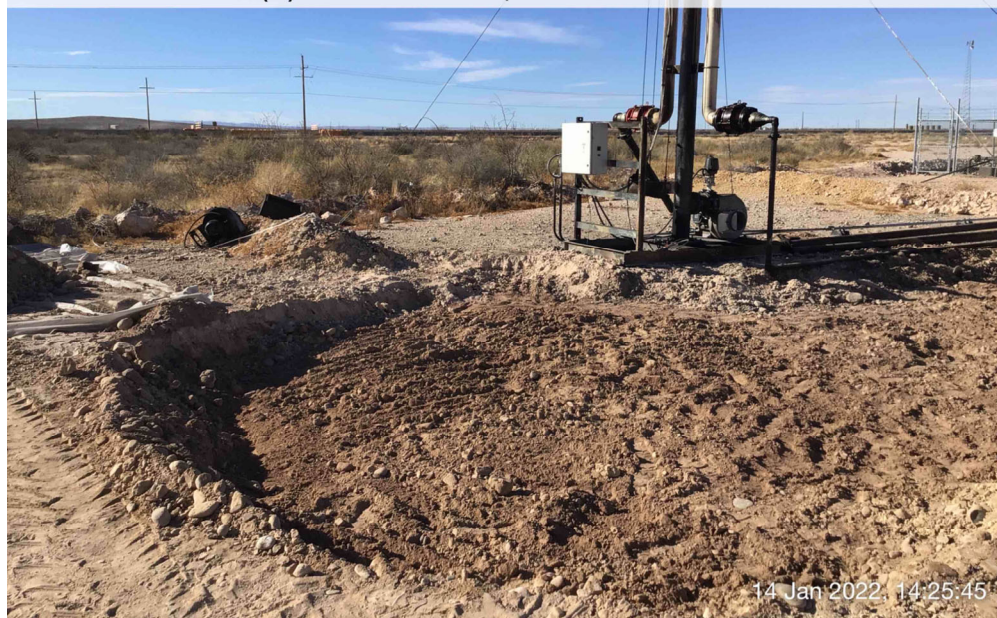
South East Elevation

Excavation

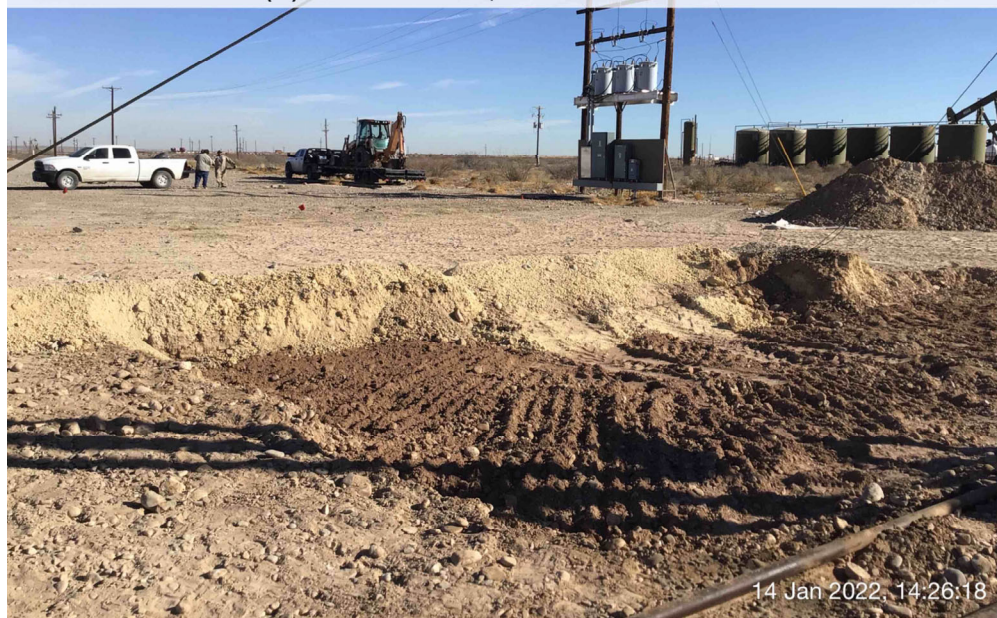
North West Elevation

Excavation

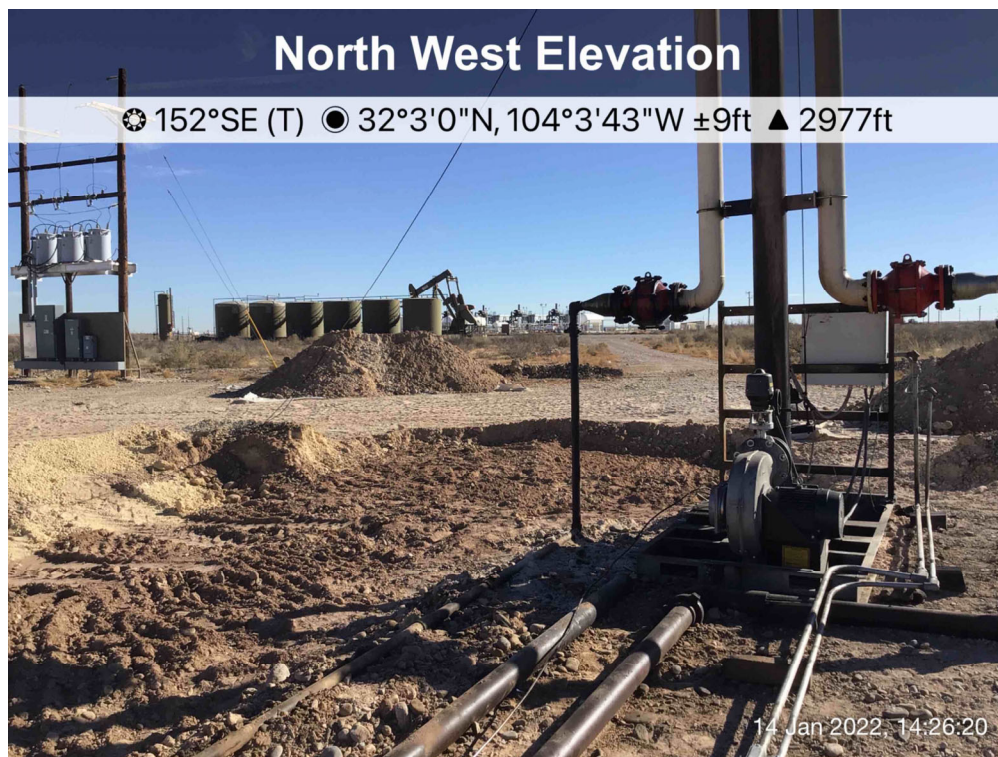
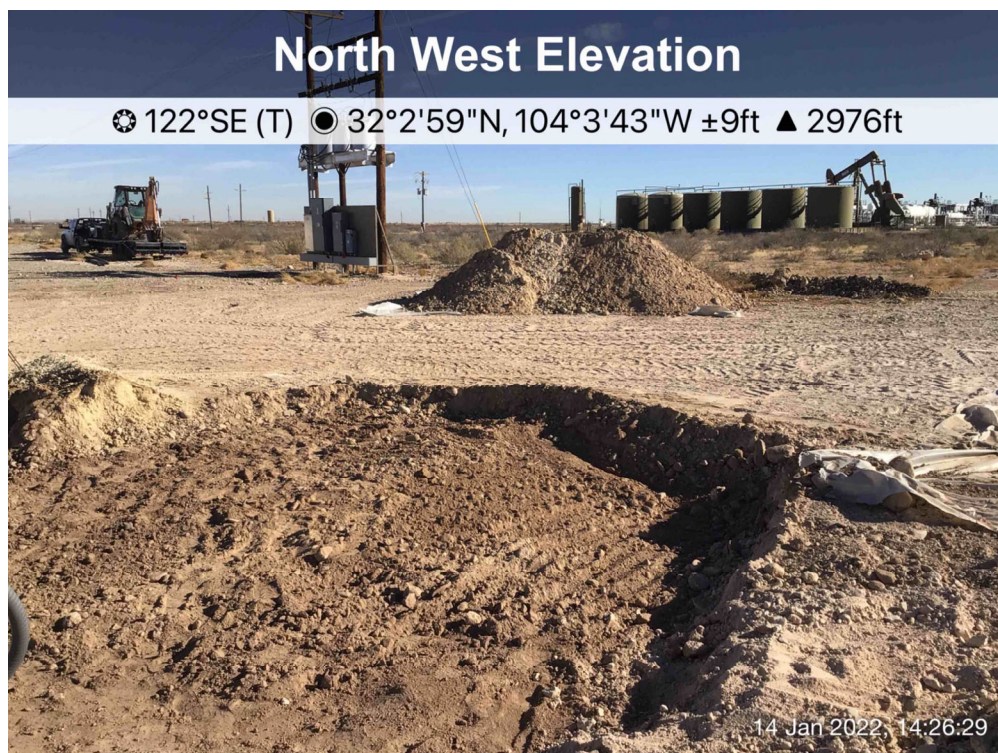
Excavation

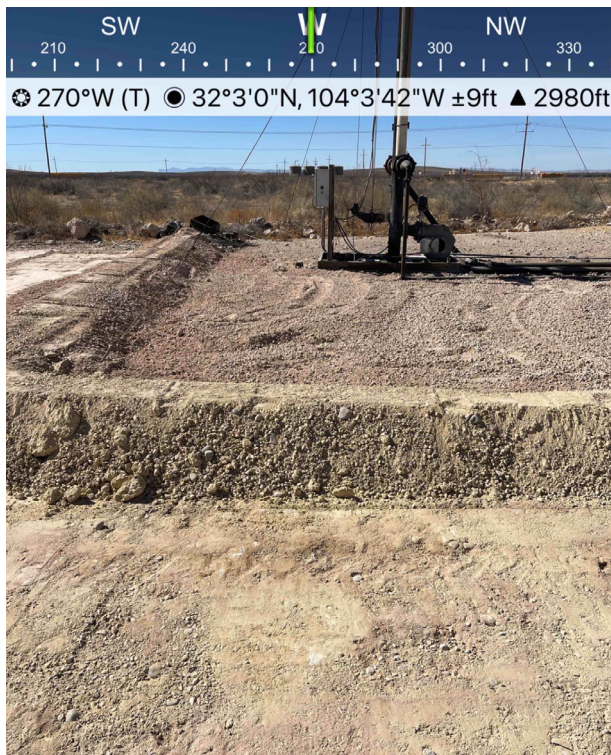
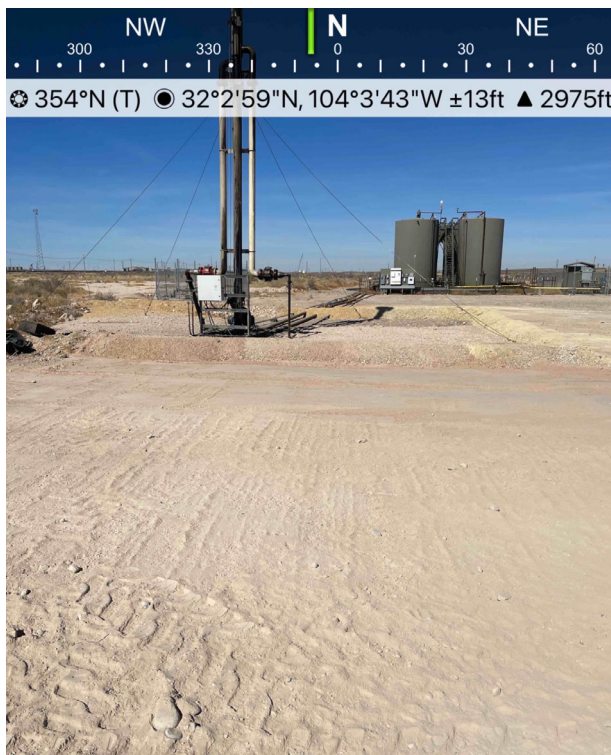
Backfill

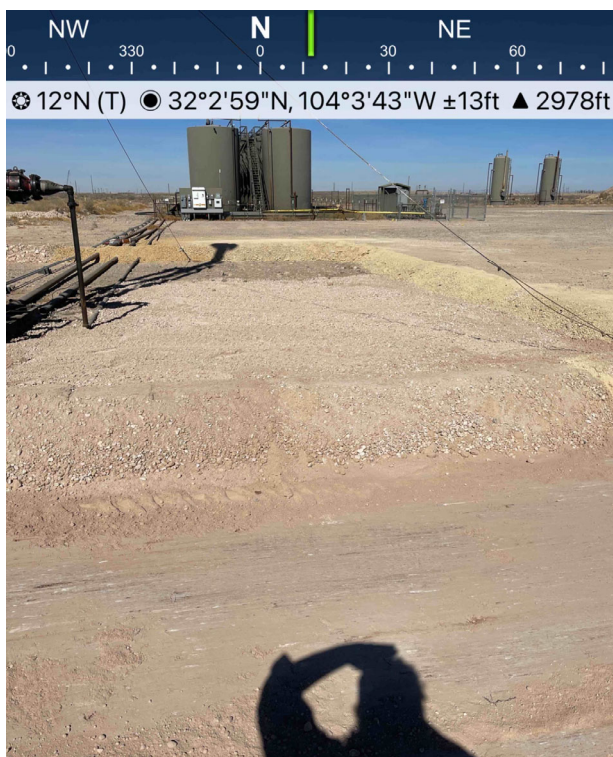
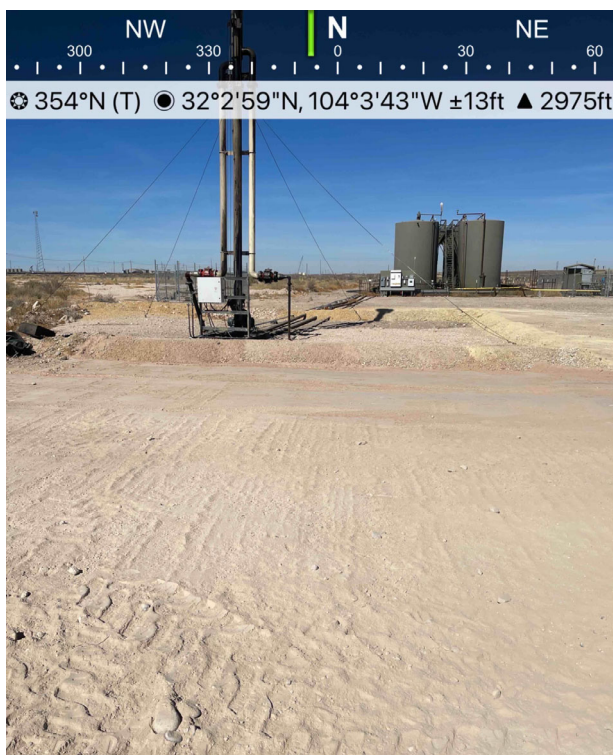
Backfill
