**Re: Release Characterization and Closure Request
ConocoPhillips
Heritage Concho
Moody 18 State Com #001H Release
Unit Letter D, Section 15, Township 25 South, Range 28 East
Eddy County, New Mexico
Incident ID# NJMW1308640545
2RP-1591**

Release Characterization and Closure Request
February 15, 2022

**MOODY 18 STATE COM #001H RELEASE
TOPOGRAPHIC MAP**

**MOODY 18 STATE COM #001H RELEASE
APPROXIMATE RELEASE LOCATION MAP**

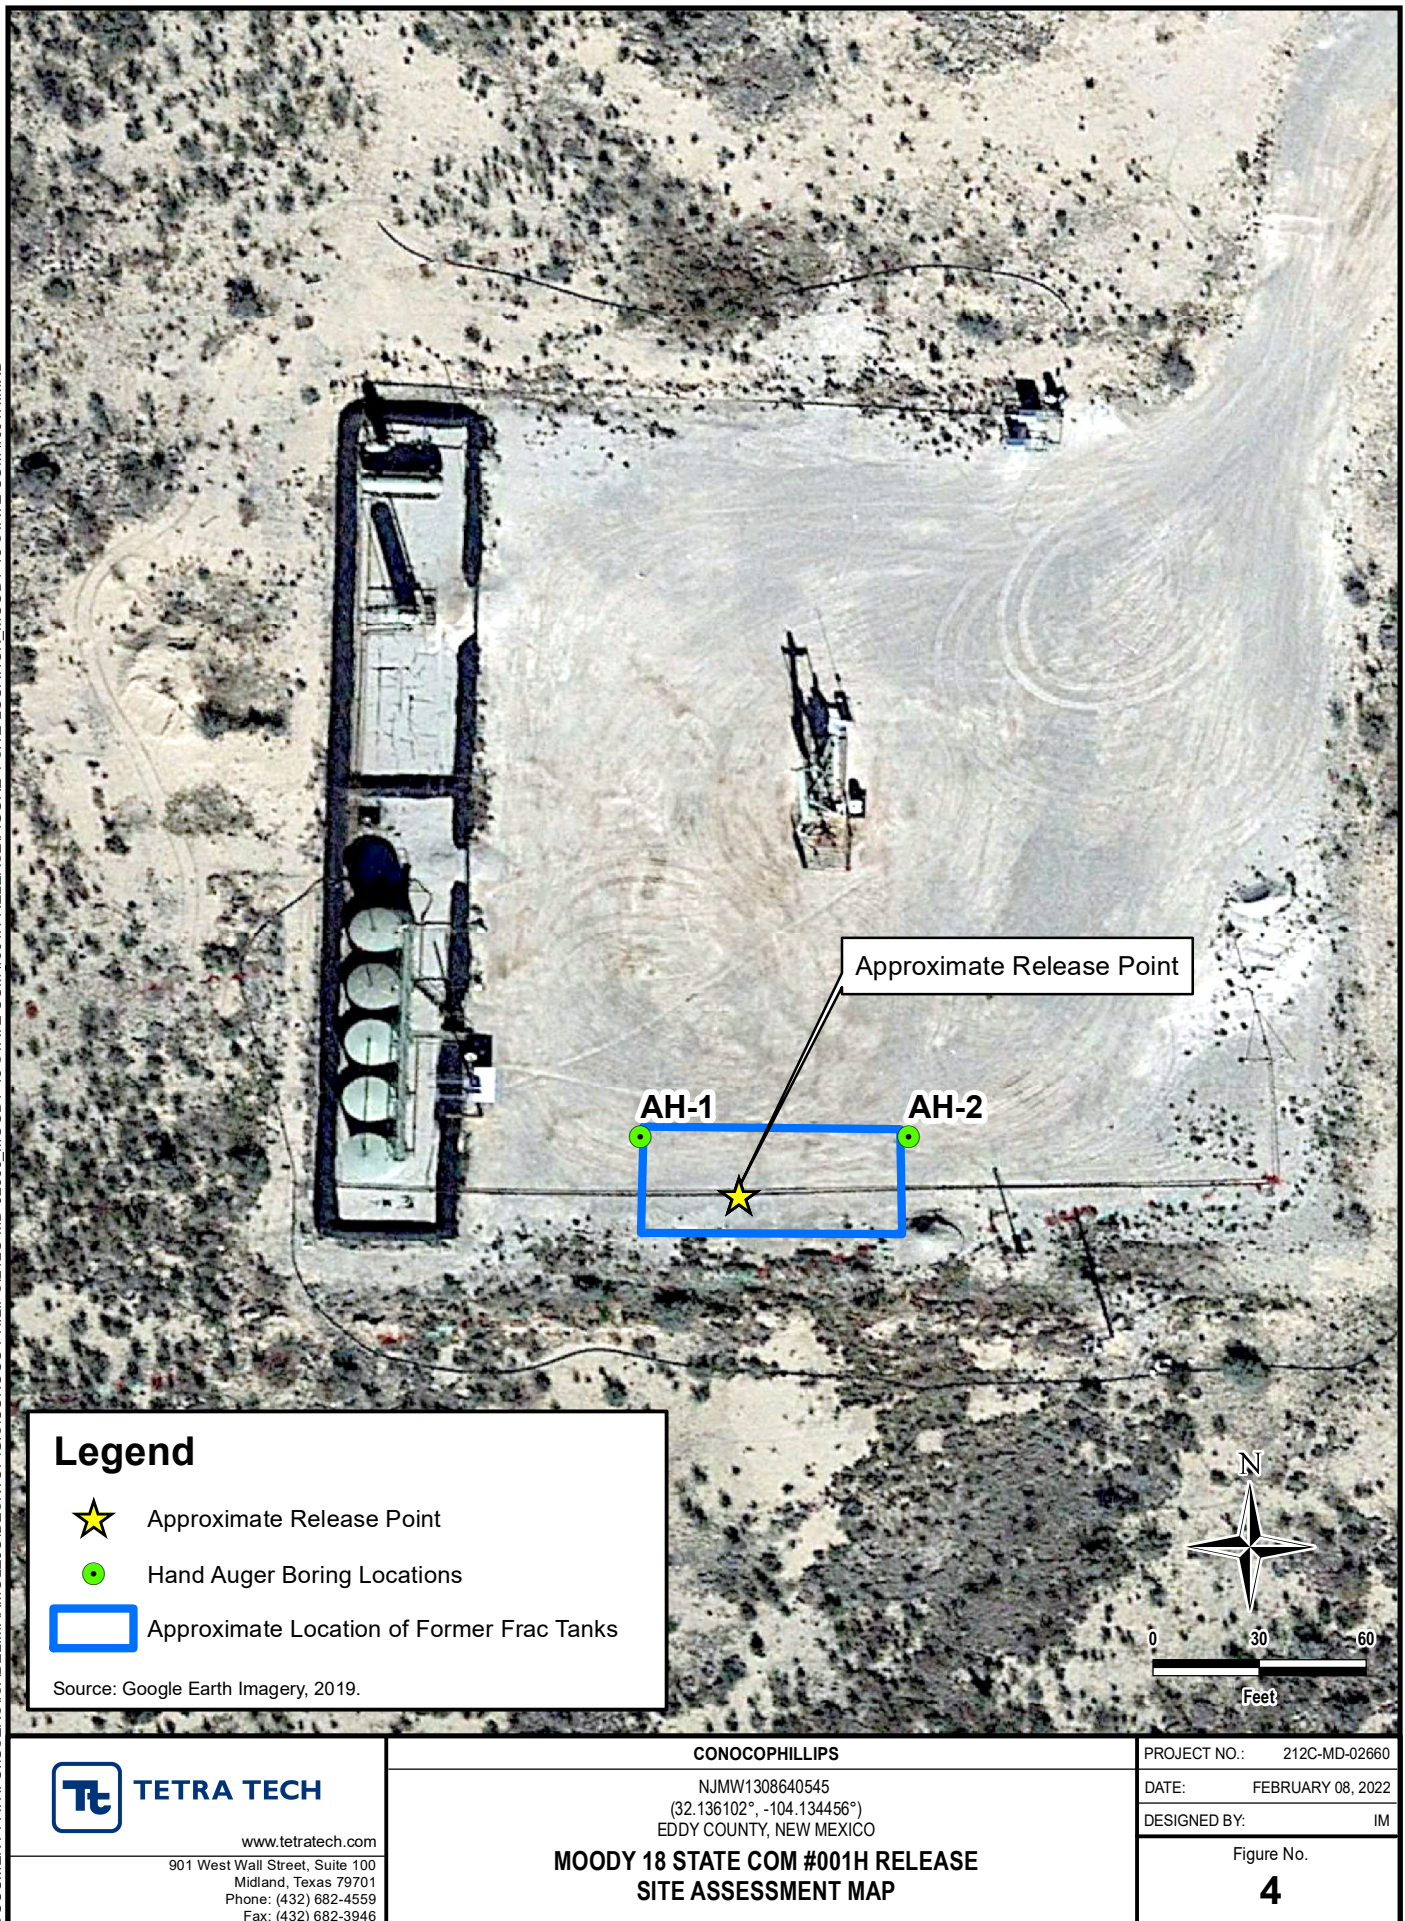
DOCUMENT PATH: C:\USERS\ISABEL.MARMOLEJO\DESKTOP\GIS\CONOCO PHILIPS\212C-MD-02660_MOODY 18 STATE COM #001H RELEASE\FIGURE 4 SITE LOCATION_MOODY 18 STATE COM #001H.MXD

On March 26, 2019, following the removal of the frac tanks, Concho was onsite to install two (2) hand auger borings (AH-1 and AH-2) at the former release location to total depths of 2 feet bgs to assess the release. The sampling locations are presented in Figure 4. A total of four (4) soil samples were collected from two (2) borings and sent to Xenco Laboratories in Midland, Texas to be analyzed for chlorides via EPA method 300, TPH via EPA Method 8015M and BTEX via EPA Method 8021B. A copy of the laboratory analytical report and chain-of-custody documentation are included in Appendix C.

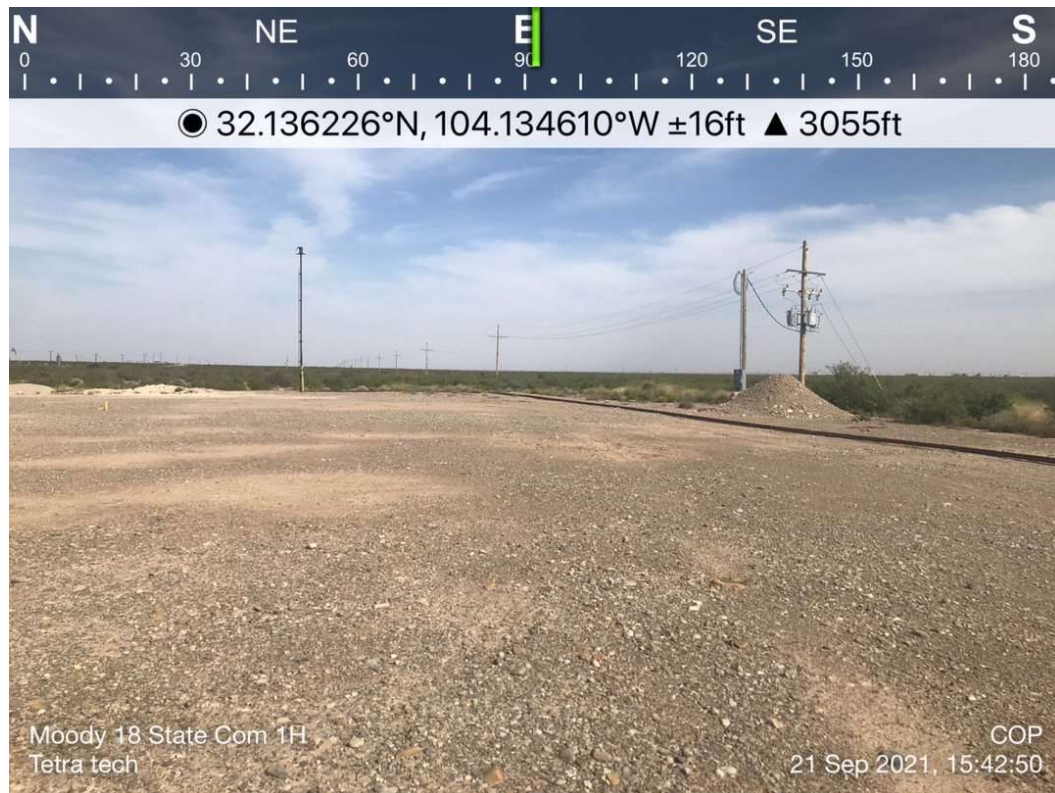
TETRA TECH, INC. PROJECT NO. 212C-MD-02578	DESCRIPTION	View east of the release area and lease pad.	2
	SITE NAME	HConcho - MOODY 18 STATE COM #001H	9/21/2021

Tetra Tech conducted a visual inspection at the Site on September 21, 2021 to assess current site conditions. No evidence of surface staining or the release was observed during the visual inspection. Photographic documentation from the visual inspection is presented in Appendix D.

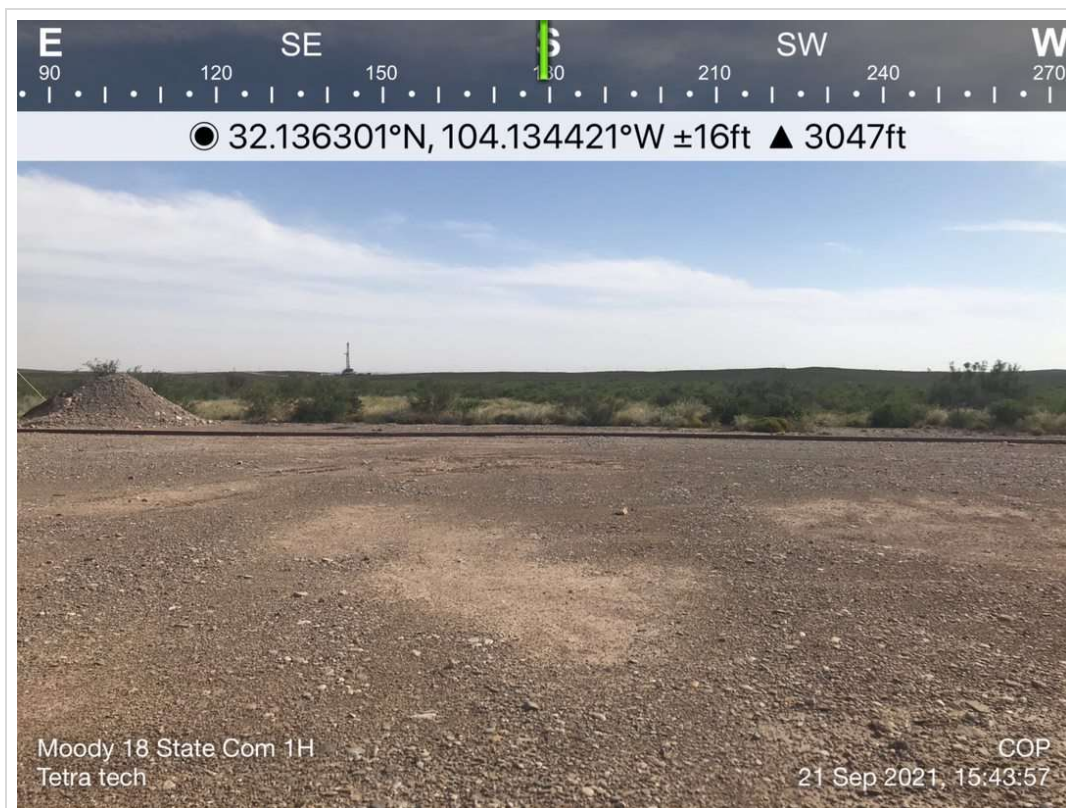
TETRA TECH, INC. PROJECT NO. 212C-MD-02578	DESCRIPTION	View south of the release area and lease pad.	3
	SITE NAME	HConcho - MOODY 18 STATE COM #001H	9/21/2021

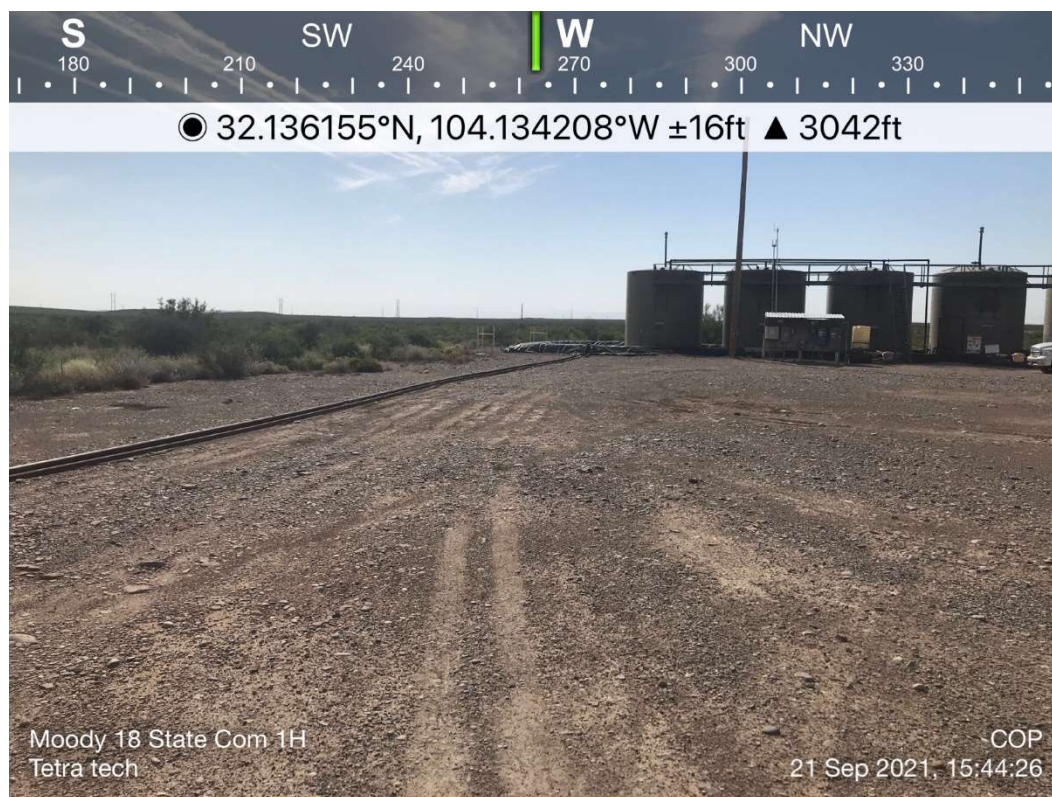
TETRA TECH, INC. PROJECT NO. 212C-MD-02578	DESCRIPTION	View west of the existing tanks and lease pad.	4
	SITE NAME	HConcho - MOODY 18 STATE COM #001H	9/21/2021

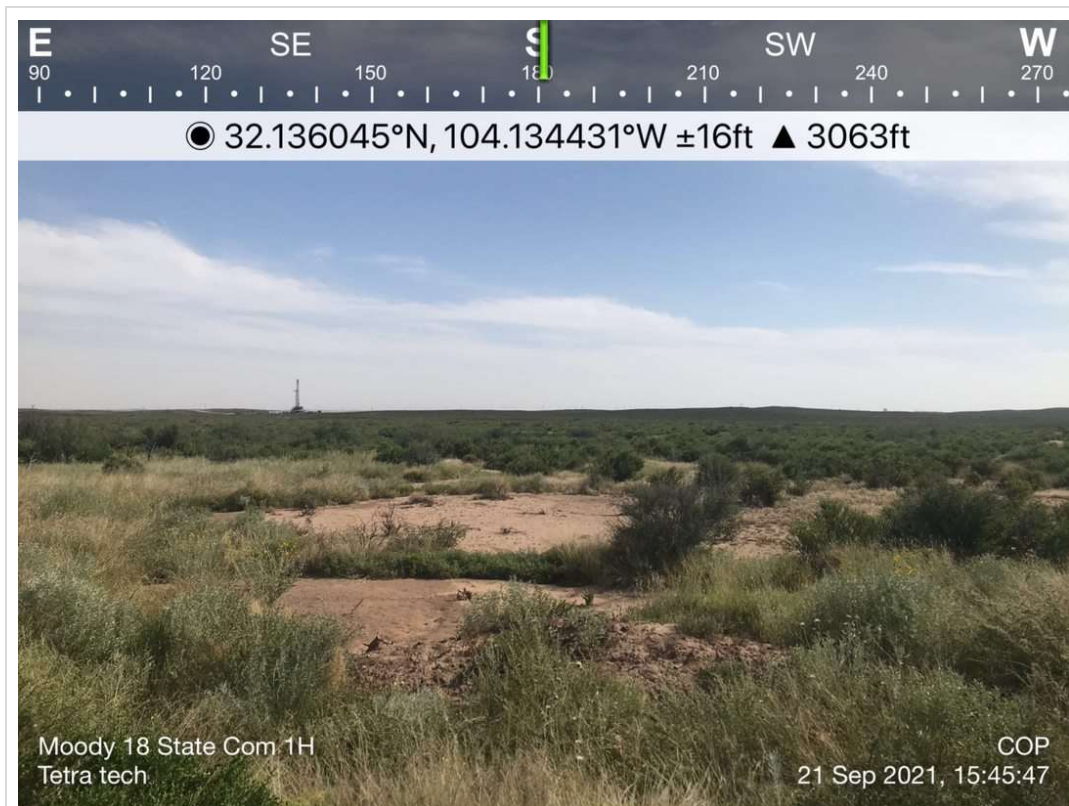
TETRA TECH, INC. PROJECT NO. 212C-MD-02578	DESCRIPTION	View south of the release area and pasture.	5
	SITE NAME	HConcho - MOODY 18 STATE COM #001H	9/21/2021
