February 28, 2022

**Re: Release Characterization and Remediation Work Plan  
ConocoPhillips  
Heritage Concho  
Y Energy State Com #001H Tank Release  
Unit Letter L, Section 32, Township 18 South, Range 30 East  
Eddy County, New Mexico  
Incident ID# nMLB1122348831  
2RP-831**

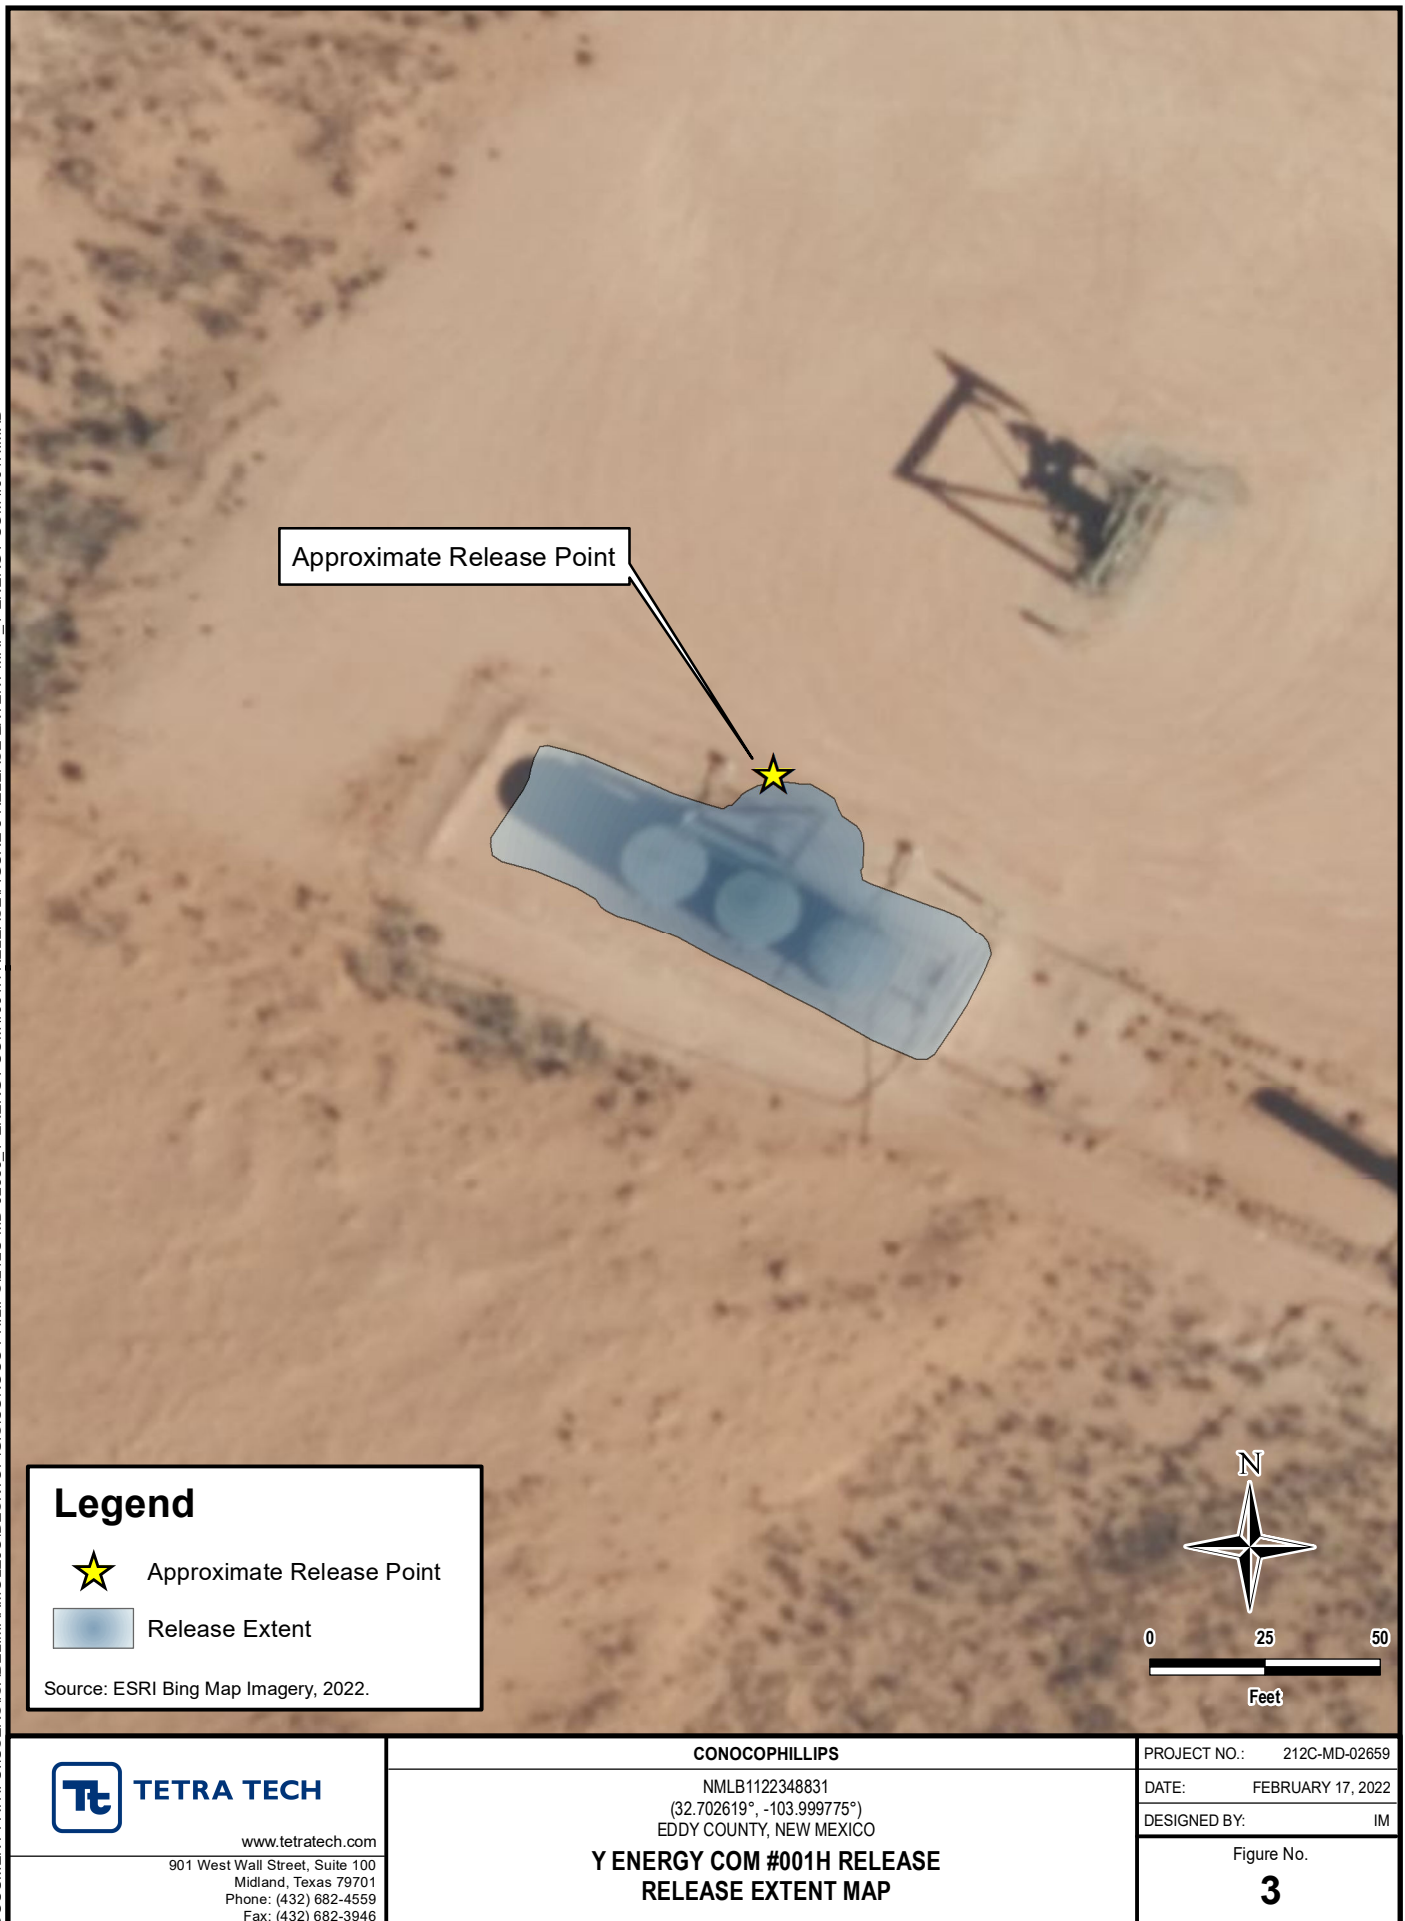
DOCUMENT PATH: C:\USERS\ISABEL.MARMOLEJO\DESKTOP\GIS\CONOCO PHILIPS\212C-MD-02659\_Y ENERGY COM #001H RELEASE\FIGURE 3 RELEASE EXTENT MAP\_Y ENERGY COM #001H.MXD

As mentioned, following the release, Concho dispatched vacuum trucks to recover standing fluid and removed visually impacted soils and gravels from within the berm walls of the facility. The release extent and approximate release location are presented in Figure 3. Tetra Tech conducted a visual inspection at the Site on September 21, 2021, to assess current site conditions. No evidence of surface staining or the release was observed during the visual inspection. Photographic documentation from the visual inspection is presented in Appendix C.

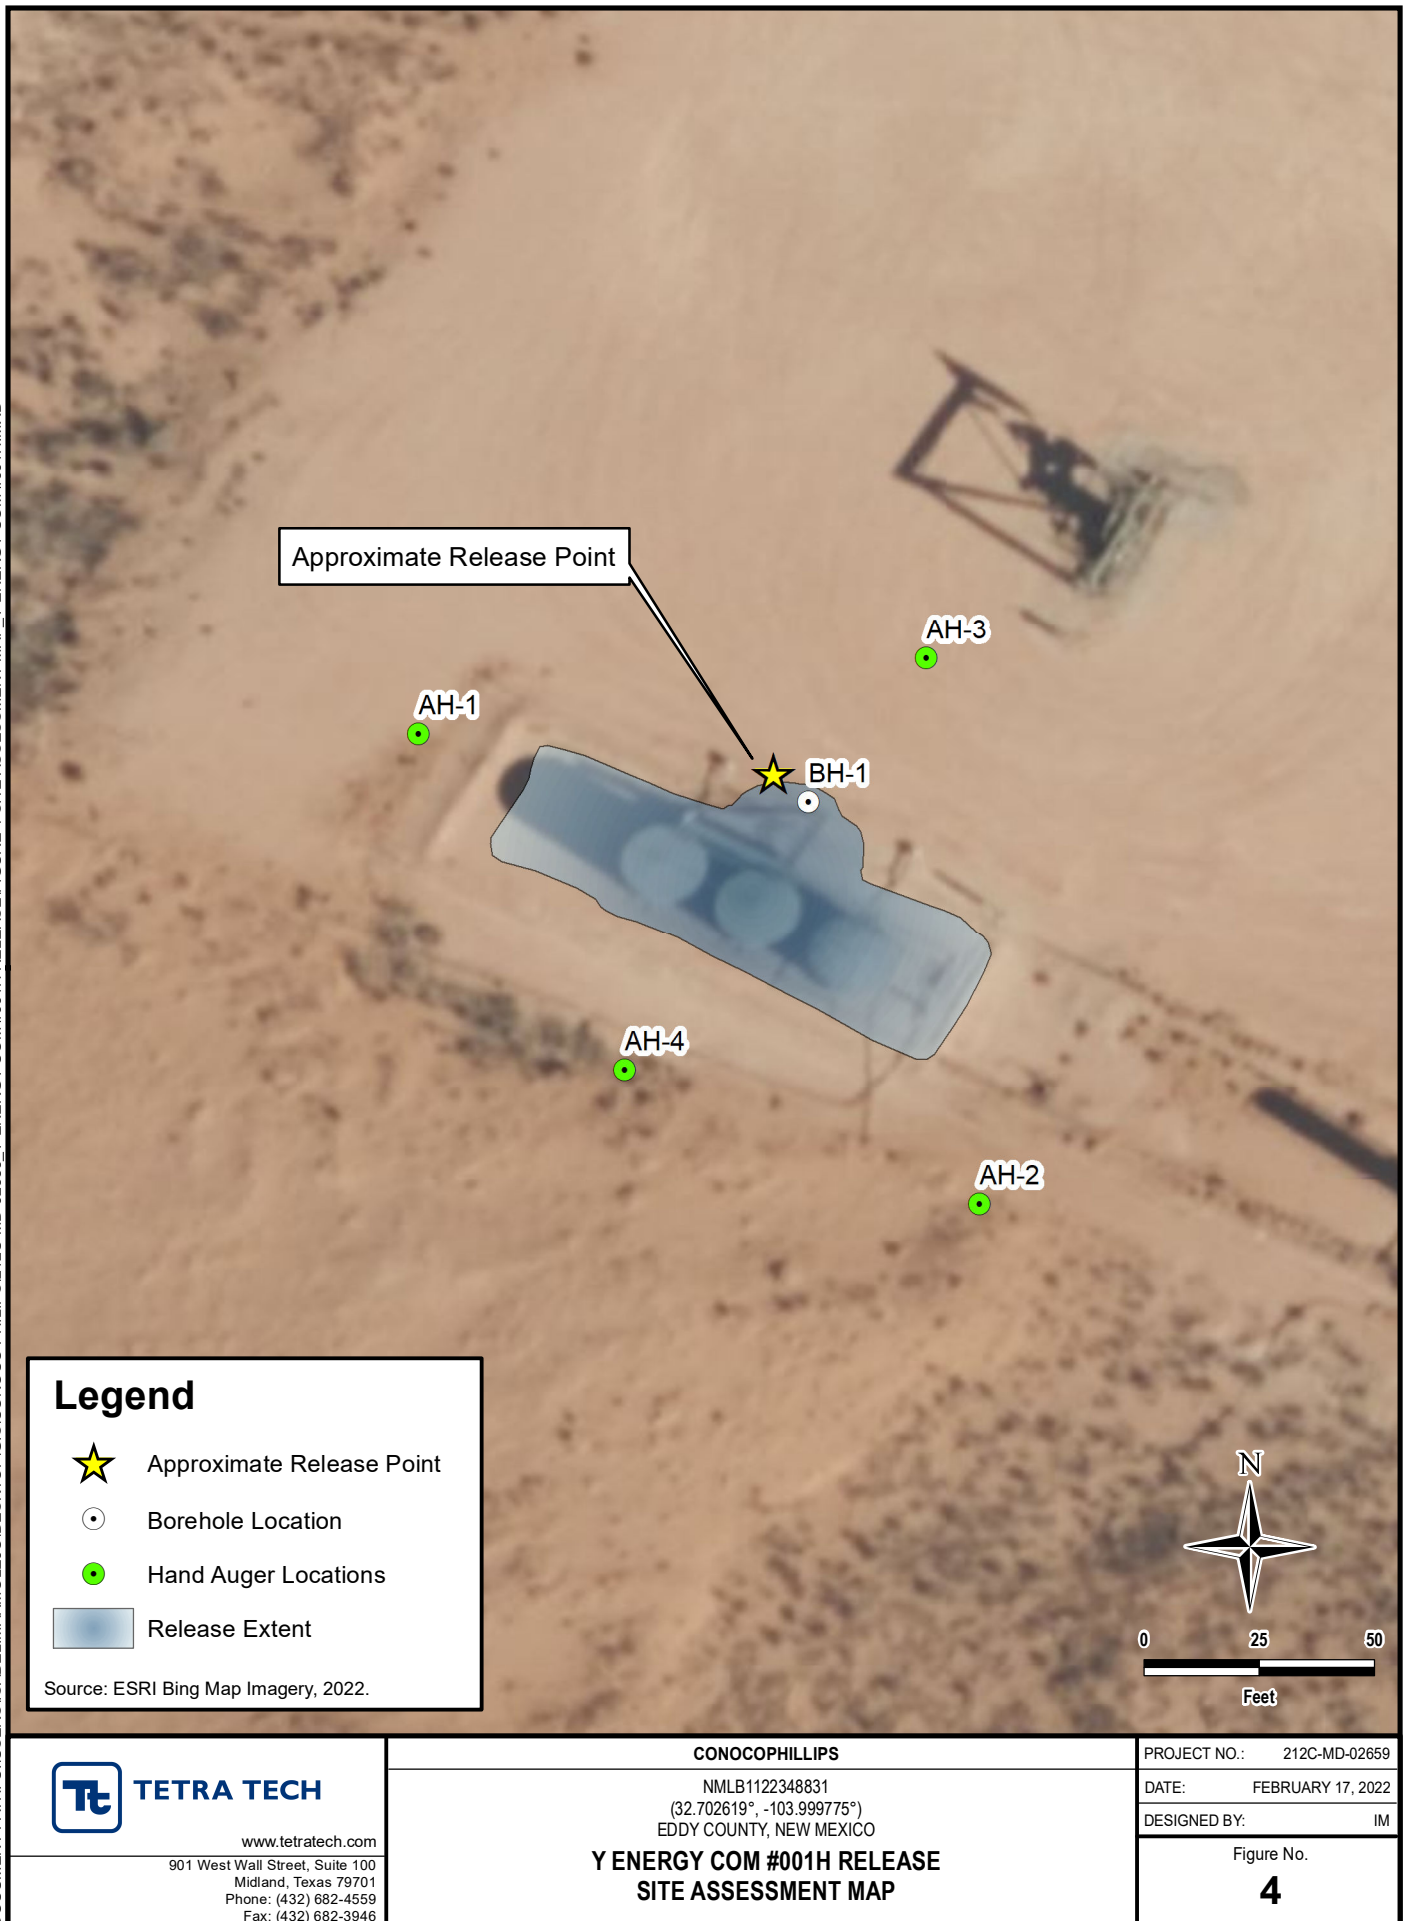
DOCUMENT PATH: C:\USERS\ISABEL.MARMOLEJO\DESKTOP\GIS\CONOCO PHILIPS\212C-MD-02659\_Y ENERGY COM #001H RELEASE\FIGURE 4 SITE ASSESSMENT MAP\_Y ENERGY COM #001H.MXD

On January 24, 2022, Tetra Tech personnel were on site to assess the release footprint. Four (4) soil borings were complete with hand auger (AH-1 through AH-4) to depths of 2 feet bgs to complete horizontal delineation of the release extent. Tetra Tech returned to the site on February 9, to drill one (1) soil boring (BH-1) using an air rotary drilling rig immediately adjacent to the berm wall to a depth of 10 feet bgs to complete vertical delineation of the release extent. Sampling was not conducted in the area within the berm walls because this area was inaccessible for the drilling rig. No evidence of staining was observed in the gravel within the berm walls, as shown in the photographic documentation presented in Appendix C. Boring locations are presented in Figure 4.

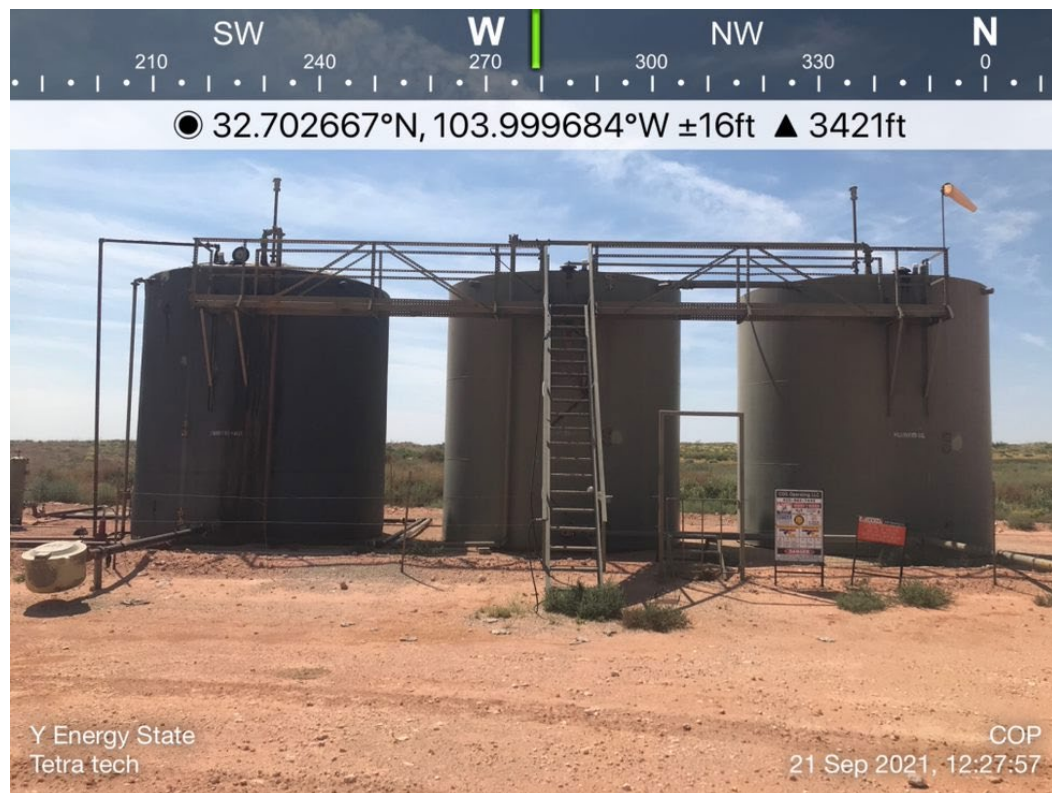
TETRA TECH, INC. PROJECT NO. 212C-MD-02578	DESCRIPTION	View west of the release area and tank batteries.	2
	SITE NAME	HConcho - Y ENERGY STATE COM #001H	9/21/2021

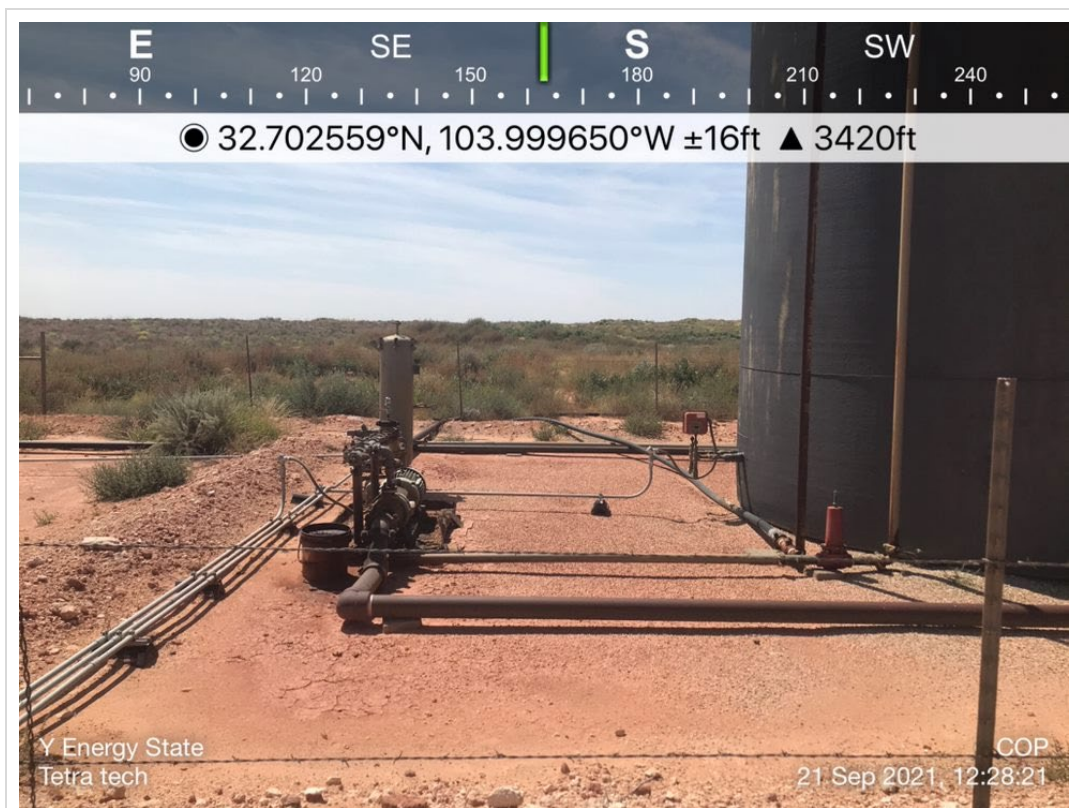
TETRA TECH, INC. PROJECT NO. 212C-MD-02578	DESCRIPTION	View south inside tank battery secondary containment.	3
	SITE NAME	HConcho - Y ENERGY STATE COM #001H	9/21/2021

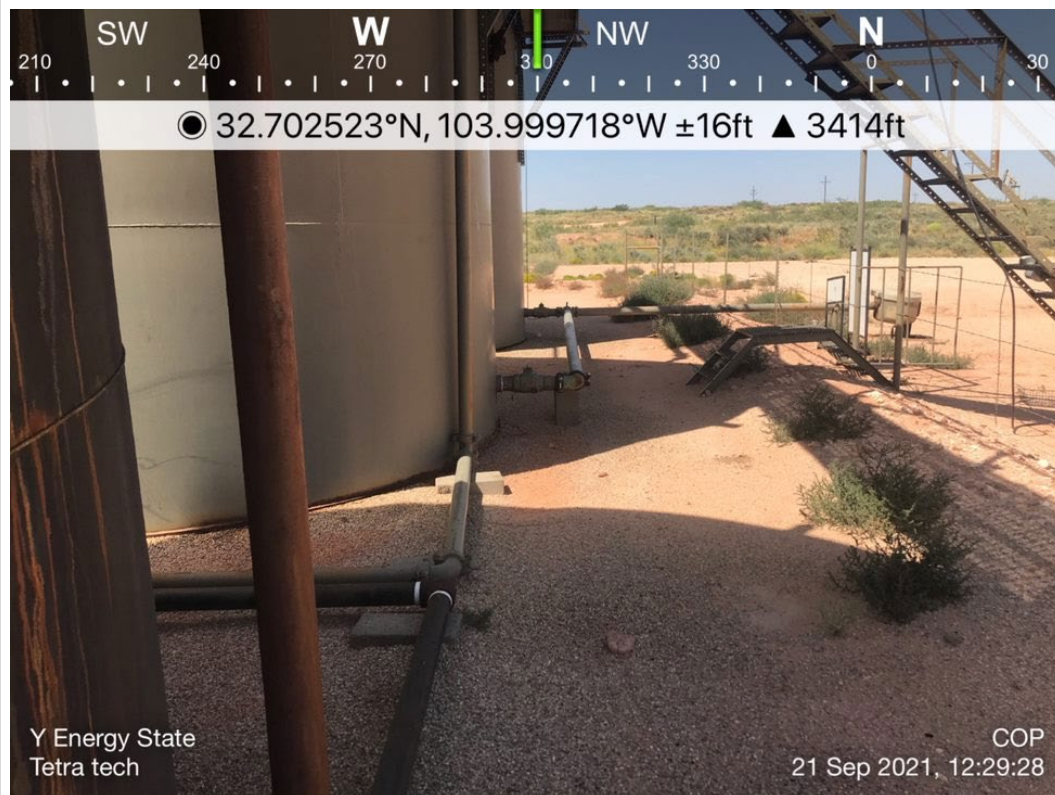
TETRA TECH, INC. PROJECT NO. 212C-MD-02578	DESCRIPTION	View northwest inside tank battery secondary containment.	4
	SITE NAME	HConcho - Y ENERGY STATE COM #001H	9/21/2021

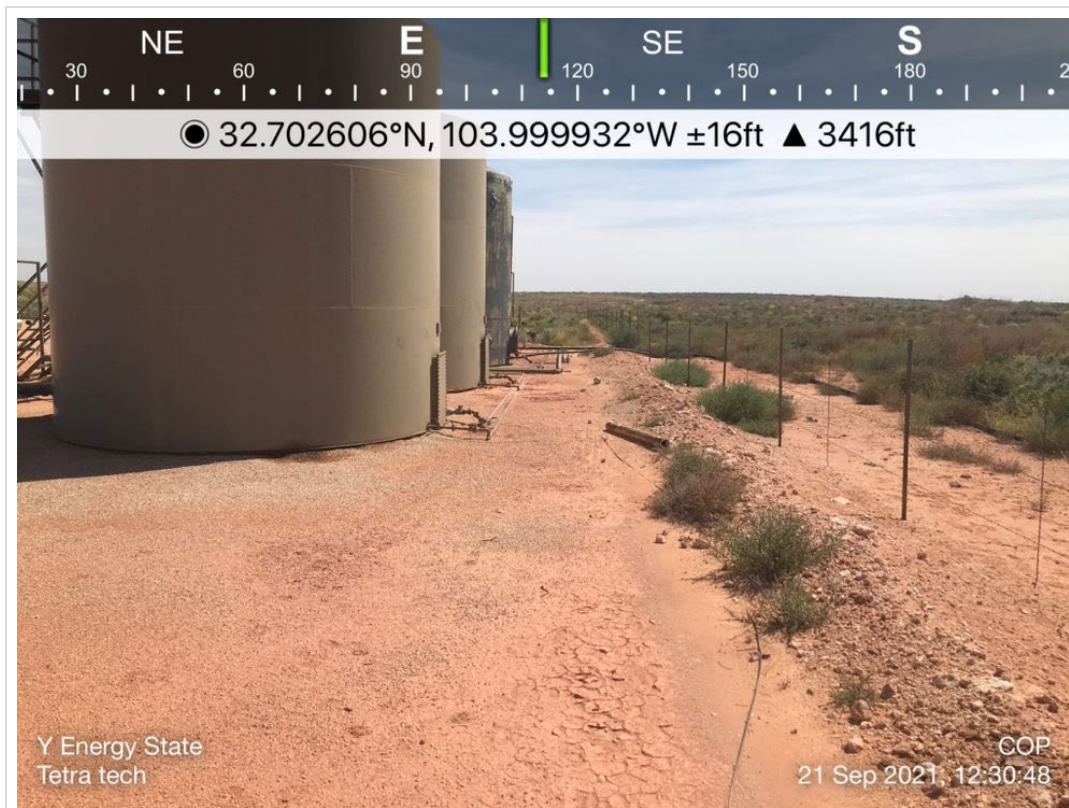
TETRA TECH, INC. PROJECT NO. 212C-MD-02578	DESCRIPTION	View east southeast east release area and tank battery secondary containment.	5
	SITE NAME	HConcho - Y ENERGY STATE COM #001H	9/21/2021

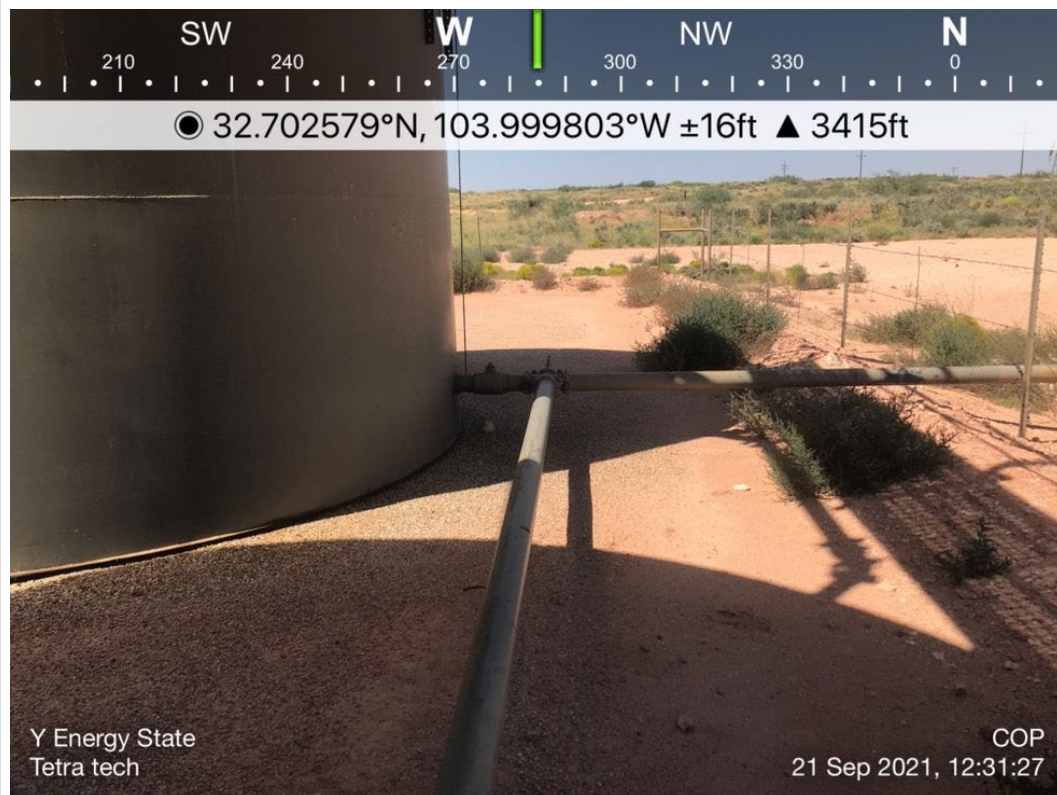
TETRA TECH, INC. PROJECT NO. 212C-MD-02578	DESCRIPTION	View west of the release area and tank battery secondary containment.	6
	SITE NAME	HConcho - Y ENERGY STATE COM #001H	9/21/2021
