**Re: Release Characterization and Closure Request
ConocoPhillips
Heritage Concho
McIntyre DK Federal #003 Water Tank Release
Unit Letter N, Section 17, Township 17 South, Range 30 East
Eddy County, New Mexico
Incident ID# nAB1424627897
2RP-2463**

Release Characterization and Closure Request
January 31, 2022

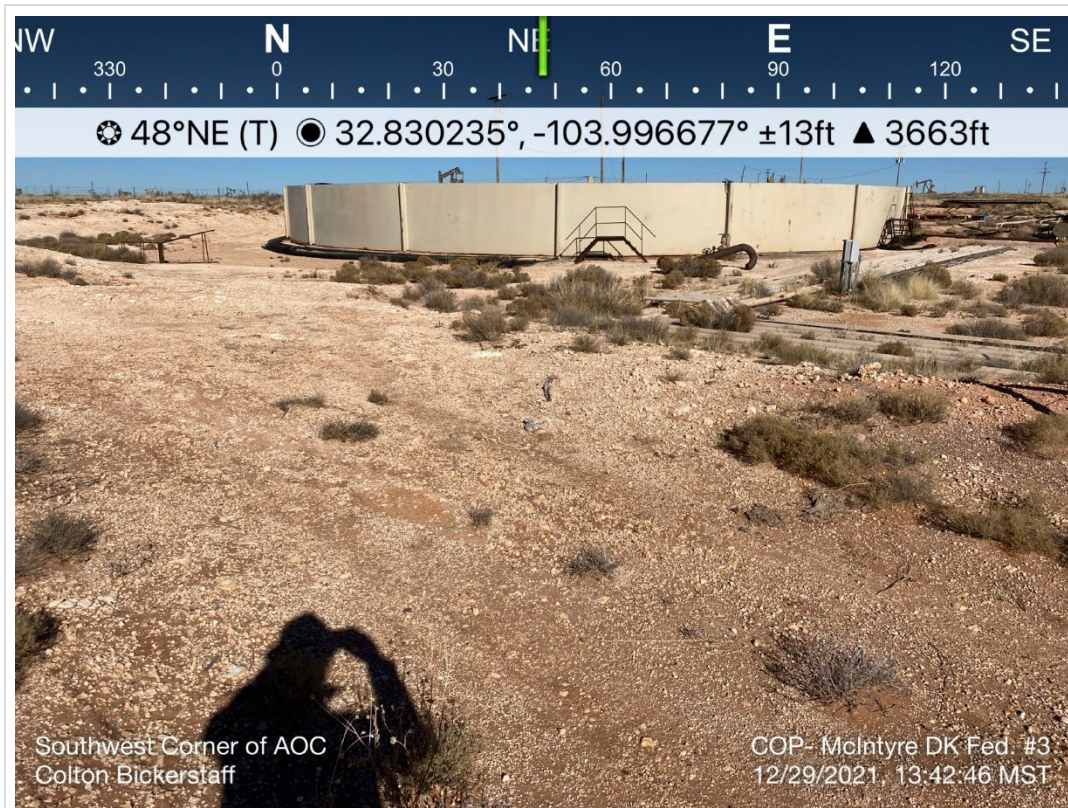
Tetra Tech performed a visual inspection on behalf of ConocoPhillips at the Site on December 29, 2021 to assess current Site conditions. No evidence of lasting impacts from the August 2014 release were observed

TETRA TECH, INC. PROJECT NO. 212C-MD-02620	DESCRIPTION	View northeast. Southwest corner of visually assessed area.	1
	SITE NAME	McIntyre DK Federal 3	12/29/2021

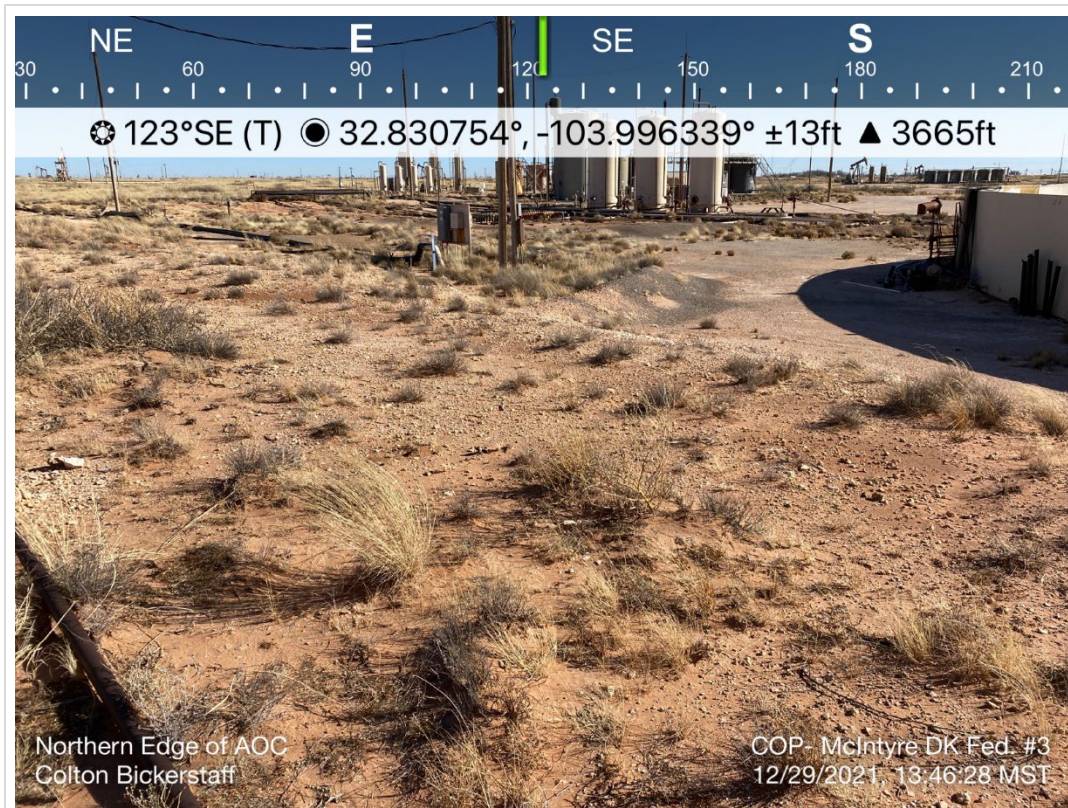
TETRA TECH, INC. PROJECT NO. 212C-MD-02620	DESCRIPTION	View east-southeast. Northeast portion of visually assessed area, north of tank.	7
	SITE NAME	McIntyre DK Federal 3	12/29/2021
