February 28, 2022

**Re: Release Characterization and Remediation Work Plan
ConocoPhillips
Heritage Concho
SRO State Com #008H Battery Release
Unit Letter P, Section 2, Township 26 South, Range 28 East
Eddy County, New Mexico
Incident ID# nHMP1518725850
2RP-3092**

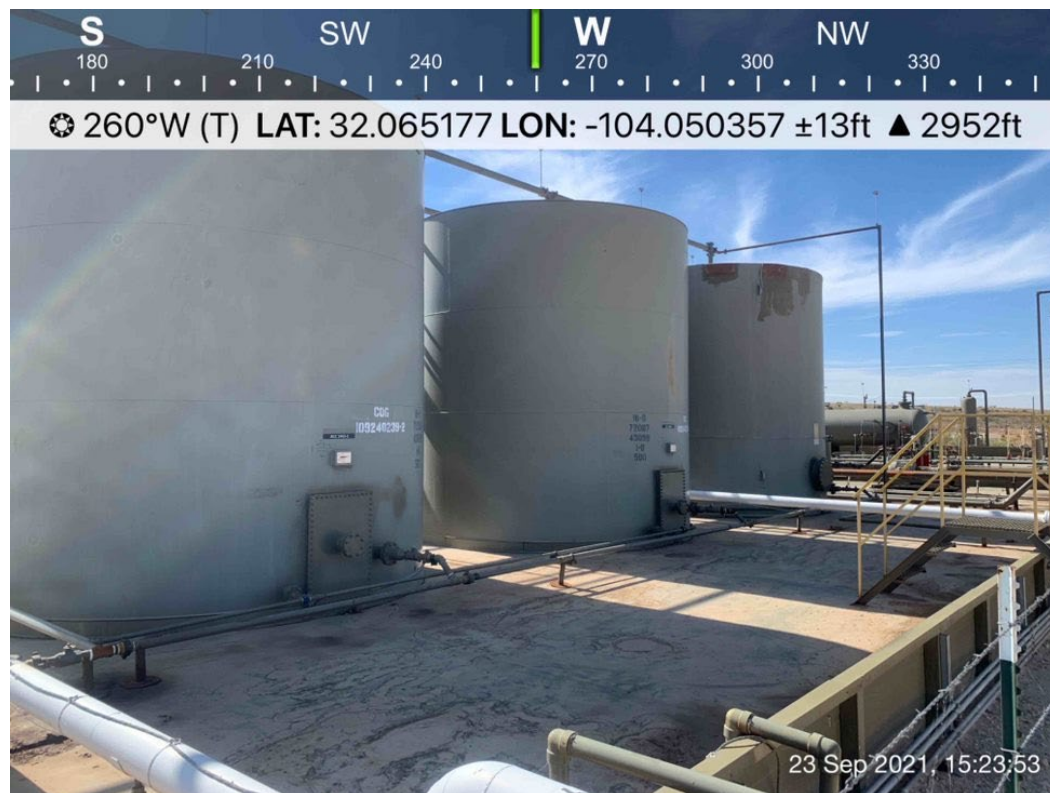
TETRA TECH, INC. PROJECT NO. 212C-MD-02578	DESCRIPTION	View west of release area and tank battery secondary containment.	2
	SITE NAME	HConcho - SRO STATE COM #008H	9/23/2021

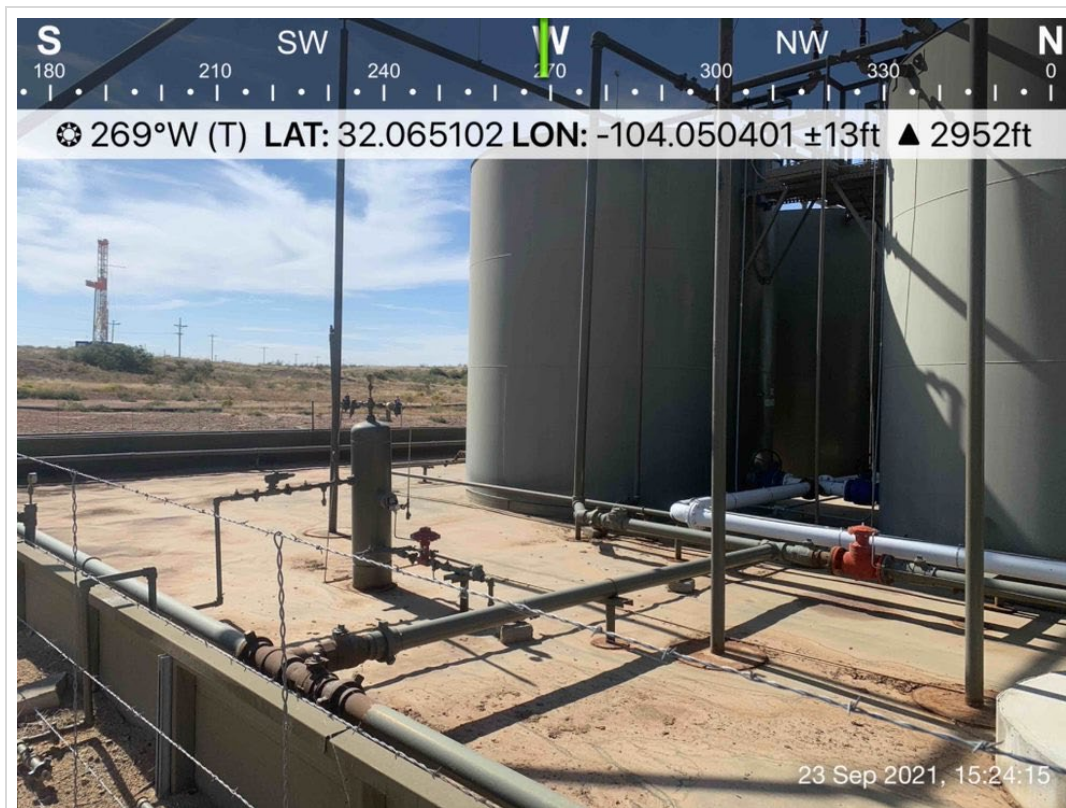
TETRA TECH, INC. PROJECT NO. 212C-MD-02578	DESCRIPTION	View west of release area and tank battery secondary containment.	3
	SITE NAME	HConcho - SRO STATE COM #008H	9/23/2021

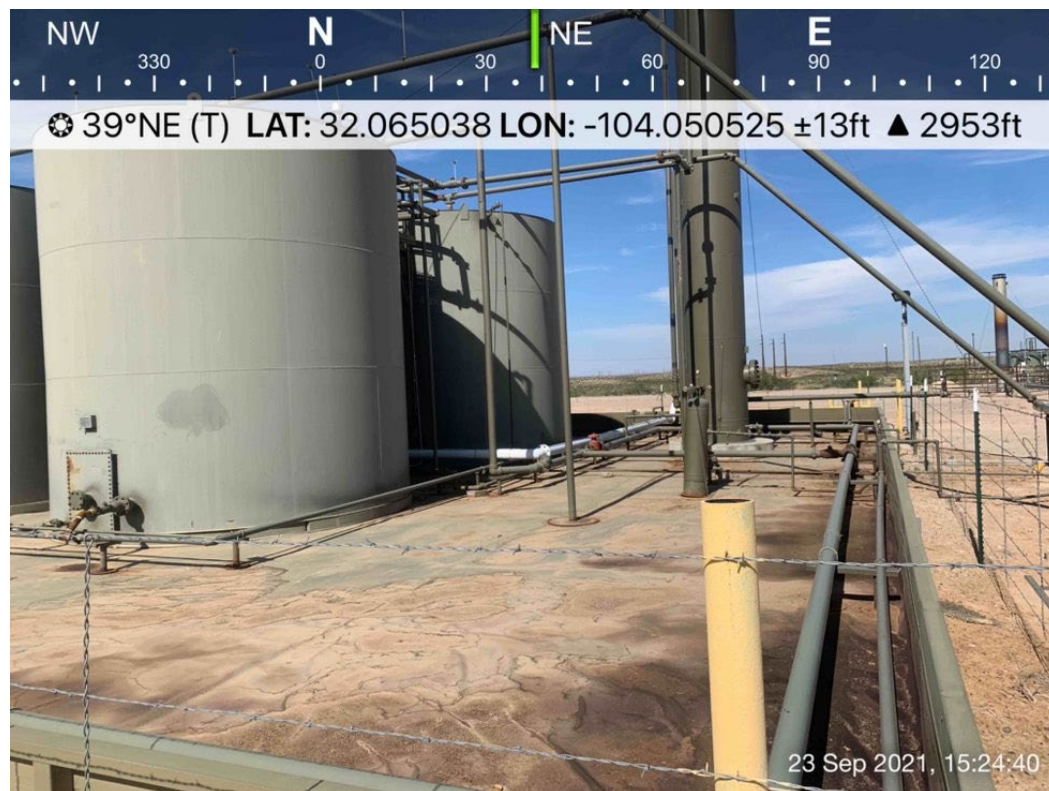
TETRA TECH, INC. PROJECT NO. 212C-MD-02578	DESCRIPTION	View northeast of release area and tank battery secondary containment.	4
	SITE NAME	HConcho - SRO STATE COM #008H	9/23/2021
