Closure Report

Running Buffalo 1 Federal Com 001H (08.27.2021)

Crude Oil Release

Source: Gasket failure at the Free Water Knockout

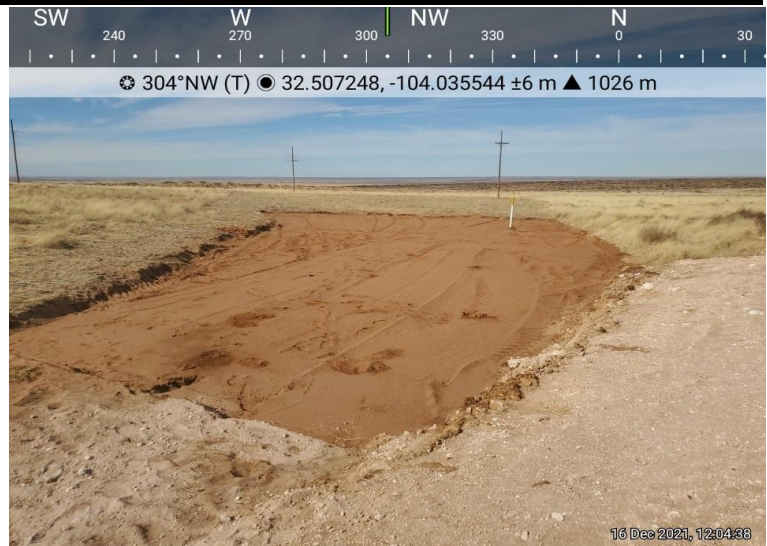
View Northwest, area of confirmation samples (1-18).

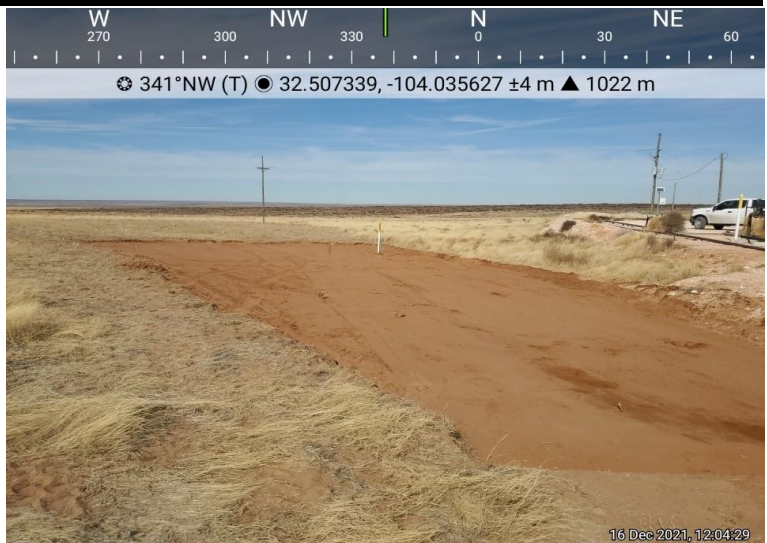
Photograph No. 2

View Northwest, area of confirmation samples (1-18).

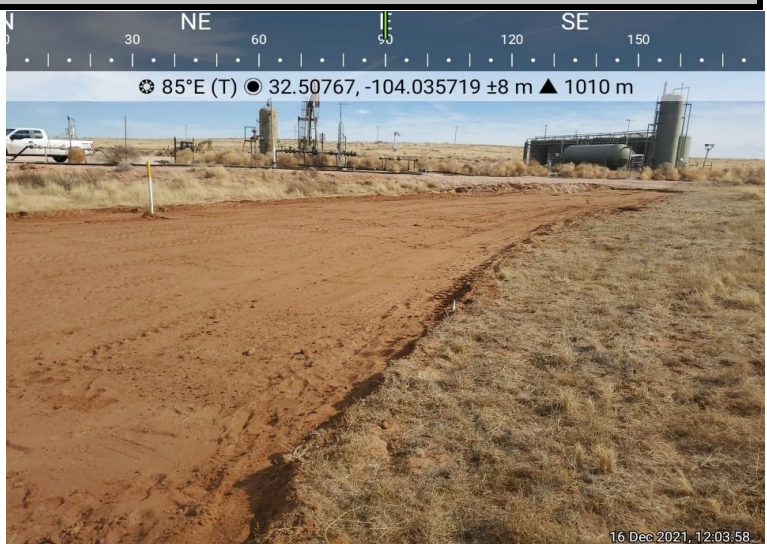
Photograph No. 3

View East, area of confirmation samples (1-18).
