Release Notification

**Re: Closure Request
Corral Canyon Expansion
Incident Number NAPP2132240471
Eddy County, New Mexico**

PHOTOGRAPHIC LOG		
XTO Energy	Corral Canyon Expansion Eddy County, New Mexico	NAPP2132240471

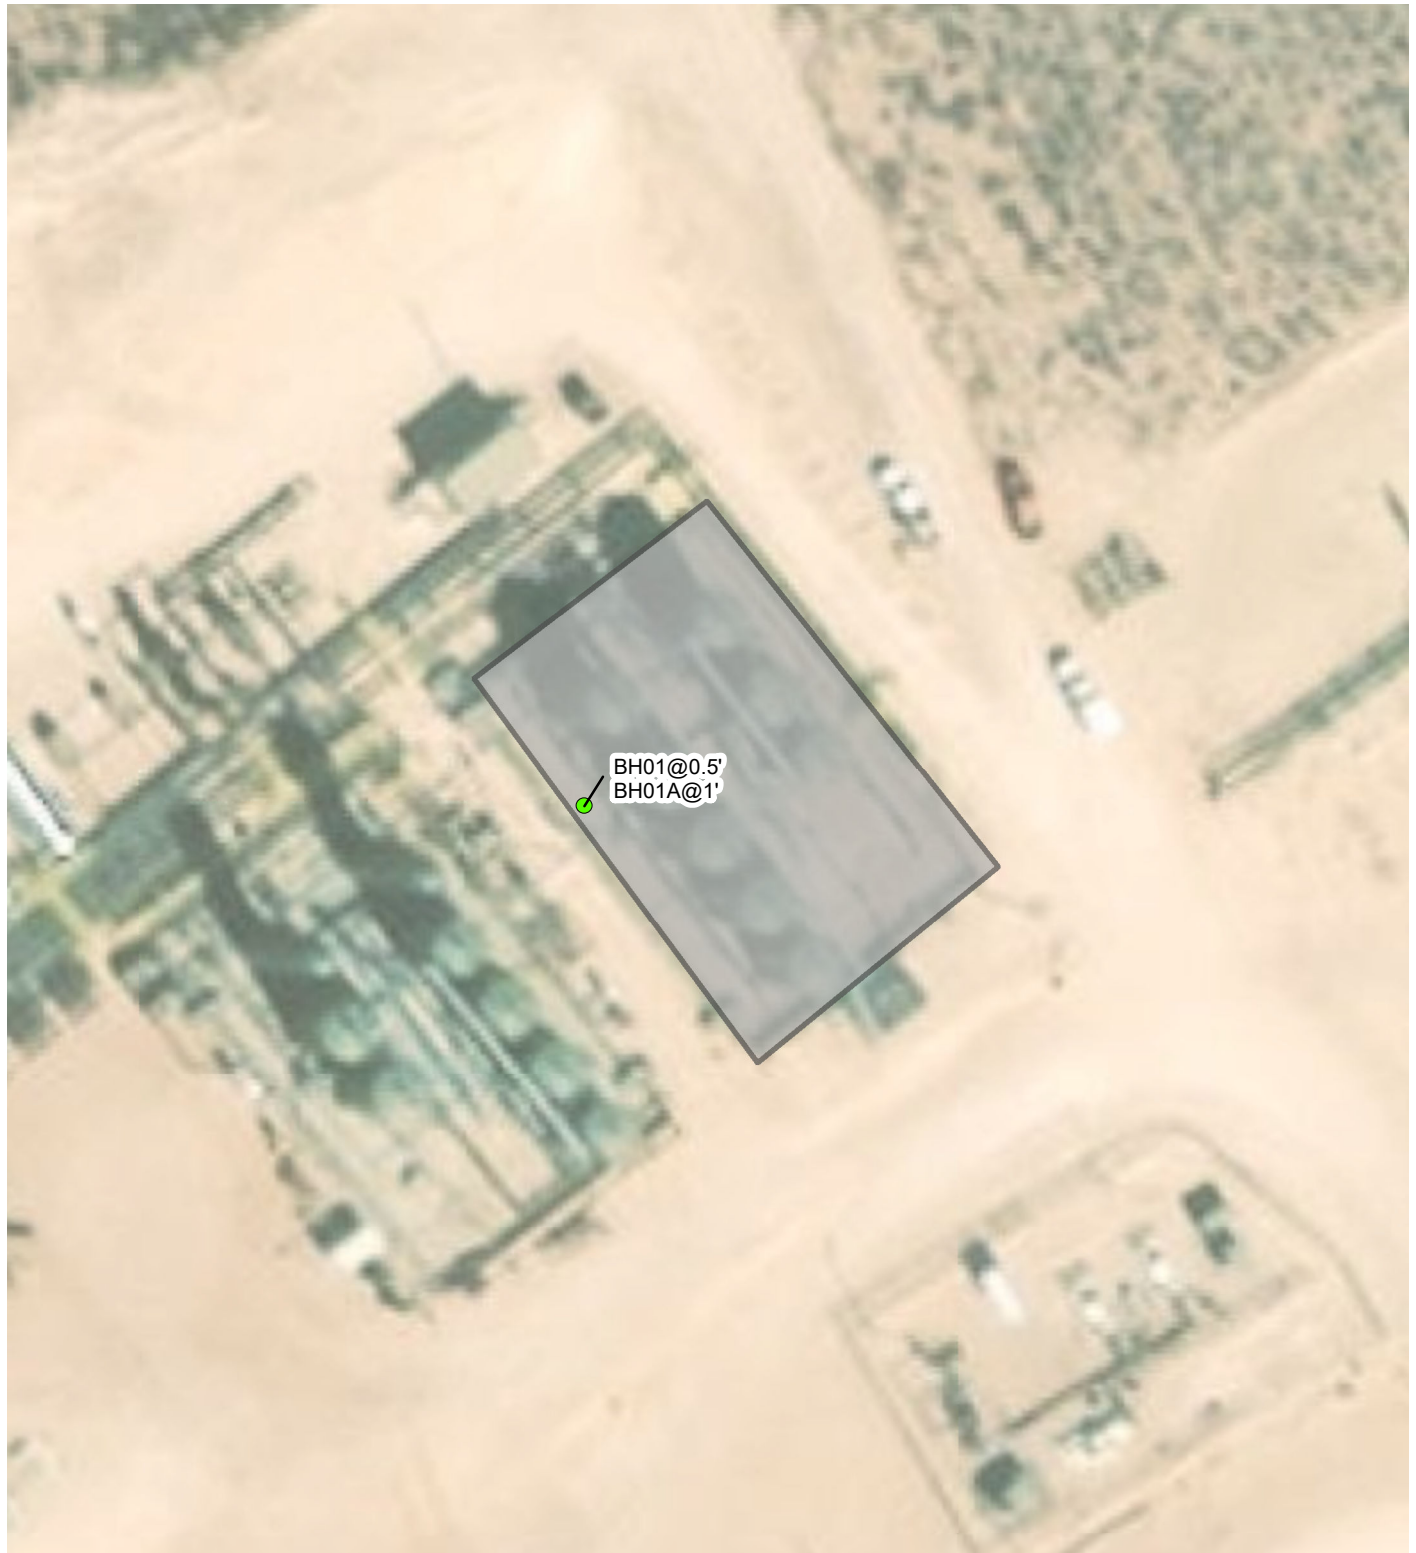
FIGURE 2
DELINEATION SOIL SAMPLE LOCATIONS
CORRAL CANYON EXPANSION
UNIT P SEC 5 T25S R29E
EDDY COUNTY, NEW MEXICO
XTO ENERGY, INC.

On December 30, 2021, WSP personnel were at the Site to evaluate the release extent based on information provided on the Form C-141 and visual observations. WSP personnel advanced one borehole (BH01) via hand-auger at the location of the tear in the liner identified during the liner integrity inspection. Two soil samples were collected from borehole BH01 at depths of 0.5 feet and 1-foot bgs. Soil from the borehole was field screened for volatile aromatic hydrocarbons and chloride utilizing a calibrated photo-ionization detector (PID) and Hach® chloride QuanTab® test strips, respectively. Field screening results and observations from the borehole were documented on a lithologic/soil sampling log which is included as Attachment 2. The borehole was backfilled with the soil removed and XTO repaired the tear in the liner. The borehole delineation soil sample location is depicted on Figure 2. Photographic documentation was conducted during the Site visit. The photographic log is included in Attachment 3.

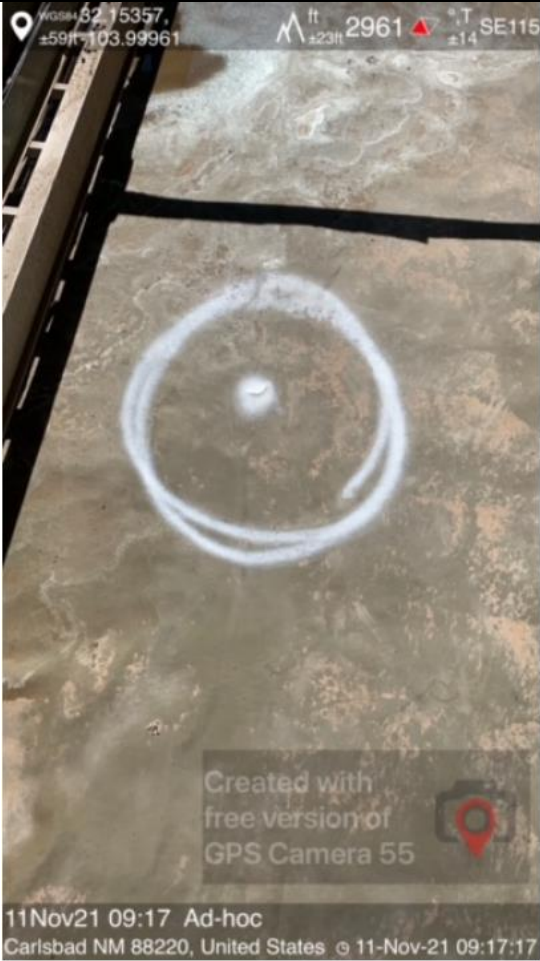
Photo No.	Date	
1	November 11, 2021	
Northeast view of the release and damaged liner

A photograph taken with a GPS camera showing a circular release and a damaged liner. The photo includes a timestamp of 11Nov21 09:17, location Carlsbad NM 88220, United States, and a watermark for GPS Camera 55. The photo also shows a compass rose indicating a bearing of 2961 degrees and a distance of 23 feet. The photo is taken from a high angle, looking down at the release and liner.

Following the failed liner integrity inspection at the Site, WSP personnel advanced one borehole (BH01) at the location of the tear in the liner to assess for the presence or absence of soil impacts resulting from the November 07, 2021 produced water release within lined containment. Two delineation soil samples were collected from borehole BH01 at depths of approximately 0.5 feet and 1-foot bgs. Laboratory analytical results indicated that benzene, BTEX, TPH-GRO/TPH-DRO, TPH, and chloride concentrations were compliant with the Site Closure Criteria and compliant with the most stringent Table 1 Closure Criteria. Additionally, field screening of soil from the borehole indicated no elevated volatile aromatic hydrocarbons or chloride concentrations beneath the tear in the liner. The release was contained laterally by the lined containment and all released fluids were recovered during initial response activities. The tear in the liner was subsequently repaired.
