RE: Closure report not recorded in OCD Imaging  
Incident ID: nRM2003745665  
AEP #: 01312020-1730-water  
Location: Crockett to Dagger Release

## Tracking # NRM2003745665 Closure Report Crockett to Dagger Release

Prepared for  
Advance Energy Partners Hat Mesa LLC  
Houston, Texas

Prepared by  
R.T. Hicks Consultants, Ltd.  
Albuquerque, New Mexico

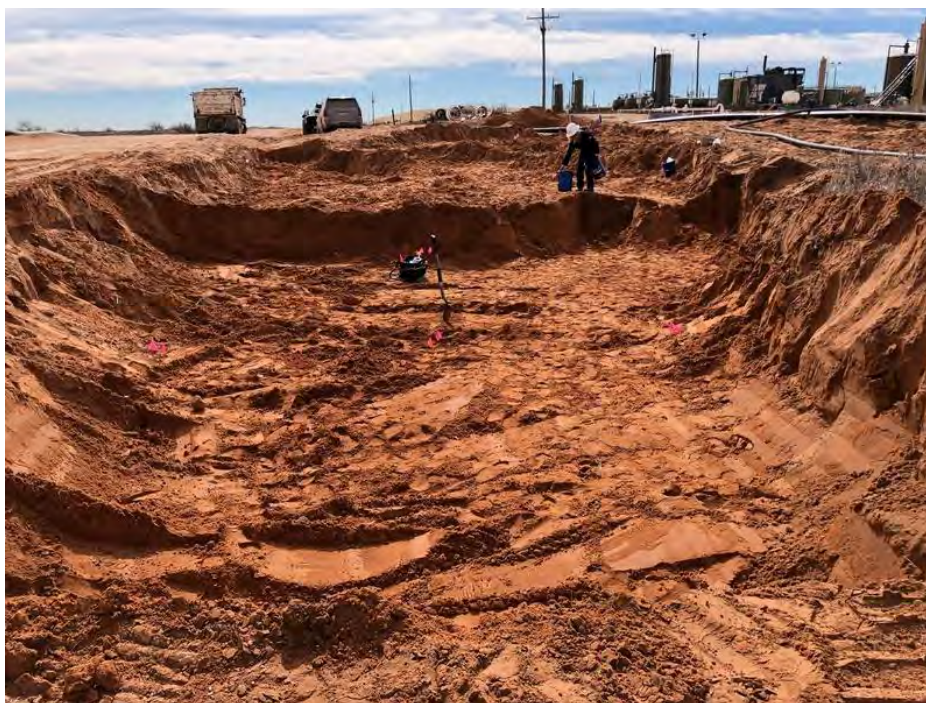
**Figure 4: Field screen for electrical conductivity (EC) during excavation. Photo is viewing south from base B-08. Date 02/07/2020. GPS: 32.4517028 N , 103.6039972 W**

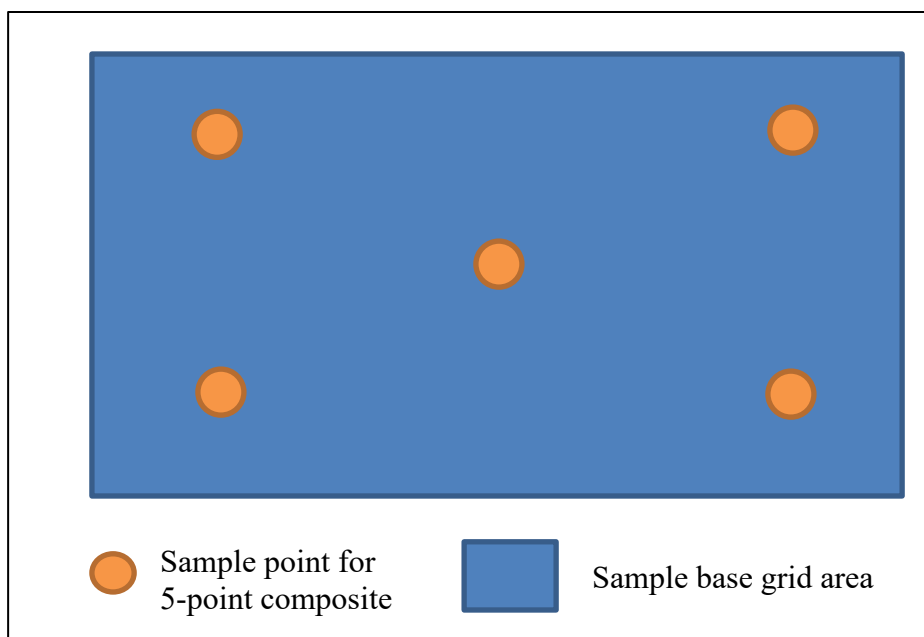
**Figure 5: Example of 5-point sample grid for composite sampling.**

Five-point composite soil samples were collected along the walls of the excavation as shown on Plate 14. Sample points for the composite wall samples were evenly distributed along the wall to obtain a representative 5-point composite sample. Samples were collected from the surface to 4-feet or excavation base depth, whichever is less. If excavation depth was greater than 4-feet, an additional confirmation sample was obtained below 4-feet.

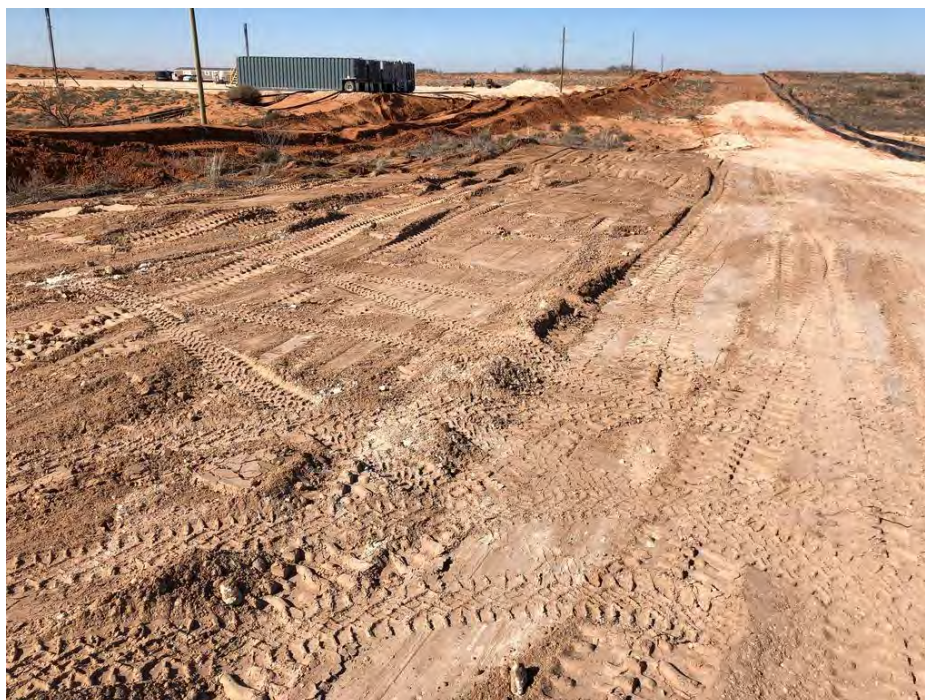
**Figure 6: Backfill of release extent. Final contouring will occur during the completion of pipeline installation. The pipeline excavation is visible in photo background left. Photo is viewing north. Date: 02/14/2020. GPS: 32.4515417 N, 103.6040278 W**
