**Re: Release Characterization and Closure Request
ConocoPhillips
SEMU Cass Penn (SEMU BTB #70) Flowline Release
Unit Letter I, Section 15, Township 20 South, Range 37 East
Lea County, New Mexico
Incident ID: NRM2026250365**

Release Characterization and Deferral Request
February 16, 2022

**SEMU CASS PENN RELEASE (SEMU BTD 70)
APPROXIMATE RELEASE EXTENT AND ASSESSMENT**

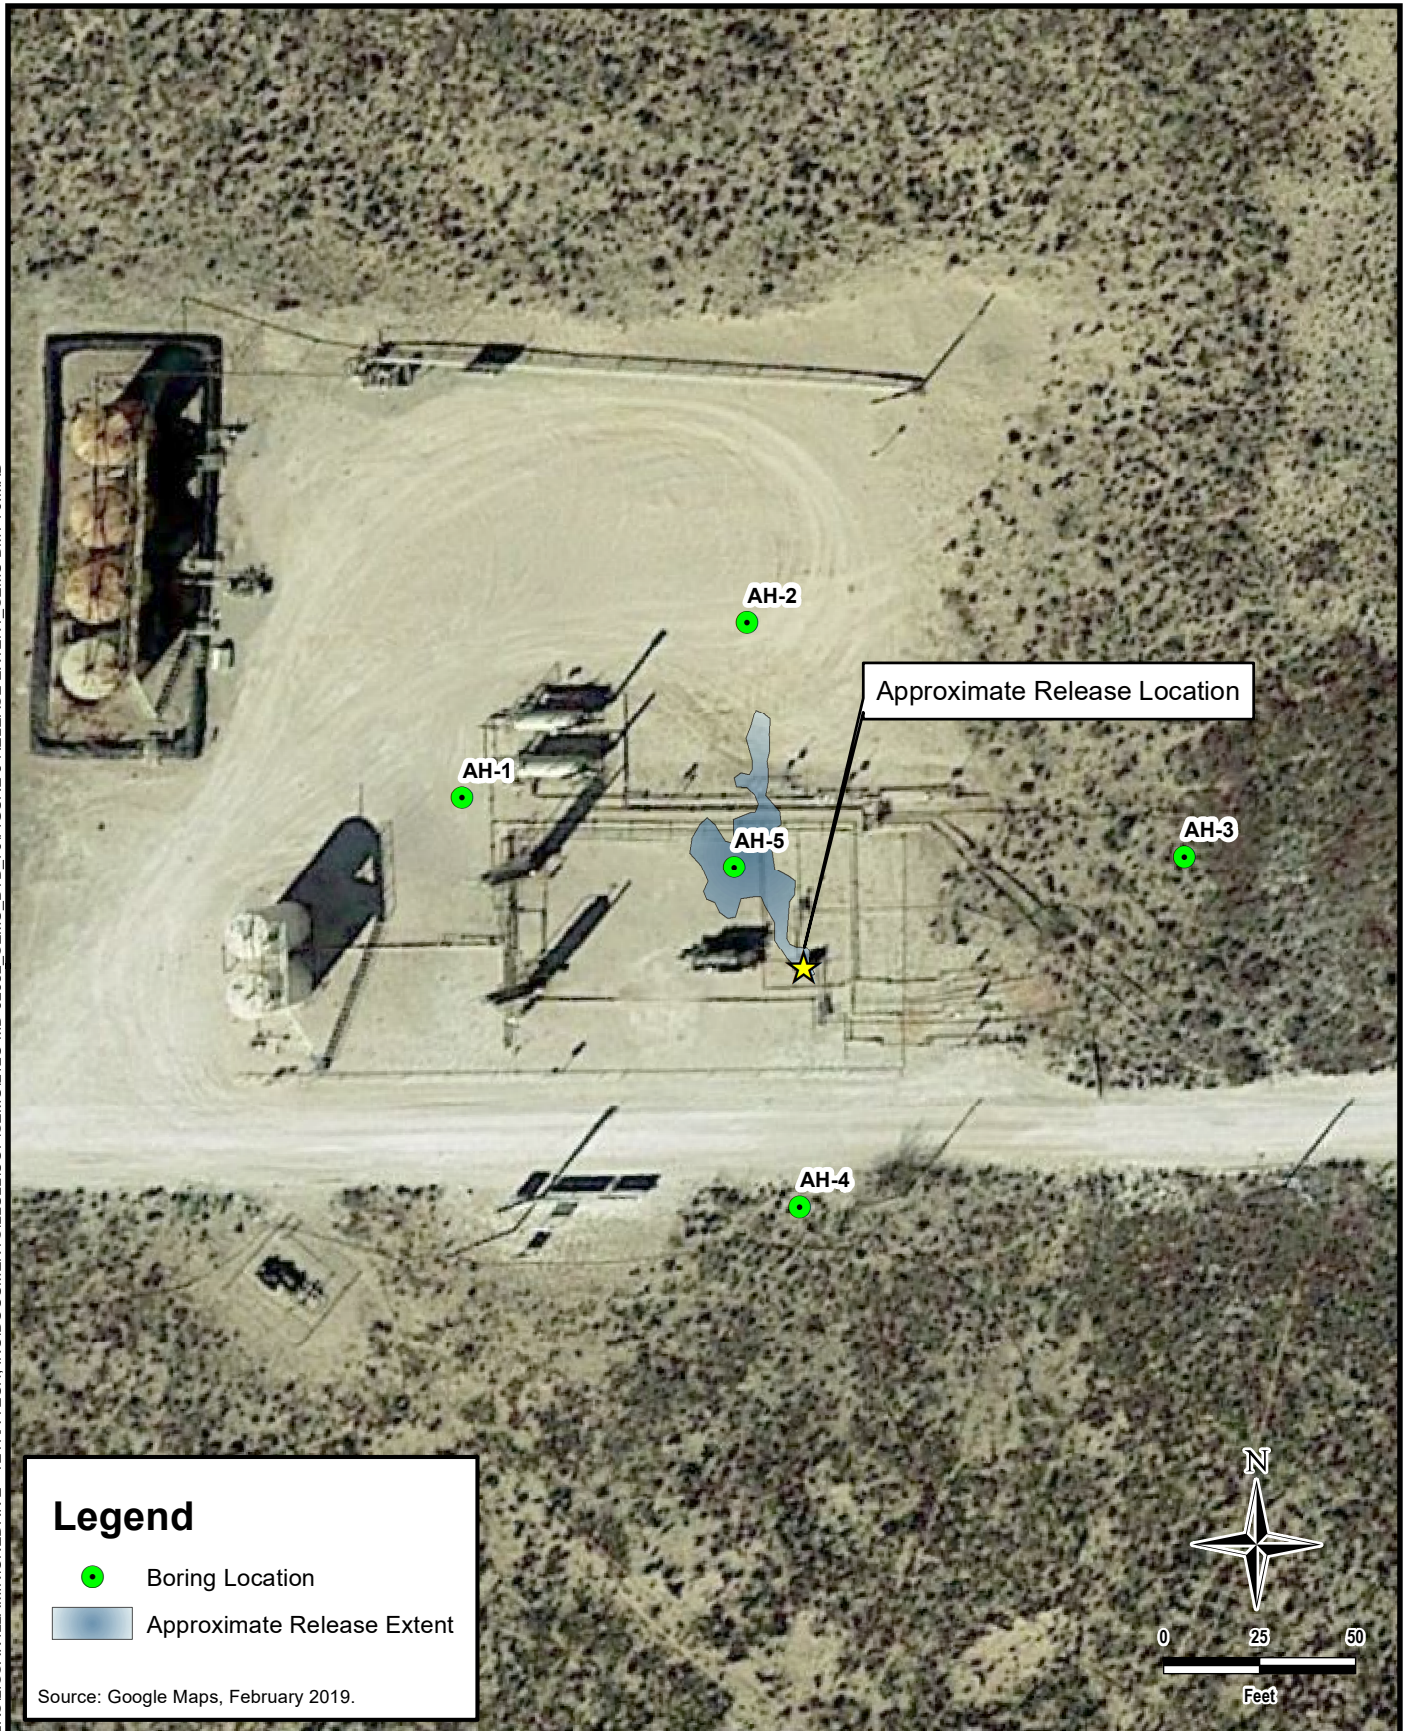
3

A total of five (5) soil borings (AH-1 through AH-5) were installed using a hand auger to define the extents of the release and to assess the release extent (Figure 3). AH-5 was installed within the release footprint to a depth of 8 feet bgs to assess the vertical extent of impacted soil. AH-1 through AH-4 were installed to a depth of 2 feet bgs to assess the lateral extent of impacted soil. AH-1 and AH-2 were installed within the pad extent to the west and north of the release footprint respectively. AH-3 and AH-4 were installed outside of the pad boundary with AH-3 in the vegetated area to the east of the release footprint and AH-4 to the south on the opposite side of the lease road.

Results from the February 2022 soil sampling event are summarized in Table 1. The boring locations are shown in Figure 3. All analytical results were below Site RRALs. Horizontal and vertical delineation was achieved during the assessment.

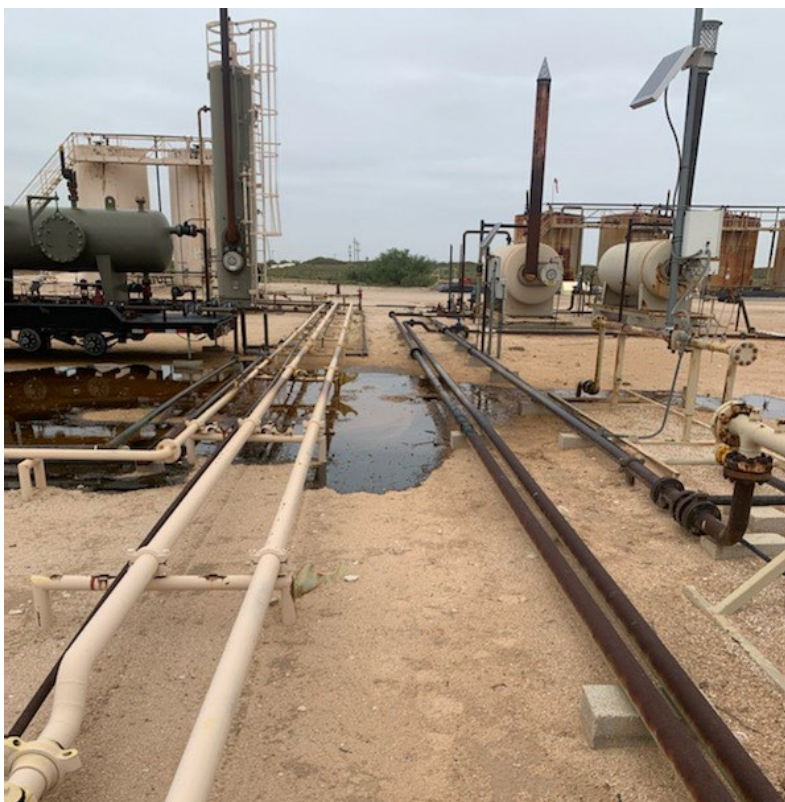
TETRA TECH, INC. PROJECT NO. 212C-MD-02682	DESCRIPTION	View of the release point and area (provided by client).	1
	SITE NAME	ConocoPhillips SEMU Cass Penn (SEMU BTB #70) Flowline Release	9/11/2020

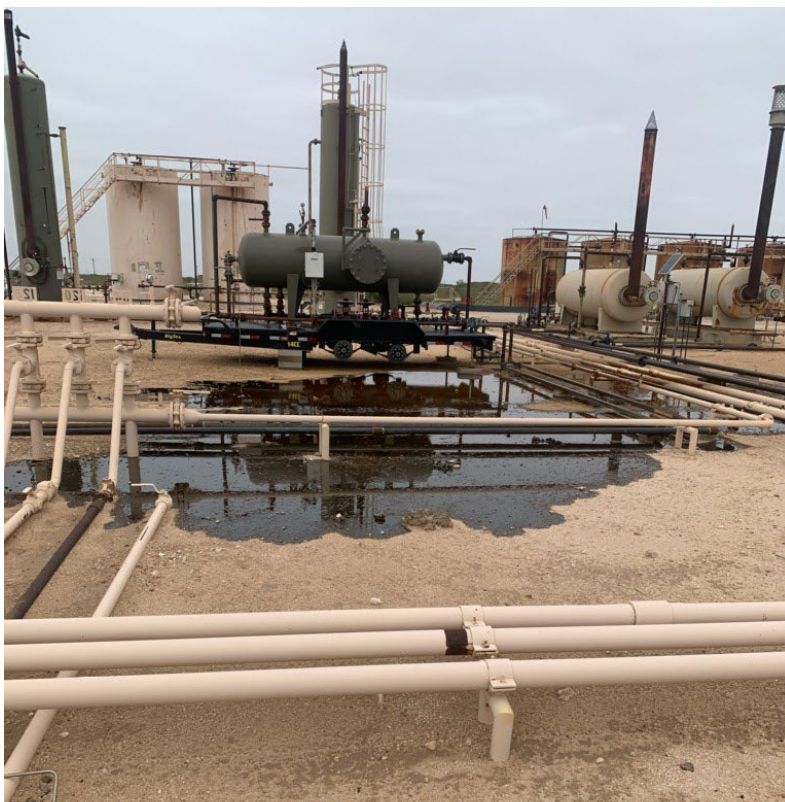
TETRA TECH, INC. PROJECT NO. 212C-MD-02682	DESCRIPTION	View of the release point and extent (provided by client).	2
	SITE NAME	ConocoPhillips SEMU Cass Penn (SEMU BTB #70) Flowline Release	9/11/2020

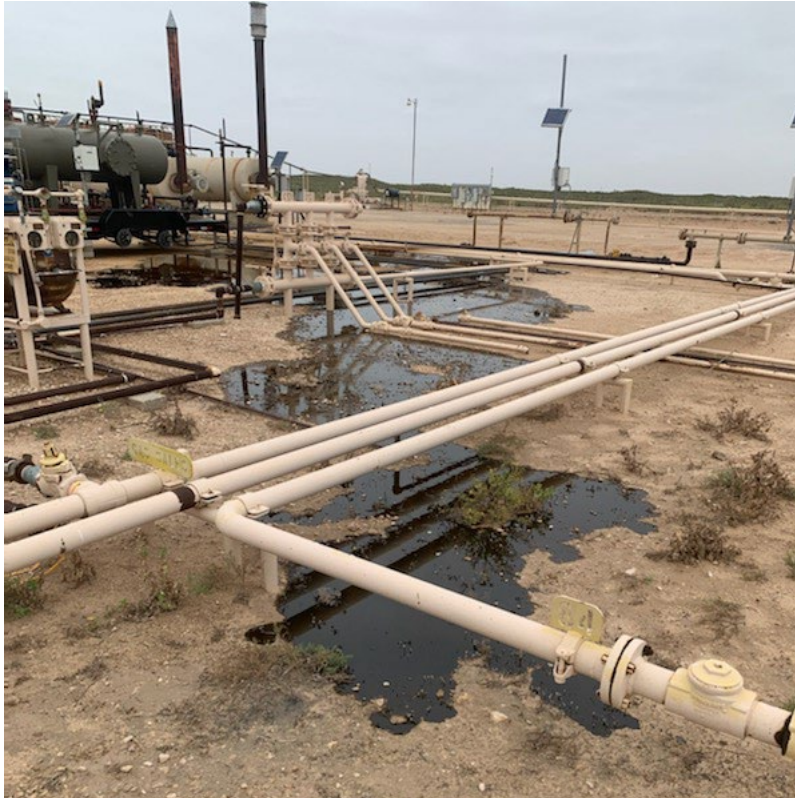
TETRA TECH, INC. PROJECT NO. 212C-MD-02682	DESCRIPTION	View of the release point and extent (provided by client).	3
	SITE NAME	ConocoPhillips SEMU Cass Penn (SEMU BTD #70) Flowline Release	9/11/2020

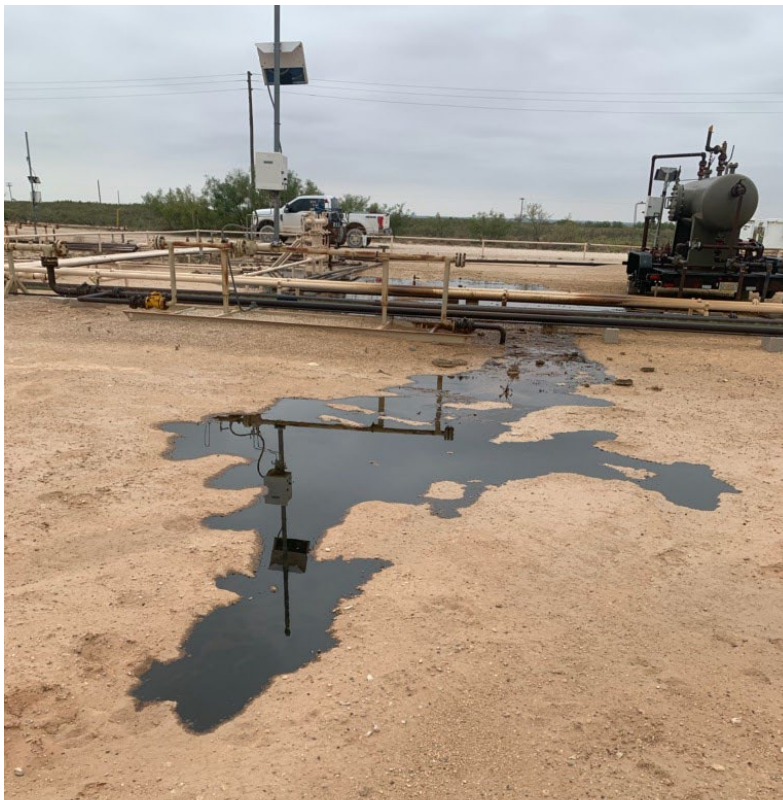
TETRA TECH, INC. PROJECT NO. 212C-MD-02682	DESCRIPTION	View of the release point and extent (provided by client).	4
	SITE NAME	ConocoPhillips SEMU Cass Penn (SEMU BTD #70) Flowline Release	9/11/2020

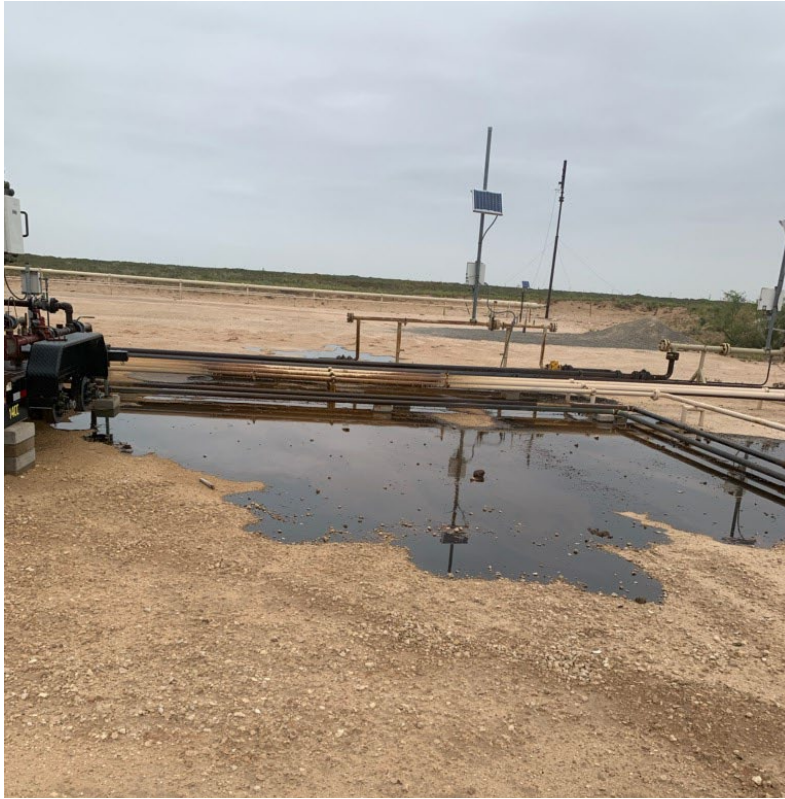
TETRA TECH, INC. PROJECT NO. 212C-MD-02682	DESCRIPTION	View of the release point and extent (provided by client).	5
	SITE NAME	ConocoPhillips SEMU Cass Penn (SEMU BTB #70) Flowline Release	9/11/2020

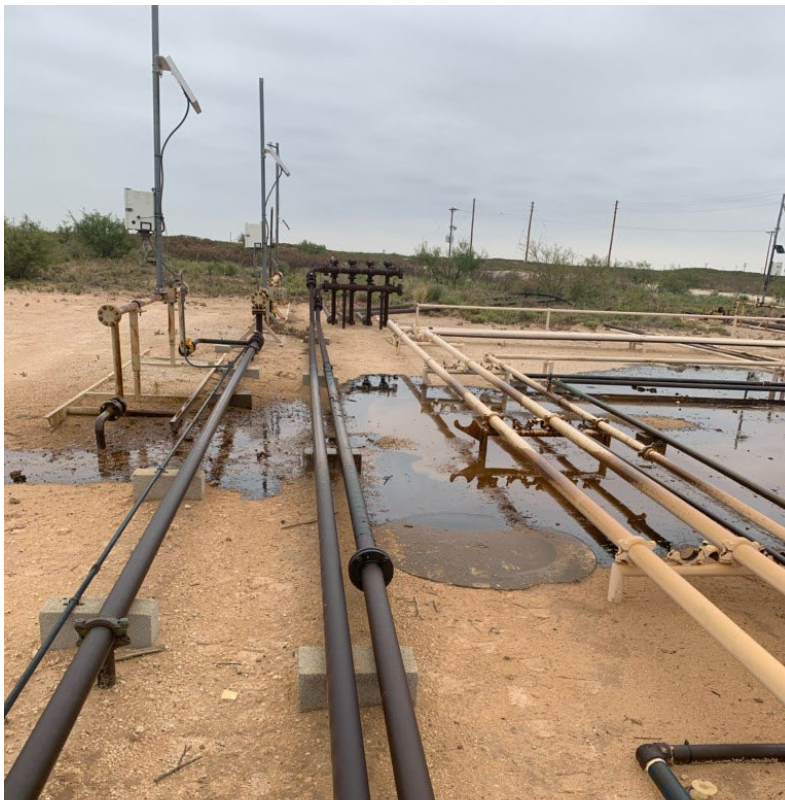
TETRA TECH, INC. PROJECT NO. 212C-MD-02682	DESCRIPTION	View of the release point and extent (provided by client).	6
	SITE NAME	ConocoPhillips SEMU Cass Penn (SEMU BTB #70) Flowline Release	9/11/2020

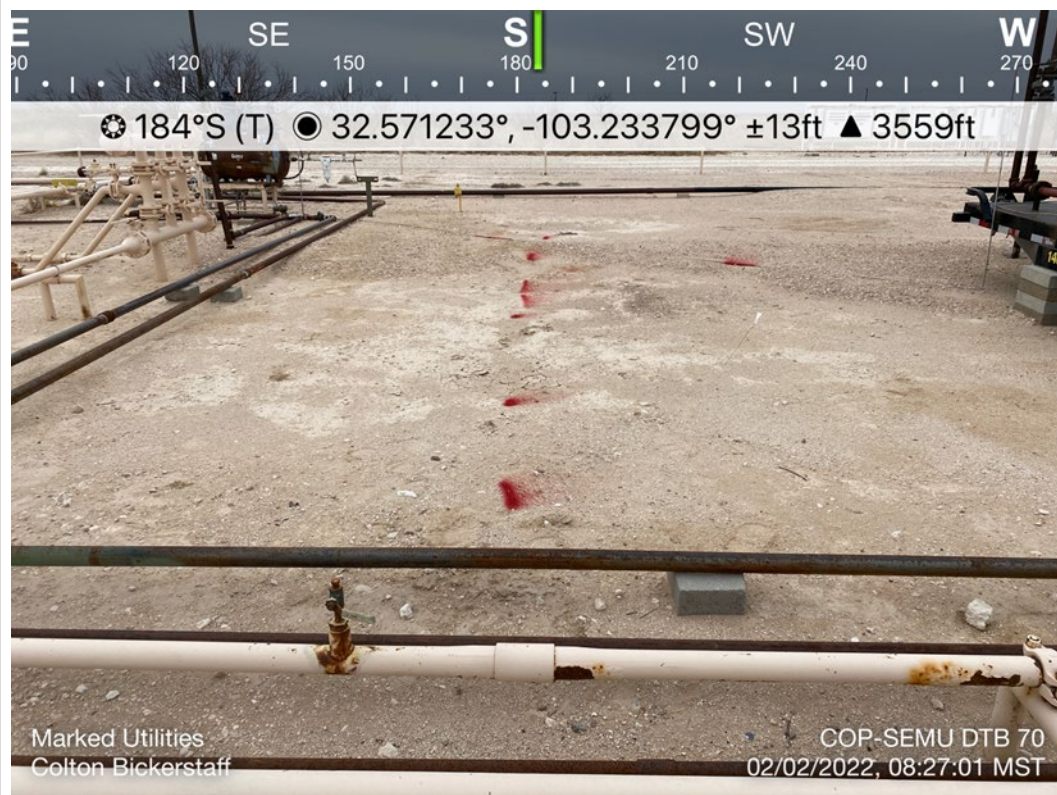
TETRA TECH, INC. PROJECT NO. 212C-MD-02862	DESCRIPTION	View south of the former release area footprint.	10
	SITE NAME	ConocoPhillips SEMU Cass Penn (SEMU BTB #70) Flowline Release	2/02/2022
