Release Notification

| Site Name: San Juan 27-4 Unit 60 | Site Type: Gas |

Executive Summary

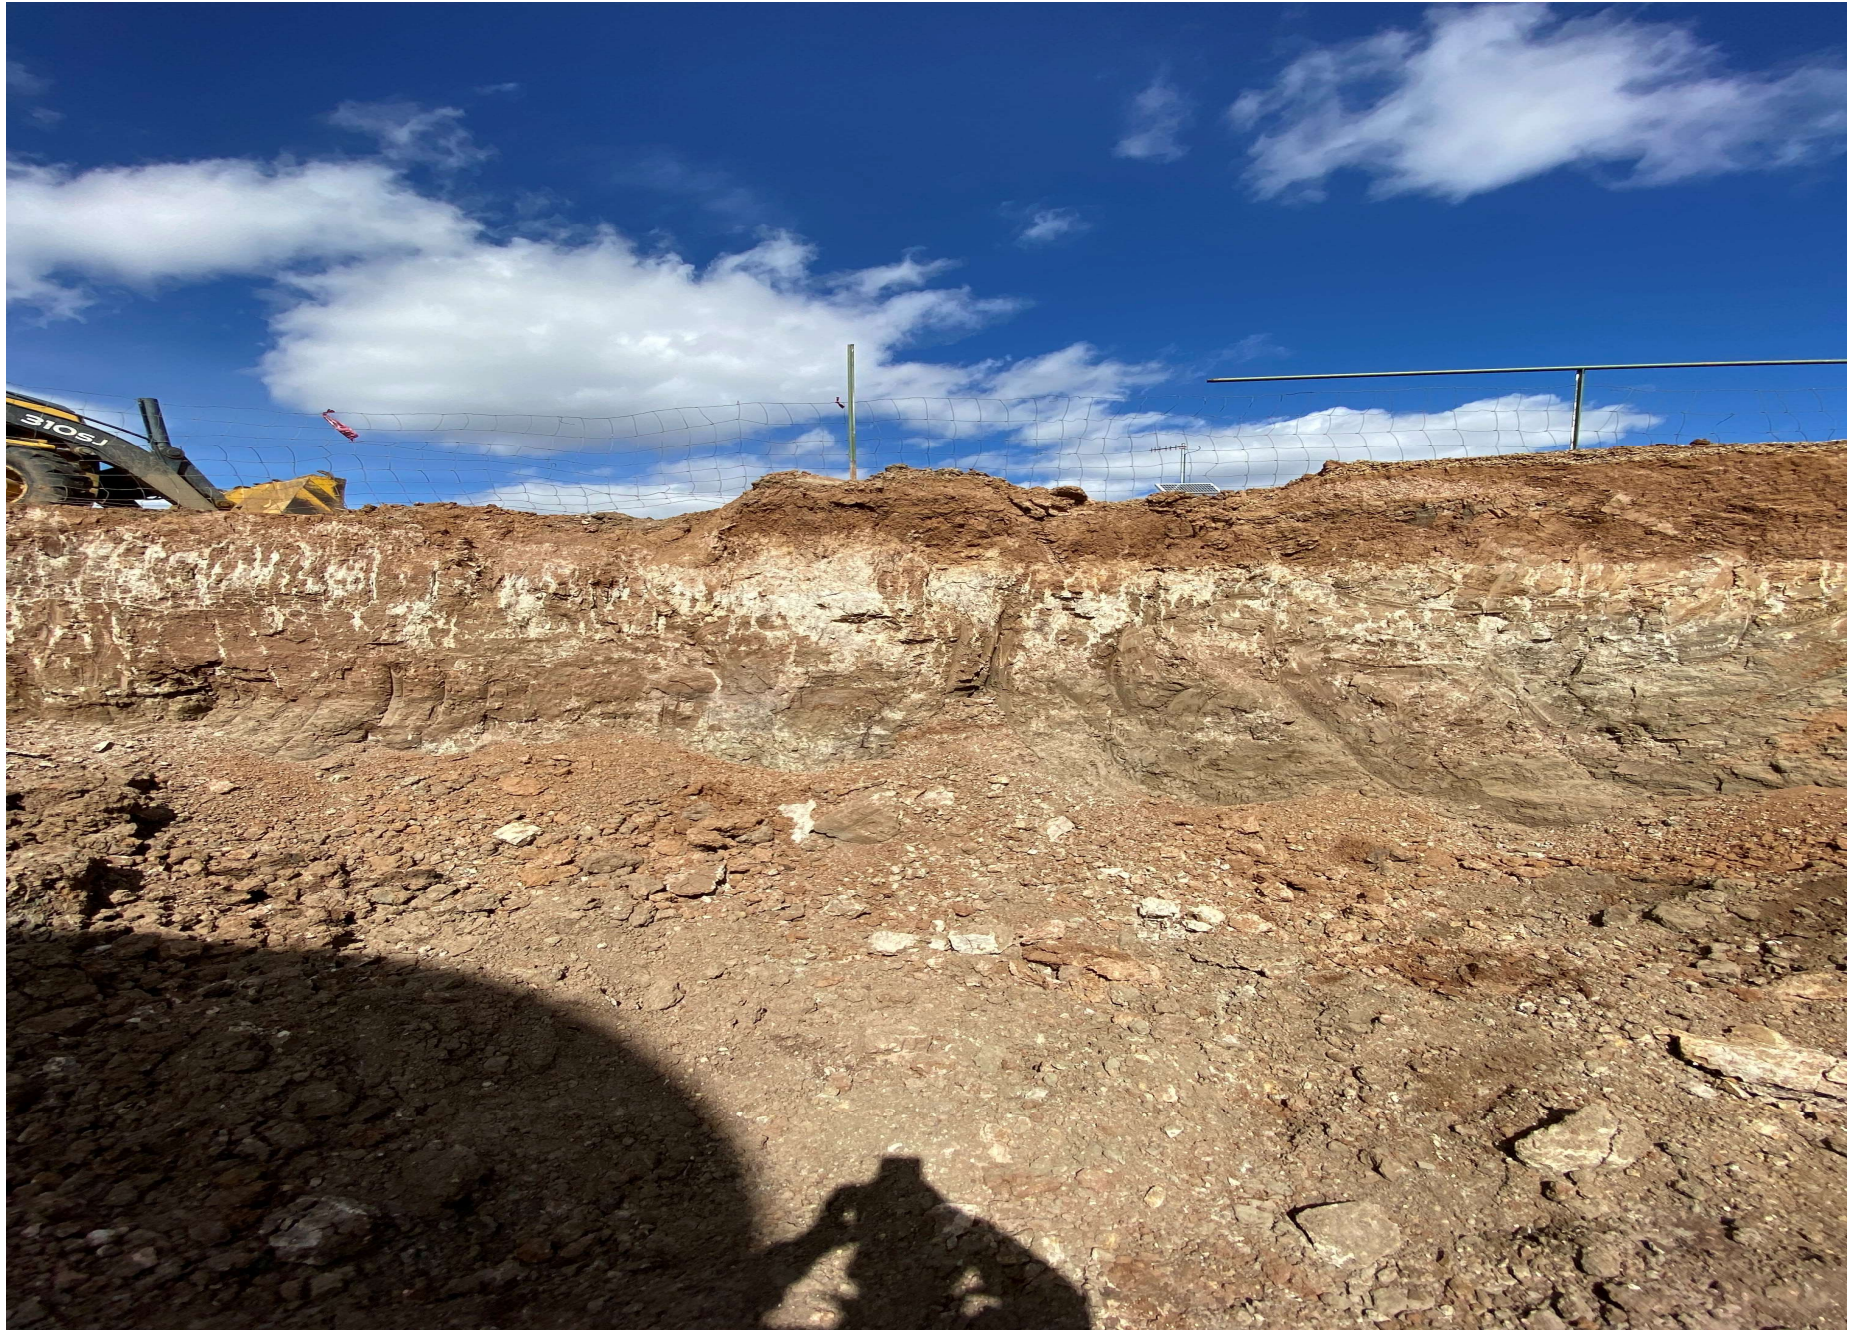
NNE Sidewall View Looking from Inside Pit – 3/9/22 at 01:36 pm, 36.56319°N 107.25150°W

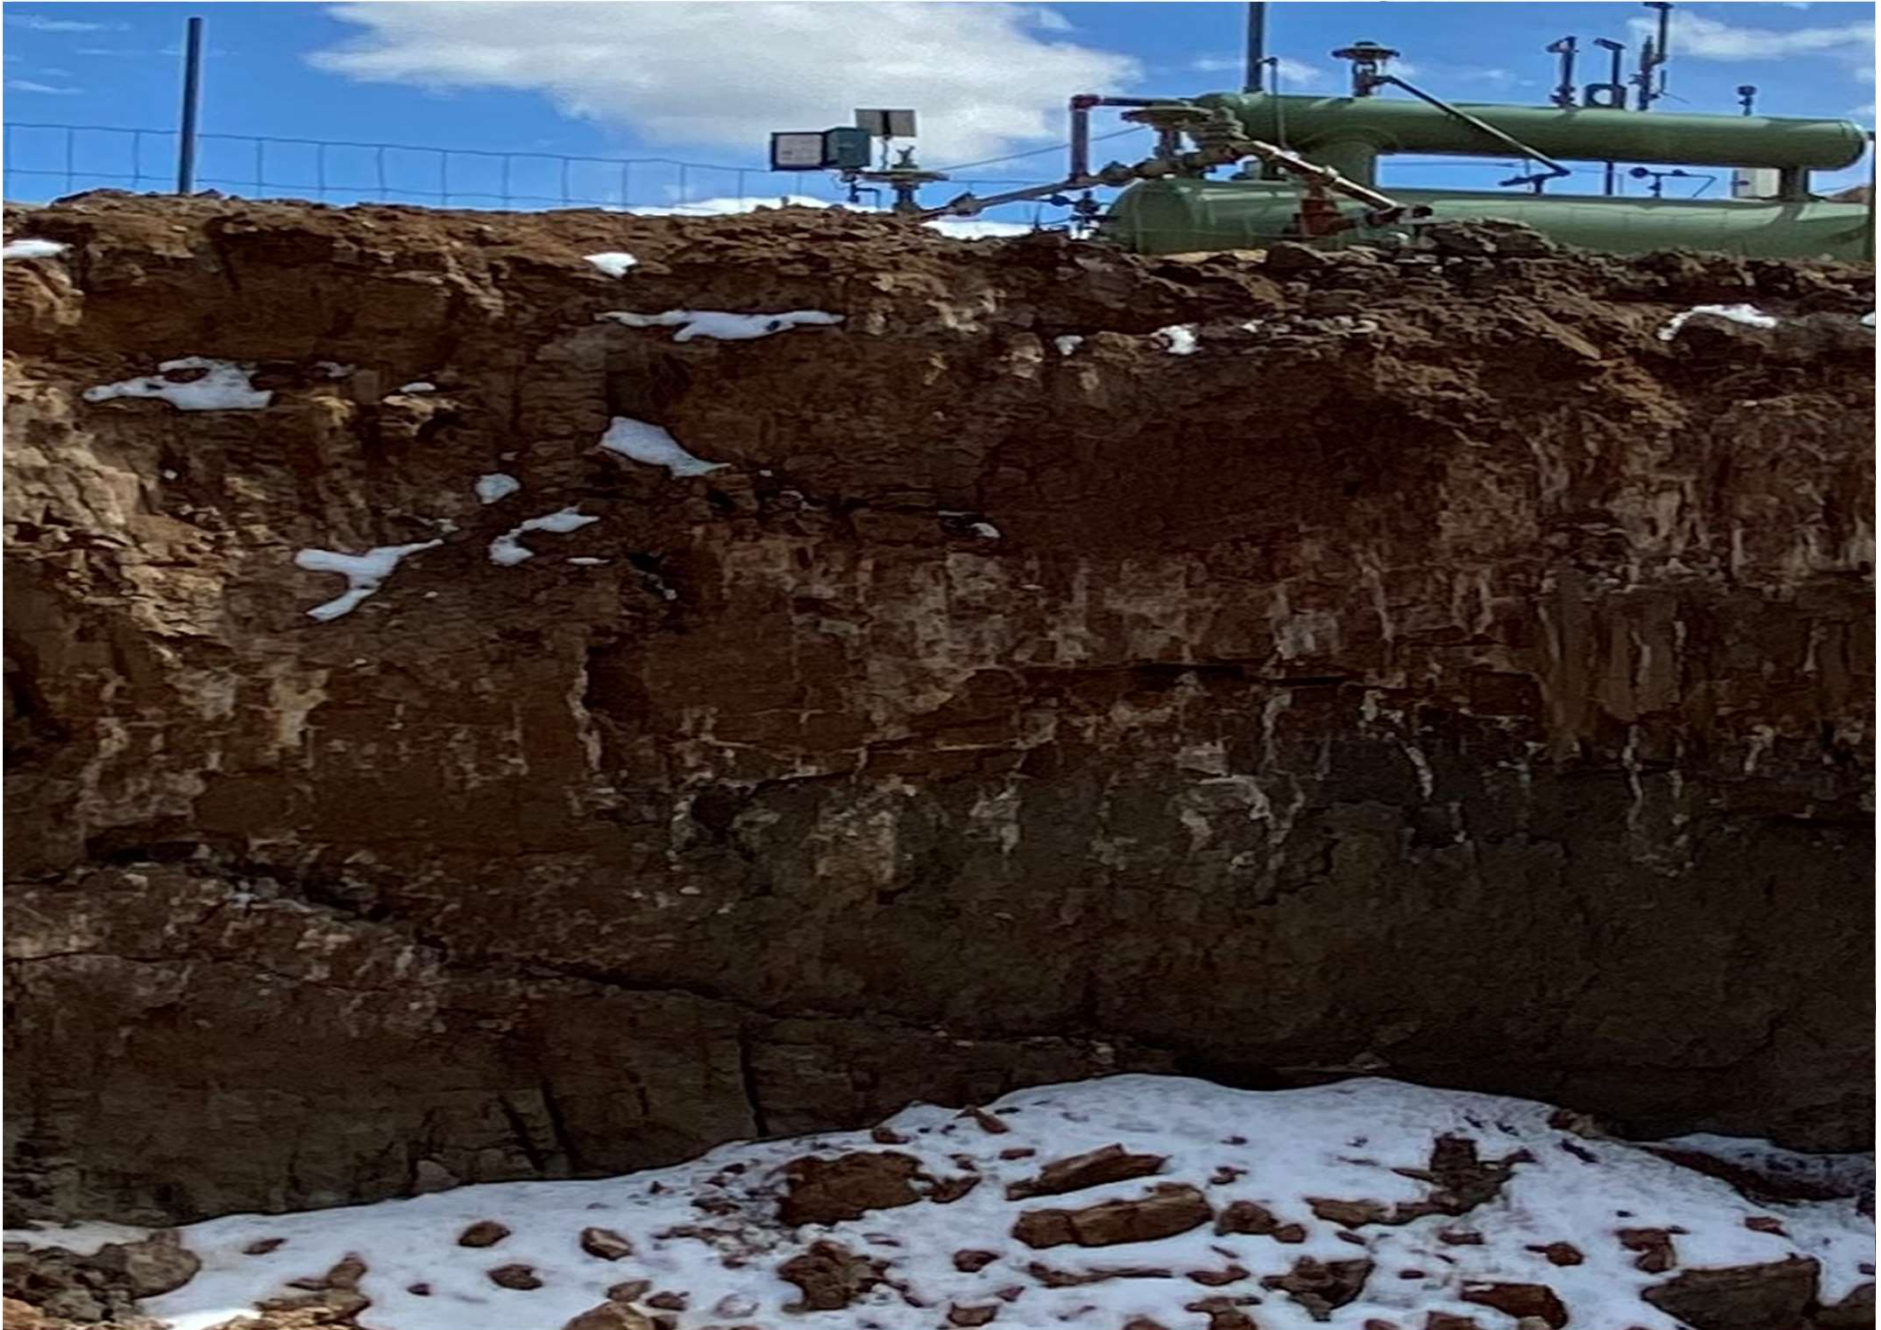
East Sidewall View Looking from Inside Pit – 3/9/22 at 01:36 pm, 36.56319°N 107.25150°W

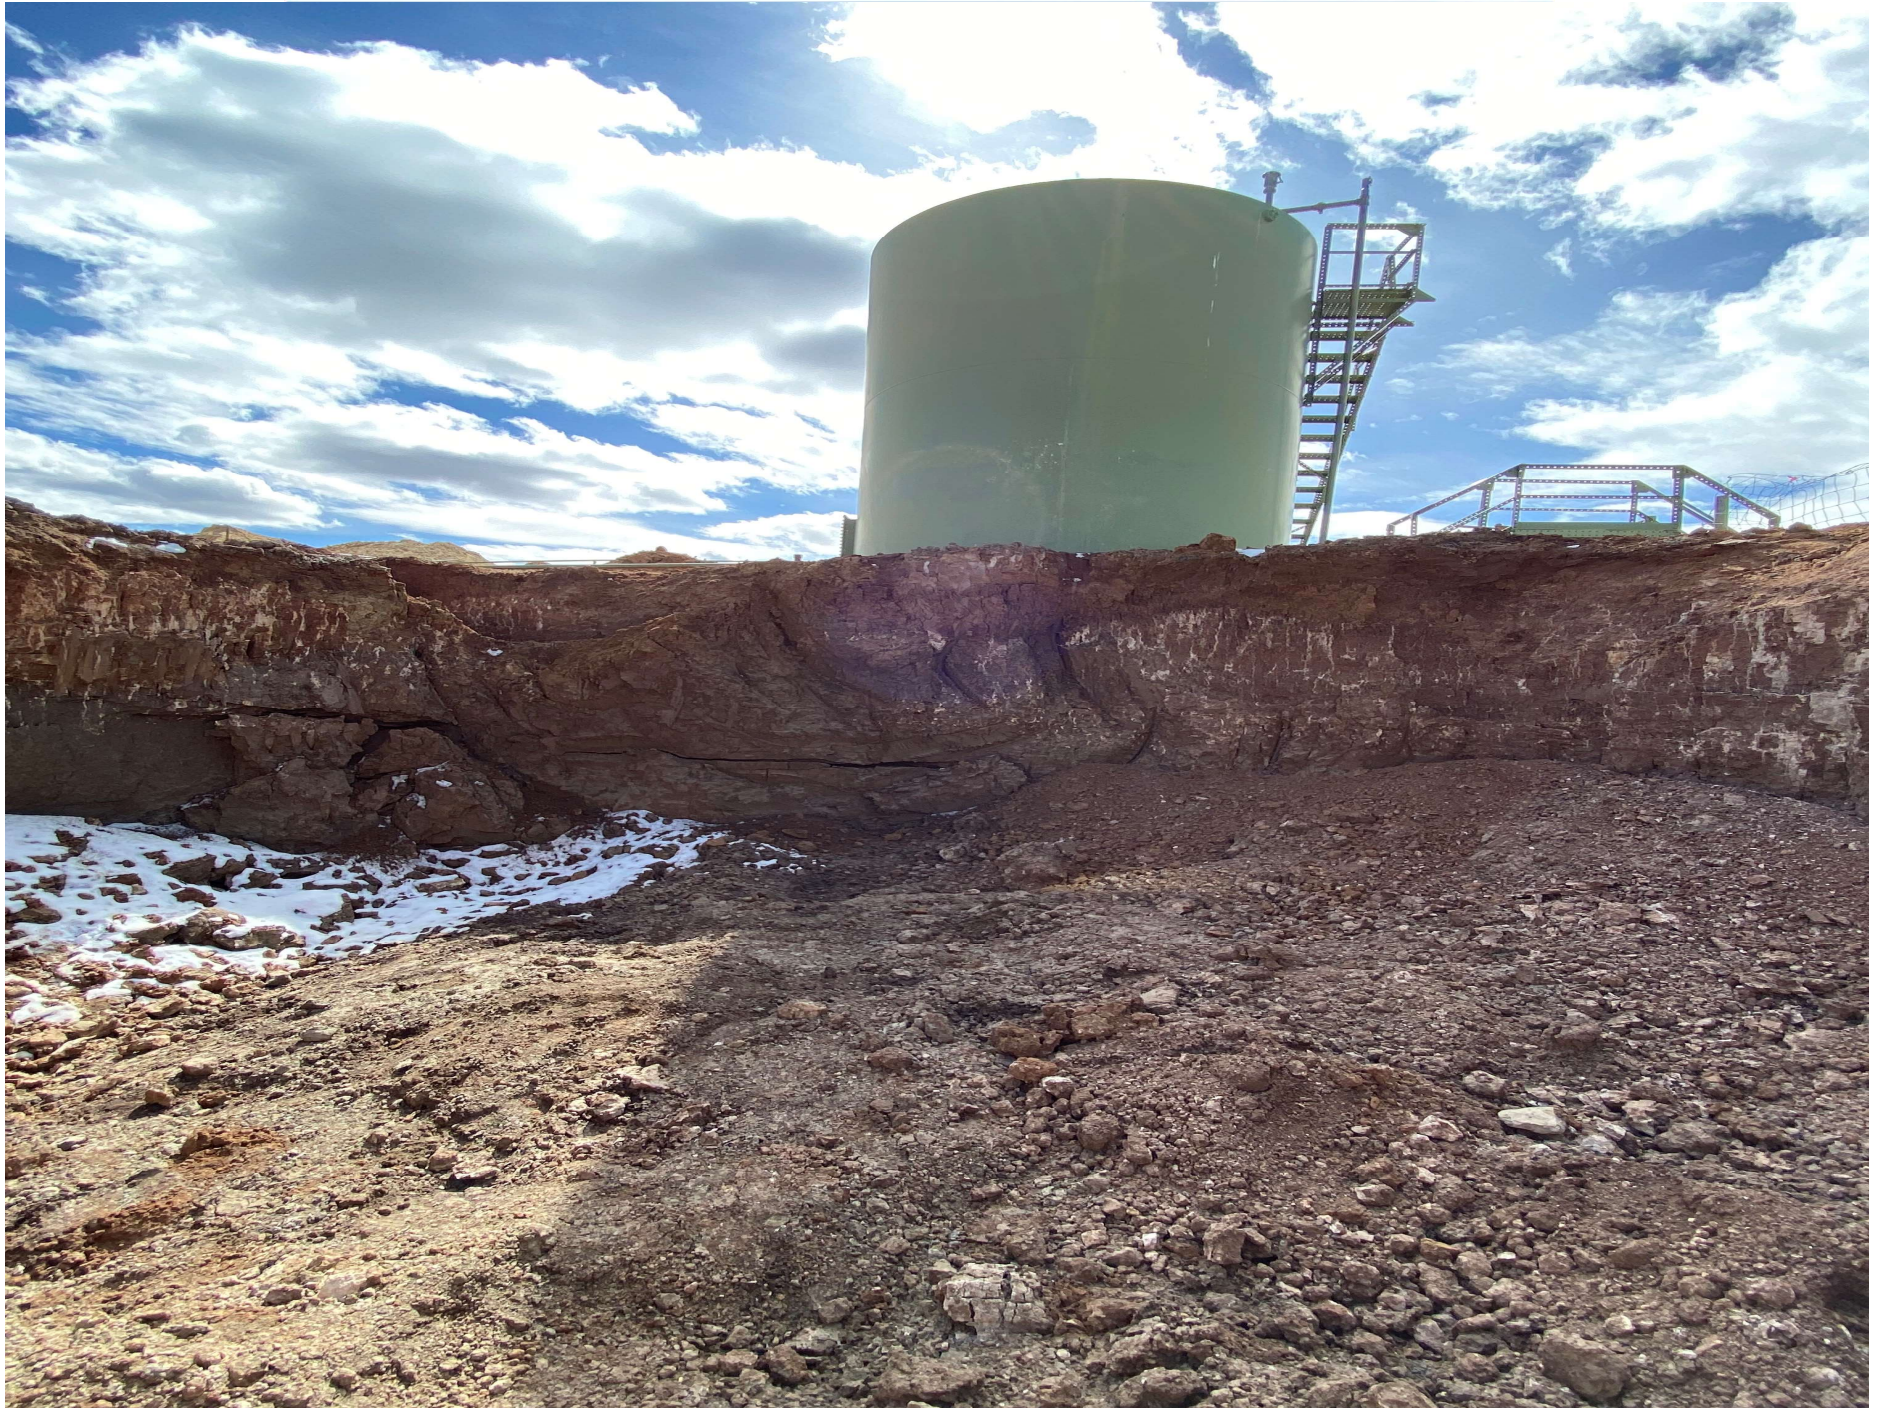
SSW Sidewall View Looking from Inside Pit – 3/9/22 at 01:36 pm, 36.56319°N 107.25150°W

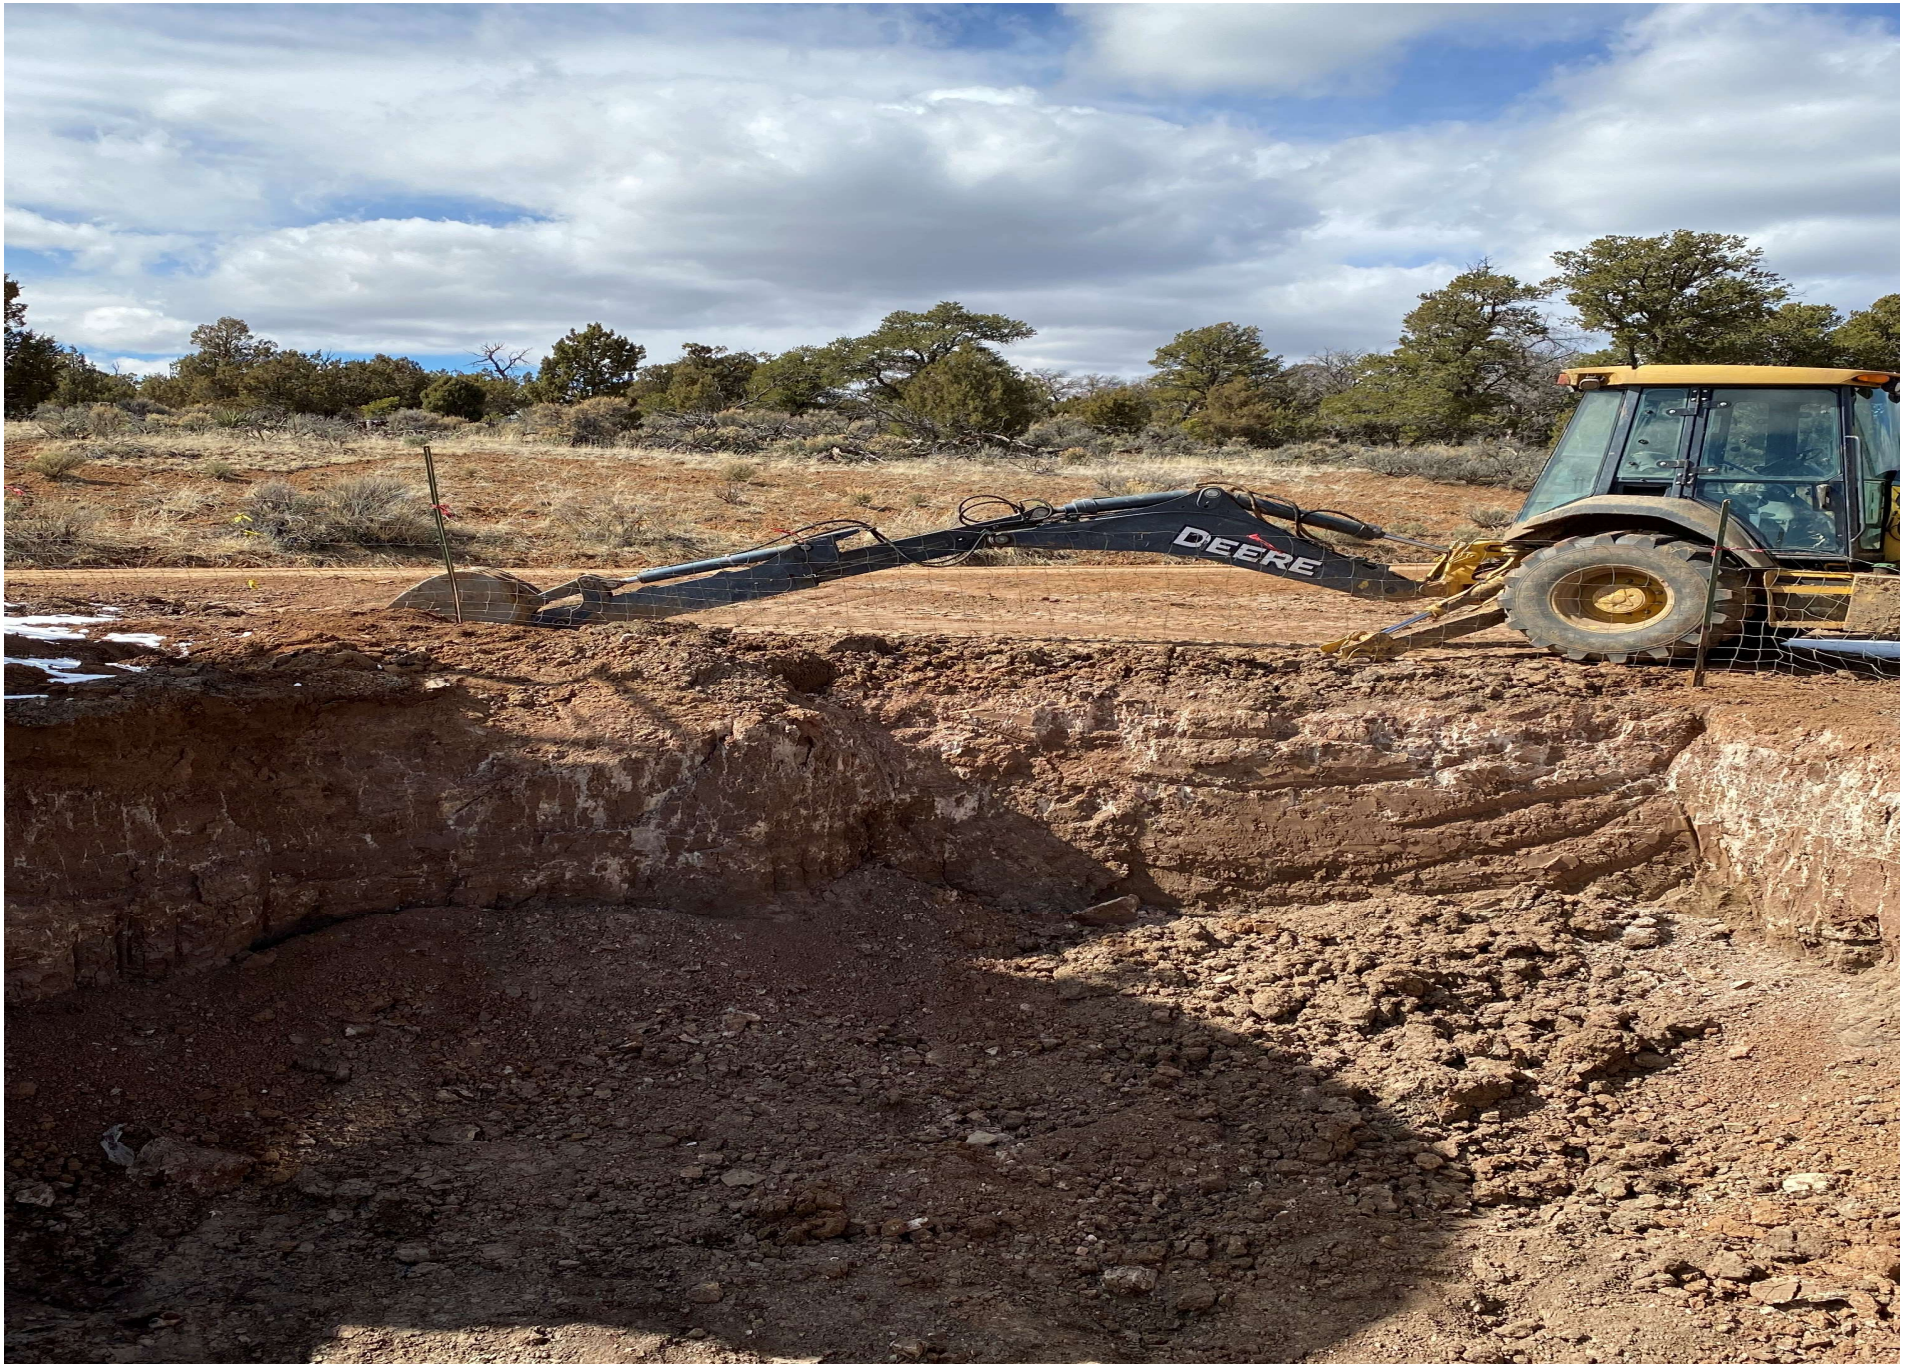
West Sidewall View Looking from Above Pit – 3/9/22 at 01:36 pm, 36.56317°N 107.25148°W

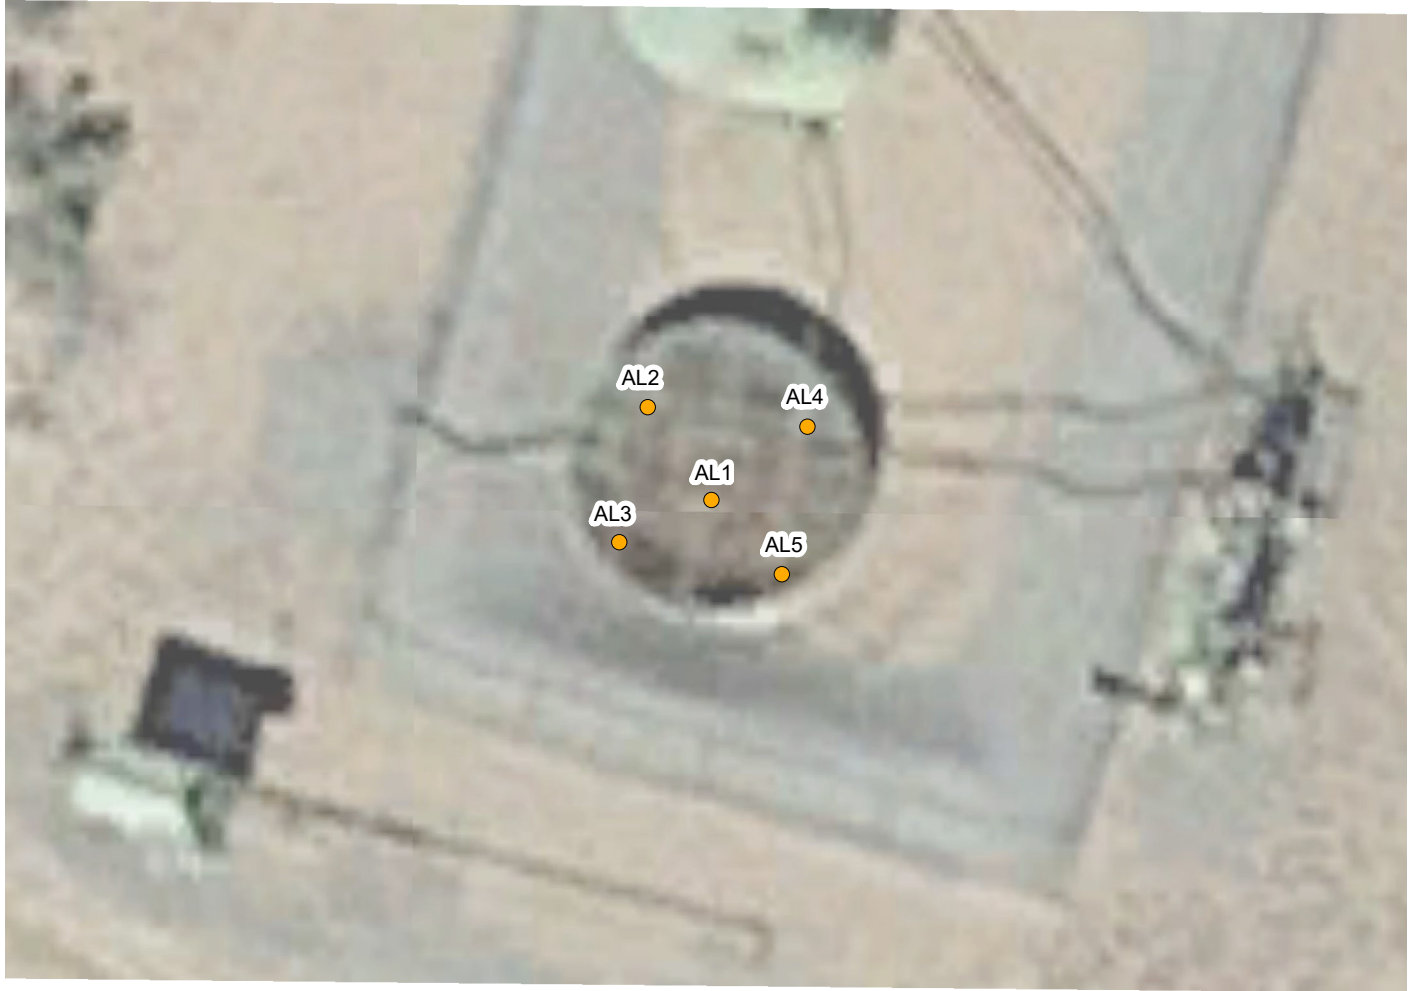
FIGURE 2
SOIL SAMPLE LOCATIONS MAP
SAN JUAN 27-4 UNIT #60
NENE SEC 21-T27N-R4W
RIO ARriba COUNTY, NEW MEXICO
HILCORP ENERGY COMPANY

● SOIL SAMPLE

During an onsite inspection, Mr. Jonathan Kelly, an inspector with the New Mexico Oil Conservation Division (NMOCD), discovered a release originating from an out-of-service below-grade tank (BGT). Specifically, Mr. Kelly noted that melted snow had entered the BGT, mixing with bottom sludge and water, and exited through corrosion holes in the steel tank. It was estimated that 5 barrels of produced water was released at the Site. Upon discovery, Hilcorp cleaned and removed the BGT from the Site and LT Environmental, Inc. (LTE) collected one, 5-point composite soil sample from the area below the BGT (Figure 2). Analytical results from the composite sample are presented on Table 1.
