Release Notification

Site Name: San Juan 27-5 Unit 83	Site Type: Gas Well
Date Release Discovered: 3/26/19	API# (if applicable) 30-039-20208

Storm water runoff filled cribbing to a level that allowed precipitation to overflow and fill the pit.

The lab results for the release at the San Juan 27-5 #83 were below all regulatory limits.
No remediation required.

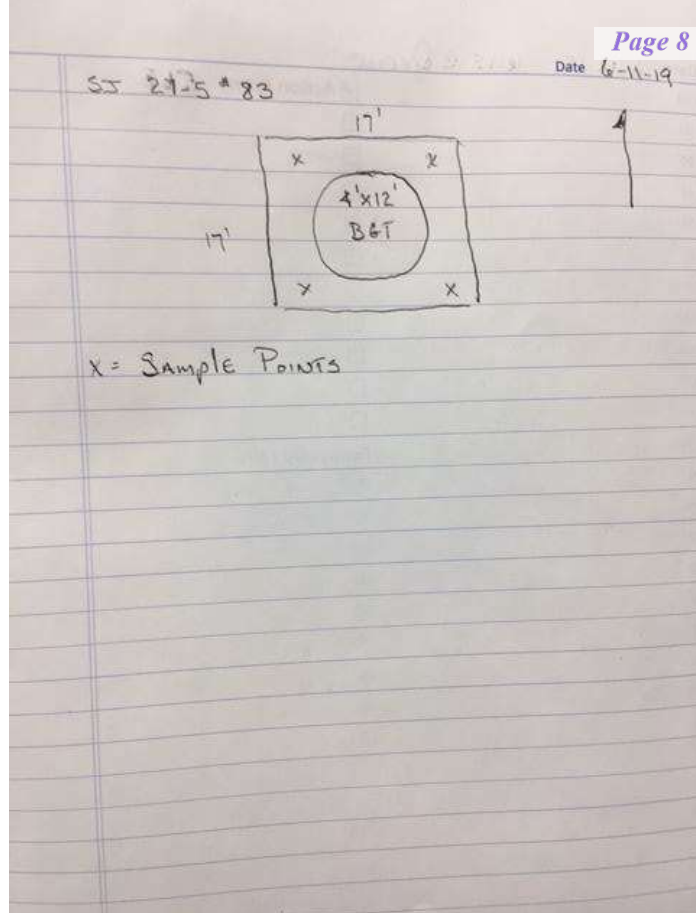
6-11-19 Confirmation Sampling

Field Data

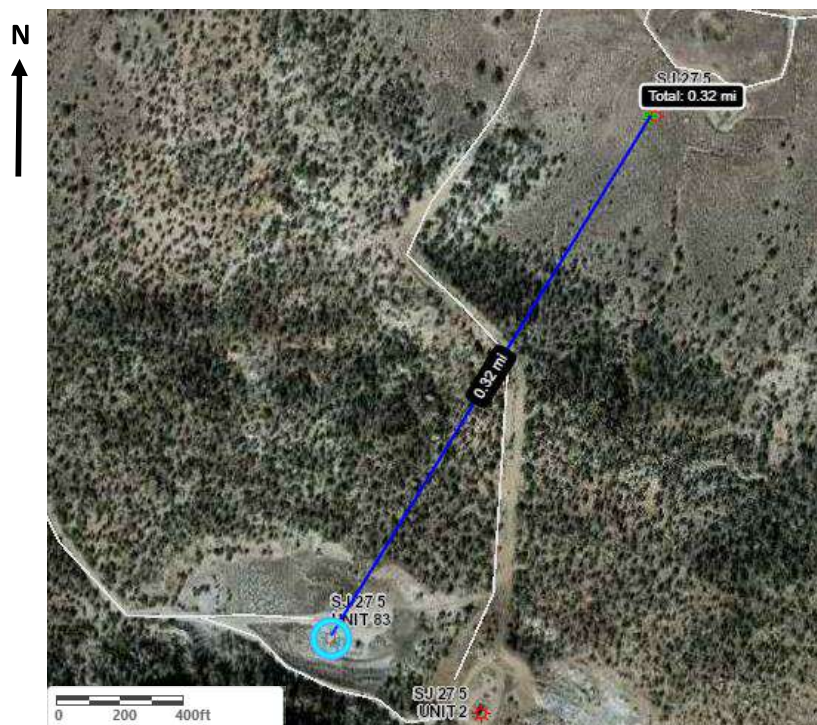
Depth to water determination – distance to POD

POD elevation: 6576'
POD GW depth: 260'

GW Depth: 6316'

SJ 27-5 unit 83 elevation: 6779'

Location >463' above GW
