**CLOSURE REQUEST**

## RE: CLOSURE REQUEST

<b>COMPANY</b>	Marathon Oil Company
<b>LOCATION</b>	Chili Parlor 17 Federal #002H
<b>API</b>	30-025-43137
<b>PLSS</b>	Unit P Sec 08 T22S R33E
<b>GPS</b>	32.399717, -103.588194
<b>INCIDENT ID</b>	nAPP2131330323

Chili Parlor 17 Federal #002H Incident ID: nAPP2131330323

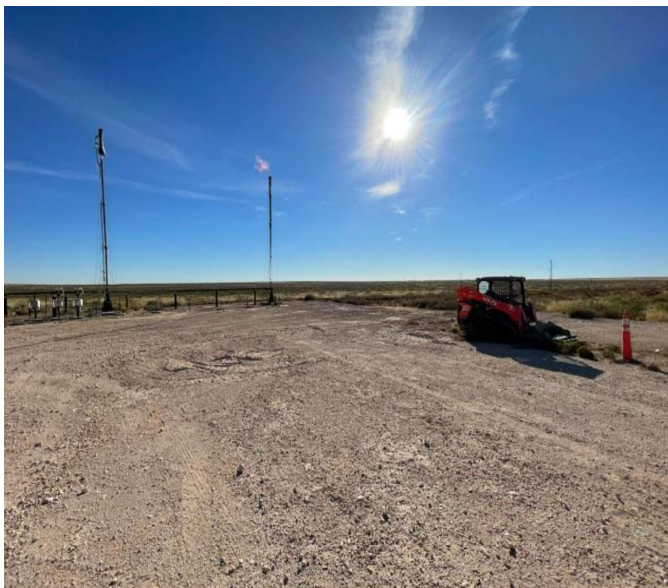
*Photo: North Side of Spill Area*

Beginning November 15, 2021, Marathon contracted Wescom to conduct remediation activities onsite and to remove any contamination from the vegetation offsite. A skidsteer was used to remove contaminated soil from the surface of the caliche pad. Impacted material from the surface scrape was transported to an approved disposal facility. The high-pressure flare stack was pressure washed and returned to working condition.

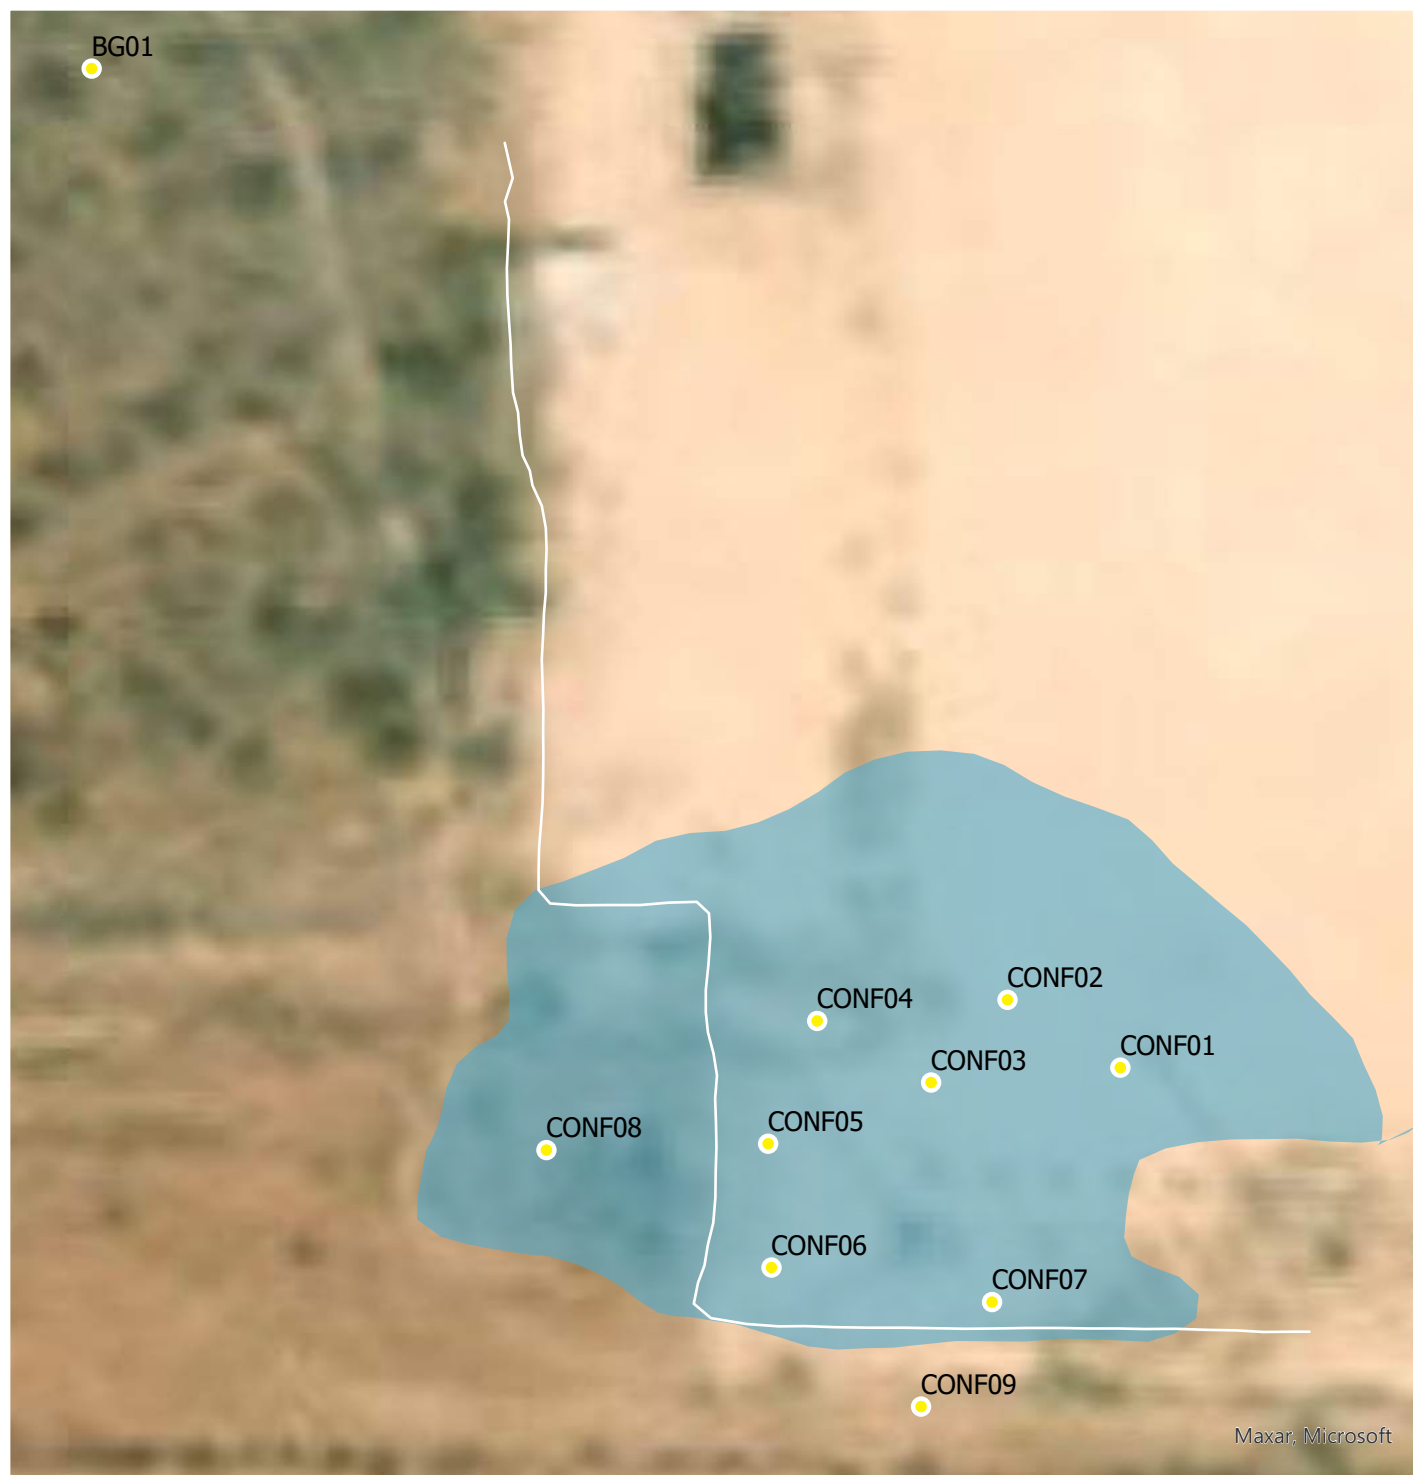
**FIGURE 1.**  
**CONFIRMATION SAMPLES**

Confirmation composite samples were obtained from the excavation on December 02, 2021. All soil samples were properly packaged, preserved, and transported to Hall Environmental by chain of custody, and analyzed for Total Petroleum Hydrocarbons, or TPH, —Method 8015M/D, BTEX—Method 8021B, and Chlorides—Method 300.0. Confirmation samples collected at zero feet and half a foot bgs were all below the applicable RRAL for the Site as shown in Table 1. A background sample BG01 was collected 55 feet Northwest of the caliche pad.

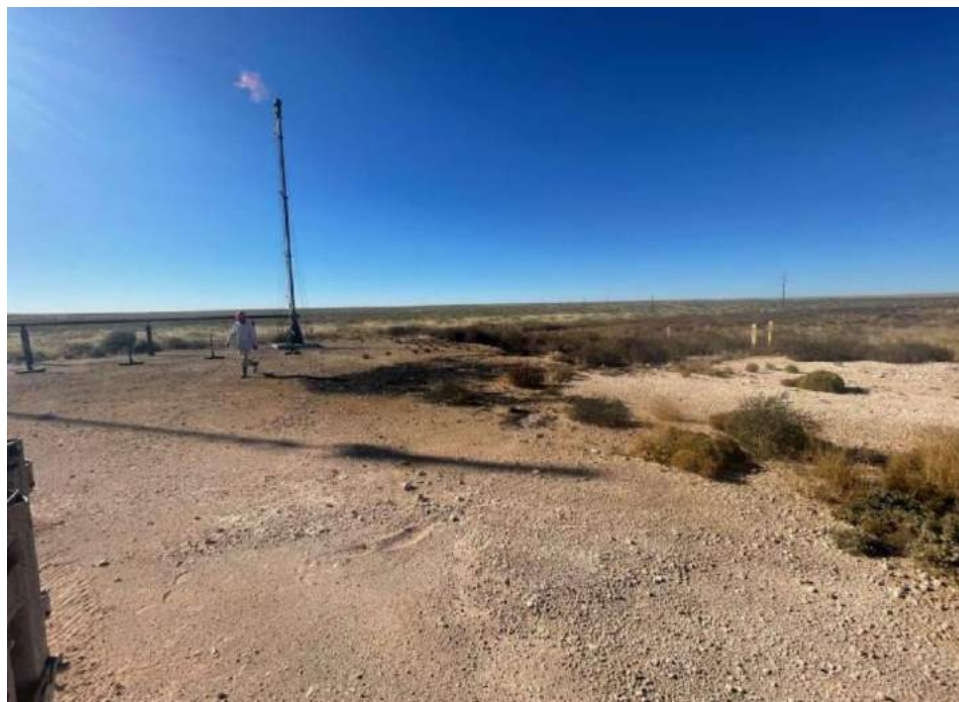
**Initial Spill Area (On-Pad)**

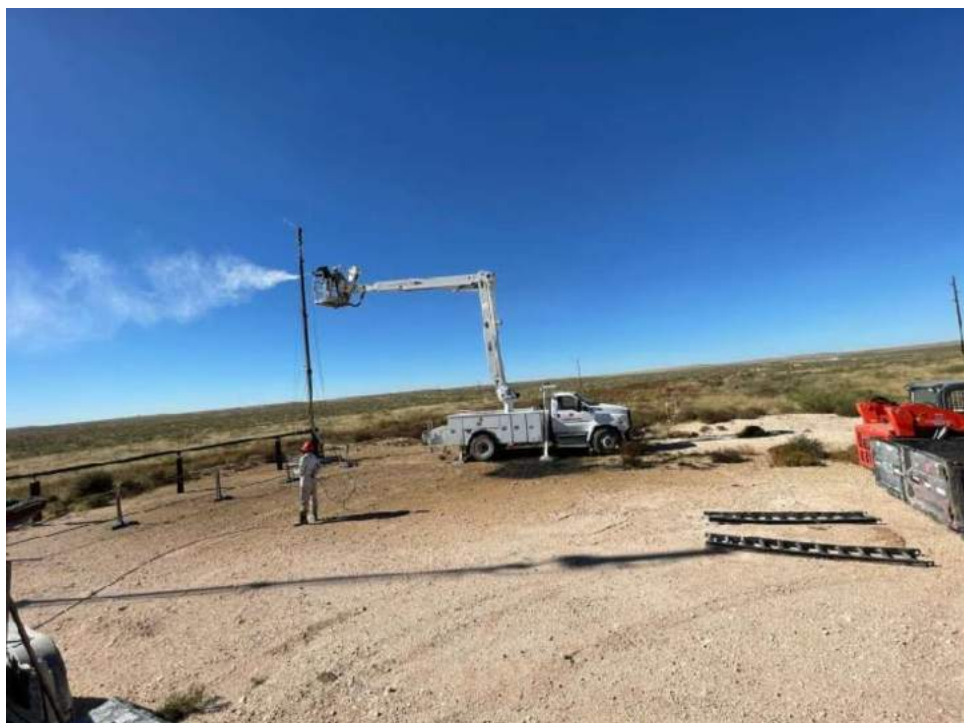
**Initial Spill Area - Cleanup (On-Pad)**

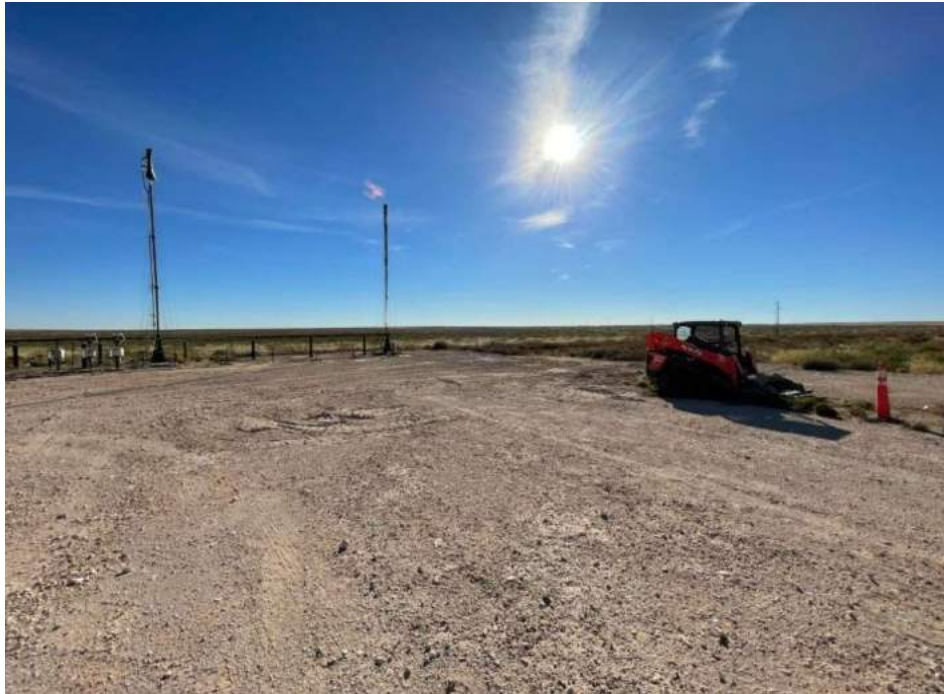
Completed Scrape of Spill Area (On-Pad)

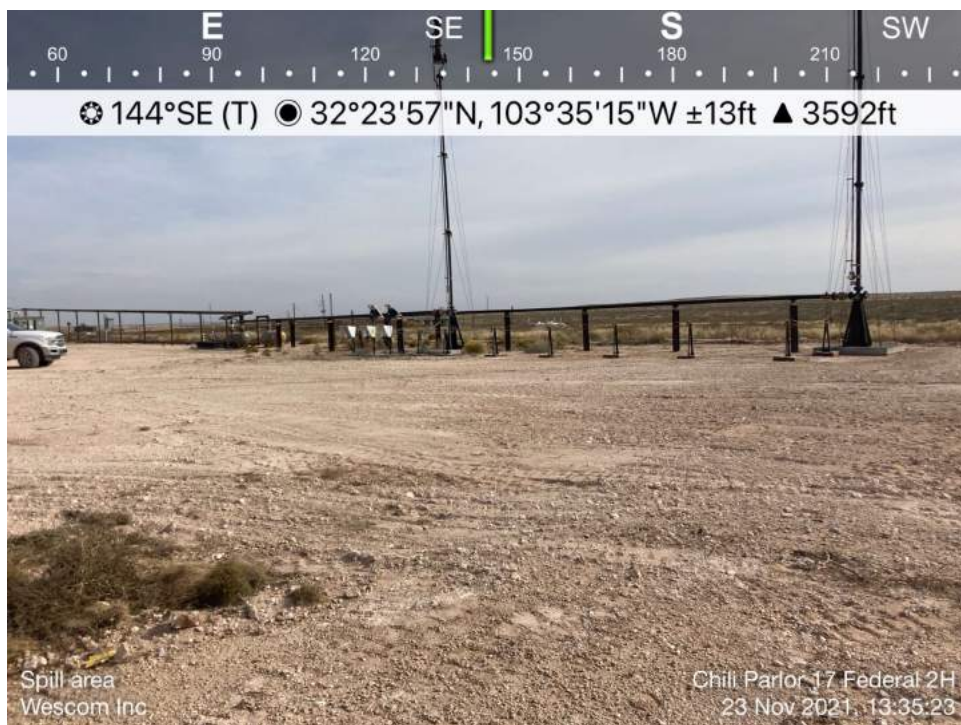
Completed Scrape of Spill Area (On-Pad)

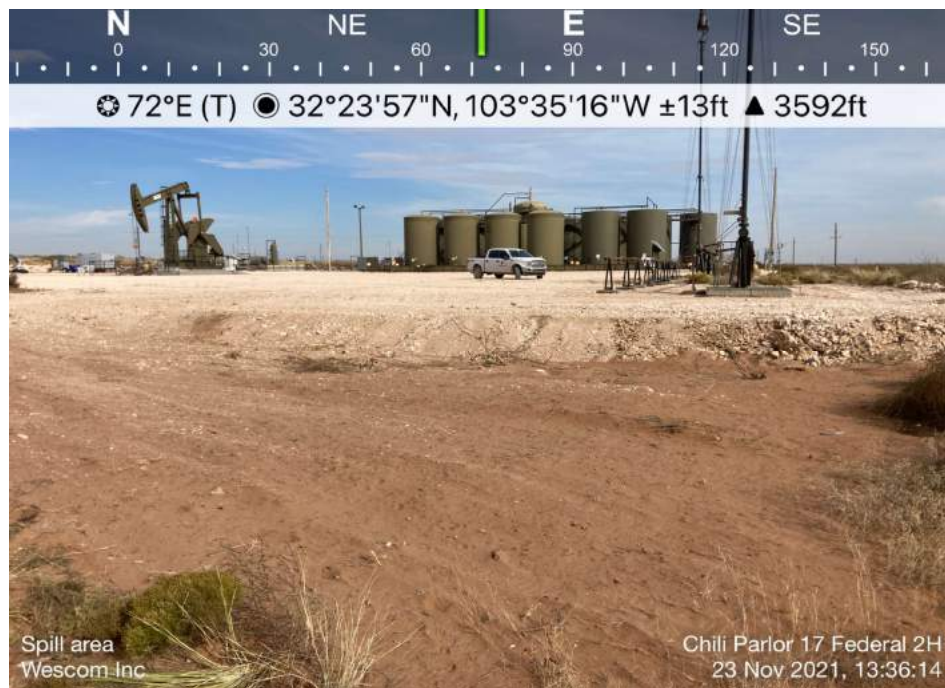
West Side of Caliche Pad

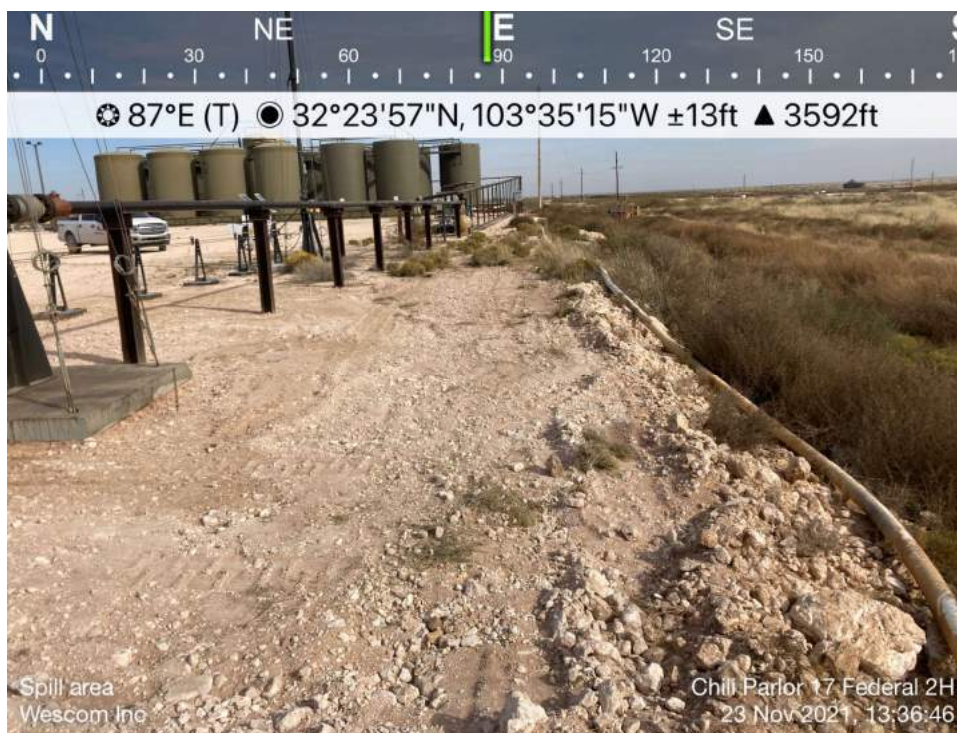
Southeast Side of Flare Line (On-Pad)

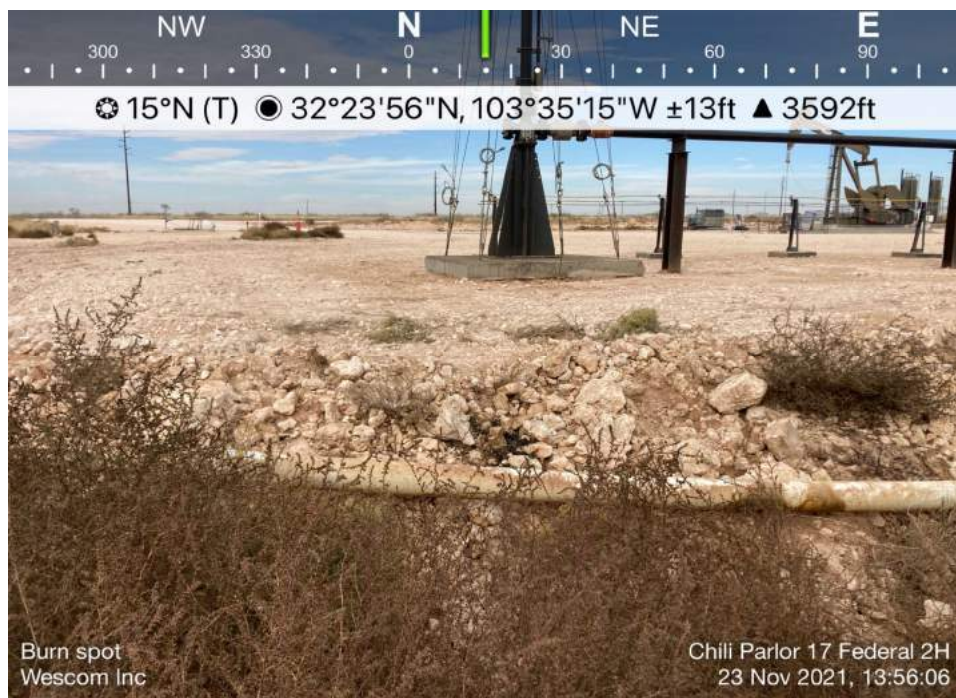
Edge of Caliche Pad (Burned Weeds)

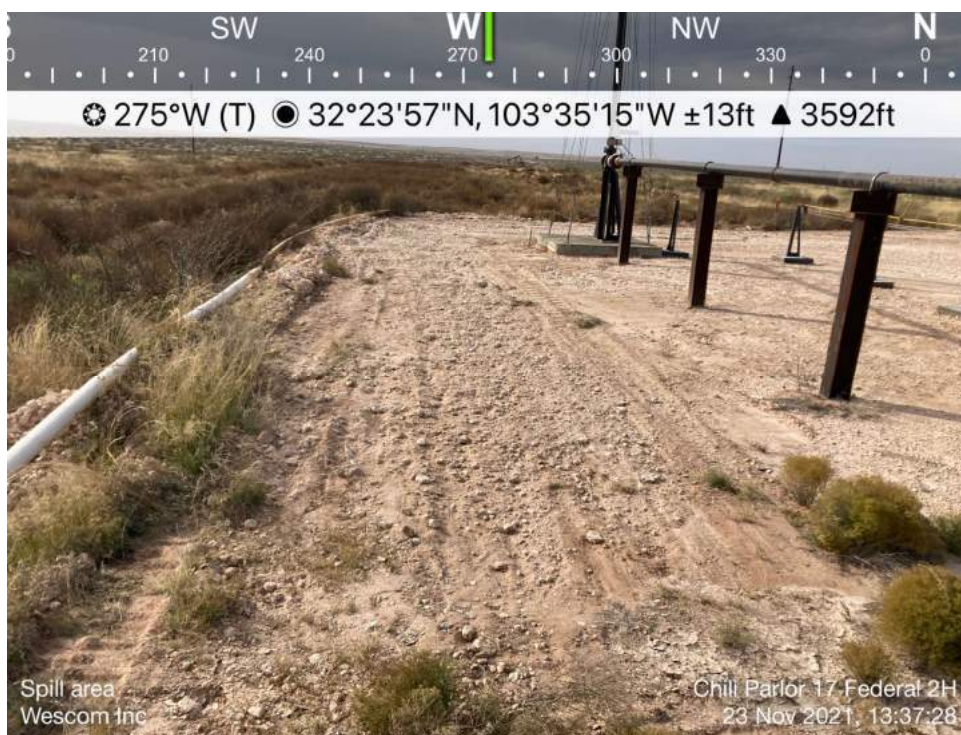
South Side of Flare Line (On-Pad)
