(Extension Approval) NAPP2128047535-BOURBON RED FRAC WATER LINE (09.27.2021)

Re: **Request for Approval of Work Plan**
Bourbon Red Frac Water Line
Tracking #: NAPP2128047535

Site Information	
Incident ID	NAPP2128047535
Site Name	Bourbon Red Frac Water Line
Company	Mewbourne Oil Co.
County	Eddy County, NM
ULSTR	M-07-19S-29E
GPS Coordinates (NAD 83)	32.669186, -104.120669
Landowner	State of NM

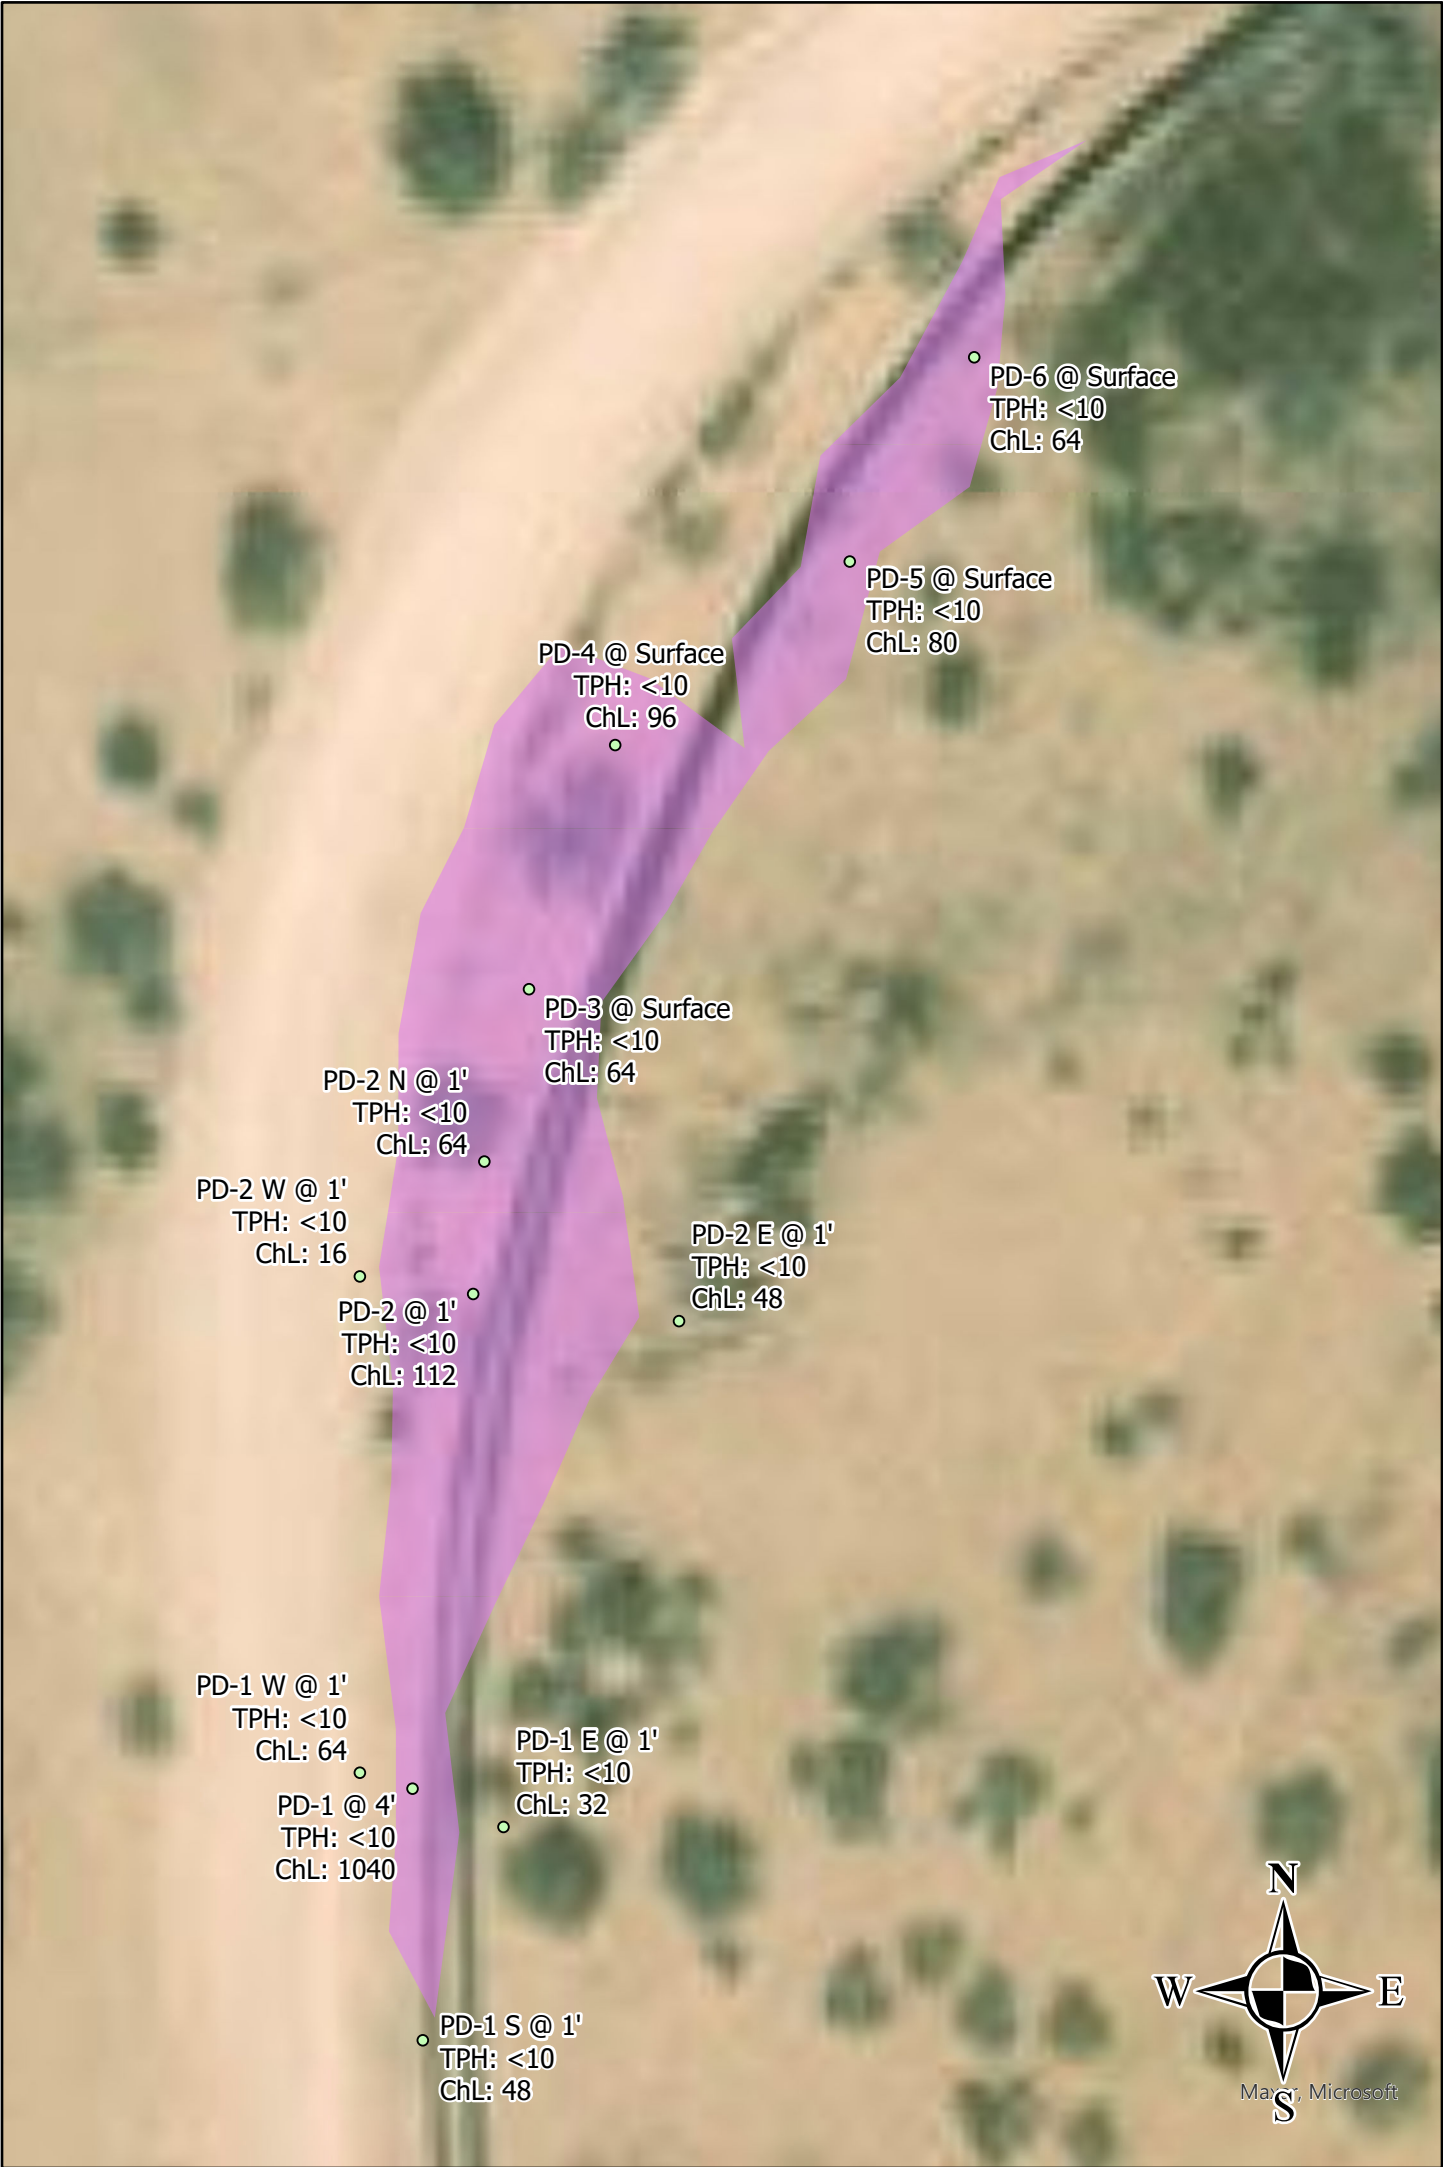
Legend: ○ Delineation ■ Release Area	Figure 2 Site Delineation Map Mewbourne Oil Co. Bourbon Red Frac Water Line Eddy County, New Mexico NMOCD Reference # NAPP2128047535	
---	---	----------

Delineation Summary	
Delineation Dates	11/1/2021 & 12/14/2021
Sample Locations	PD-1 – PD-6
Total Initial Samples	13
Depths Sampled	Surface to 6 ft bgs.
Delineation Map	Figure 2
Laboratory Results	Table 1

A total of Six (6) delineation sample point (PD-1 – PD-6) in the Pasture were investigated to depths ranging between Surface and 6 ft bgs using a hand auger or backhoe. A total of Thirteen (13) samples were collected for laboratory analysis during the initial delineation of the site.

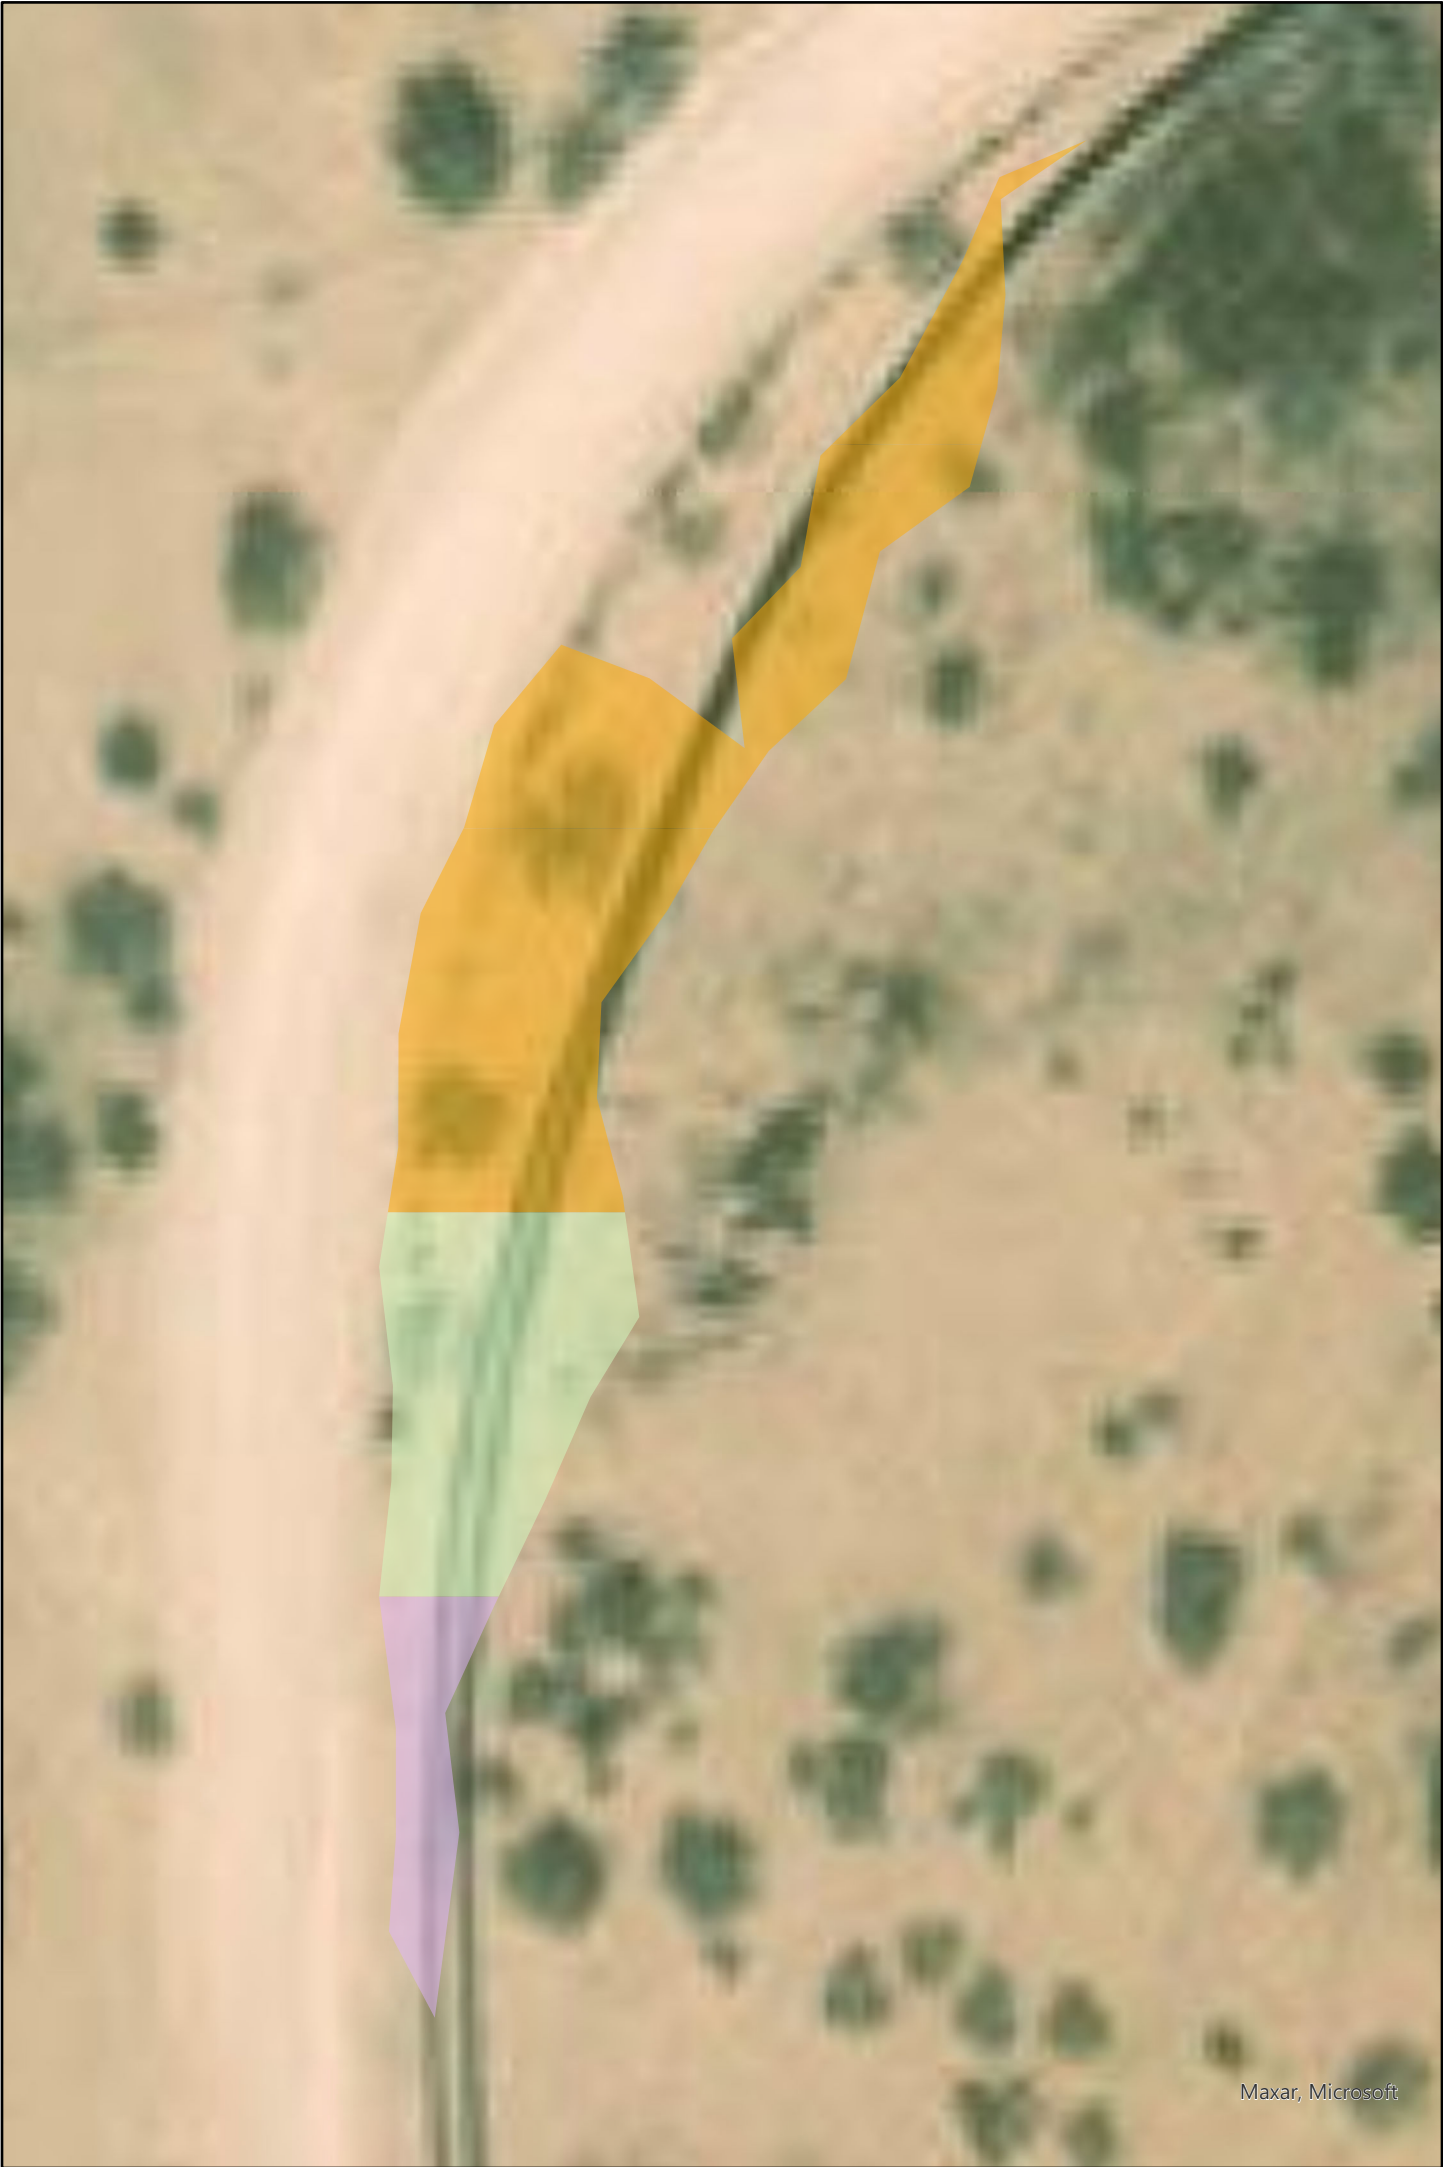
<p>Legend:</p> <p>Excavation Depth</p> <p>1'</p> <p>4'</p> <p>None</p>	<p>Figure 3</p> <p>Proposed Excavation Map</p> <p>Mewbourne Oil Co.</p> <p>Bourbon Red Frac Water Line</p> <p>Eddy County, New Mexico</p> <p>NMOCD Reference #</p> <p>NAPP2128047535</p>	<p>0 5 10 20 30 40 Feet</p> <p>

Remediation Proposal	
Proposed Remediation Dates	Within 90 days of approval
Liner Variance Request	None
Deferral Request	None
Proposed Depths Excavated	1' – 4' bgs
Proposed 5-point Confirmation Sample Area – Floors and Walls	500 sqFt
Estimated Volume of Excavated Soil	125 yds
Proposed Excavation Map	Figure 3

Impacted soil within the release margins will be excavated and temporarily stockpiled on-site on a 6-mil plastic sheeting, pending final disposition. The floors of the excavated area will be advanced until laboratory analytical results from confirmation soil samples indicate Chloride, Benzene, BTEX, and TPH concentrations are below the NMOCD Closure Criteria listed in the Table above, and all walls will be advanced to meet reclamation standard. Confirmation soil samples (five-point composites representing no more than 500 ft² of the excavated area) were collected from the floor and sidewalls.

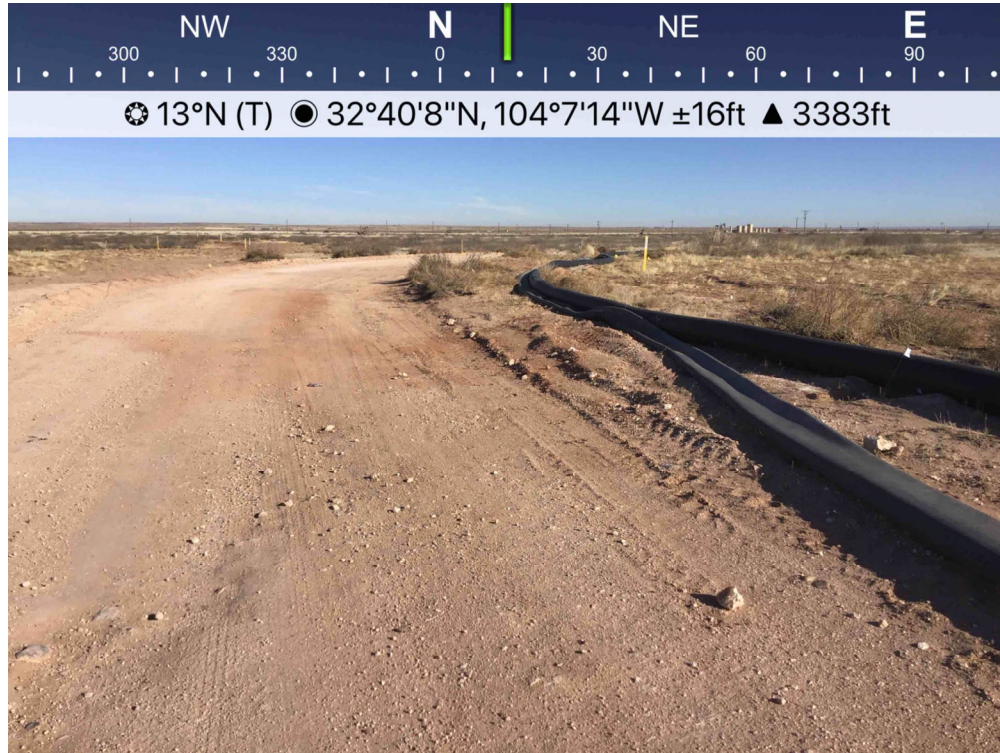
Initial Release

Pasture:

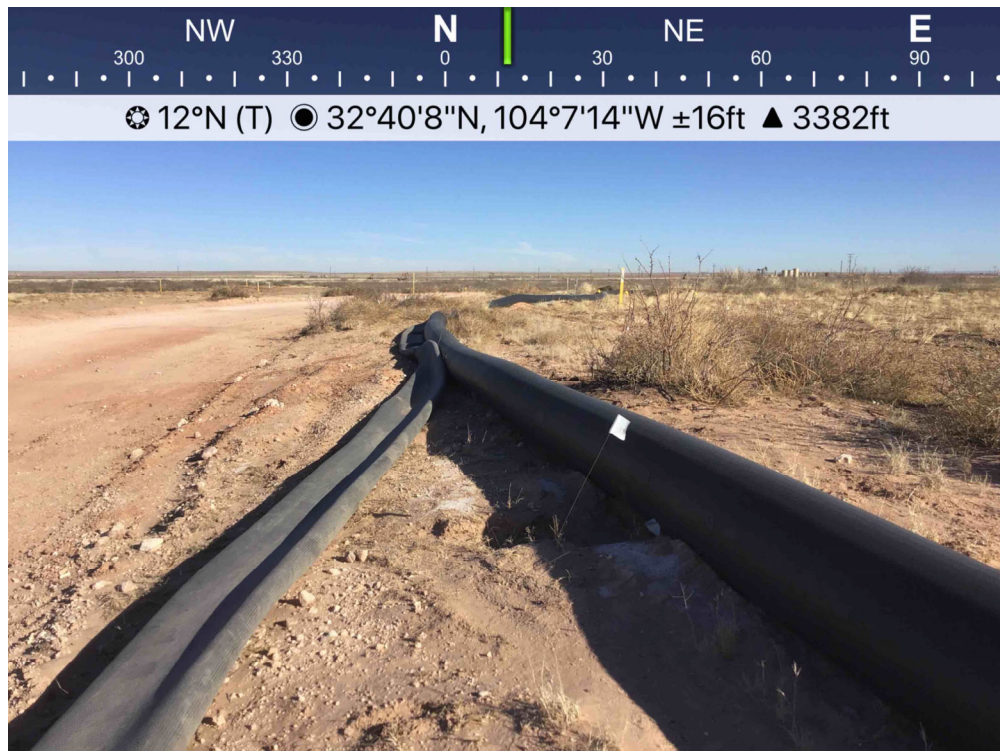
Pasture:

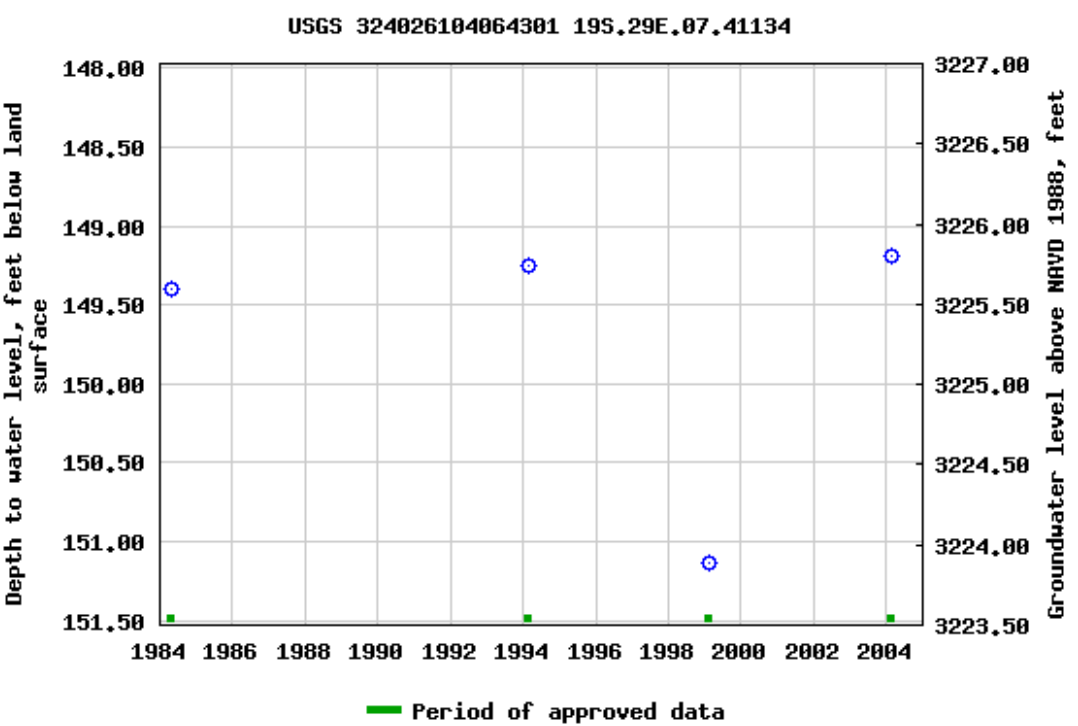
Eddy County, New Mexico
Hydrologic Unit Code 13060011
Latitude 32°40'26", Longitude 104°06'43" NAD27
Land-surface elevation 3,375 feet above NAVD88
The depth of the well is 199 feet below land surface.
This well is completed in the Other aquifers (N9999OTHER) national aquifer.
This well is completed in the Artesia Group (313ARTS) local aquifer.

Breaks in the plot represent a gap of at least one year between field measurements.
[Download a presentation-quality graph](#)
