Re: Site Assessment, Remediation, and Closure Report
Morris Arco 26 #002 Transfer Line Manifold
API No. 30-015-29258
GPS: Latitude 32.636090 Longitude -104.452190
UL "B" Sec. 26, T19S, R25E
Eddy County, NM
NMOCD Ref. No. NAPP2130741101

Morris Arco 26 #2 SWD

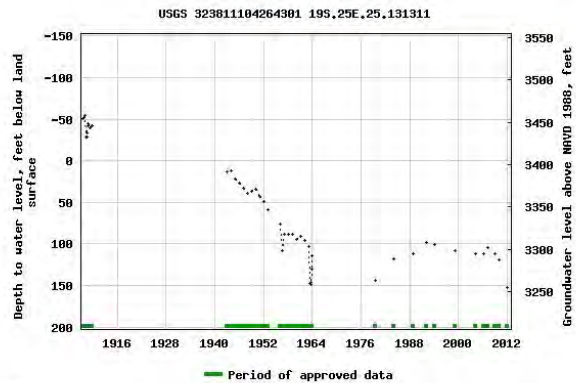
USGS 323811104264301 19S.25E.25.131311

According to the New Mexico Office of the State Engineer, depth to the nearest groundwater in this area is 40 feet below grade surface (BGS). According to the United States Geological Survey (USGS), the nearest groundwater in this area is 152 feet BGS. The closest waterway is Brantley Lake located approximately 4.45 miles to the southeast of this location. See Appendix A for referenced water surveys.

Breaks in the plot represent a gap of at least one year between field measurements.

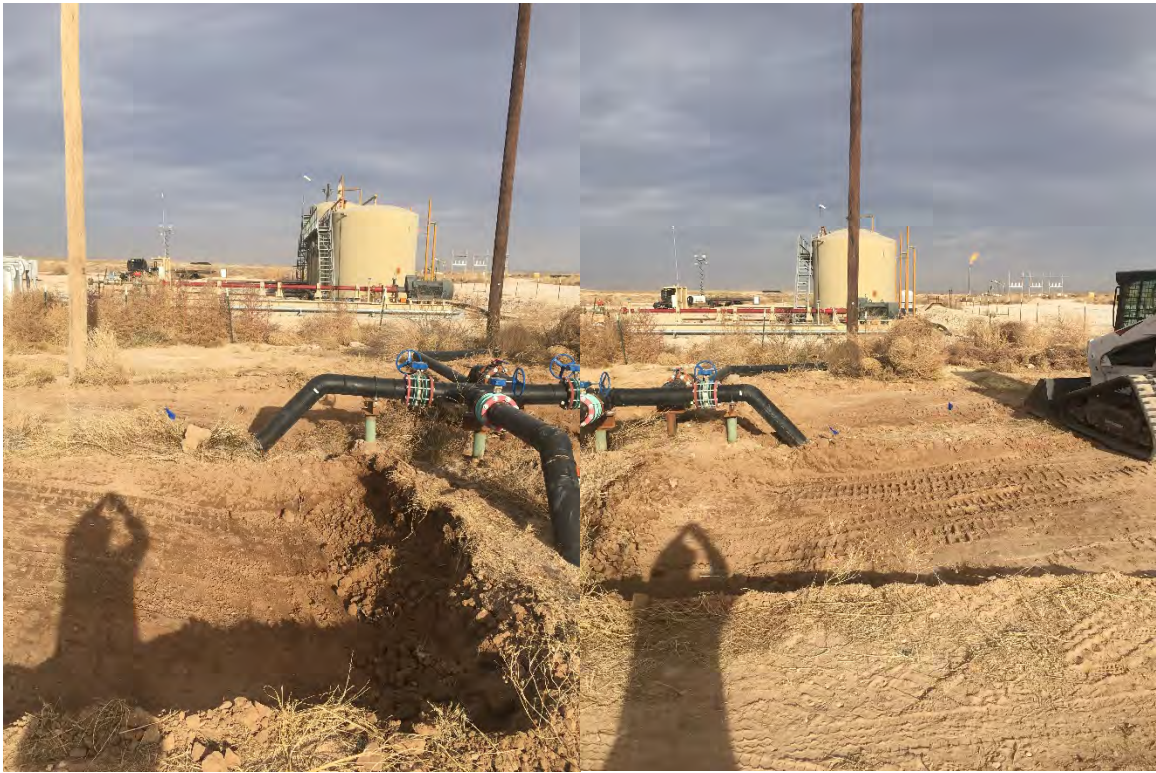
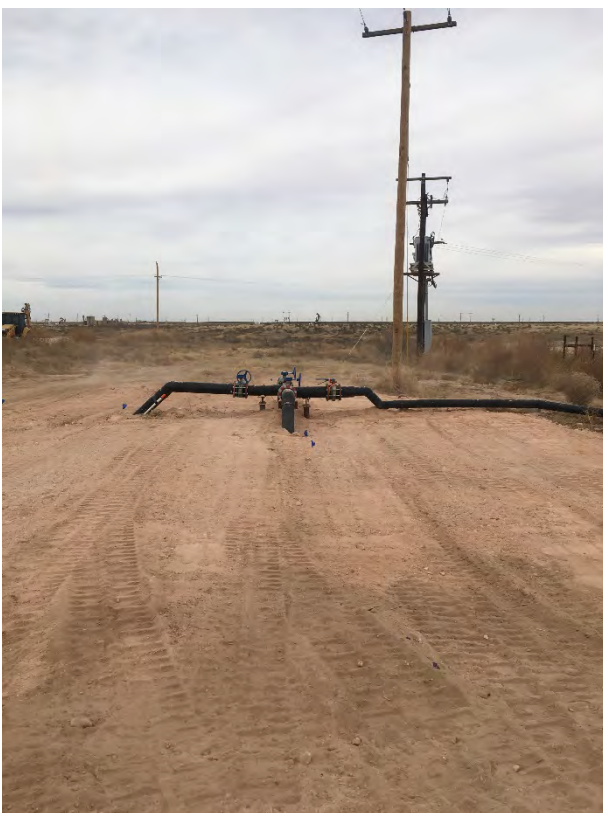
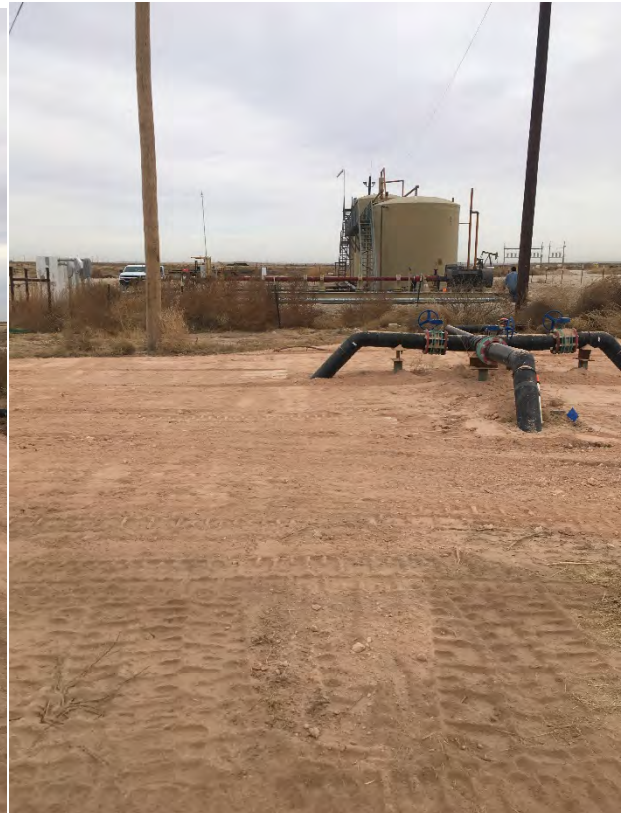
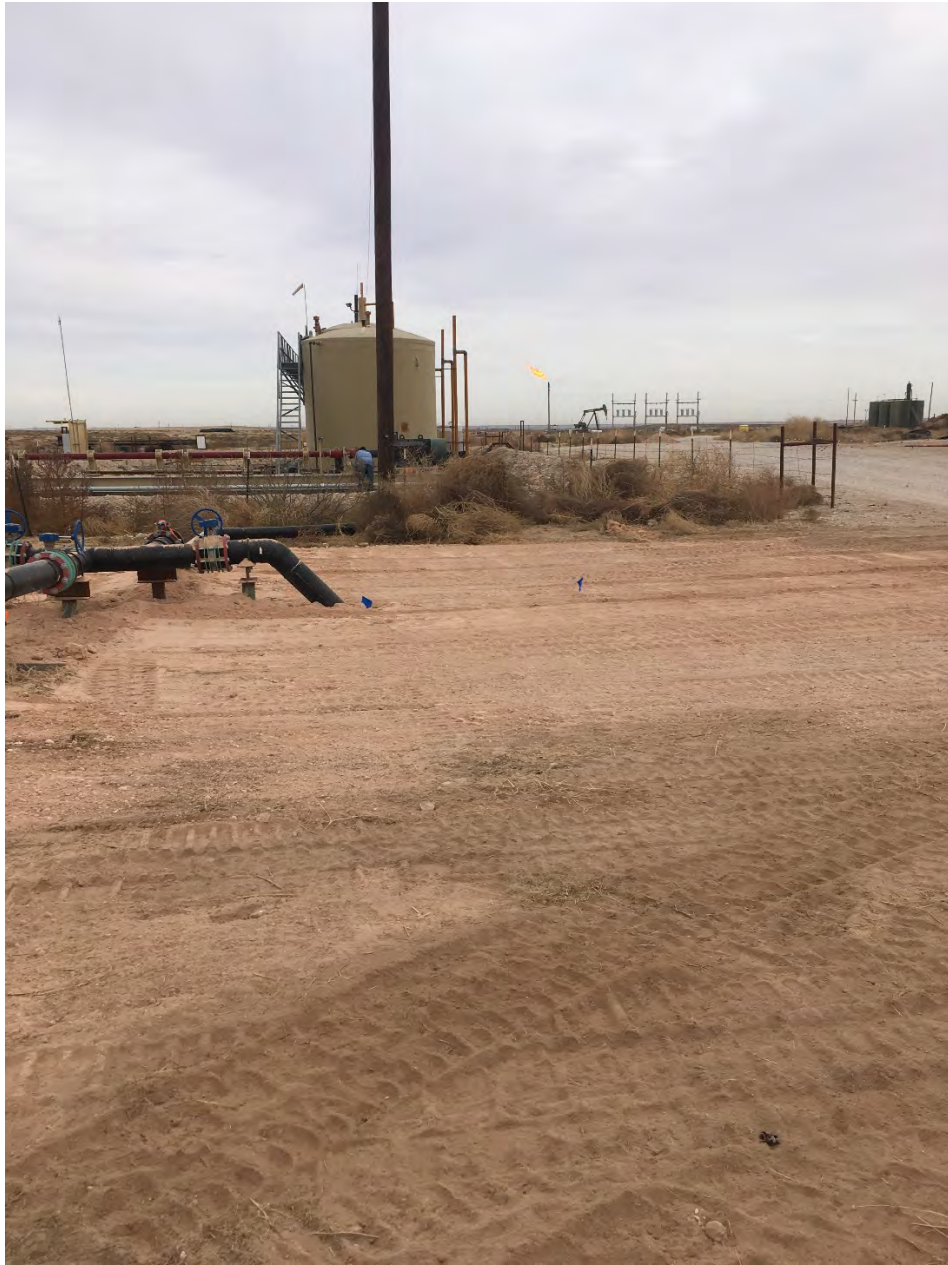
SITE PHOTOGRAPHS

On December 7th, 2021, Pima mobilized personnel and equipment to conduct remedial activities. We excavated the contaminated area to various depths. Bottom and sidewall composite samples were obtained to ensure that the horizontal and vertical extents of the contamination had been removed. Photographic Documentation can be found in Appendix D.

Based on the sample results, the bottom and sidewalls were below NMOCD Closure Criteria 19.15.29 NMAC. The contaminated material was transported to Lea Land, a NMOCD approved disposal site. The excavation was then backfilled with clean like material, machine compacted and contoured to match the surrounding terrain.
