**Re: 2020 Soil Assessment Report - Deferral Request – LPU Central Battery  
Case No. 1RP-2315  
Lea County, New Mexico**

## 2020 SOIL ASSESSMENT REPORT

LPU Central Battery

Case No. 1RP-2315 & 1RP-2365

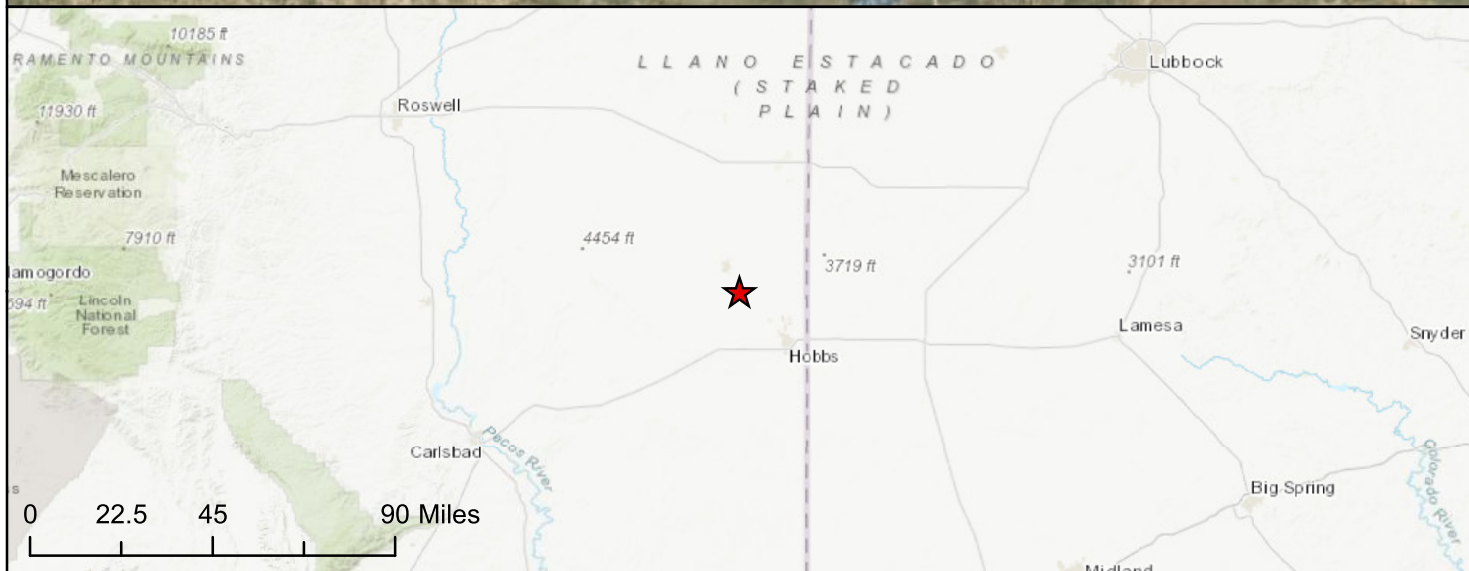
FIGURE  
1

The Site is approximately 5.6 miles south of Lovington, in Unit B, Section 1, Township 17 South, Range 36 East, Lea County, New Mexico. A site location map is included as **Figure 1**.

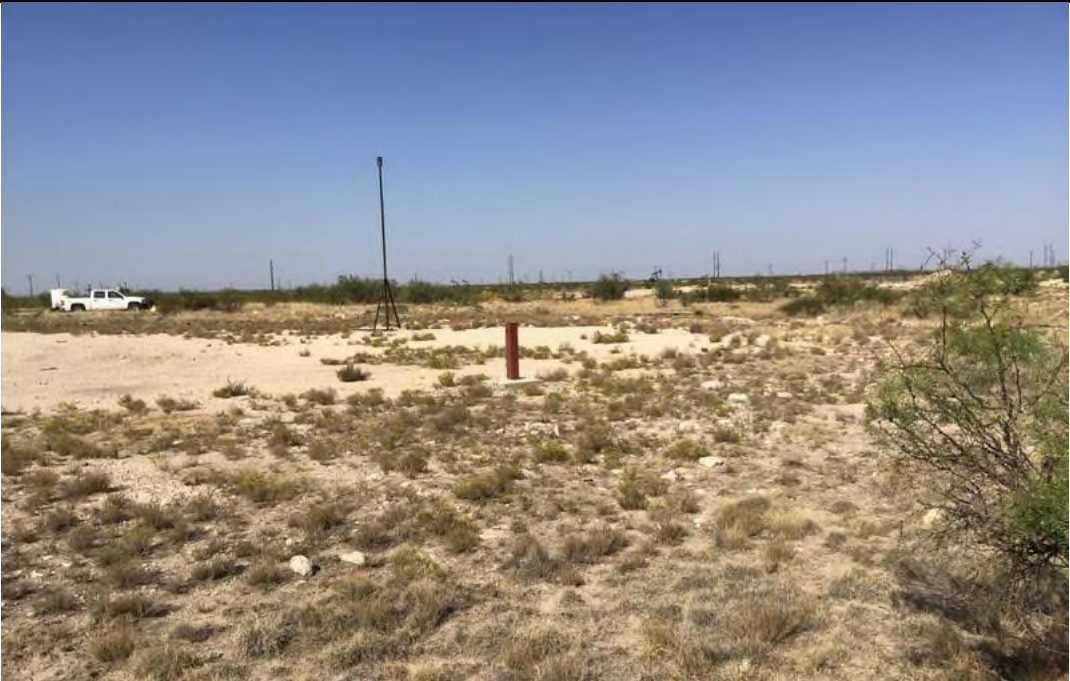
| ARCADIS | | PHOTOGRAPHIC LOG |
|---|---|---|
| <b>Photo No.</b><br>1 | <b>Date:</b><br>10/14/2020 | |

| ARCADIS | | PHOTOGRAPHIC LOG |
|---|---|---|
| <b>Direction Photo Taken:</b><br>Facing West | | |
| <b>Description:</b><br>Near SB-3, burn-off stack | | |

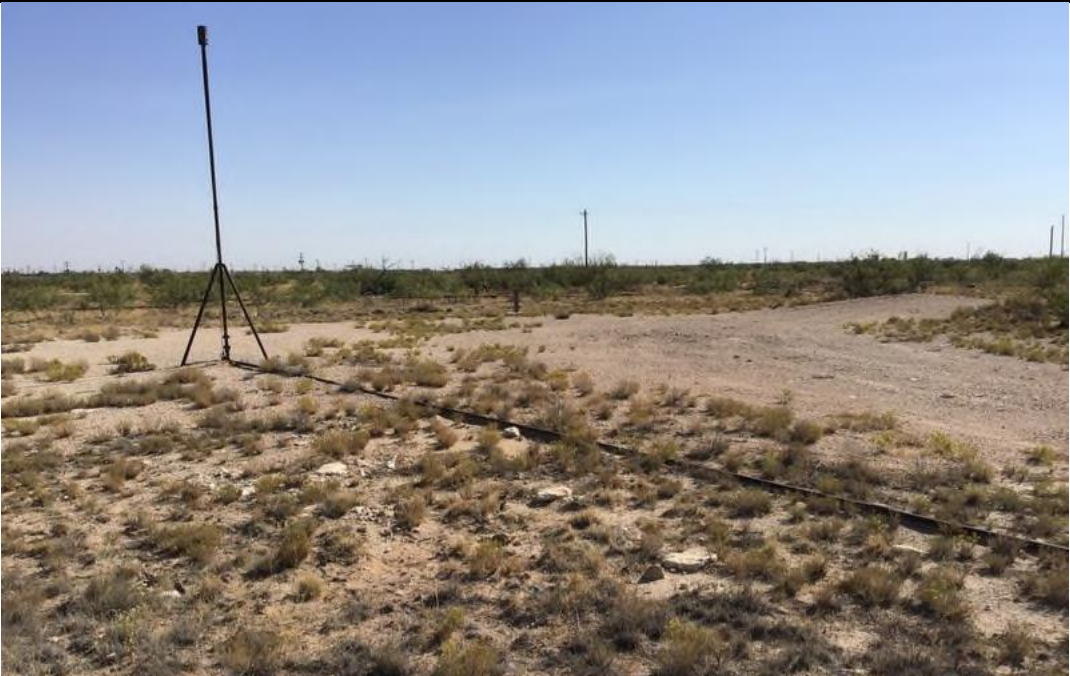
| ARCADIS | | PHOTOGRAPHIC LOG |
|---|---|---|
| <b>Photo No.</b><br>2 | <b>Date:</b><br>10/14/2020 | |

| ARCADIS | | PHOTOGRAPHIC LOG |
|---|---|---|
| <b>Direction Photo Taken:</b><br>Facing East | | |
| <b>Description:</b><br>Near SB-1, burn-off stack and piping leading to it | | |

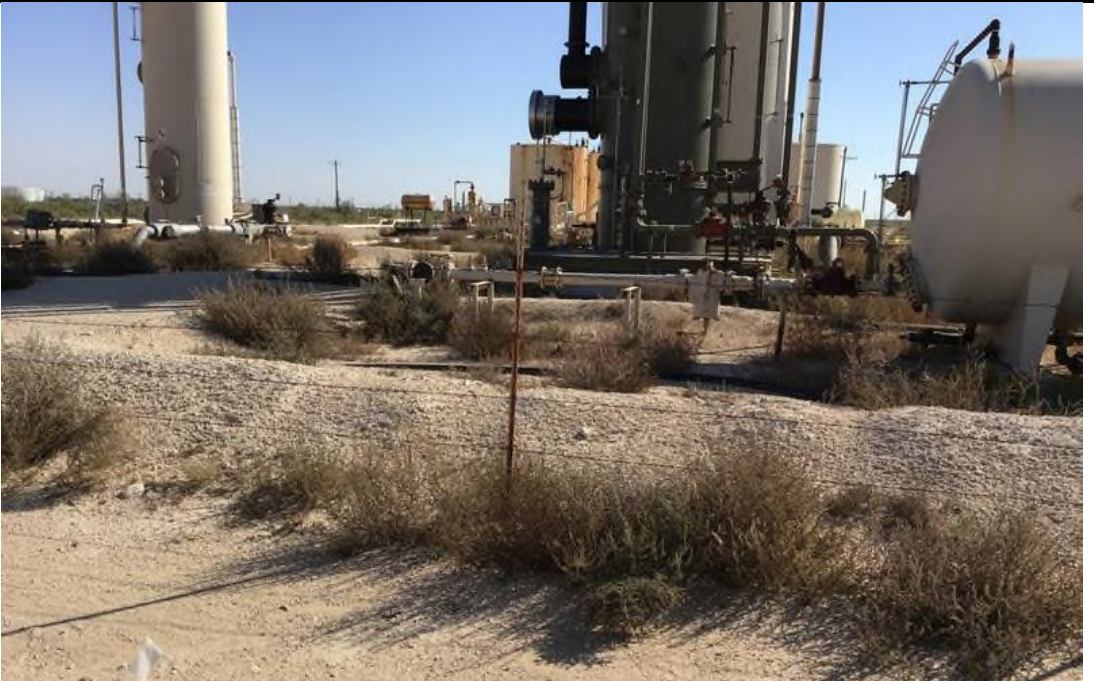
| <b>Photo No.</b><br>3 | <b>Date:</b><br>10/14/2020 | | |

| <b>Direction Photo Taken:</b><br>Facing East | | | |
| <b>Description:</b><br>Near SB-10, heater treater visible | | | |

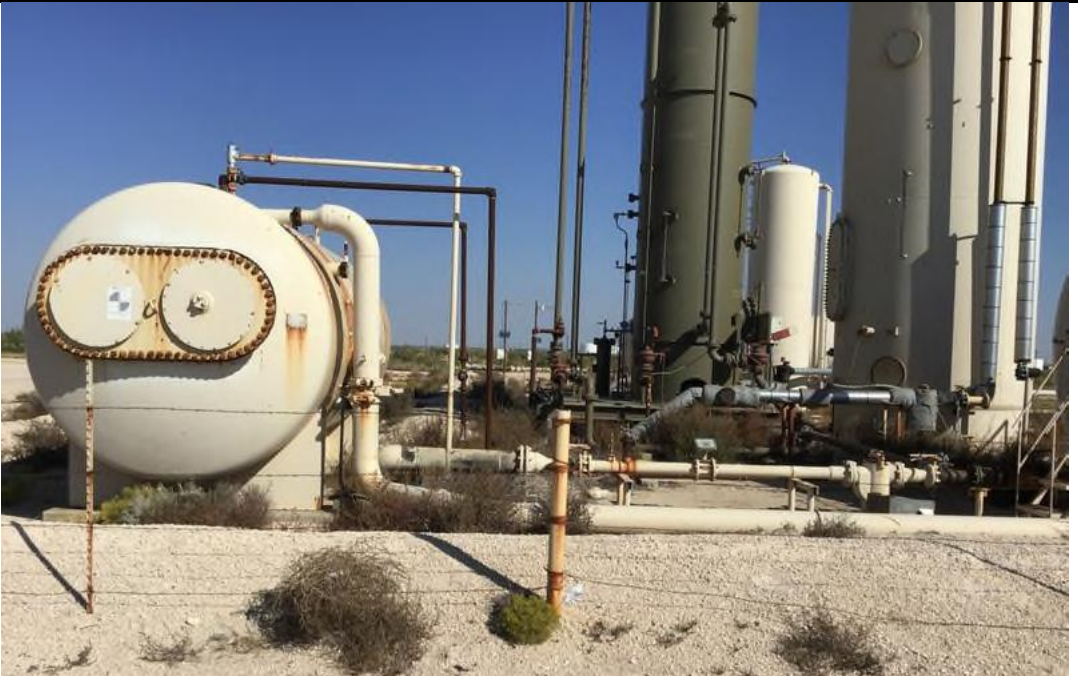
| <b>Photo No.</b><br>4 | <b>Date:</b><br>10/14/2020 | | |

| <b>Direction Photo Taken:</b><br>Facing North | | | |
| <b>Description:</b><br>Near SB-12 | | | |

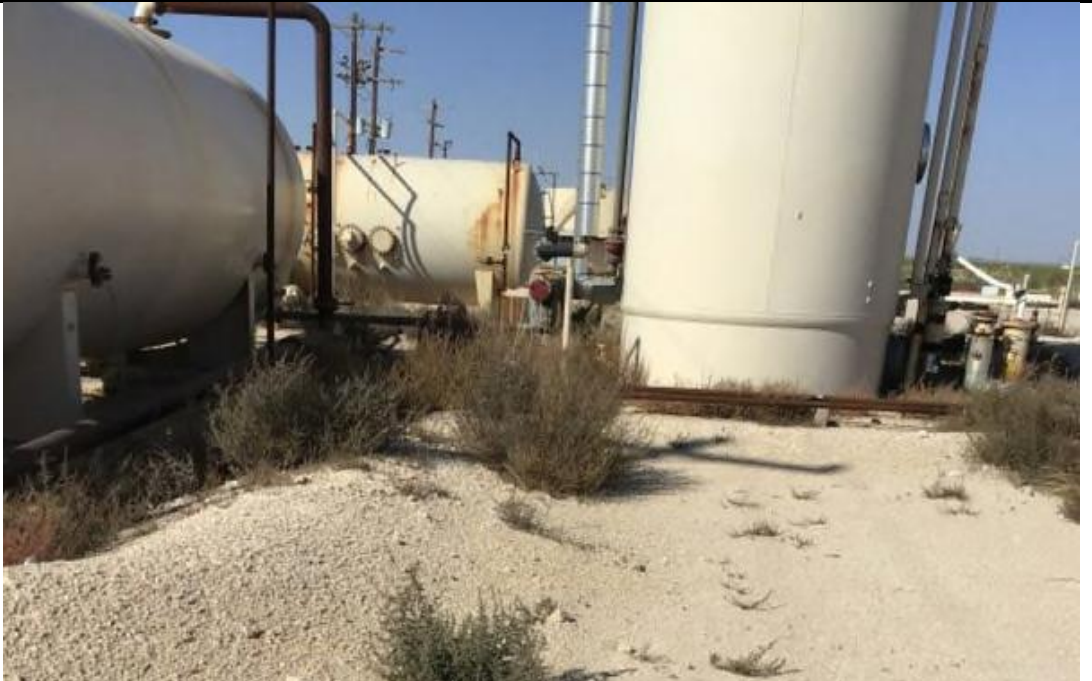
| <b>Photo No.</b><br>7 | <b>Date:</b><br>10/14/2020 | | |

| <b>Direction Photo Taken:</b><br>Facing West | | | |
| <b>Description:</b><br>Near SB-14 | | | |

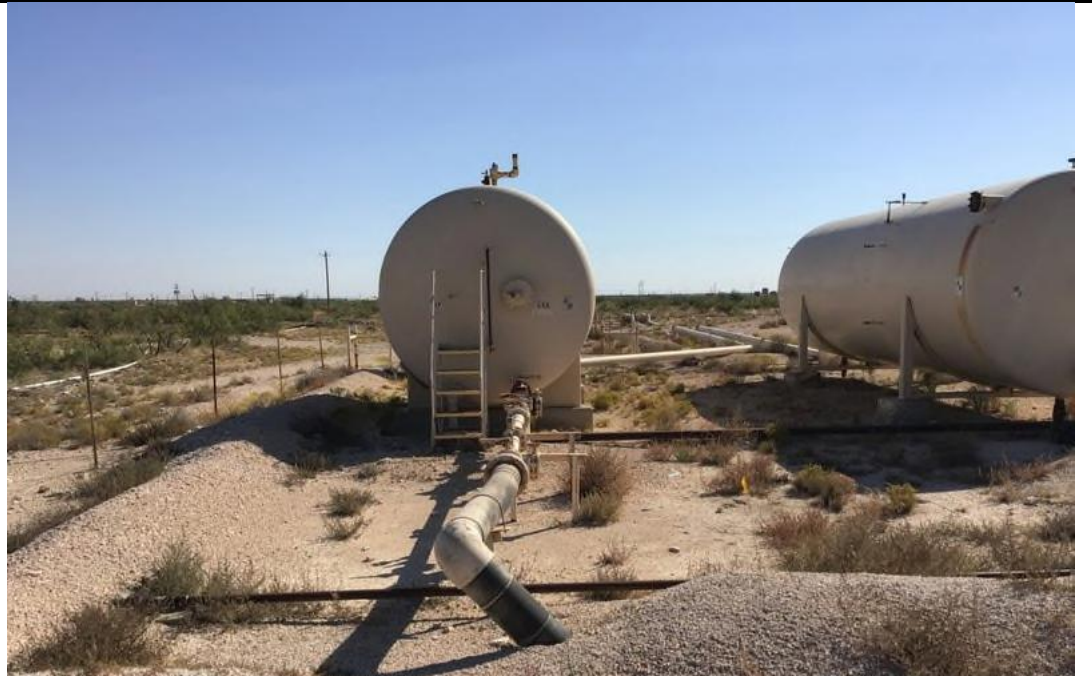
| <b>Photo No.</b><br>8 | <b>Date:</b><br>10/14/2020 | | |

| <b>Direction Photo Taken:</b><br>Facing East | | | |
| <b>Description:</b><br>Northwest corner of fenced pad | | | |

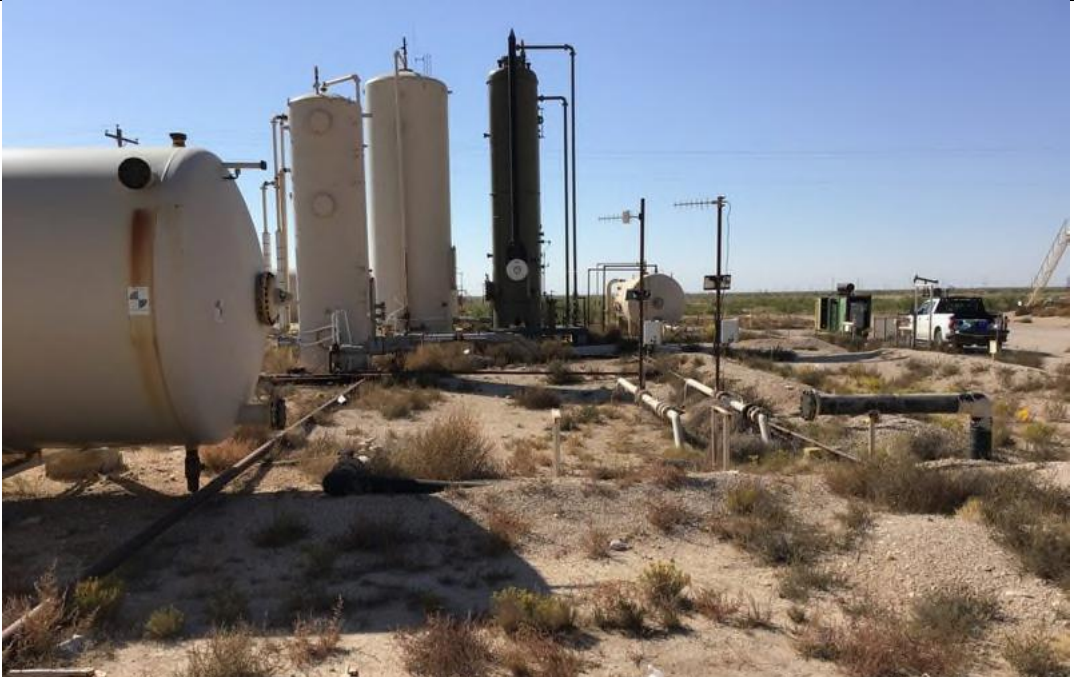
| <b>Photo No.</b><br><b>9</b> | <b>Date:</b><br>10/14/2020 | | |

| <b>Direction Photo Taken:</b><br>Facing South | | | |
| <b>Description:</b><br>Near SB-5 | | | |

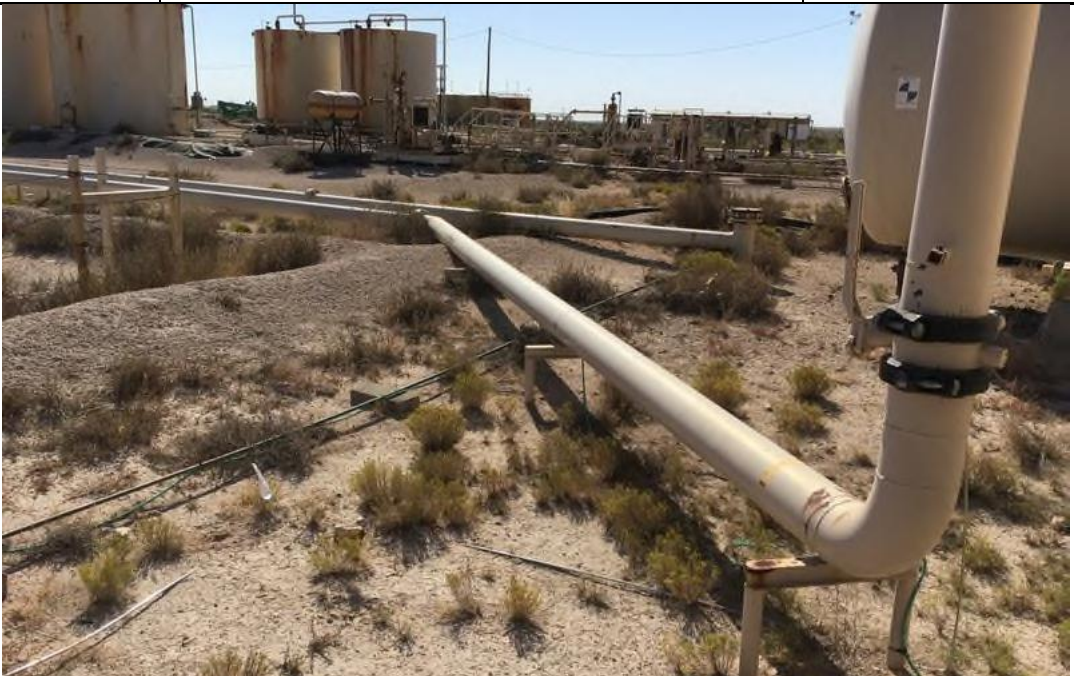
| <b>Photo No.</b><br><b>10</b> | <b>Date:</b><br>10/14/2020 | | |

| <b>Direction Photo Taken:</b><br>Facing Southeast | | | |
| <b>Description:</b><br>Near SB-4 | | | |
