**Re: Site Assessment, Remediation, and Closure Report**  
**Rose #002H**  
**API No. 30-015-45113**  
**GPS: Latitude 32.682299 Longitude -104.426263**  
**UL "D", Sec. 7, T19S, R26E**  
**Eddy County, NM**  
**NMOCD Ref. No. NRM2025560181**

Pima Environmental Services, LLC (Pima) has been contracted by Spur Energy Partners (Spur) to perform a spill assessment and submit this closure report for a produced water release that occurred at the Rose #002H (Rose). The initial C-141 was submitted on September 11<sup>th</sup>, 2020 (Appendix C). This incident was assigned Incident ID NRM2025560181, by the New Mexico Oil Conservation Division (NMOCD).

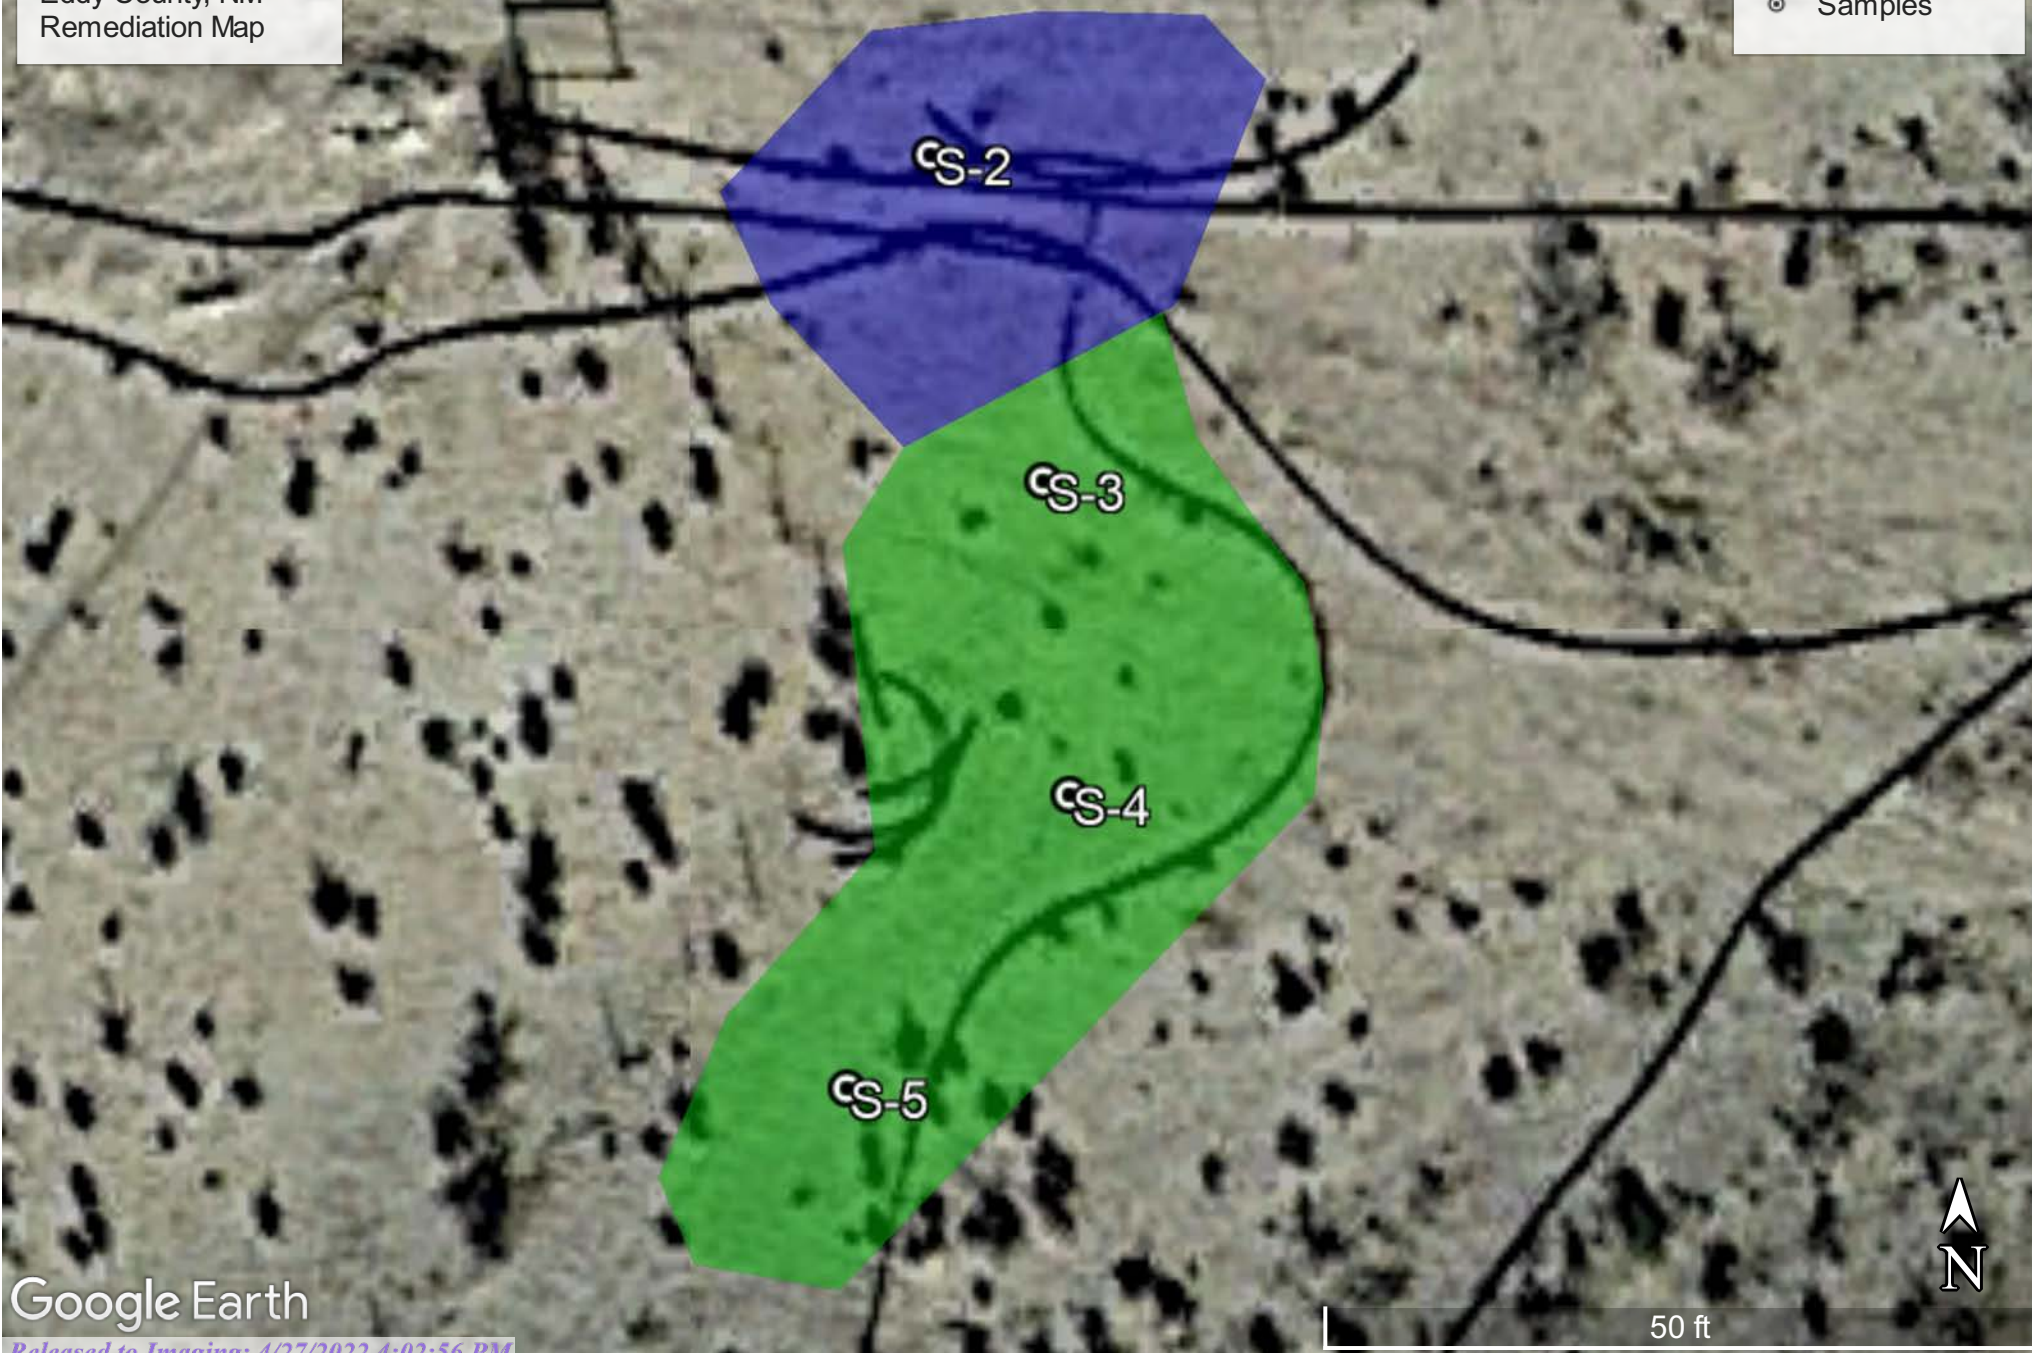
Spur Energy  
API #30-015-45113  
Eddy County, NM  
Confirmation Sample Map

On December 1<sup>st</sup>, 2021, after sending a 48-hour notification, Pima returned to collect confirmation samples of the affected area. The laboratory results of this sampling event can be found in the following table. A confirmation sample map can be found in Figure 6.

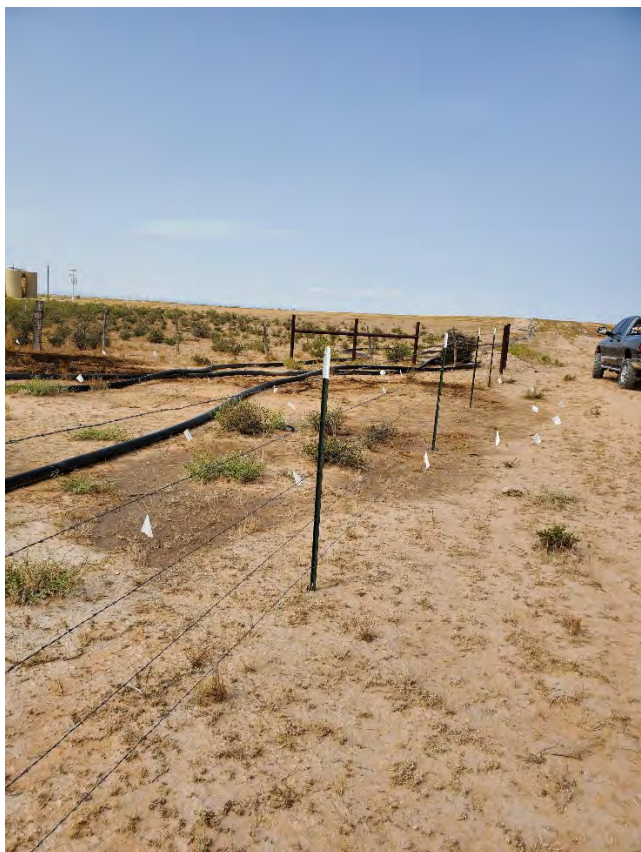
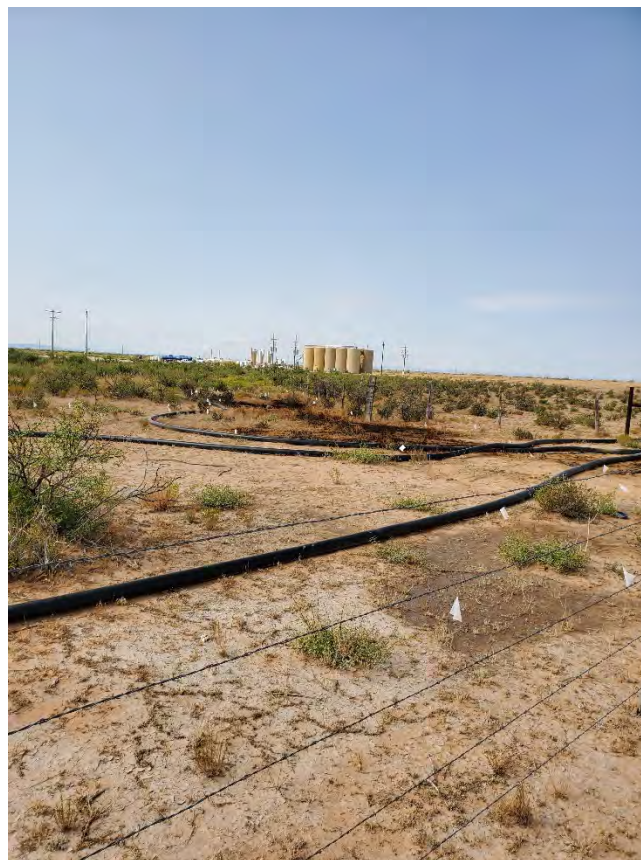
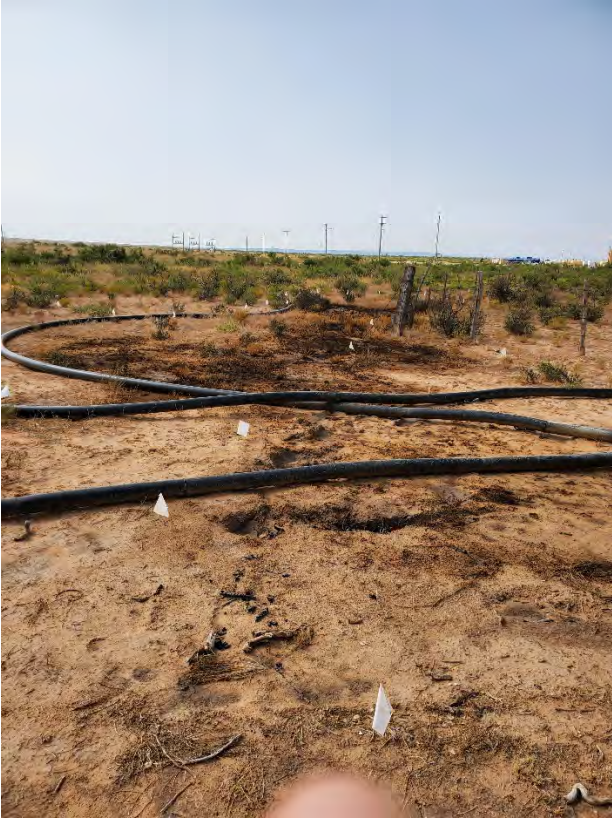
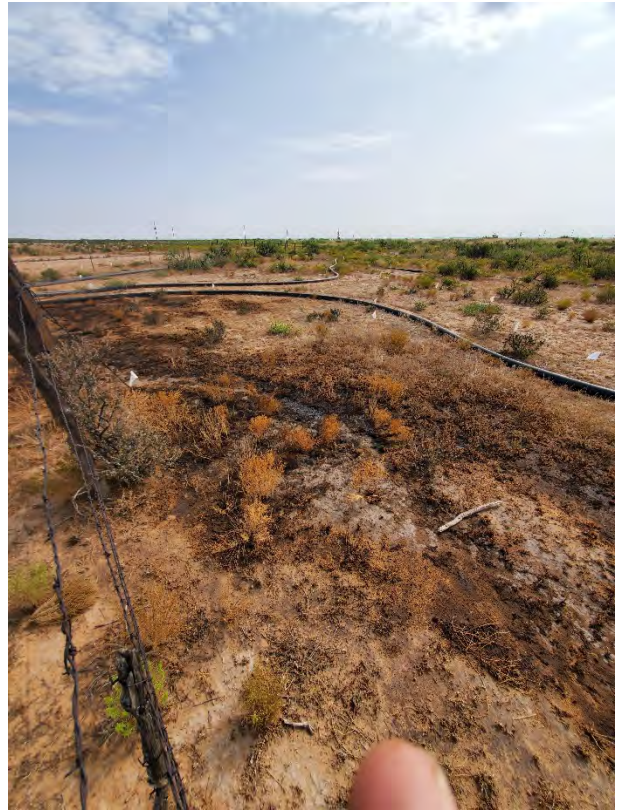
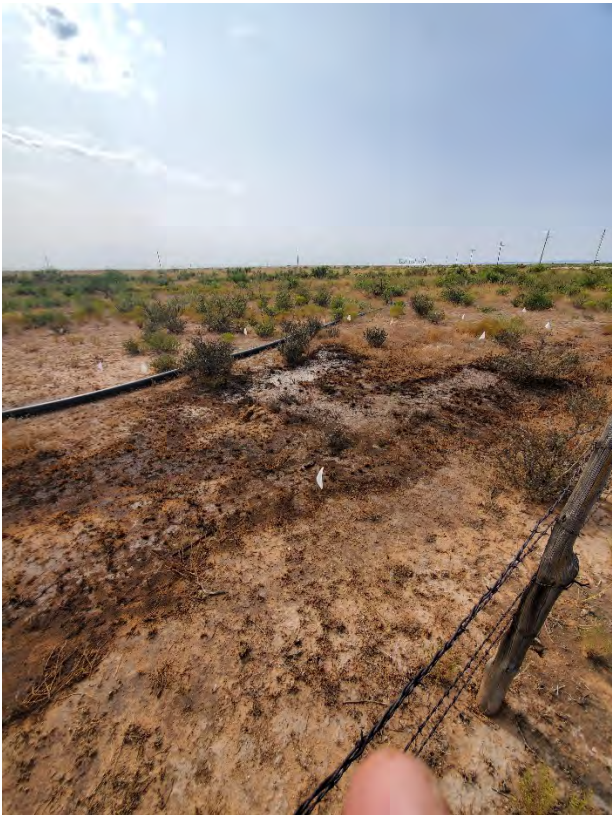
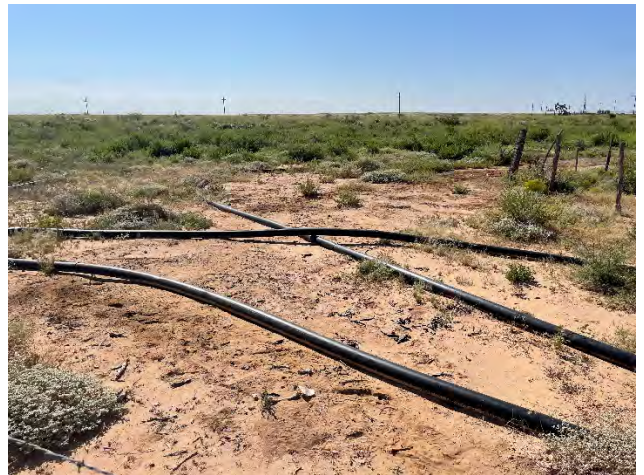
**Site Assessment**

**NRM2025560181:** On September 8<sup>th</sup>, 2020, the check valve developed a pin hole on the Rose CTB Water Line. The leak is located SE of the battery approximately 300 yards in the pasture area, the estimated area of impact is 12'x7'. The volume of the release was calculated to be approximately 30 barrels (bbls) of produced water. A vacuum truck was able to recover approximately 27 bbls of total fluid.
