Release Notification

RE: CLOSURE REPORT
Trunk E Release
NMOCD Incident No. NAPP2103643602
Harvest Release Report No. RRS201209A
NW¼ NW¼, Section 11, T26N, R3W
Rio Arriba County, New Mexico

Trunk E Release Excavation Clearance Report

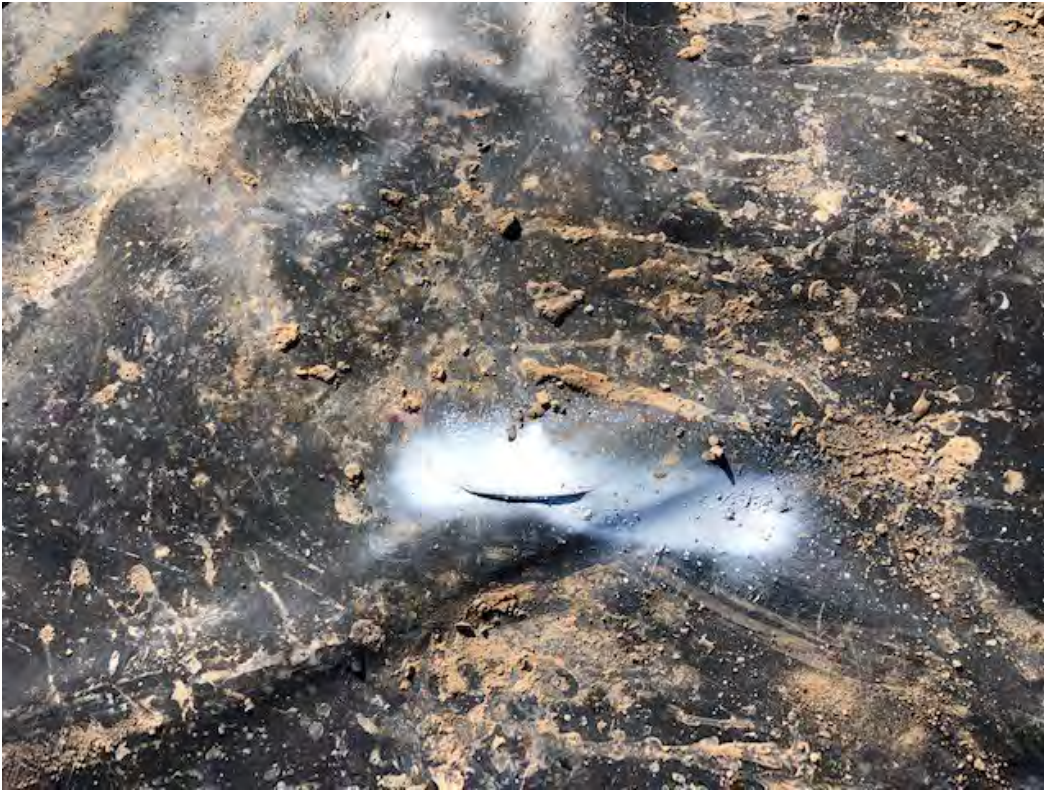
Multiple pinhole leaks and a tear were observed in the liner upon inspection, therefore Harvest proceeded with delineation and remediation in coordination with JANOGA and NMOCD. Project correspondence is attached. Soil confirmation samples were initially collected by Harvest when weather conditions allowed on January 12, 2021, with the collection of 5-point composite samples including two from each side wall and one composite sample from the base. Final composite samples were collected by Harvest on February 11, 2021, after additional soils were removed from the excavation. Sample locations are presented on Figure 3. The final excavation measured approximately 40 ft by 50 ft by 5 to 10 ft deep and included approximately 1,447 cubic yards of overburden and contaminated soil.

Photo 1: Liner inspection.

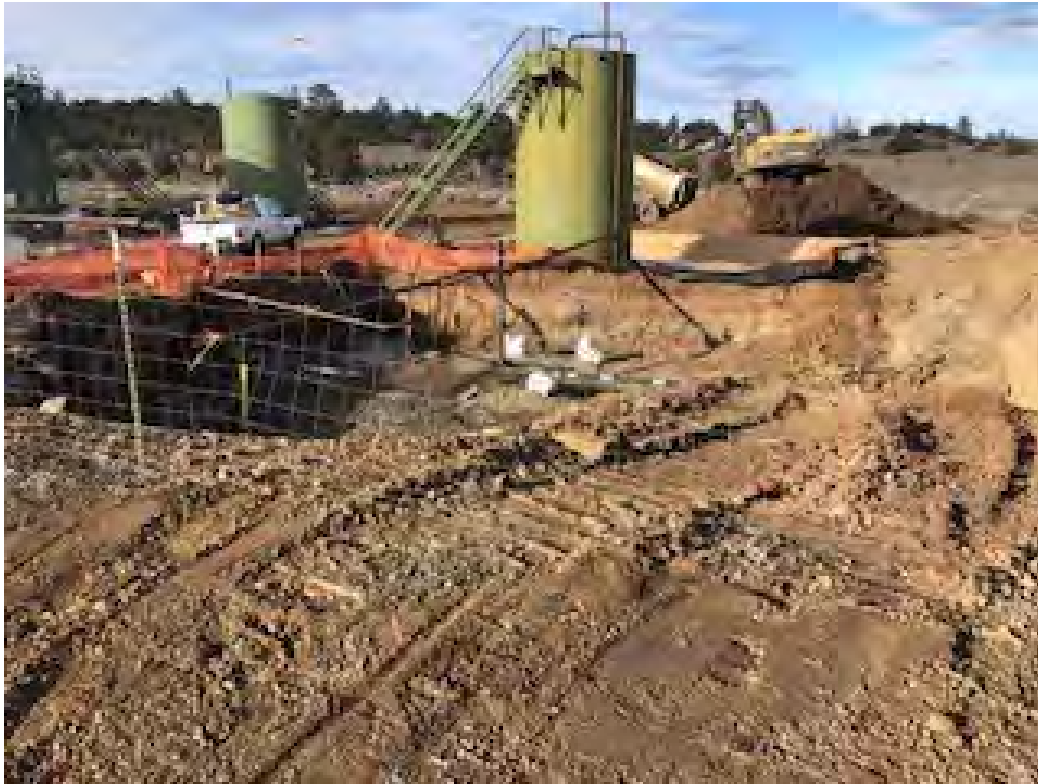
Photo 3: Excavation, 12 Feb. 2021. View is to the southwest.

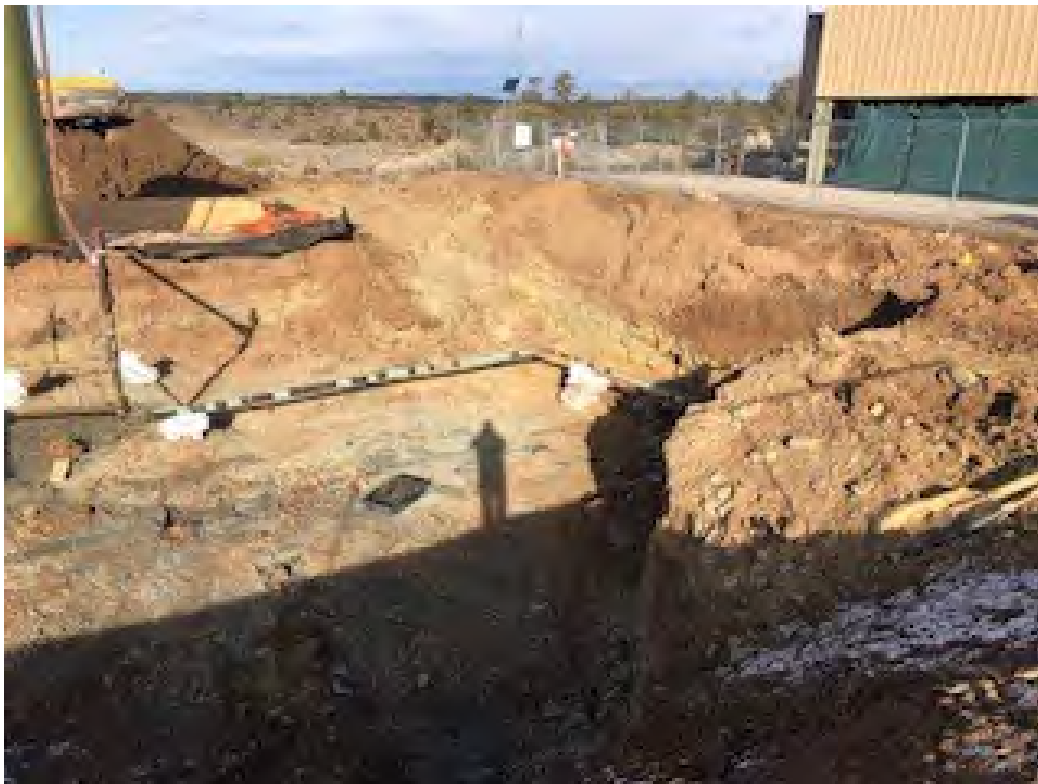
Photo 4: Excavation, 12 Feb. 2021. View is to the west.

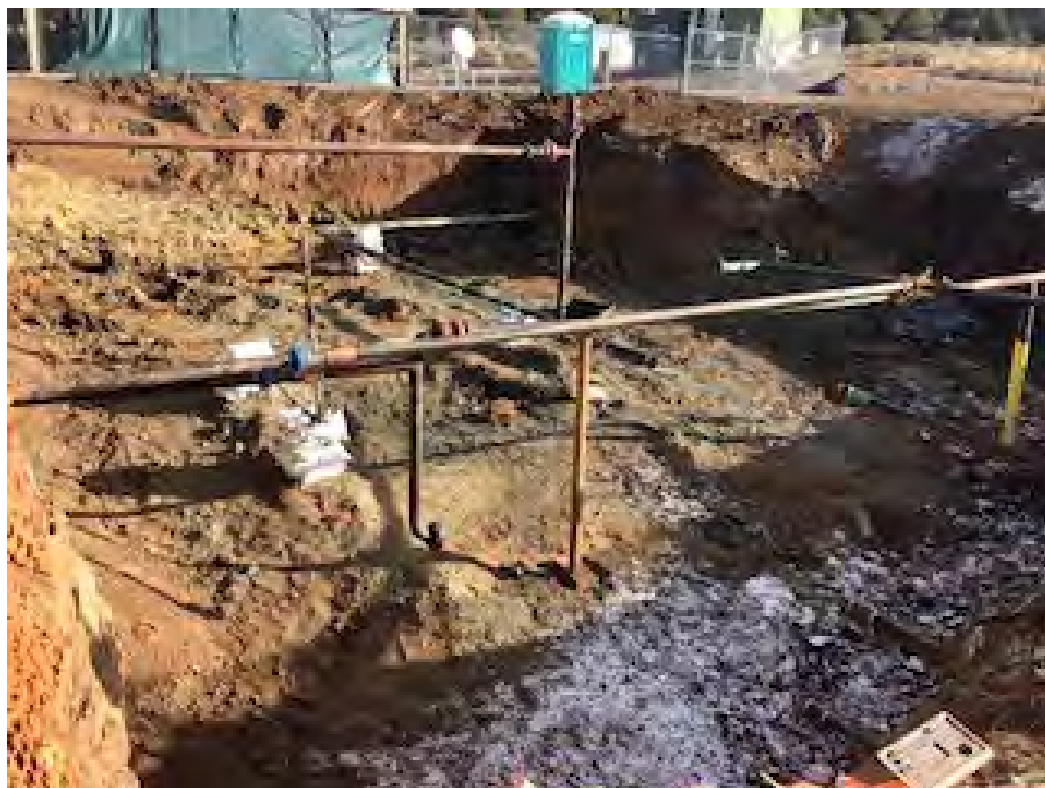
Photo 5: Excavation, 12 Feb. 2021. View is to the north.

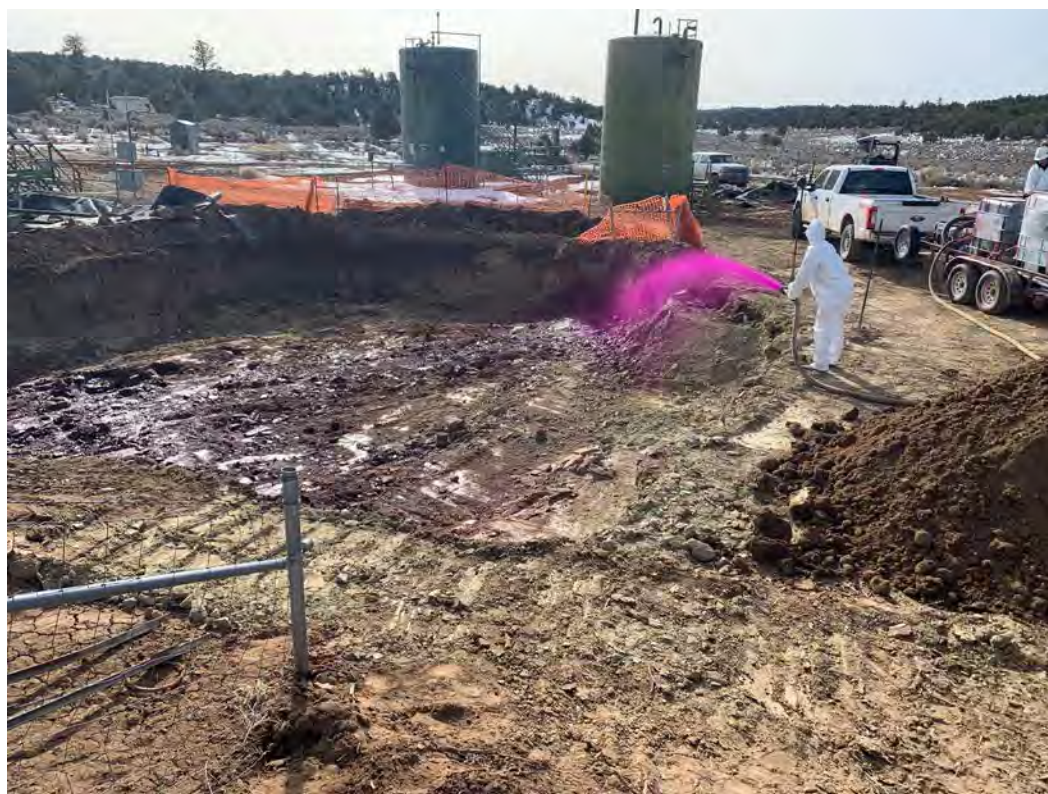
Photo 6: Application of potassium permanganate.

The excavation base was sprayed with potassium permanganate at the direction of KC Manuel of the Jicarilla Environmental Project Office (EPO). Mr. Manuel provided verbal approval to Morgan Killion of Harvest to backfill the excavation on February 13, 2021. Correspondence documentation is attached.
