Release Notification

CLOSURE REPORT

**Jicarilla 55 #3
SE ¼, S35 T23N R3W
Sandoval County, New Mexico**

December 14, 2020
Ensolum Project No. 05A1226125

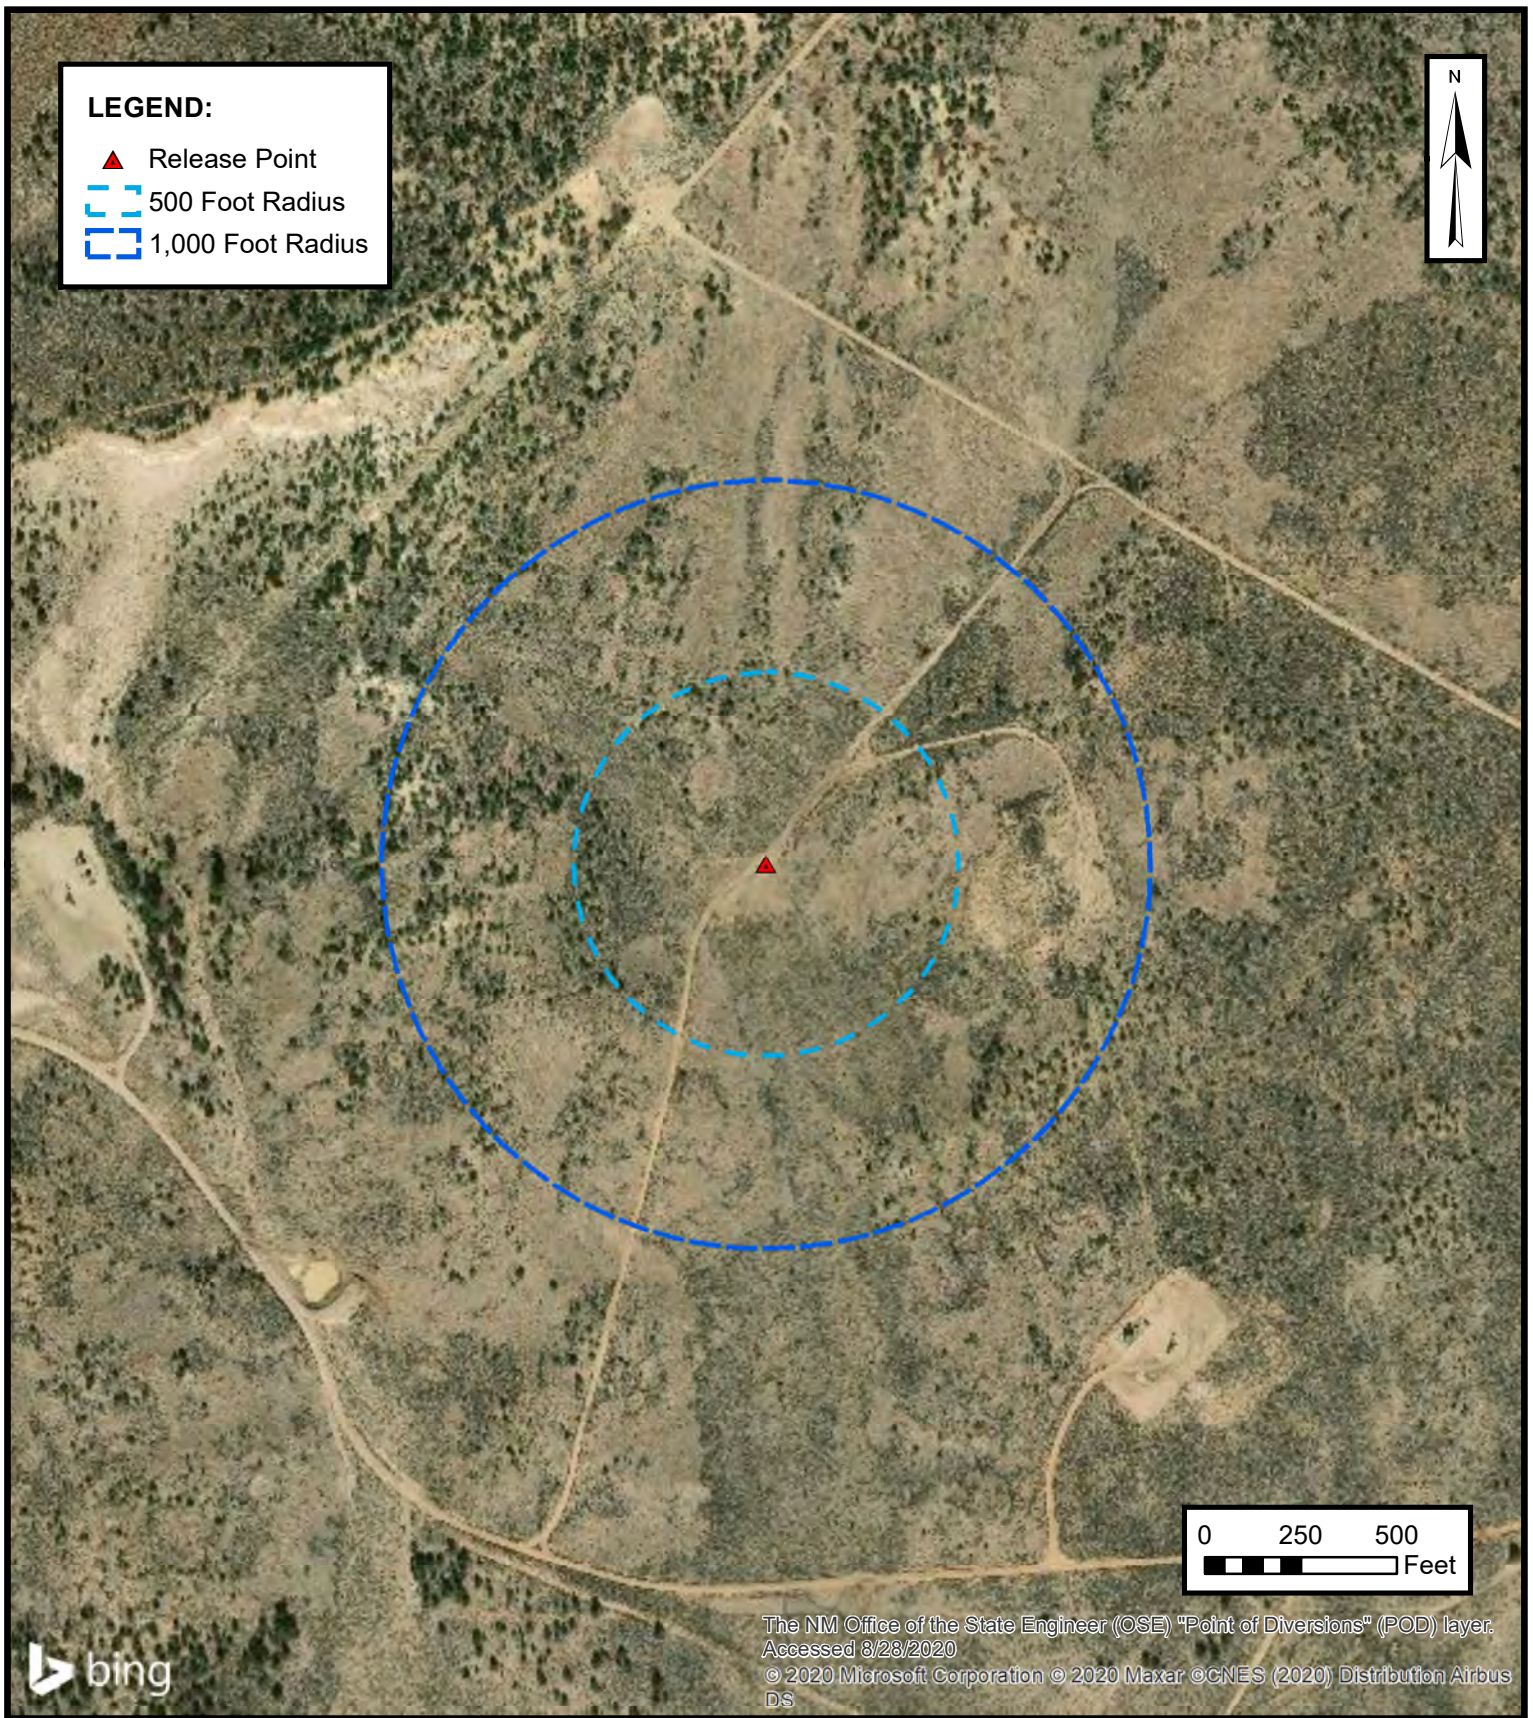
FIGURE
E

- No springs, or private domestic fresh water wells used by less than five (5) households for domestic or stock watering purposes were identified within 500 feet of the Site (**Figure E, Appendix B**).

- No fresh water wells or springs were identified within 1,000 feet of the Site (**Figure E, Appendix B**).
- The Site is not located within incorporated municipal boundaries or within a defined municipal fresh water well field covered under a municipal ordinance adopted pursuant to New Mexico Statutes Annotated (NMSA) 1978, Section 3-27-3.

WATER WELL AND NATURAL SPRING LOCATION

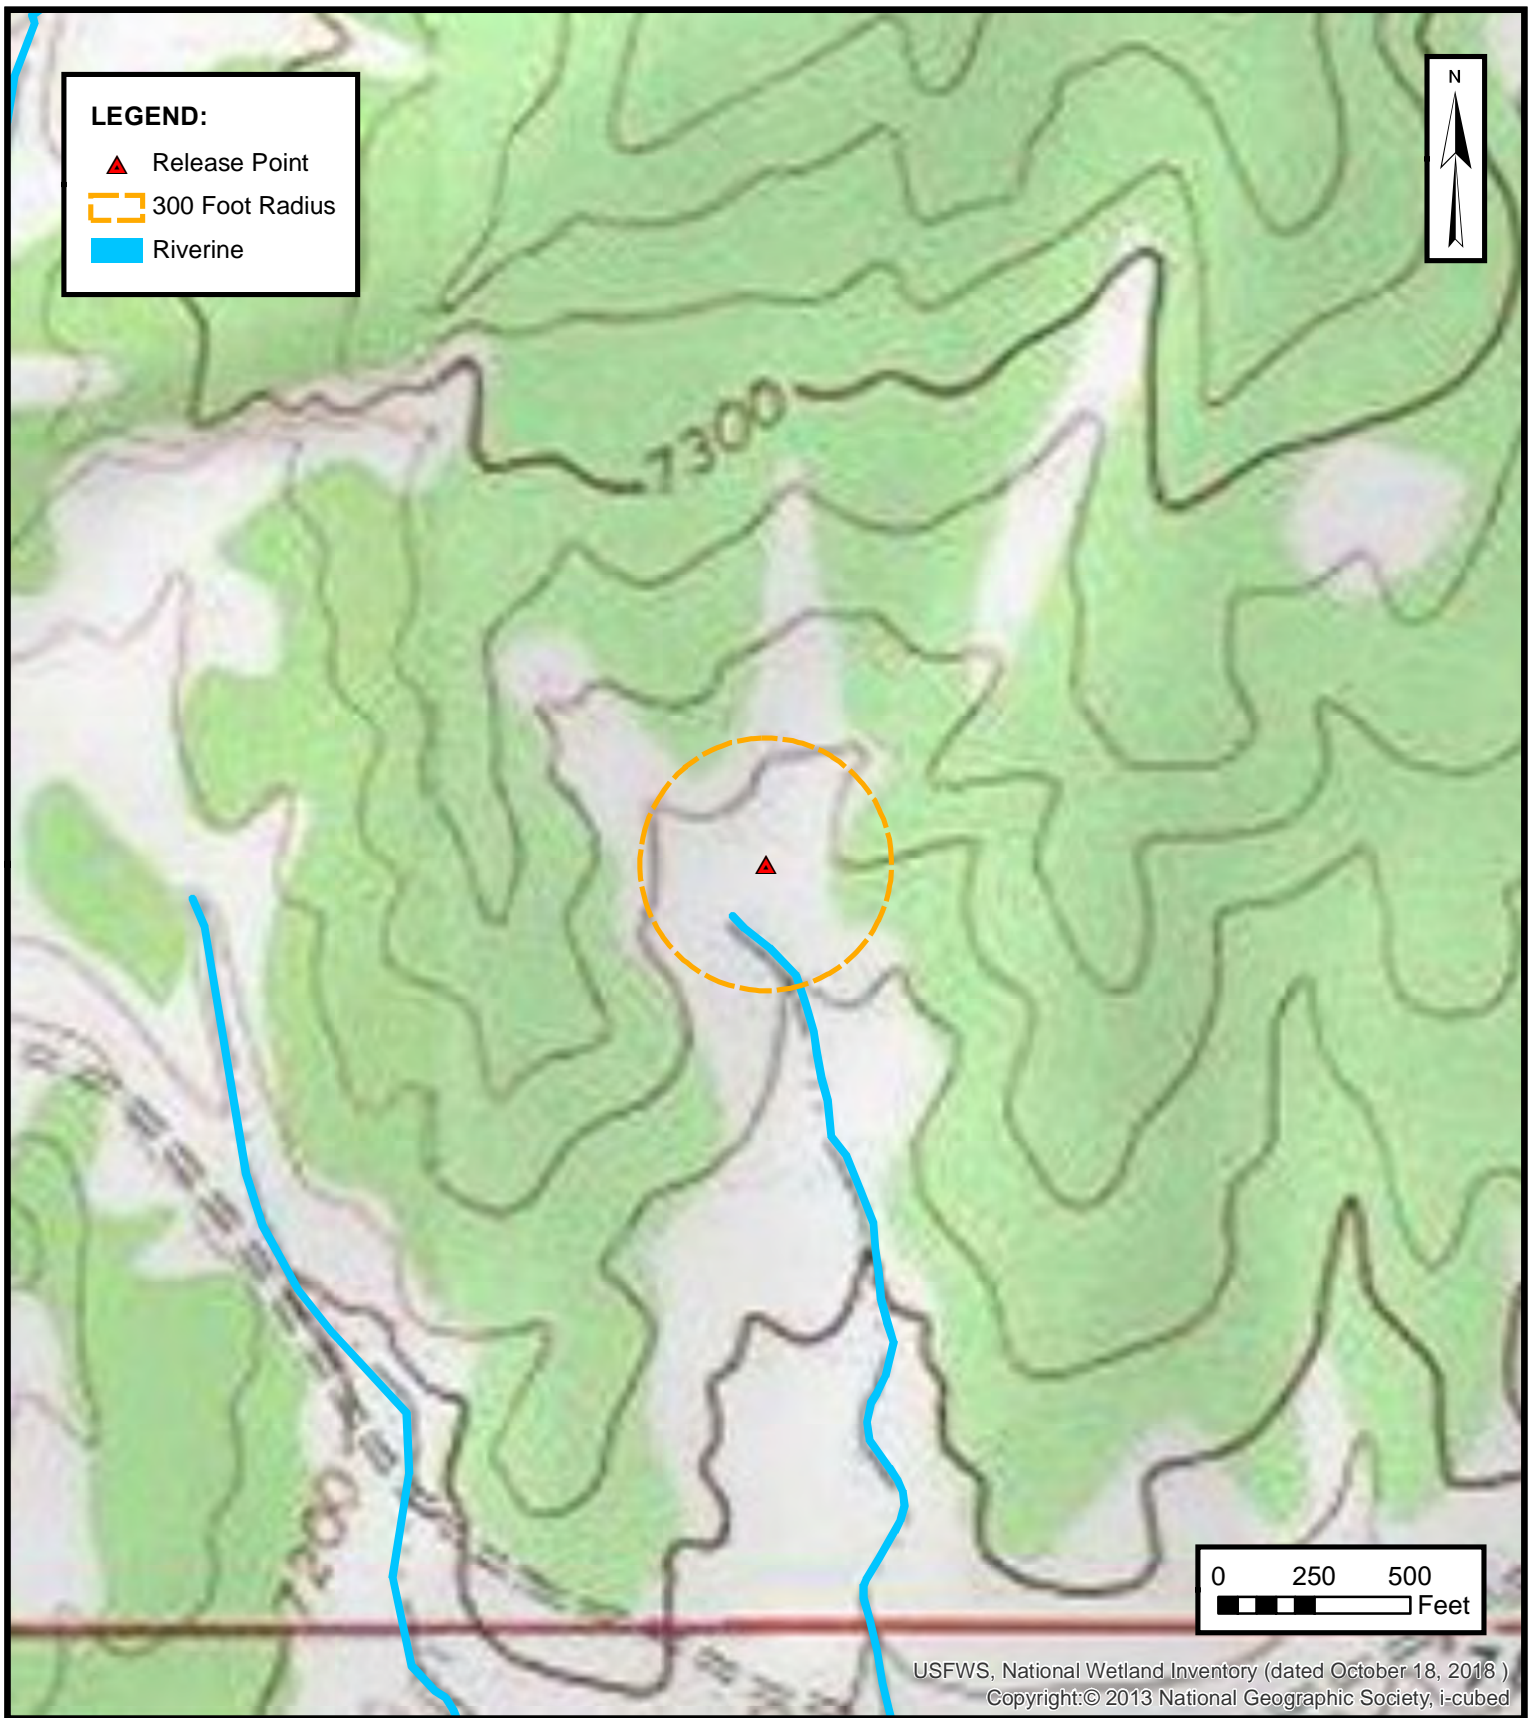
FIGURE
F

- Based on information identified in the U.S. Fish & Wildlife Service National Wetlands Inventory Wetlands Mapper, the Site is not located within 300 feet of a wetland (**Figure F, Appendix B**).

WETLANDS

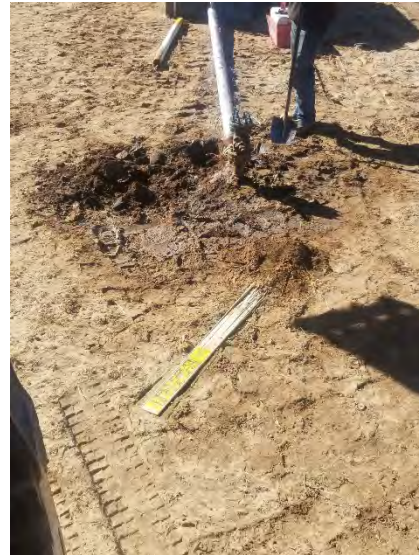
**Photograph 1**

Photograph Description: View of release area.

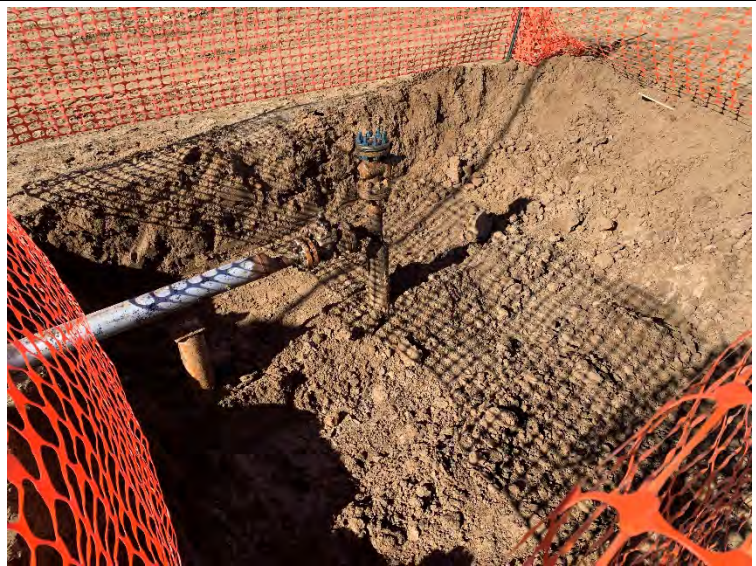
**Photograph 2**

Photograph Description: View of the initial excavation.

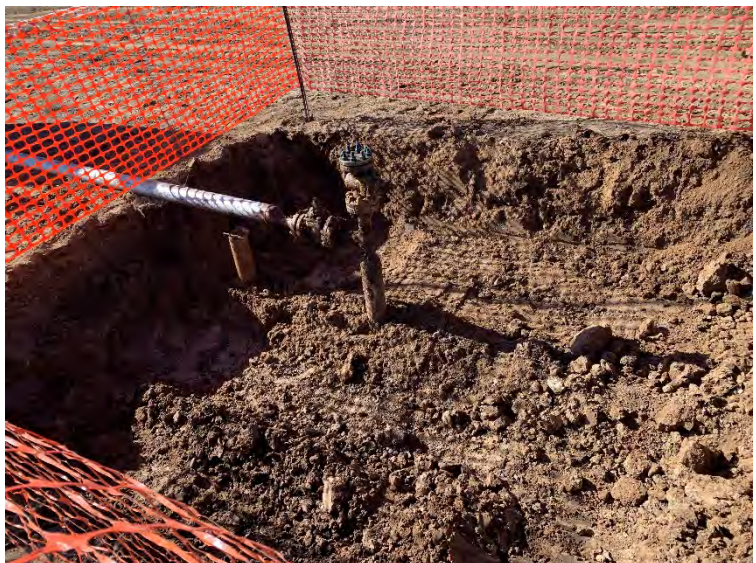
**Photograph 3**

Photograph Description: View of the initial excavation.

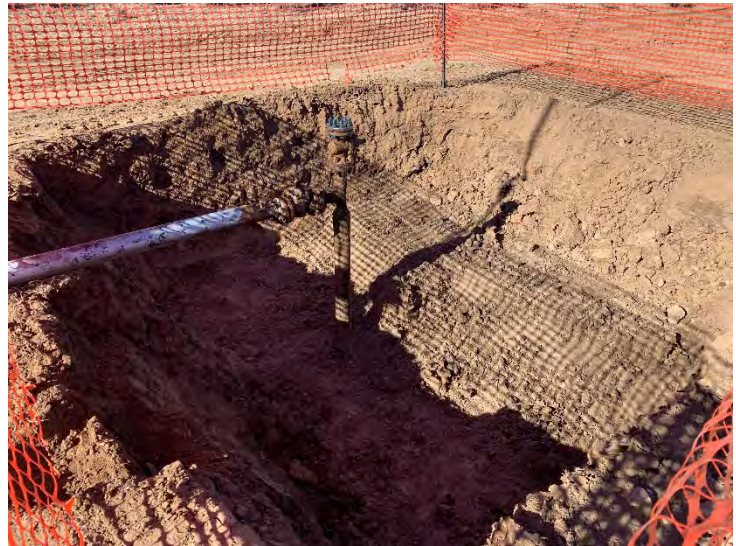
**Photograph 4**

The final excavation measured approximately 13.5 feet long and 12.5 feet wide at the maximum extents. The maximum depth of the excavation measured approximately four (4) feet bgs.

Photograph Description: View of the final excavation.

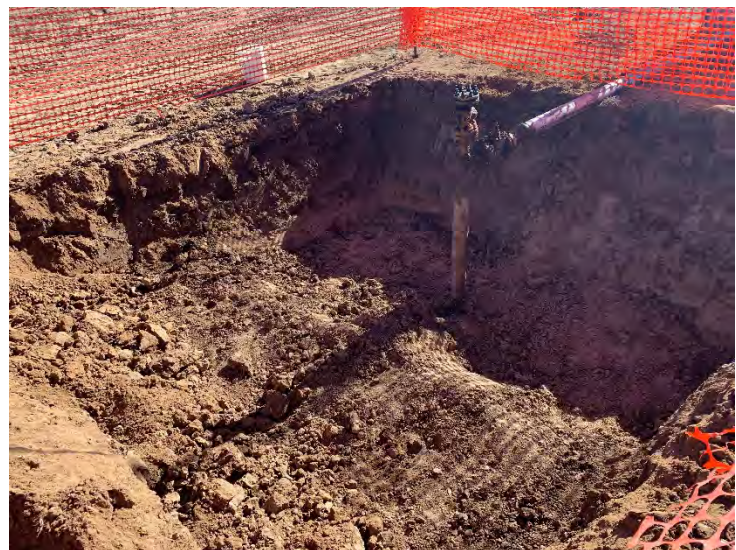
**Photograph 5**

Photograph Description: View of the final excavation.

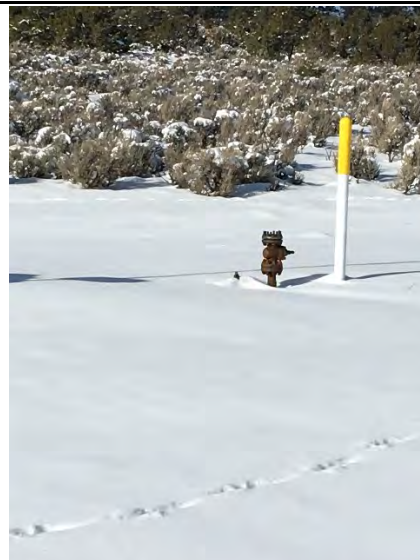
**Photograph 6**

Photograph Description: View of the excavation after initial restoration.

The excavation was backfilled with JAN-EPO approved native imported fill and was then contoured to surrounding grade.
