**RE: Termination Request**

**Rice Operating Company – Vacuum SWD System**

**Vacuum Jct. C-31 (1R425-84): UL/C, Sec. 31, T17S, R35E**

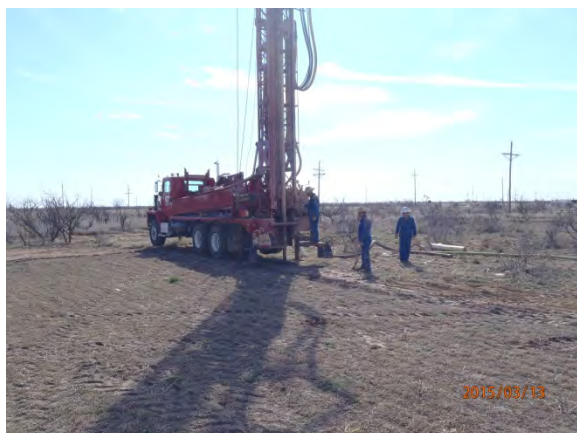
Drilling MW-1, facing southeast 3/13/15

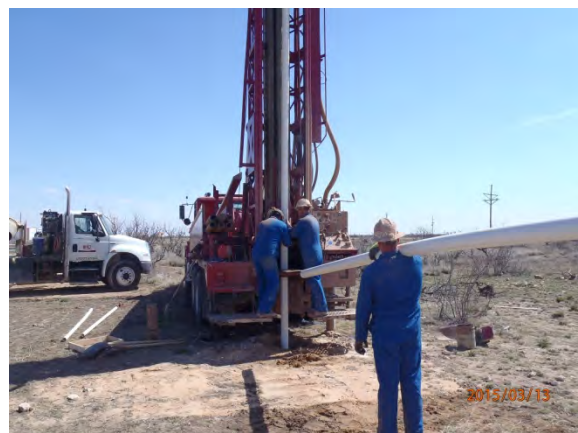
Installing casing in MW-1, facing east 3/13/15

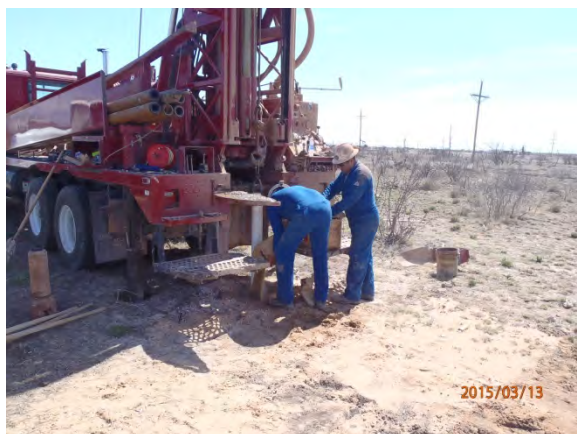
Adding the sand pack, MW-1 3/13/15

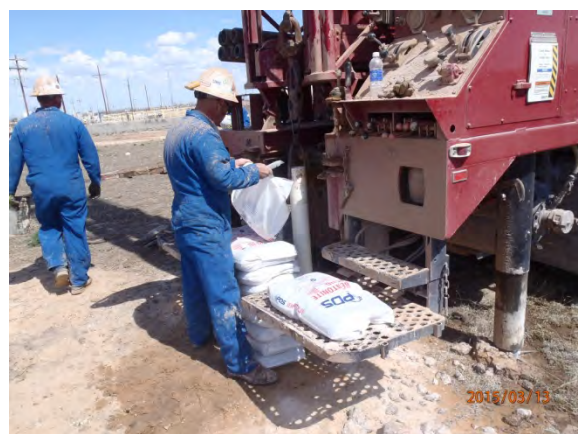
Placing the bentonite seal, MW-1 3/13/15

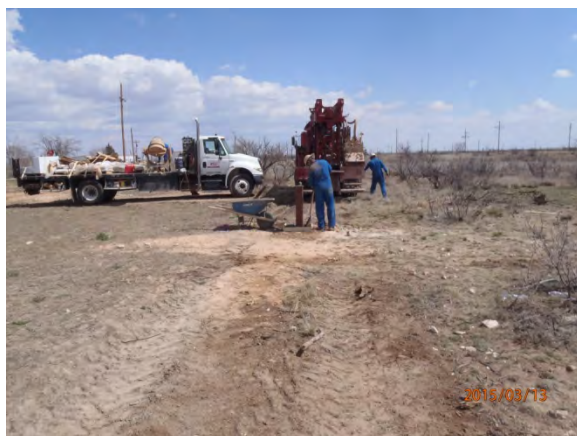
Concreting in well, facing east 3/13/15

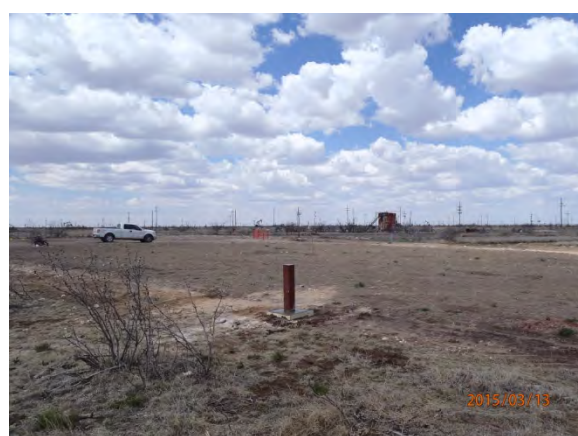
Completed MW-1, facing northwest 3/13/15

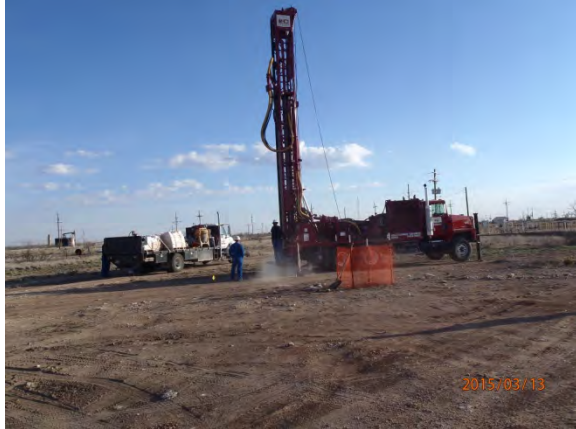
Drilling MW-2, facing north 3/13/15

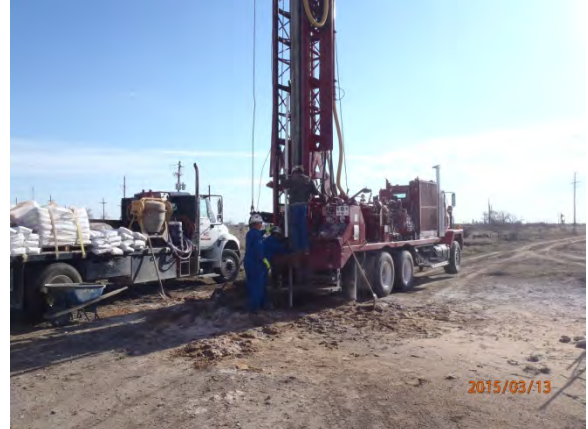
Installing casing in MW-2, facing north 3/13/15

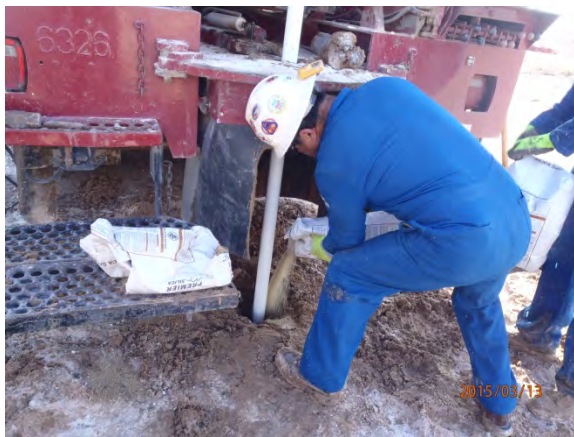
Adding the sand pack, MW-2 3/13/15

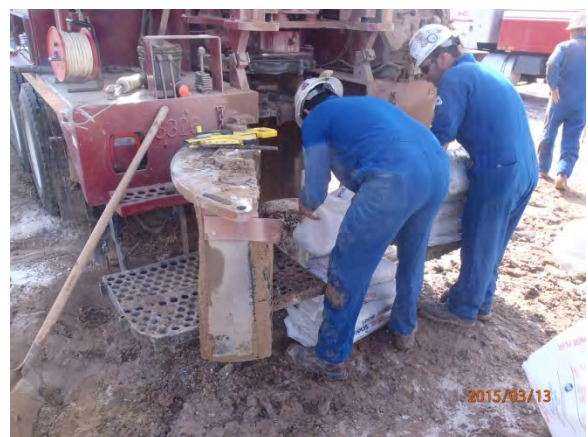
Placing the bentonite seal, MW-2 3/13/15

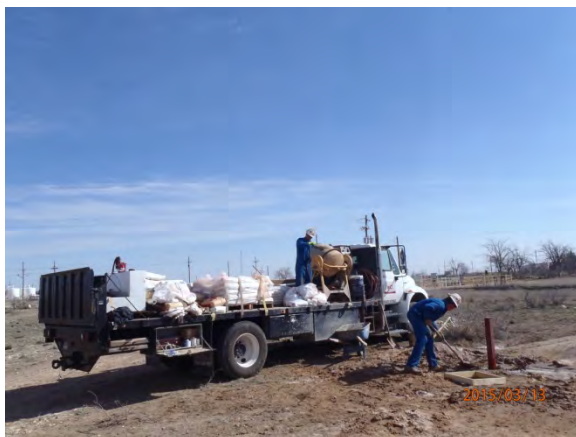
Concreting in well, facing northeast 3/13/15

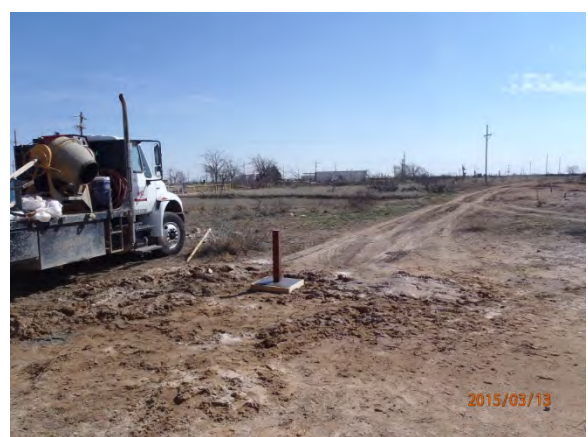
Completed MW-2, facing northeast 3/13/15

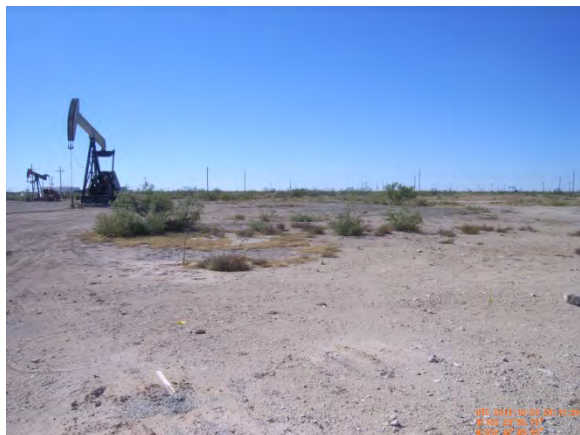
Site prior to excavation,  
facing west

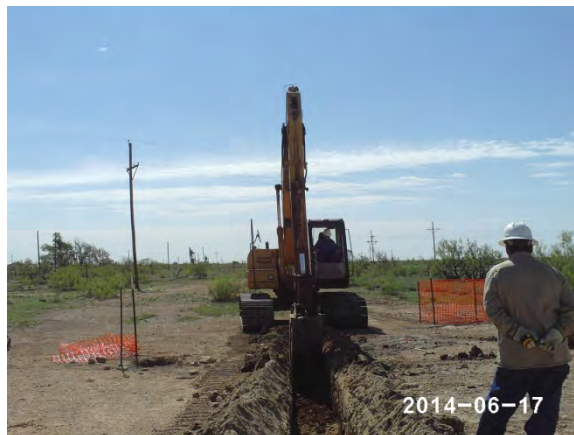
Excavating the site,  
Facing east

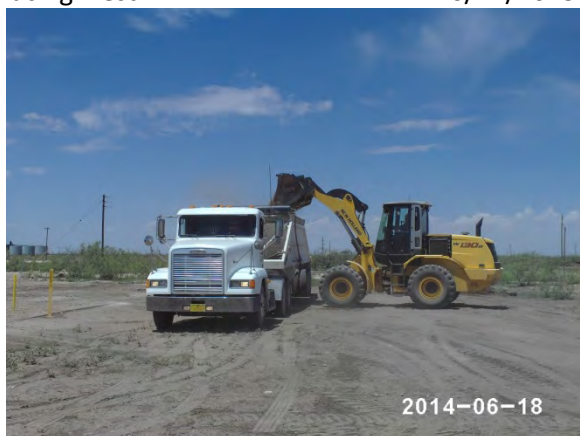
Exporting the spoil pile,  
Facing west

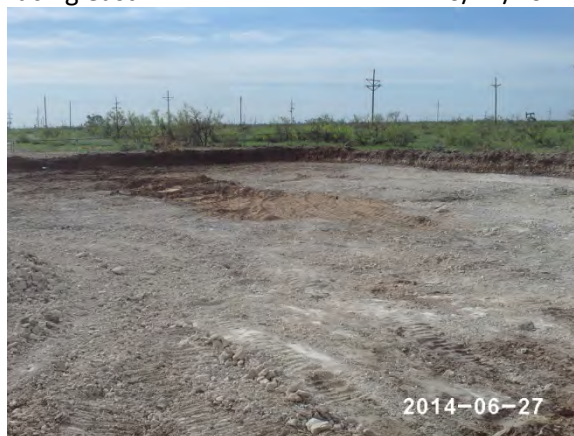
Modified 84x132 ft final excavation,  
facing southeast

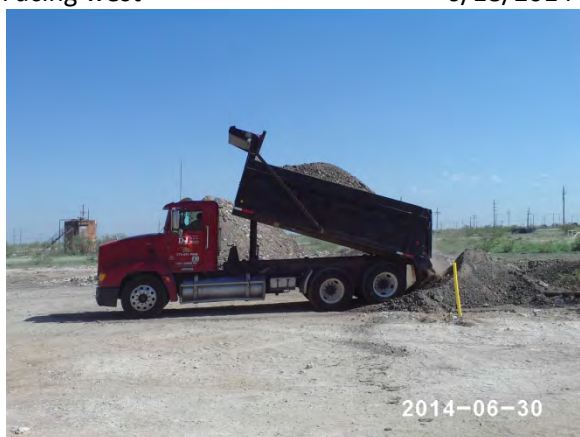
Importing soil,  
facing north

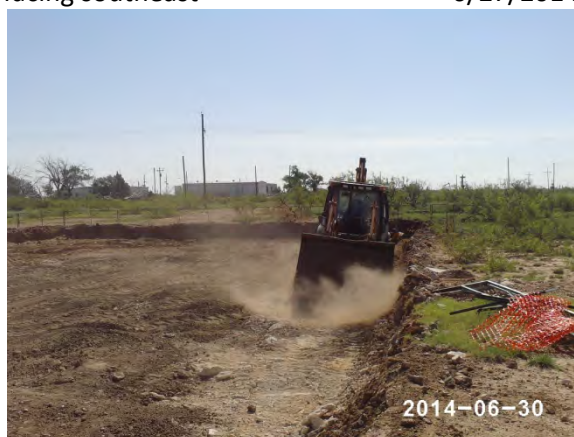
Padding 6' of soil,  
facing east

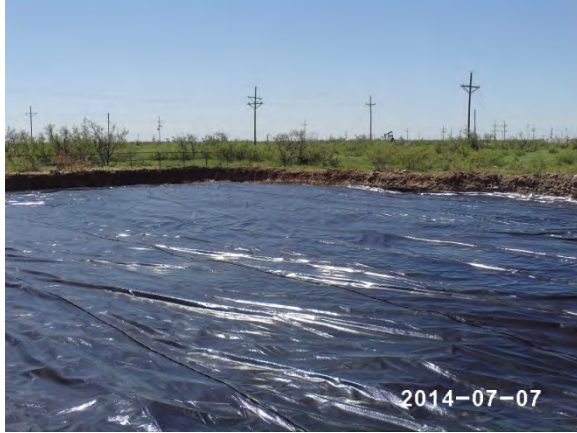
20-mil poly liner installed at 3 ft bgs,  
facing southeast 7/7/2014

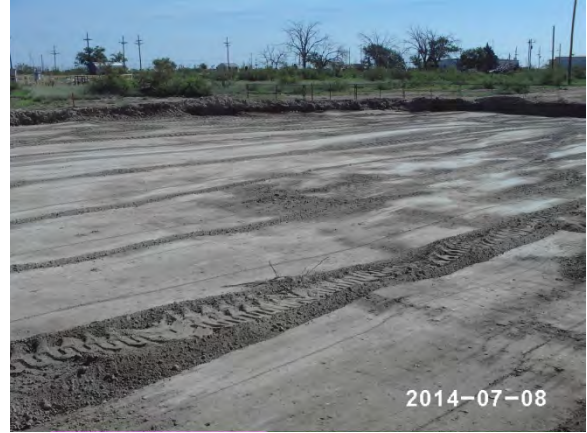
Padding above the liner,  
facing northeast 7/8/2014

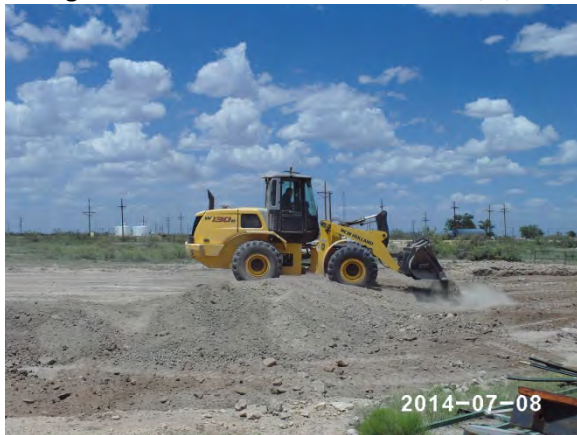
Backfilling the excavation,  
facing north 7/8/2014

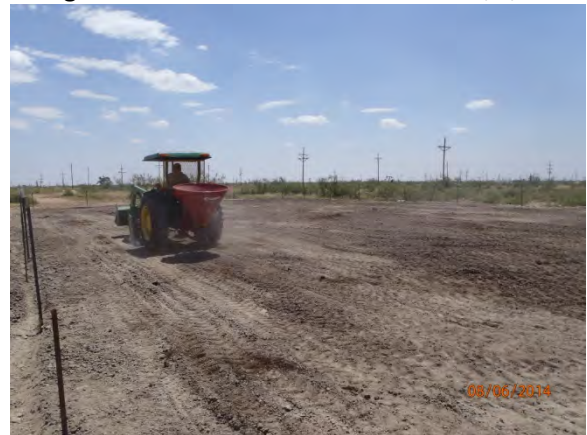
Seeding location,  
facing southeast 8/6/2014

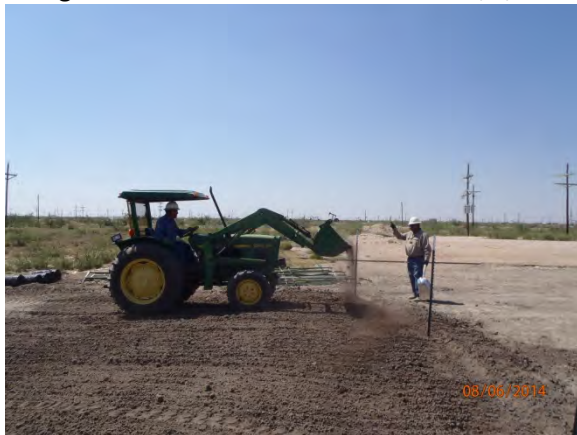
Laying amendments,  
facing south 8/6/2014

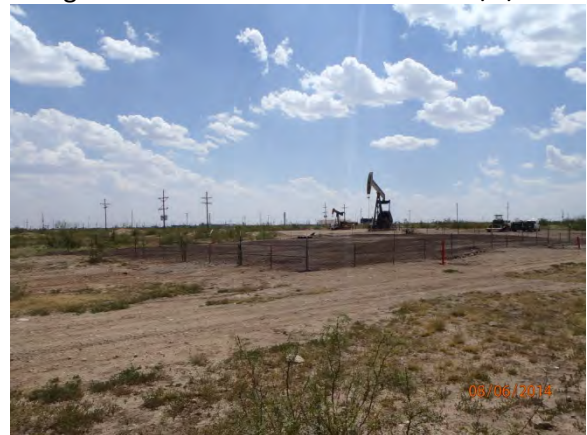
Site complete,  
facing southwest 8/6/2014
