**RICE** *Operating Company*

**RE: Termination Request****Rice Operating Company – Vacuum SWD System****Vacuum Jct. D-31 (1R425-81): UL/D, Sec. 31, T17S, R35E**

# Figures

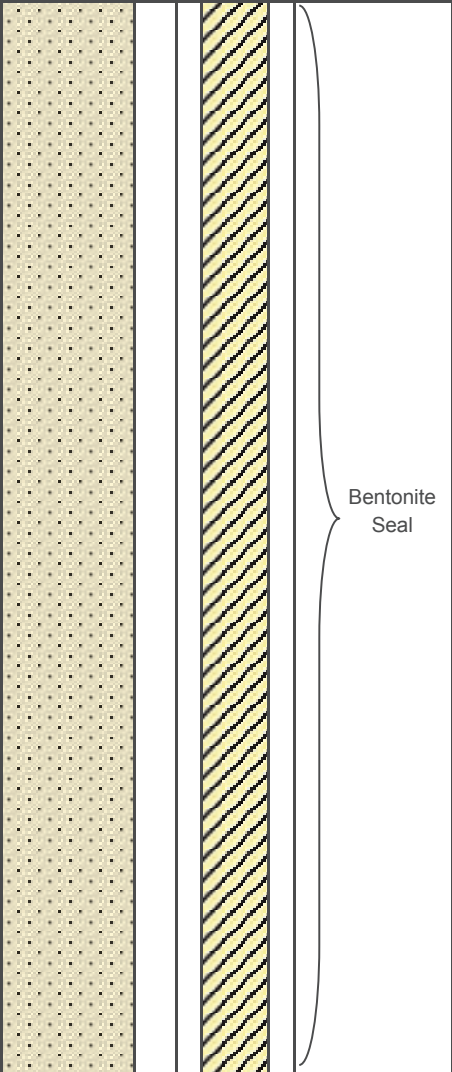
50 ft	2699	CI-3200	0.1				
		GRO <10					
		DRO <17.5		MOIST RED SAND

Bentonite Seal
55 ft	1865		0.2				
60 ft	2392		0.4				
				MOIST RED SAND

65 ft	1628		0.4				
70 ft	970		0.3	MOIST RED SAND

75 ft	1046		0.2				
80 ft	1271		0.2	MOIST RED SAND

85 ft	961	CI-1020	0.8				
		GRO <10	DRO 14.9

TAN SAND/NO ODOR

90 ft	1890		9.8		
				TAN SAND/NO ODOR	
95 ft	1947		97.5		
100 ft	2475	CI-2480	18.4		
		GRO <10			
		DRO <10			
105 ft	1945		16		
110 ft	1788		12.3		
115 ft	1611	CI-1630	8.5		
		GRO <10			
		DRO <10

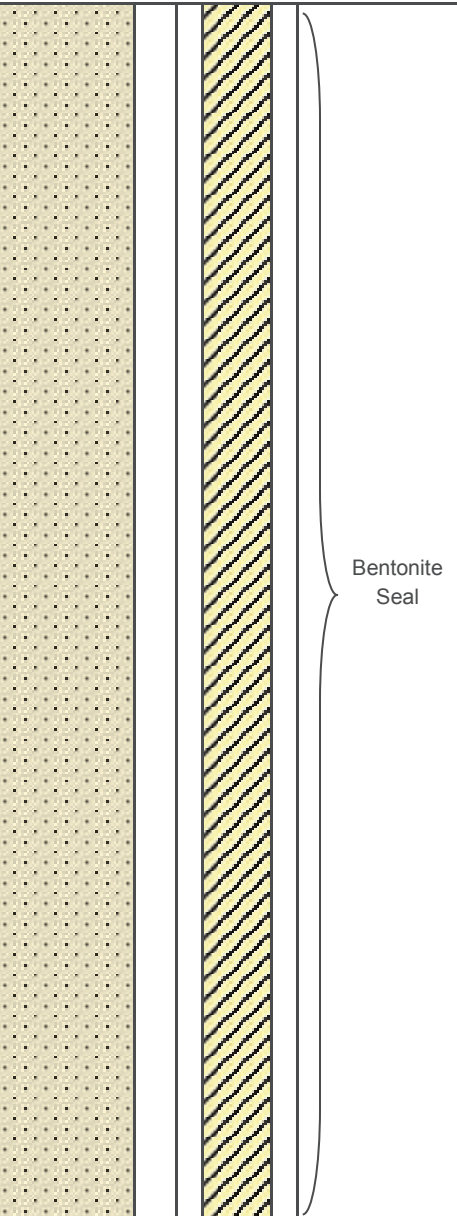
Bentonite Seal

85 ft	634		19.6	TAN SAND/NO ODOR

90 ft	1,883		380.0		
95 ft	1,957	CI-1960	384.0		
	B <0.05	T <0.05	GRO <10		
	E <0.05	X <0.15	DRO <10		
100 ft	888		372.0		
105 ft	1,370		392.0		
110 ft	1,087		130.0		
115 ft	512	CI-496	63.9		
	B <0.05	T <0.05	GRO <10		
	E <0.05	X <0.15	DRO <10

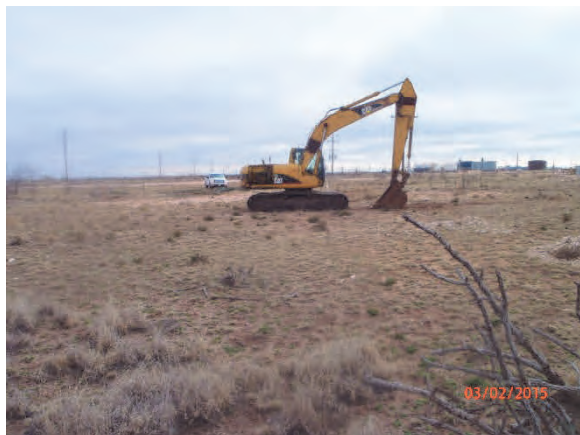
Site prior to excavation,  
facing south

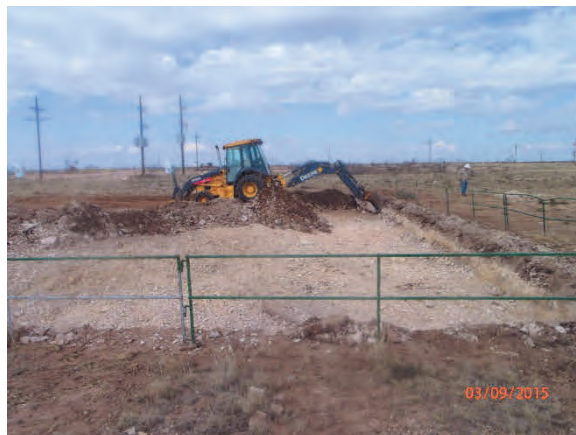
Digging excavation,  
facing west

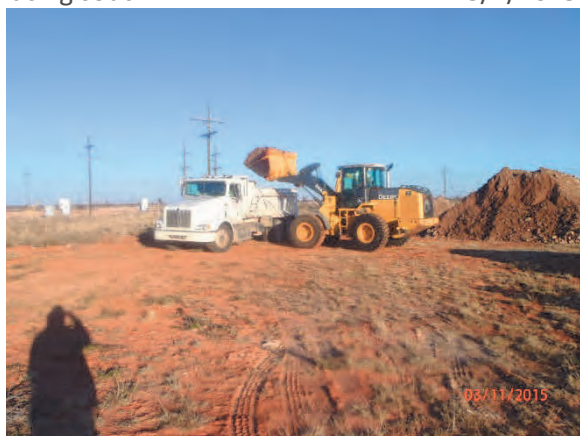
Exporting spoiled material,  
facing northwest

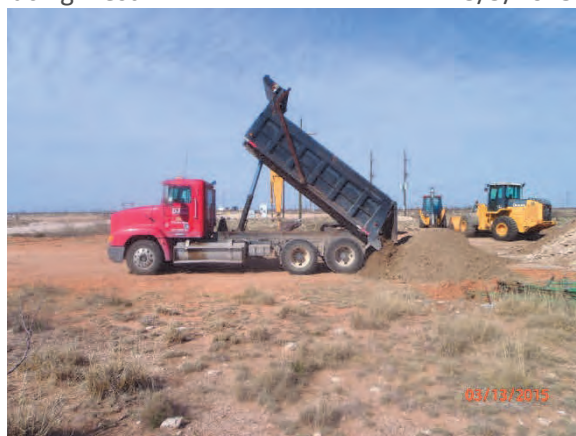
Importing topsoil,  
facing west

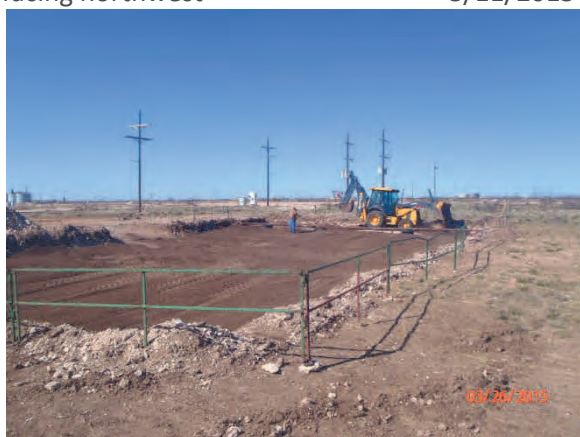
6" padding of topsoil,  
facing southwest

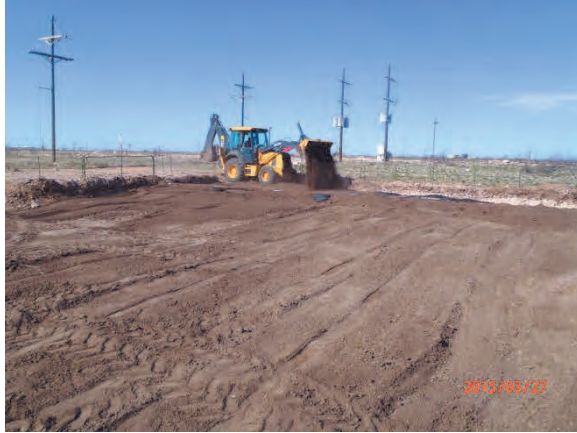
Backfilling above the liner,  
facing southwest 3/27/2015

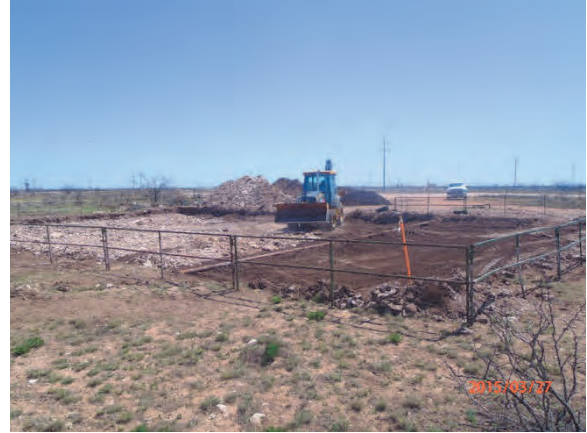
Backfilling the site with caliche rock,  
facing southeast 3/27/2015

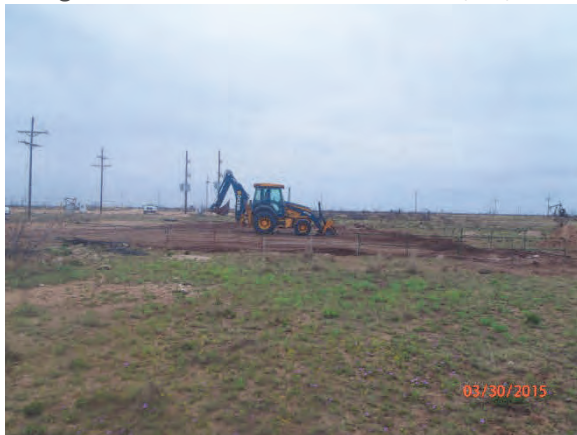
Contouring the site,  
Facing west 3/20/2015

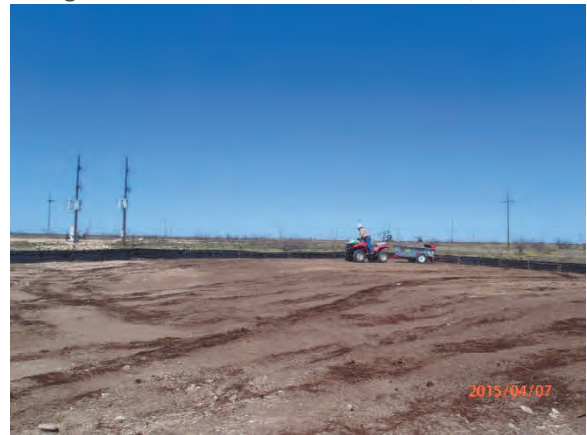
Spreading amendments,  
facing northwest 4/7/2015

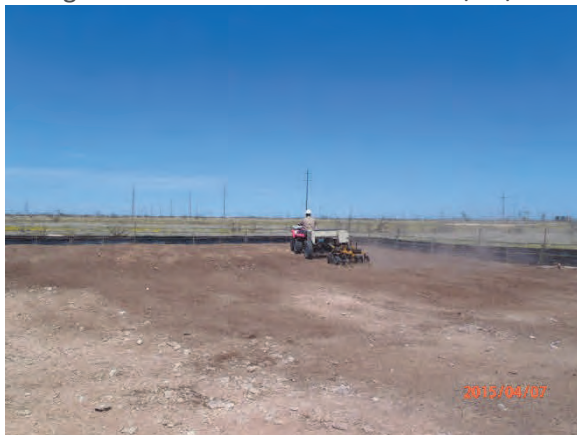
Seeding and disking the site,  
facing northeast 4/7/2015

Custom Seed Mix	<input checked="" type="checkbox"/> Prescribed Mix	Seed Mix Name:	18 lbs. Summer Wheat, 18 lbs. Blue Grama	Date:	4/7/2015
Broadcast	Push Broadcasting Seeder and Tractor		Method: With Broadcast Seeder		
Soil conditions during seed:	Dry	<input checked="" type="checkbox"/> Damp	<input type="checkbox"/> Wet		
Observations:	The seed was disced into the site.

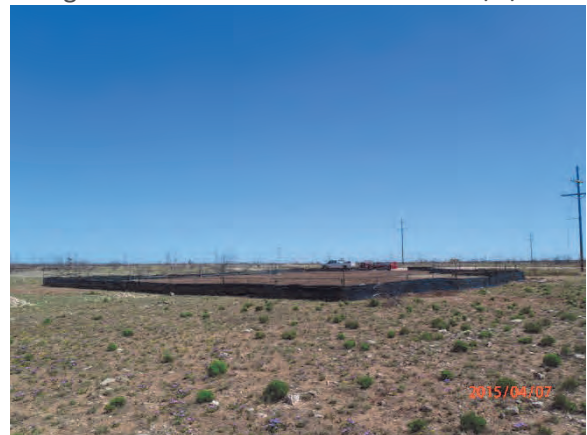
Site complete,  
facing southeast 4/7/2015

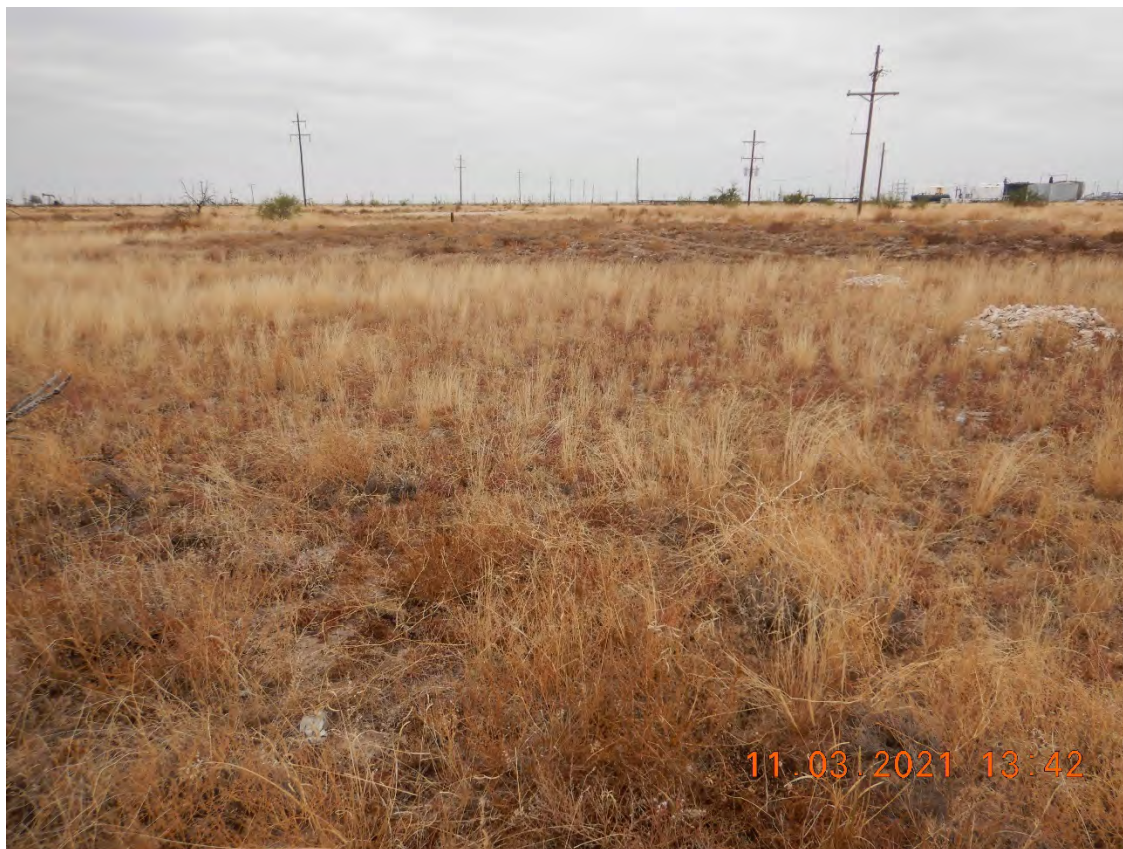
Facing South
