**Pima Environmental Services**  
**5614 N. Lovington Highway**  
**Hobbs, NM 88240**  
**575-964-7740**

March 14<sup>th</sup>, 2022

**Re: Site Assessment, Remediation, and Closure Report**  
**Flat Head Federal Com #027H Flowline**  
**API No. N/A**  
**GPS: Latitude 32.839754 Longitude -103.739695**  
**UL C, Sec. 14, T17S, R32E**  
**Lea County, NM**  
**NMOCD Ref. No. NAPP2130548866**

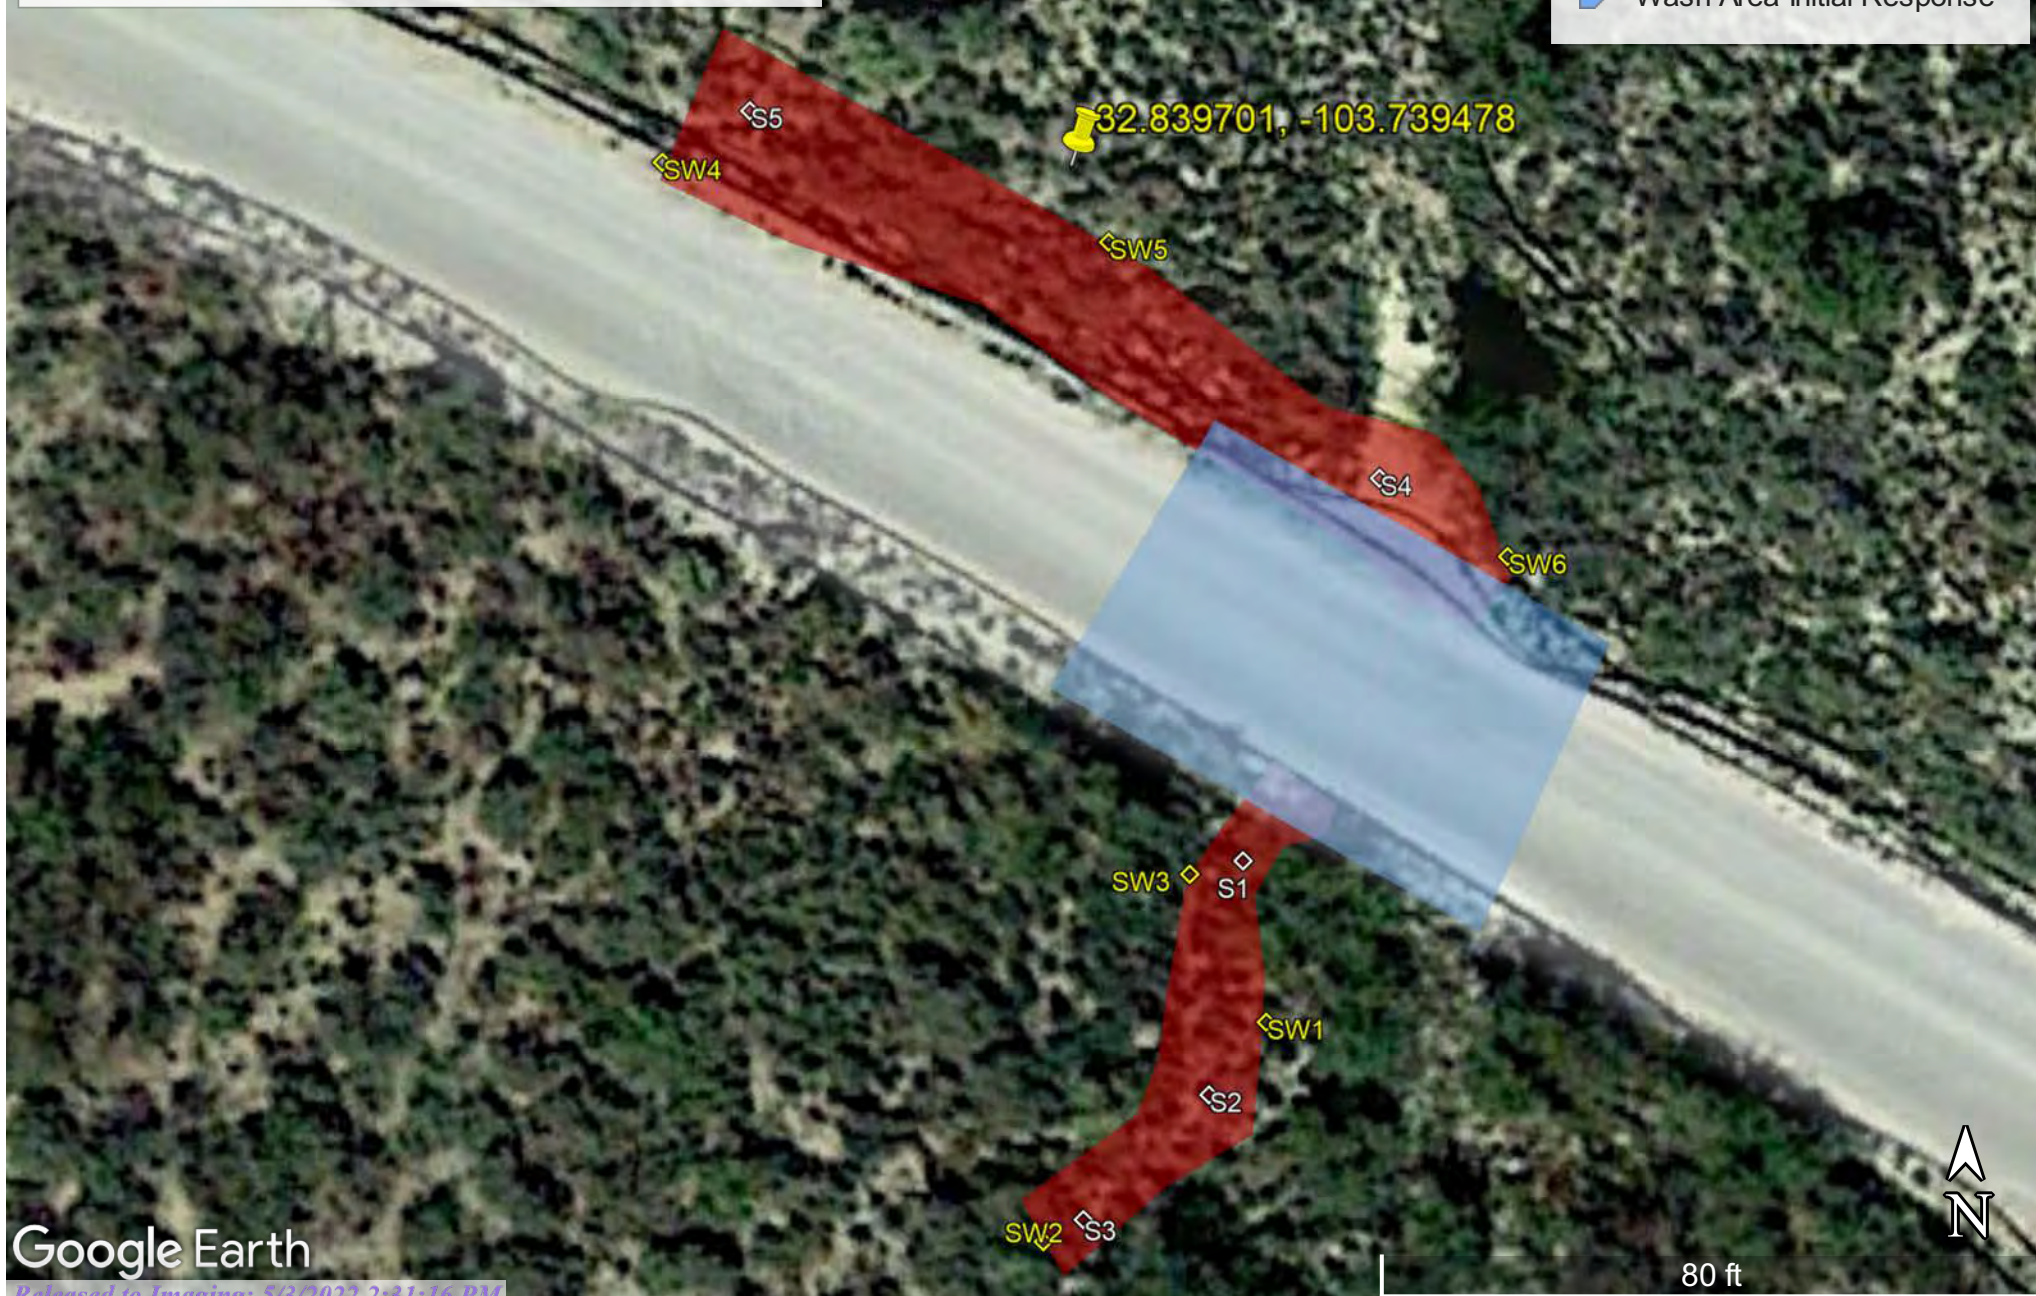
Spur Energy  
API # N/A  
Lea County, NM  
Site Map

On November 17<sup>th</sup>, 2021, Pima personnel returned to the site to assess the area. We sampled the area around the blacktop road and pasture. Laboratory results of this sampling event can be found in the following data table. A site map can be found in Figure 4.

Spill Area-2,500sqft
-

Wash Area-Initial Response

On October 28<sup>th</sup>, 2021, Pima Environmental mobilized personnel, and equipment to the site to provide immediate response activities. We washed down the roadway and shoulders with a bioremediation chemical solution.

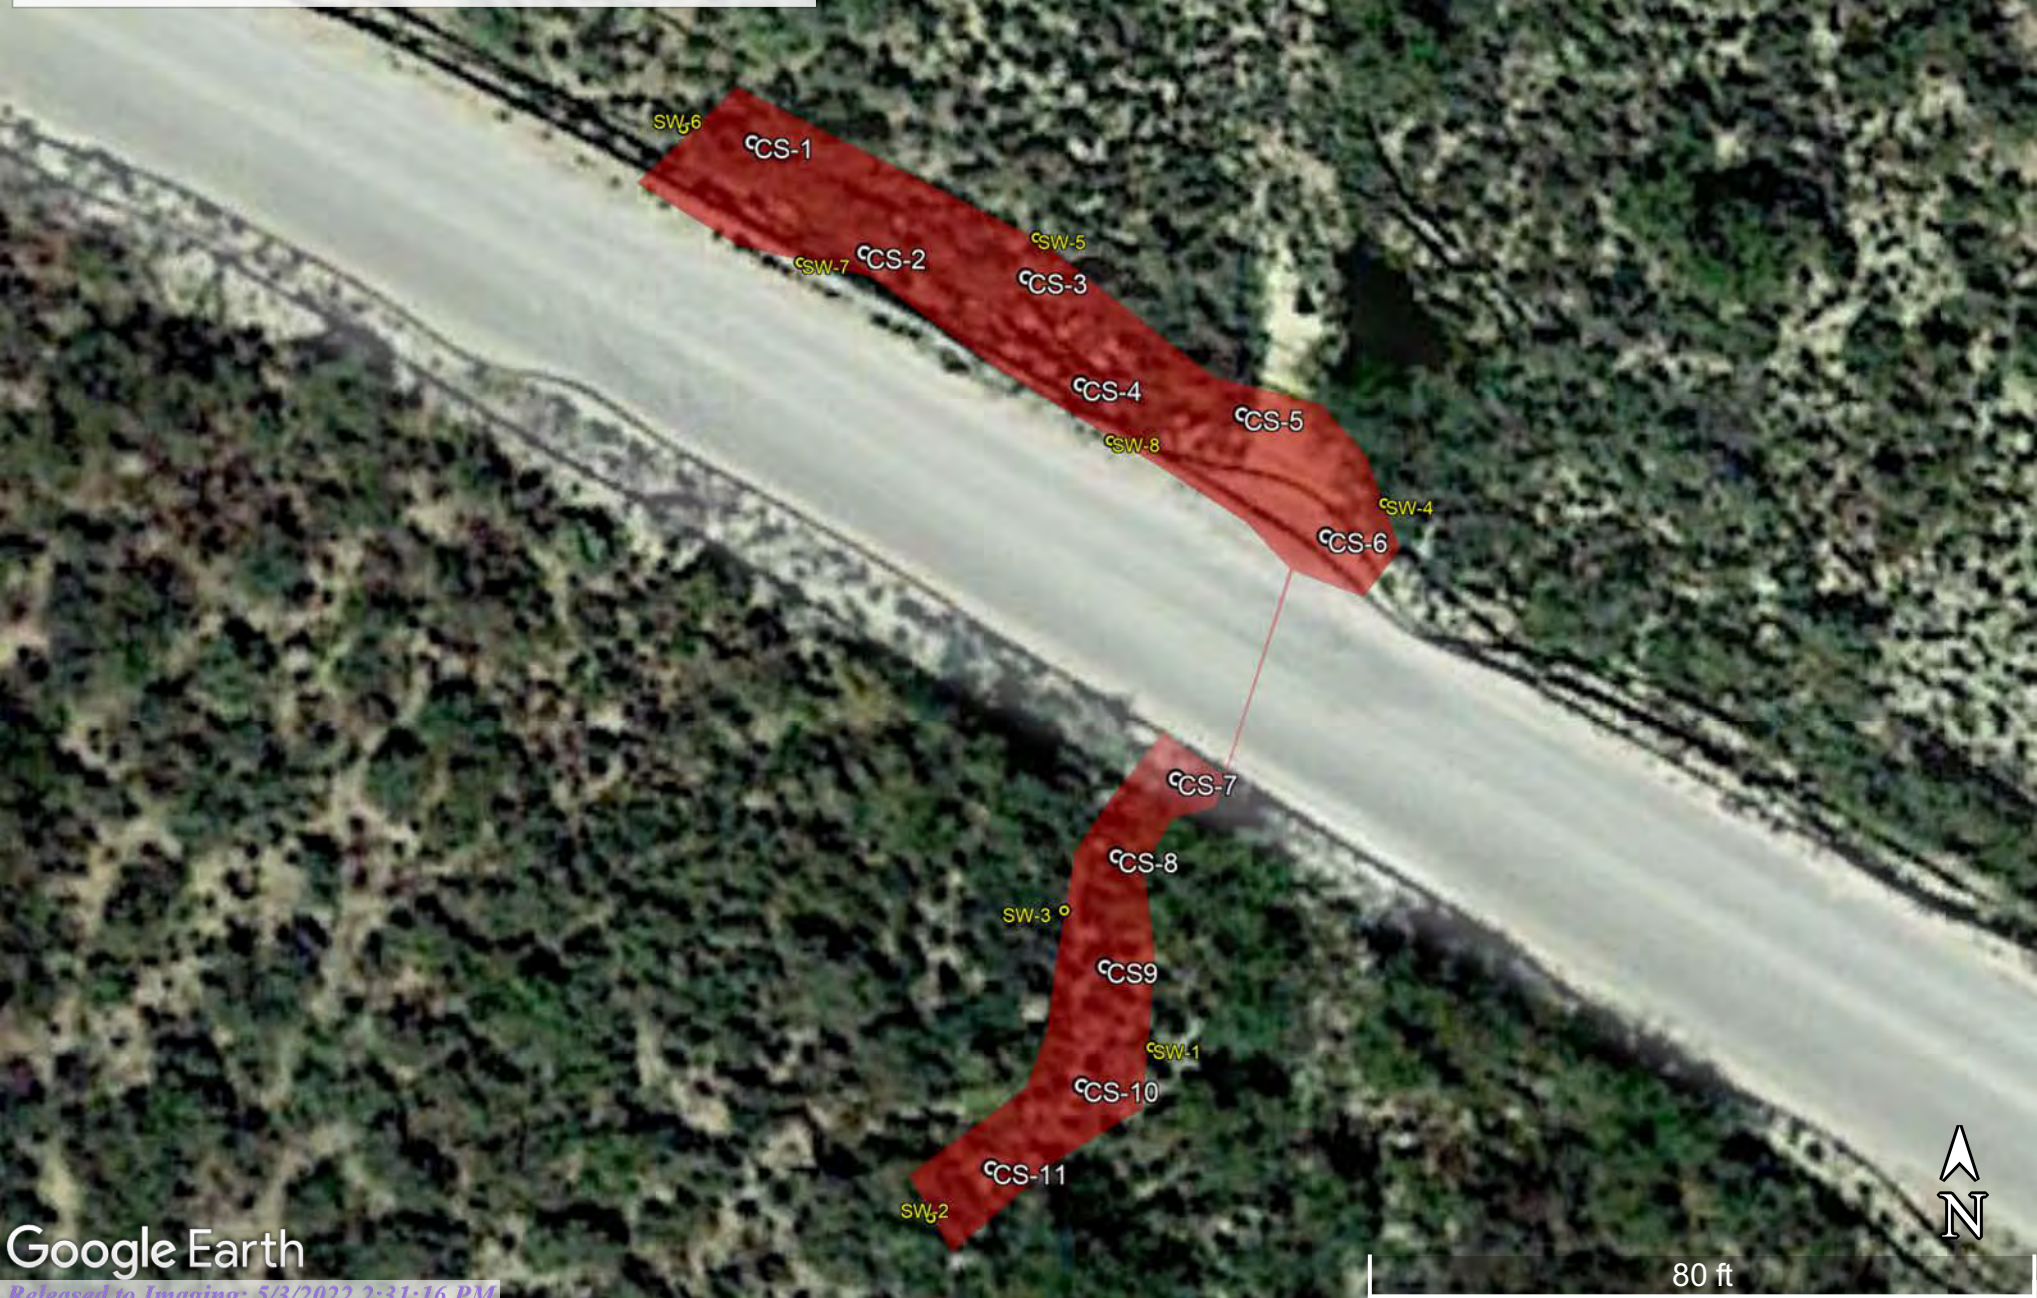
Spur Energy  
API # N/A  
Lea County, NM  
Confirmation Sample Map

On February 11<sup>th</sup>, 2022, after sending a 48-hour notification (Appendix C), Pima collected confirmation samples of the excavated areas. Laboratory results of this sampling event can be found in the following data table. A confirmation sample map can be found in Figure 5.

Based on the sample results, the bottom and sidewalls were below NMOCD Closure Criteria 19.15.29 NMAC. The contaminated material was transported to Lea Land, an NMOCD approved disposal site. The excavation was then backfilled with clean like material, machine compacted and contoured to match the surrounding terrain. See Appendix D for photographic documentation. A confirmation sample map can be found in Figure 5.

- Confirmation Samples
- Confirmation Sidewalls
- Excavation-2,200sqft

On February 7<sup>th</sup>, 2022, Pima mobilized personnel and equipment to conduct remedial activities. We excavated the contaminated areas on the north and south sides of the roadway. Samples were taken during the project to ensure that all contamination had been removed. The contaminated soil was hauled to an approved, lined disposal facility and clean backfill material was brought in.

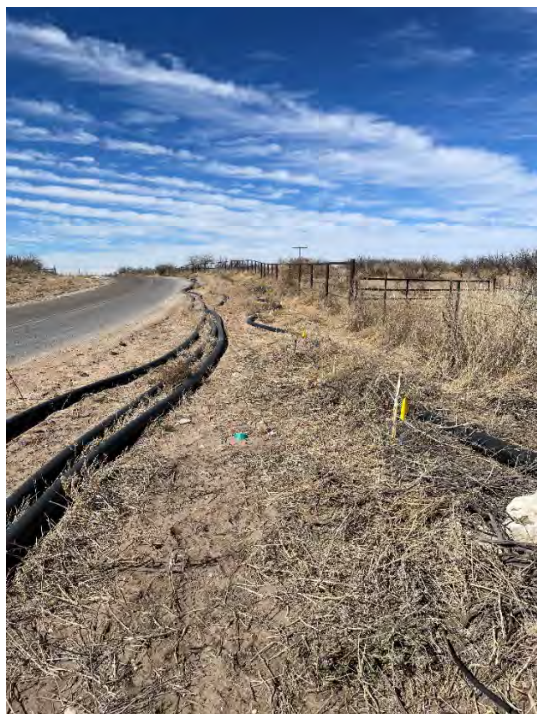
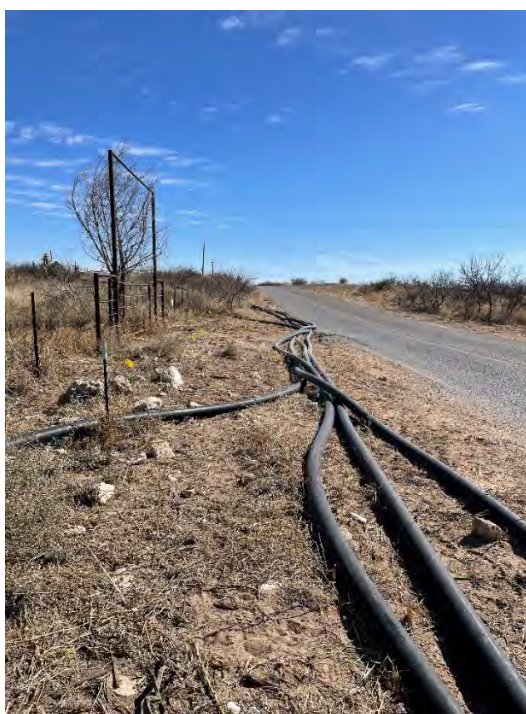
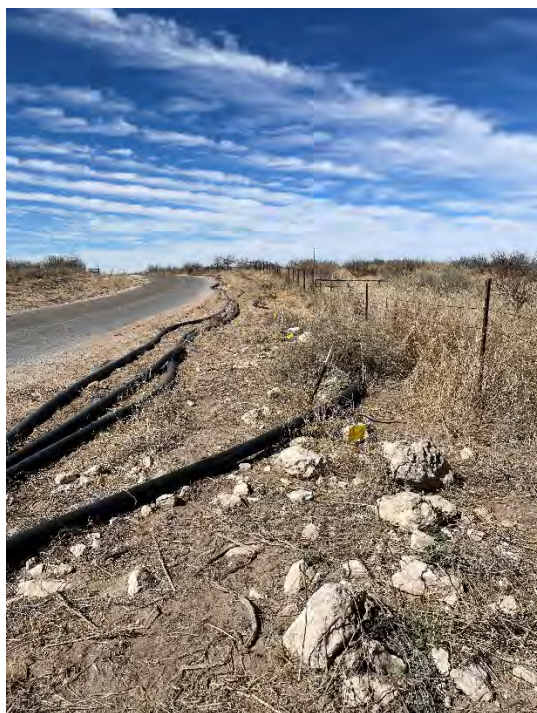
Pre-Treatment – North Side

**NAPP2130548866;** On October 27<sup>th</sup>, 2021, a flow line was cut by a tractor. The released fluids were calculated to be approximately 50 barrels (bbls) of produced water. A vacuum truck was able to recover approximately 45 bbls of fluid.
