## Release Notification

Site Name: Poseidon CTB	Site Type: Tank Battery
Date Release Discovered: 3/3/2022	API# (if applicable): N/A

## **Poseidon Tank Spill in containment**

## **Poseidon CTB Liner Inspection**

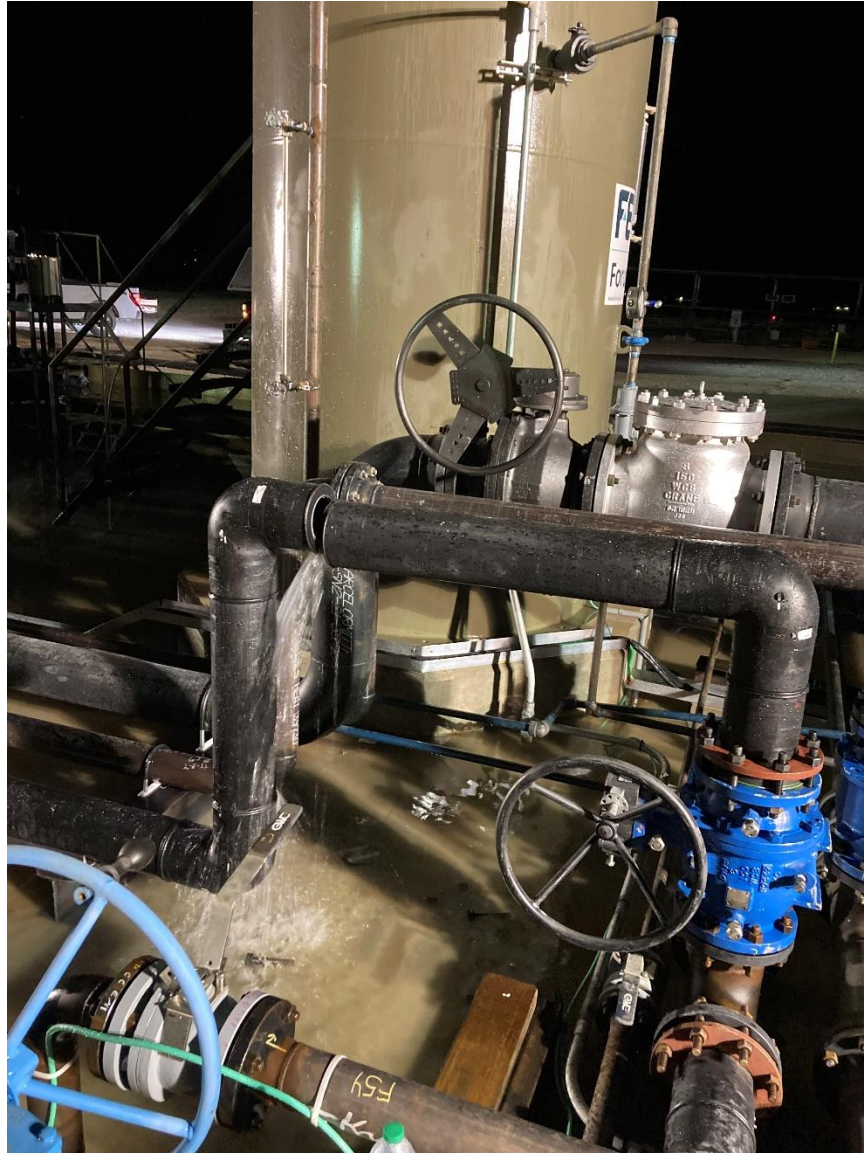
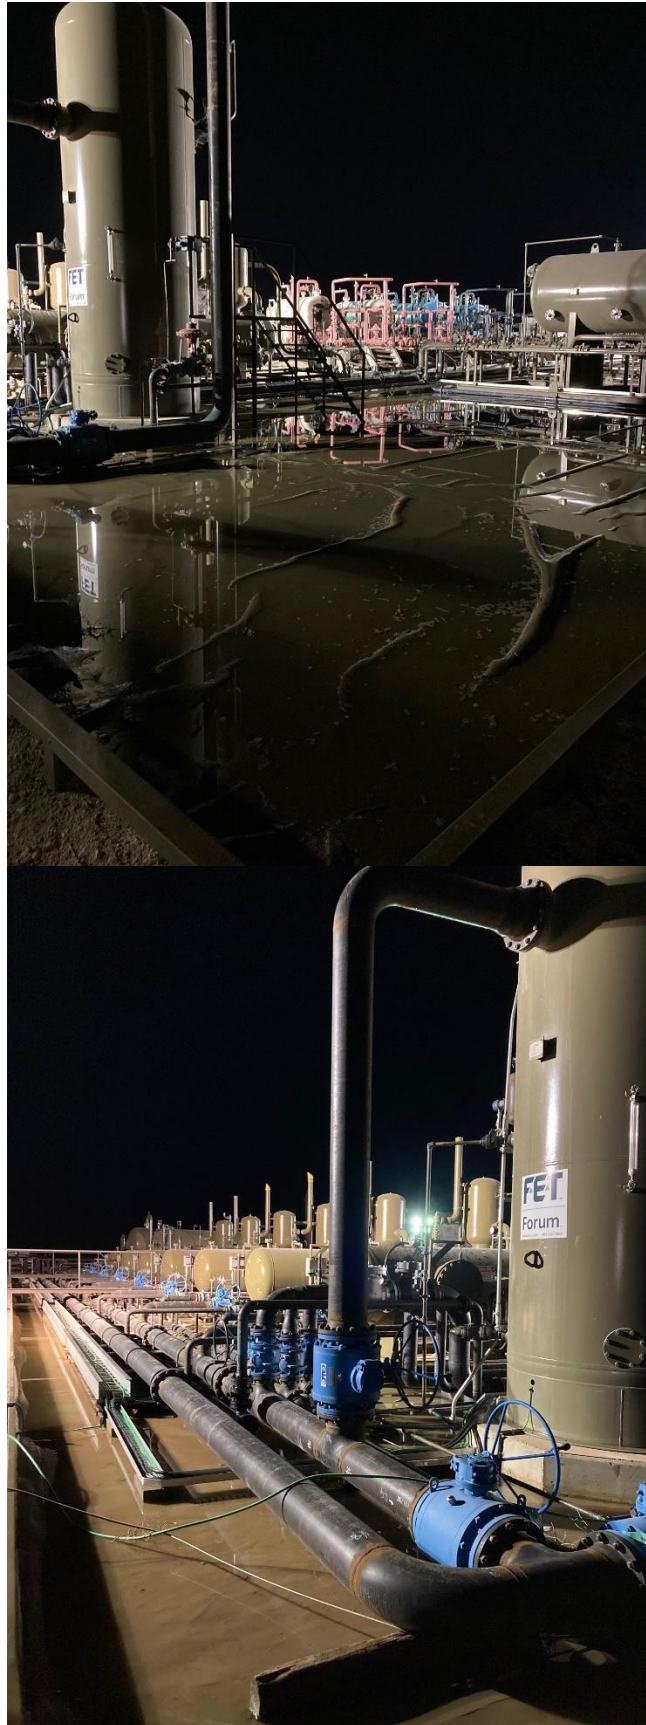
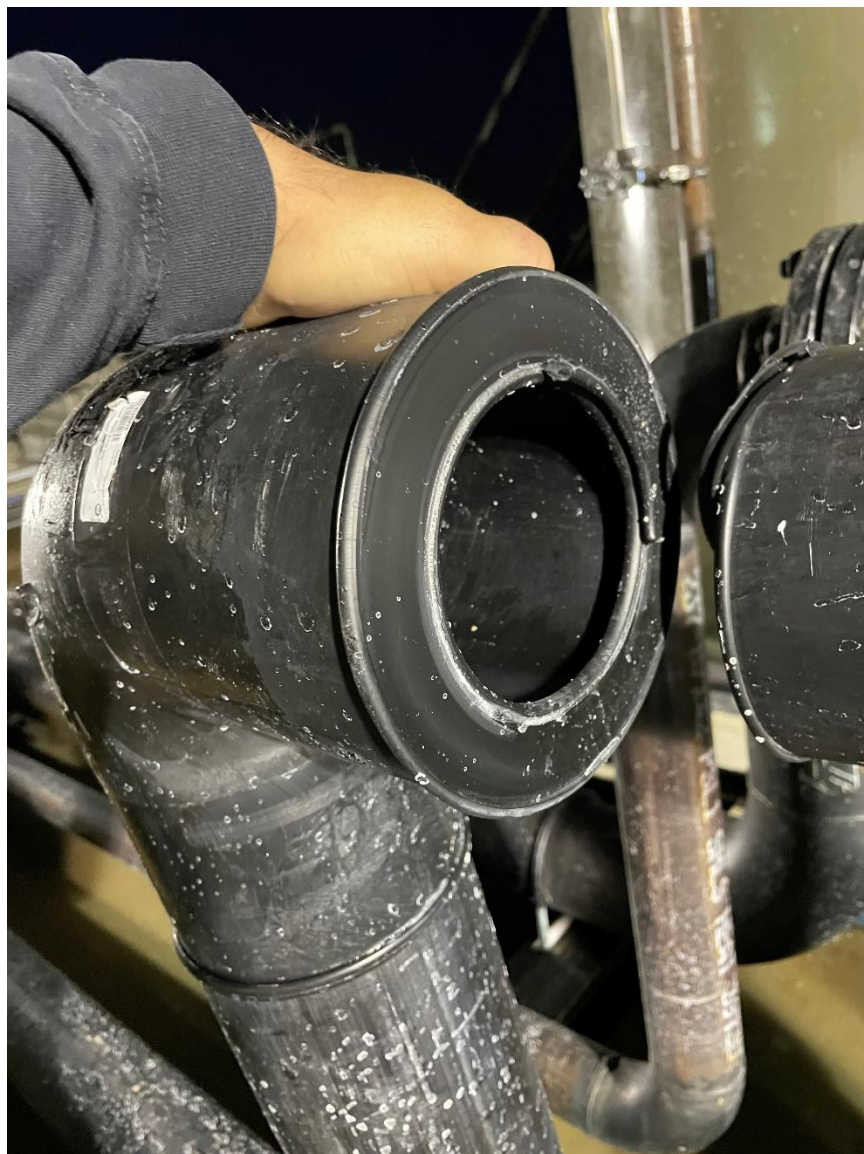
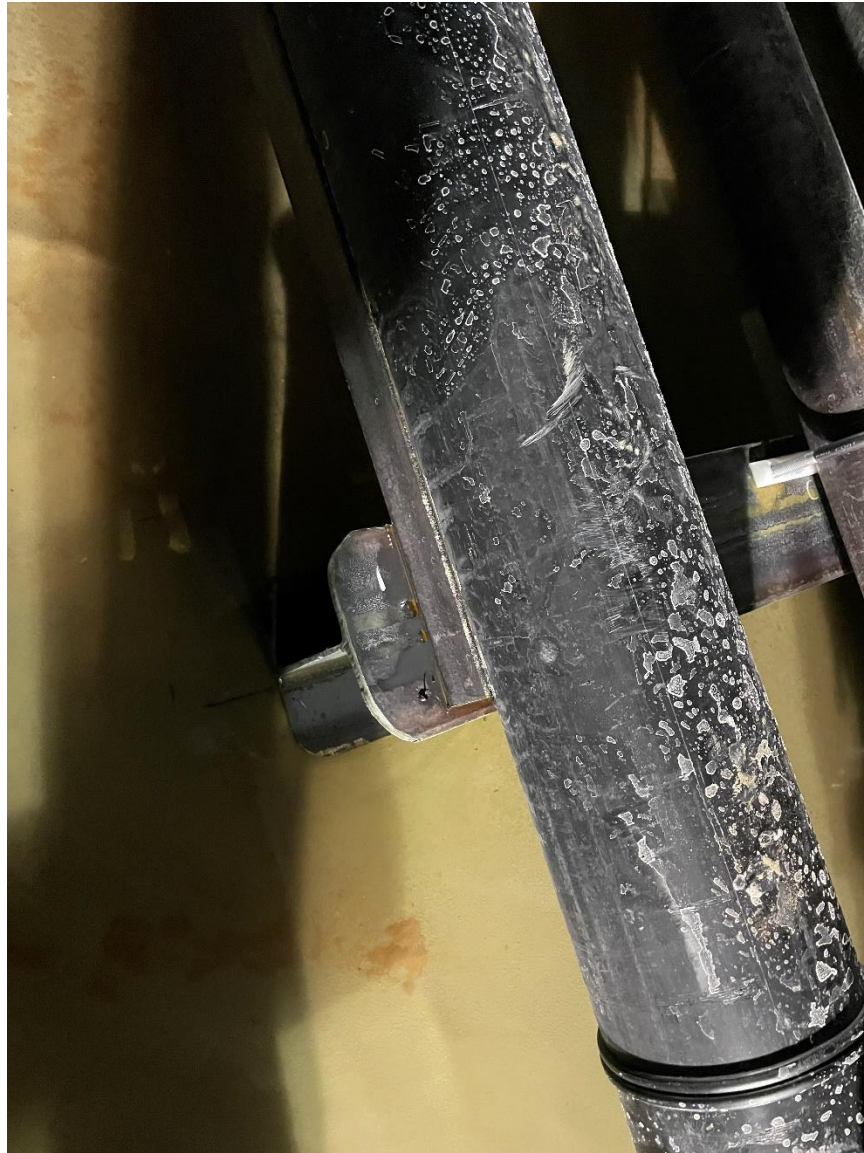
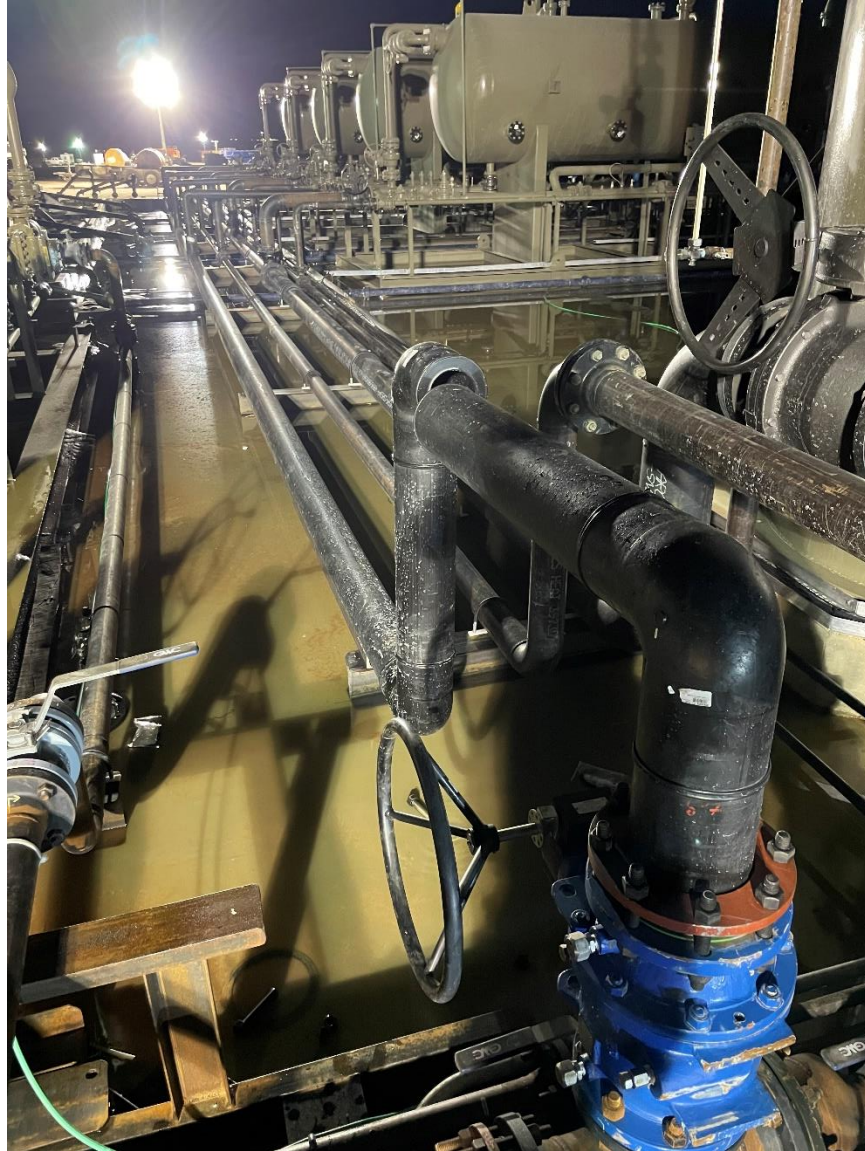
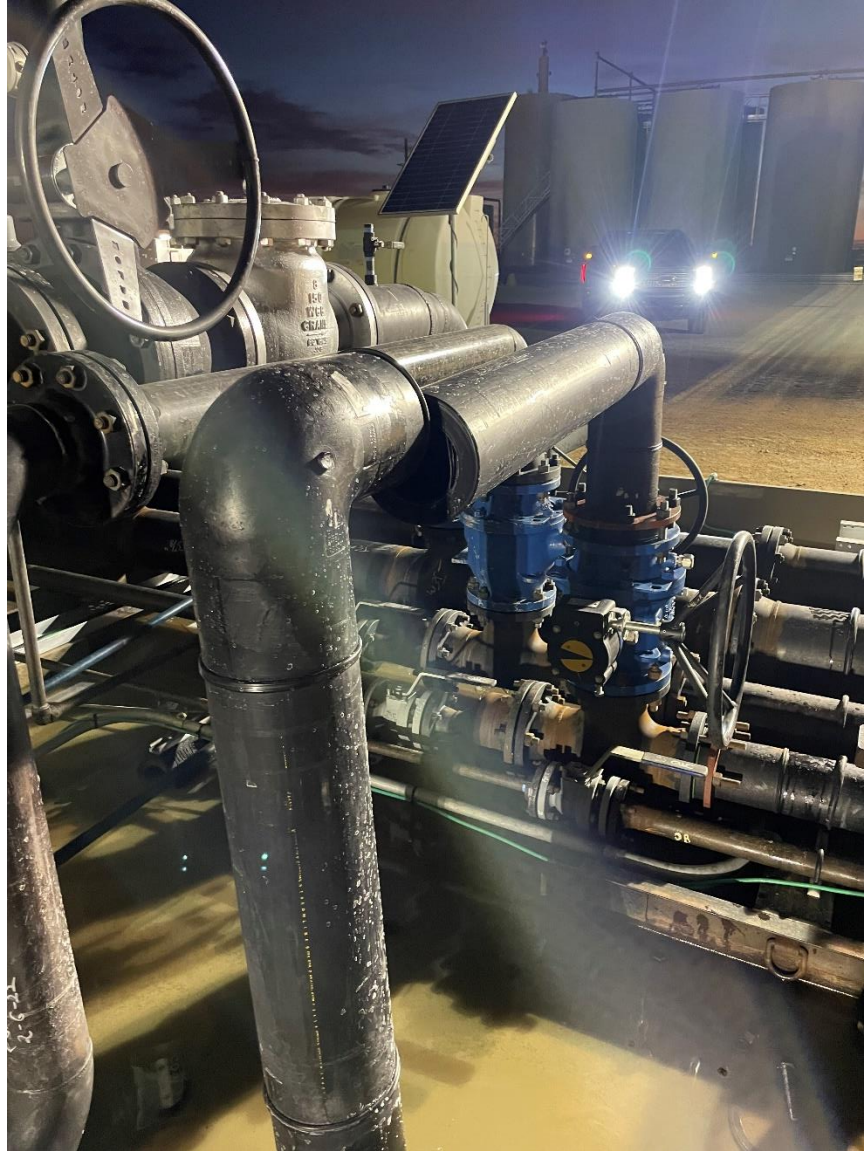
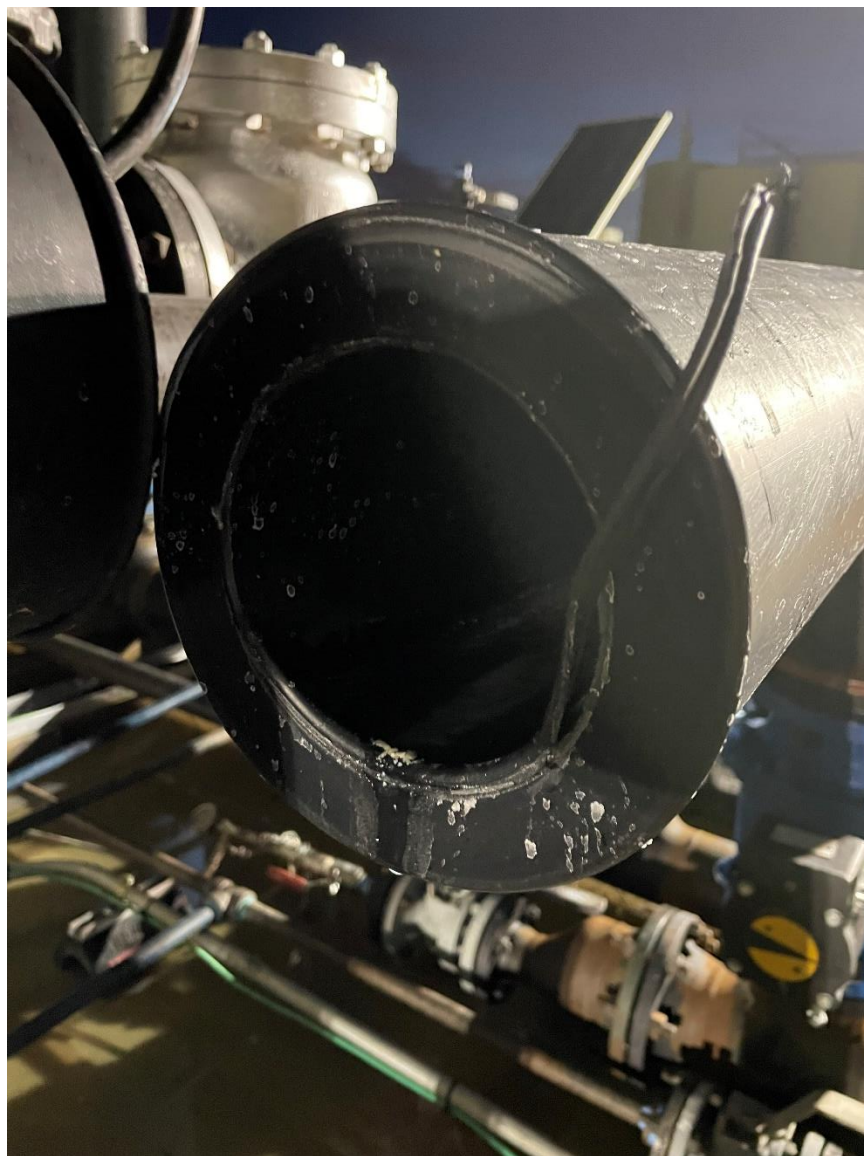
## **Poseidon CTB Tank Spill in containment**

At 2:30 AM a release was noticed by the field operator of the Poseidon CTB. This release occurred due to a poly pipe coming apart at the fuse and spilling produced water into the secondary containment. The Release of the poly pipe was controlled immediately upon discovery. No fluids were released beyond secondary containment. Fluids were recovered via vac truck by Redline Oilfield Services. Tanks and secondary containment were cleaned, and site was returned to production.

As there was no fluid that left containment a site map, nor a sampling was never done for this release. No lab release was necessary, and a notice was sent to NMOCD on 3/24/2021 to Mike Bratcher for an inspection of the liner. Pictures of the spill and liner integrity were taken and are attached below:

- Actions that have been or will be taken to prevent a recurrence of the incident – Poly crew came back and cut/refused and confirmed 100% bondage and pressure tested to working pressure for 1 hr.

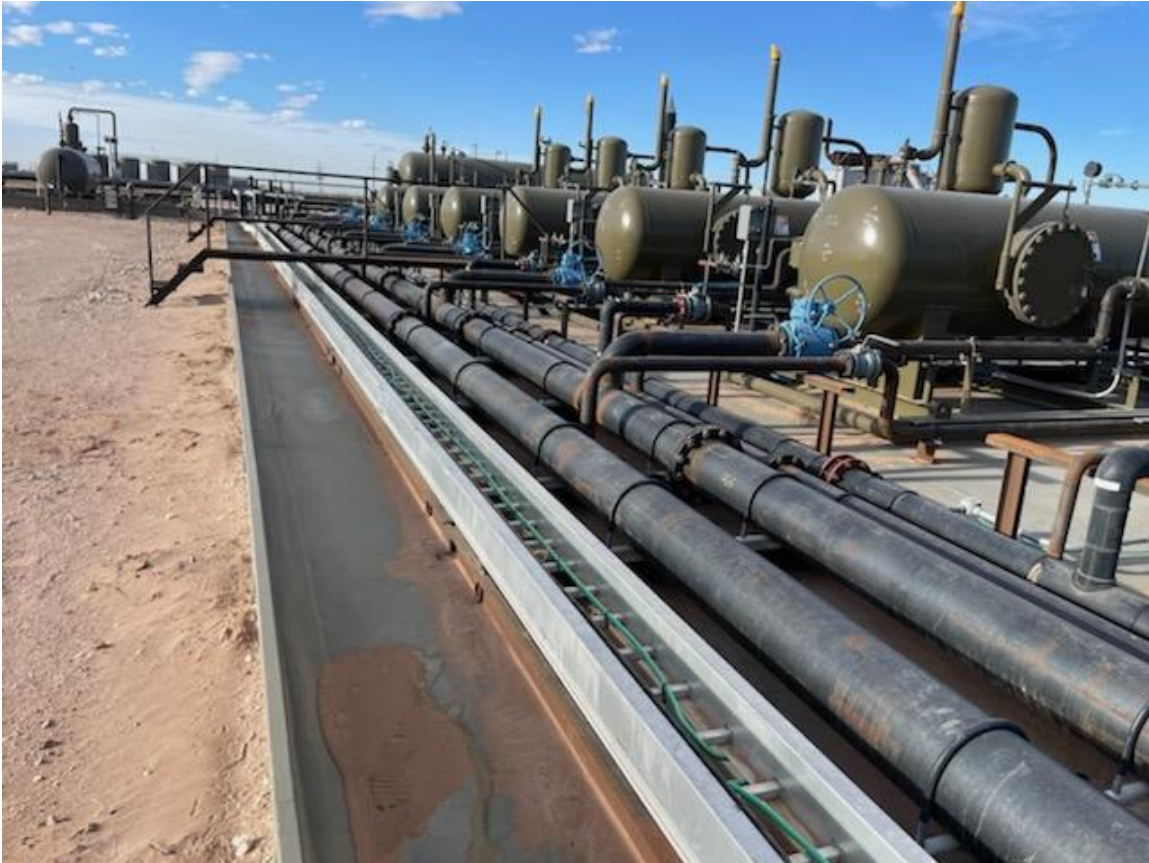
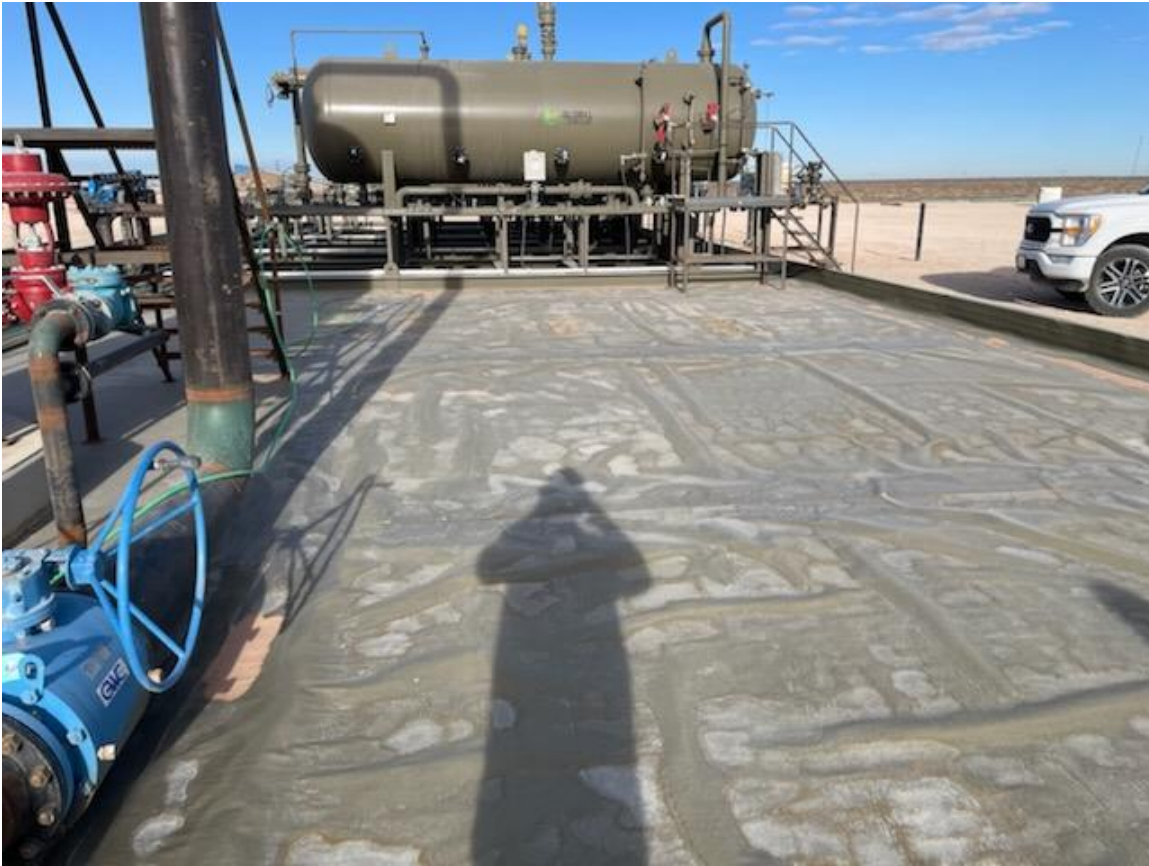
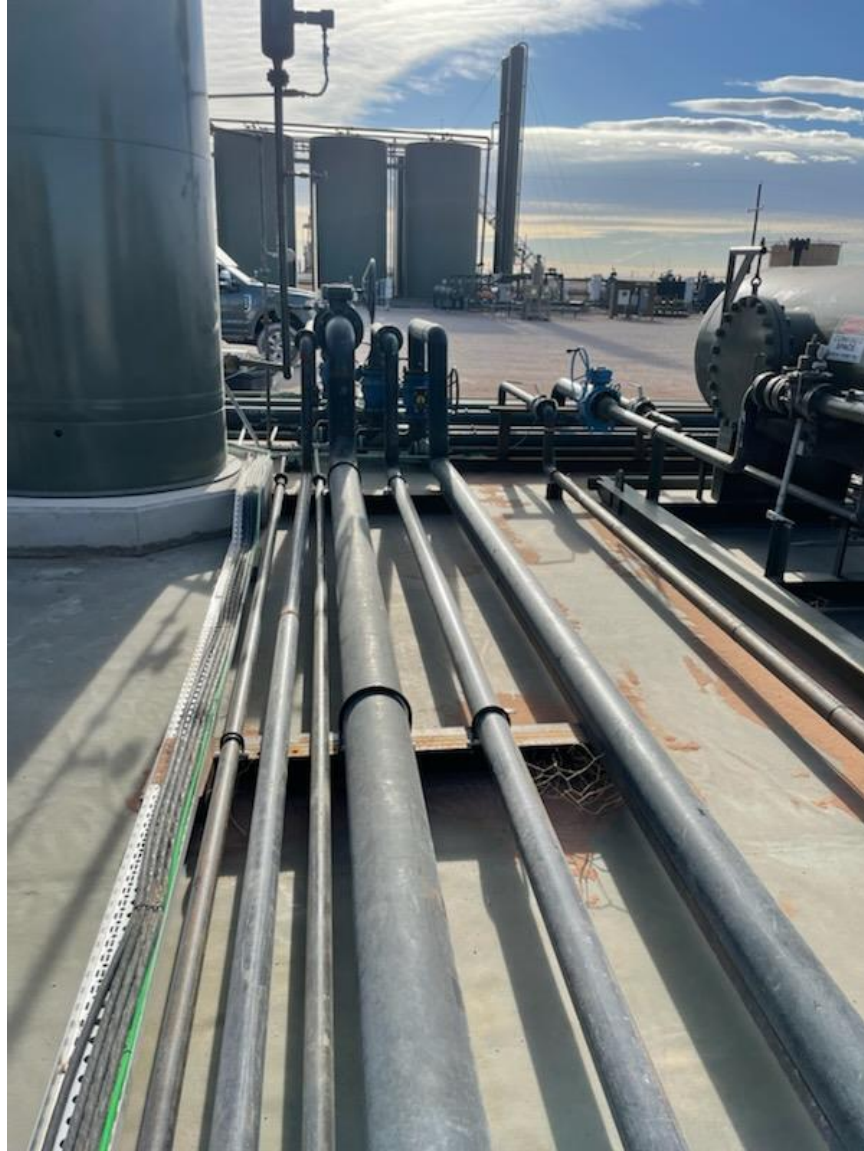
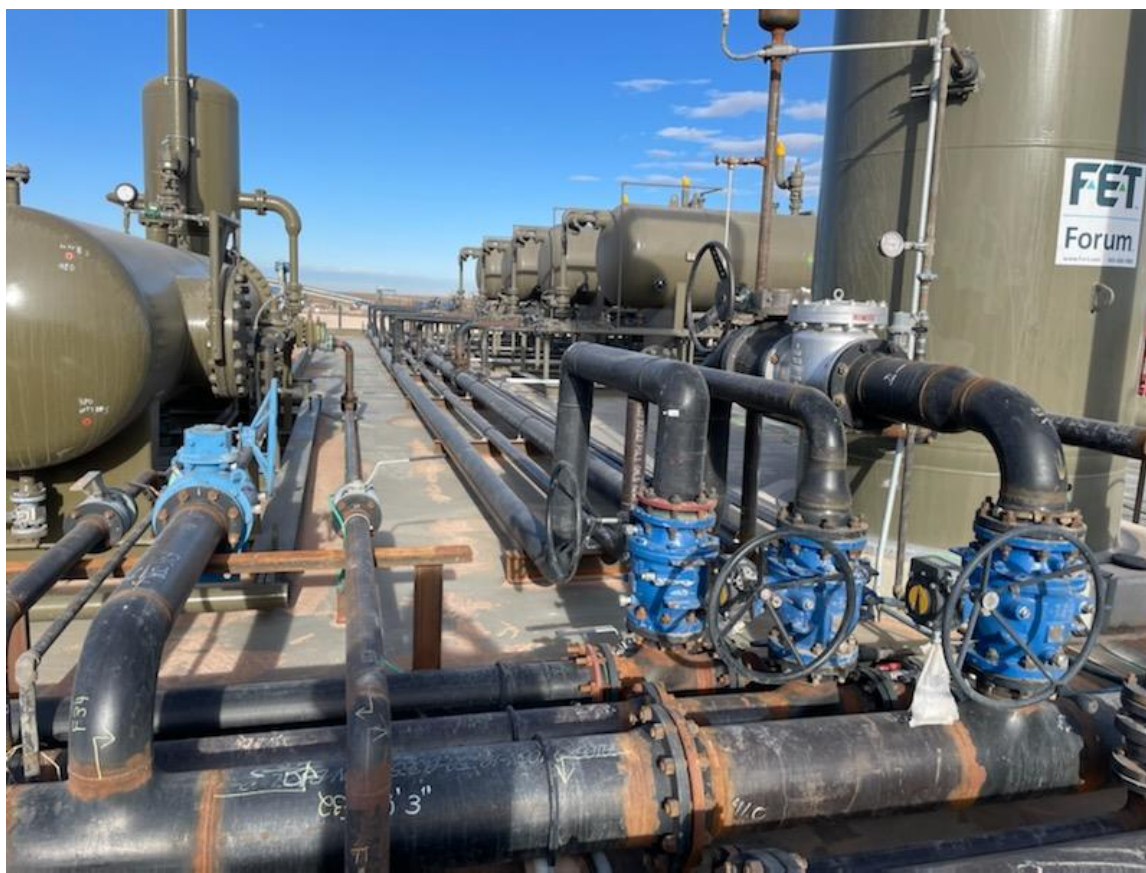
Date of inspection: 3/29/2022
