Site Name San Juan 28-4 Unit 18	Site Type Gas Well
Date Release Discovered 1/11/2020	API# (if applicable) 30-039-07225

# **REMEDIATION WORK PLAN**

**SJ 28-4 UNIT #18  
NCE2003757811  
RIO ARRIBA COUNTY, NEW MEXICO**

**RE: Remediation Work Plan  
Hilcorp Energy Company  
SJ 28-4 Unit #18 – NCE2003757811  
Rio Arriba County, New Mexico**

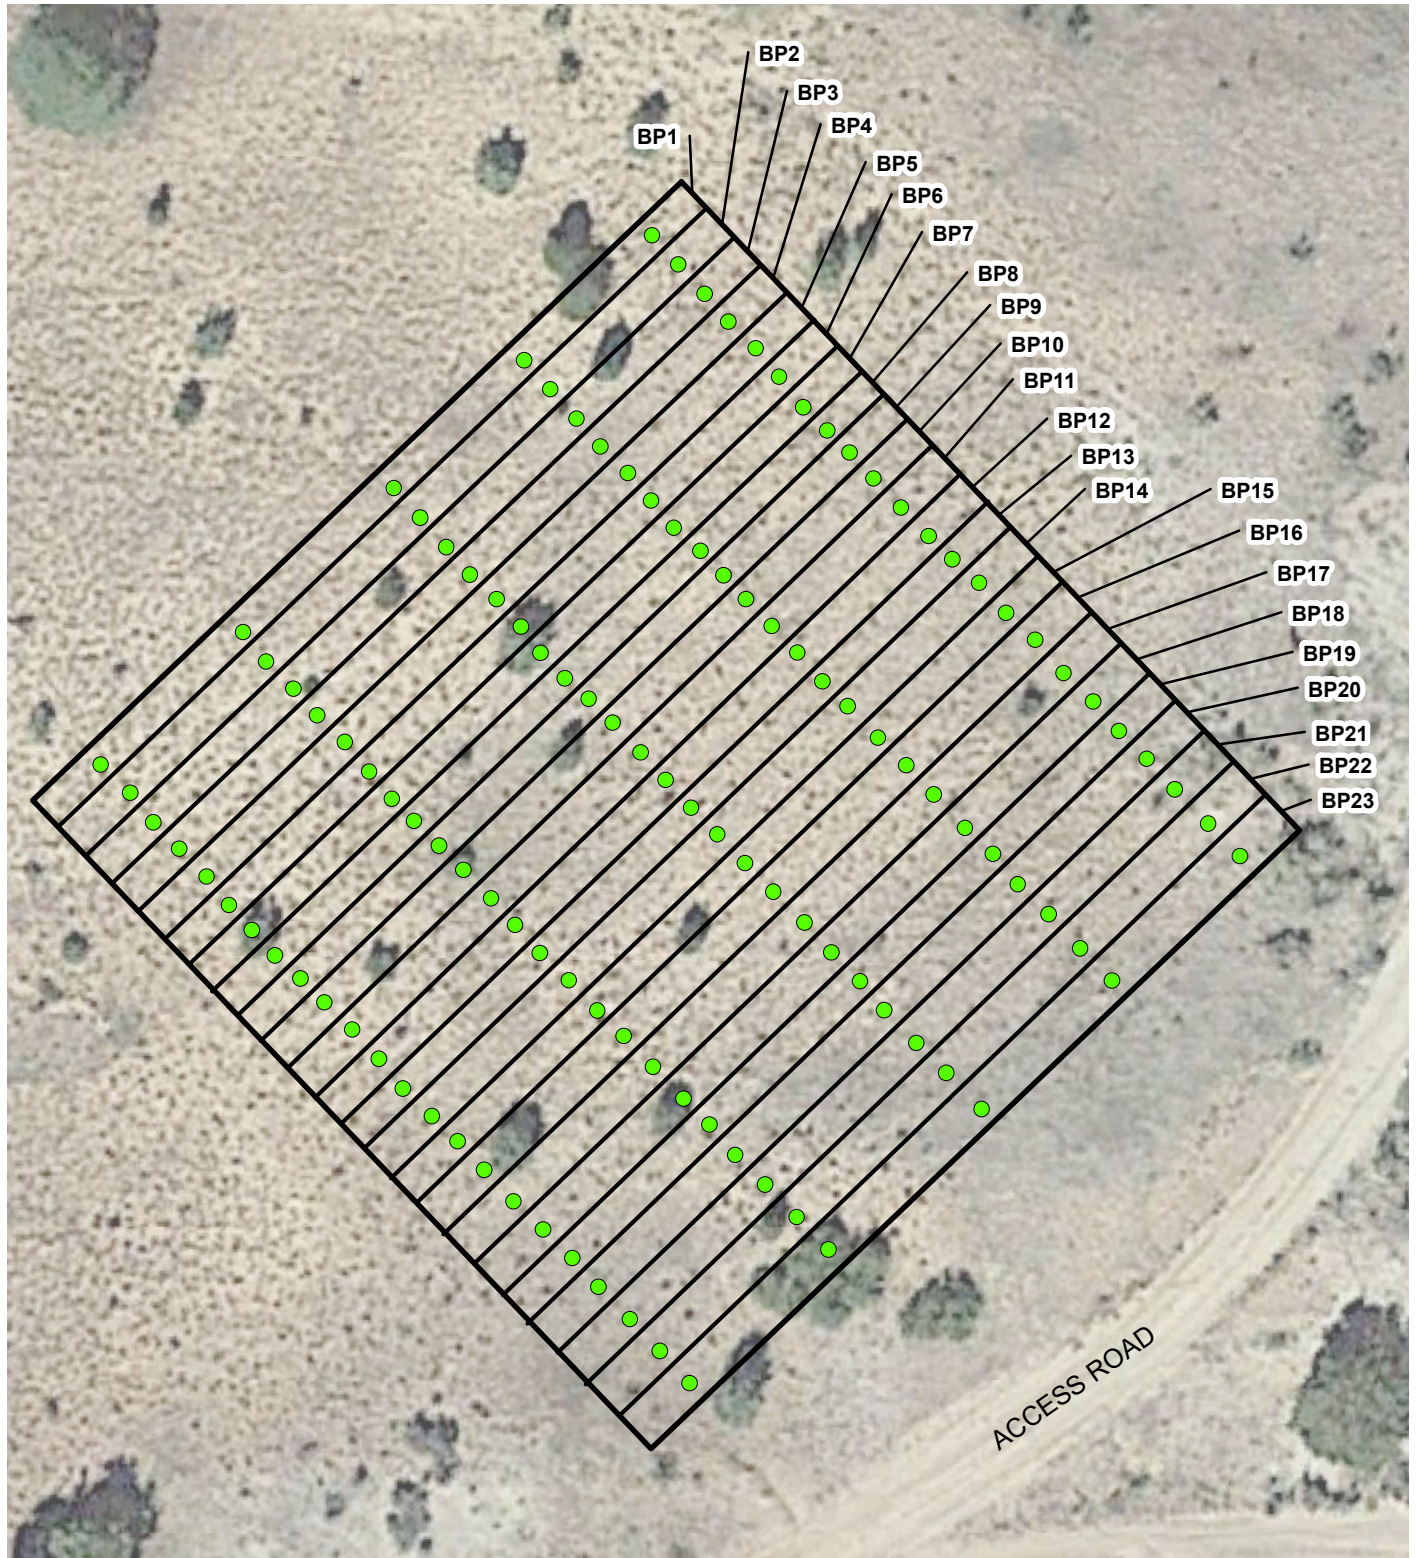
**FIGURE 5**  
**PROPOSED VADOSE ZONE SAMPLE LOCATIONS**  
 SAN JUAN 28-4 #18  
 LOT 4 SEC 31-T28N-R4W  
 RIO ARRIBA COUNTY, NEW MEXICO  
 HILCORP ENERGY COMPANY

- PROPOSED ALIQUOT VADOSE ZONE SAMPLE  
(5-POINT COMPOSITE SAMPLES WILL BE  
COLLECTED FROM BENEATH EACH BIOPILE)

□ BERM (140' X 140')

BIOPILE DIMENSIONS  
140' X 6' X 2'

After backfilling the treated soil, Hilcorp will collect 5-point composite soil samples from vadose zone soils beneath the area that biopiles were placed (Figure 5). Hilcorp will also collect additional vadose zone soil samples from areas where water may have collected during rain or watering events. Soil samples be collected from 6 inches below the native soil surface. The locations of the additional vadose zone samples (if any) to be taken beneath areas of where water may have pooled will be determined by the GPS coordinates taken by Hilcorp during the weekly inspections. Vadose zone soil samples will be submitted for laboratory analysis of BTEX by EPA Method 8021, TPH- GRO, TPH- DRO, and TPH- MRO by EPA Method 8015.

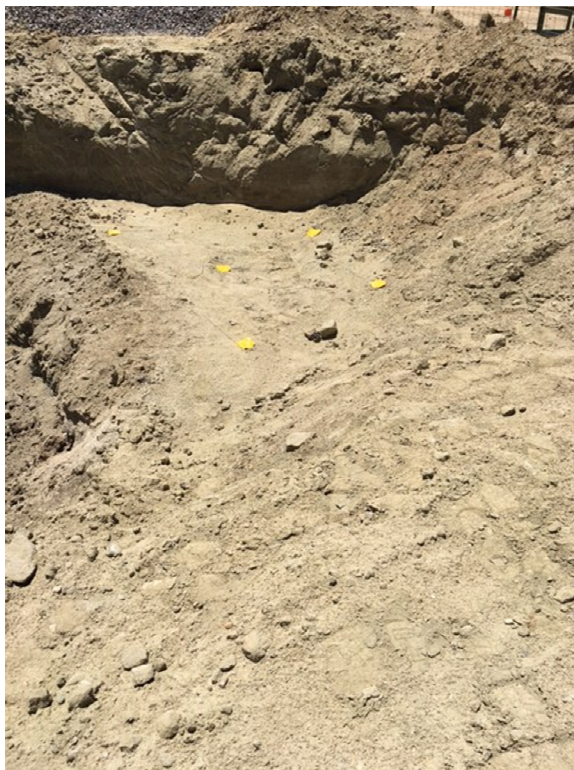
**Photograph 1:** South wall of excavation.

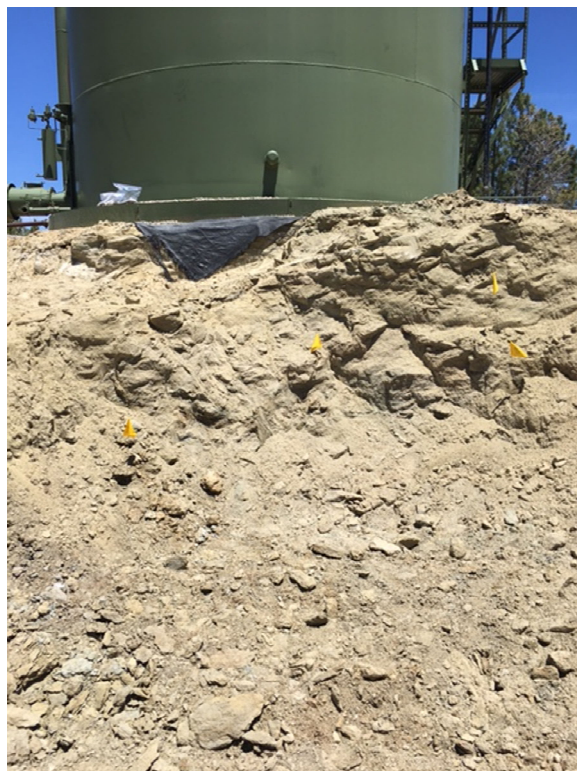
**Photograph 2:** North Wall of excavation.

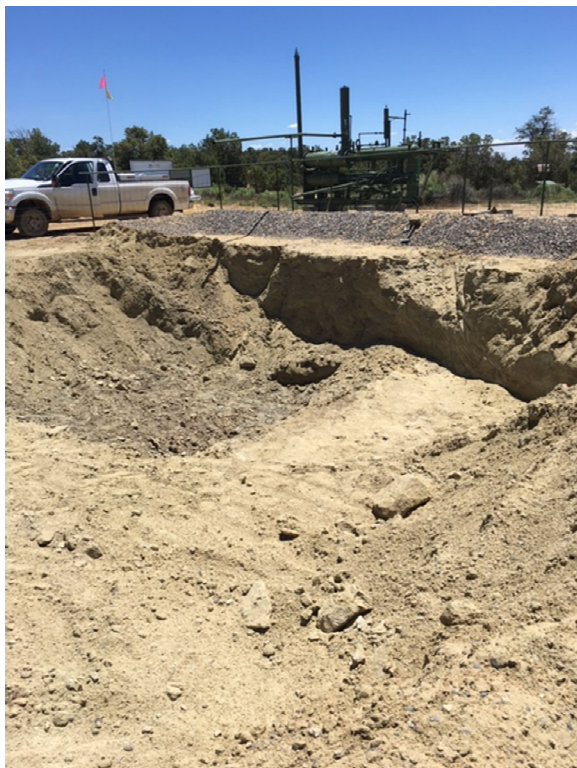
**Photograph 3:** East Wall of excavation.

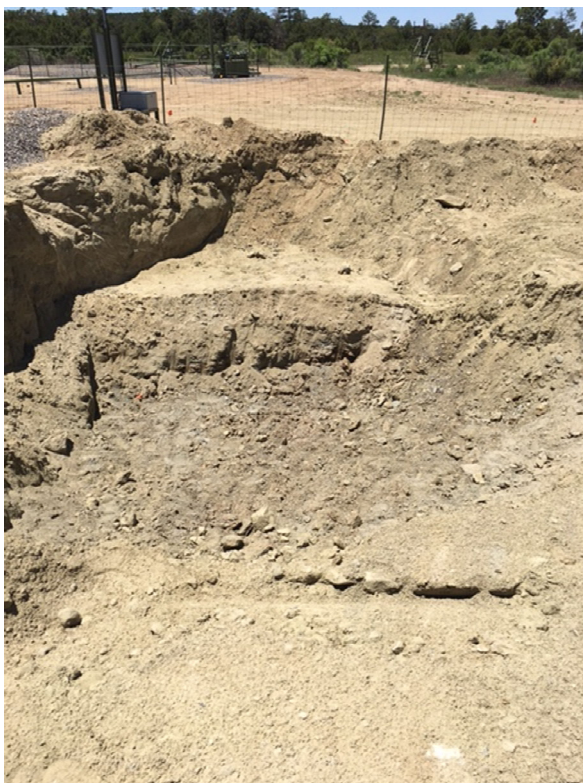
**Photograph 4:** West Wall of excavation.
