Release Notification

Site Name Lateral M-11 Pipeline	Site Type Natural Gas Pipeline
Date Release Discovered 1/18/2021	API# (if applicable)

RE: CLOSURE REPORT
Lateral M-11 Pipeline Release
NMOCD Incident No. nAPP2102540540
NW¼ SW¼, Section 26, T29N, R4W
Rio Arriba County, New Mexico

Lateral M-11 Pipeline Excavation Clearance Report

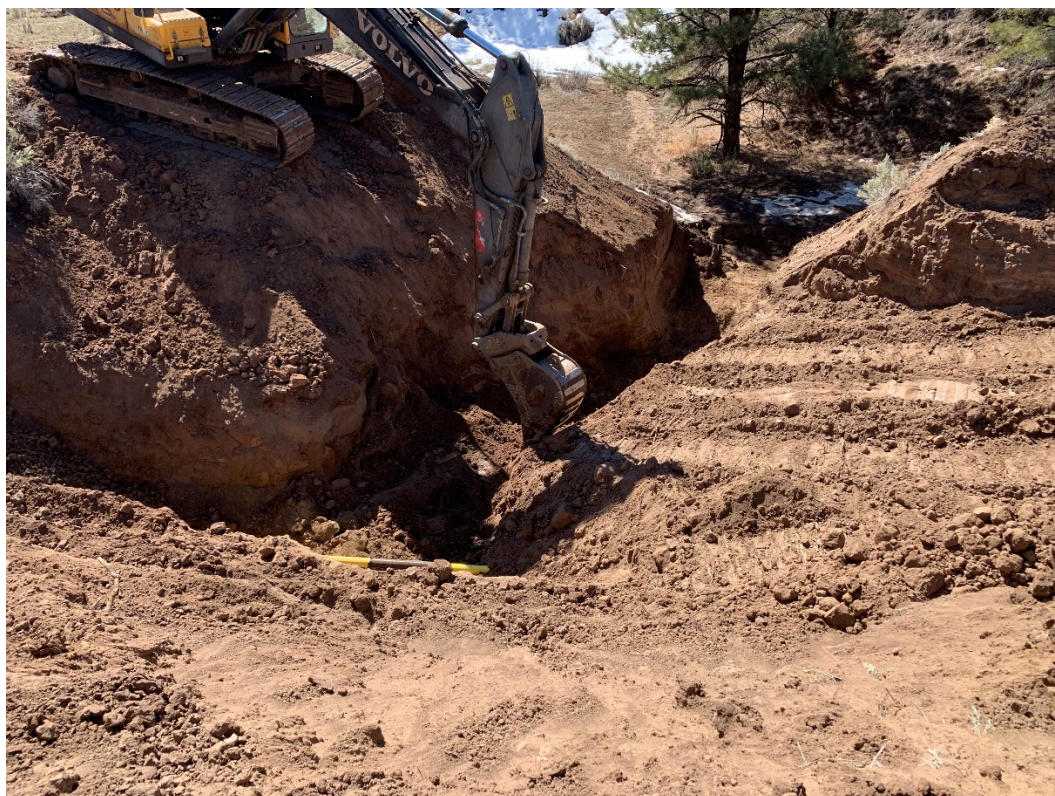
Photo 1: Pipeline excavation, March 11, 2021.

- A Harvest field crew excavated the damaged section of the line to lower the line and make repairs.
- The Harvest field crew reached out to Jodi Bohannon/Harvest, who contacted US Forest Service (USFS) with a question about the field work. USFS immediately directed Harvest to stop all work.

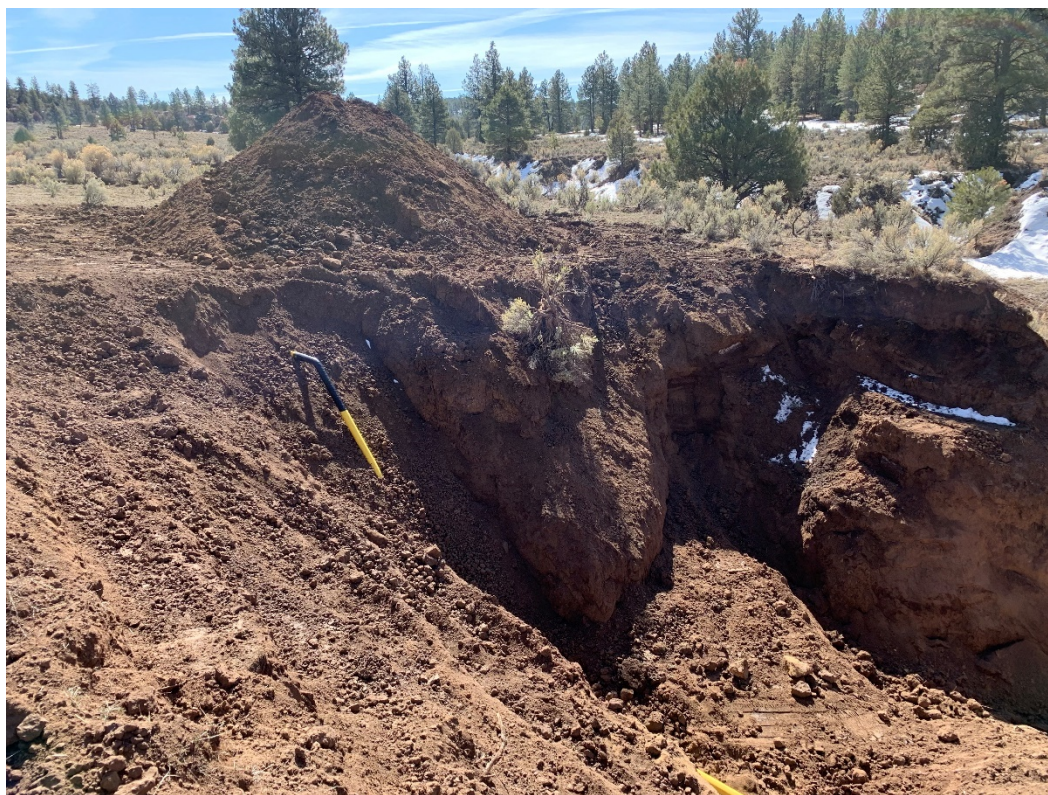
Photo 2: Pipeline excavation, March 11, 2021.

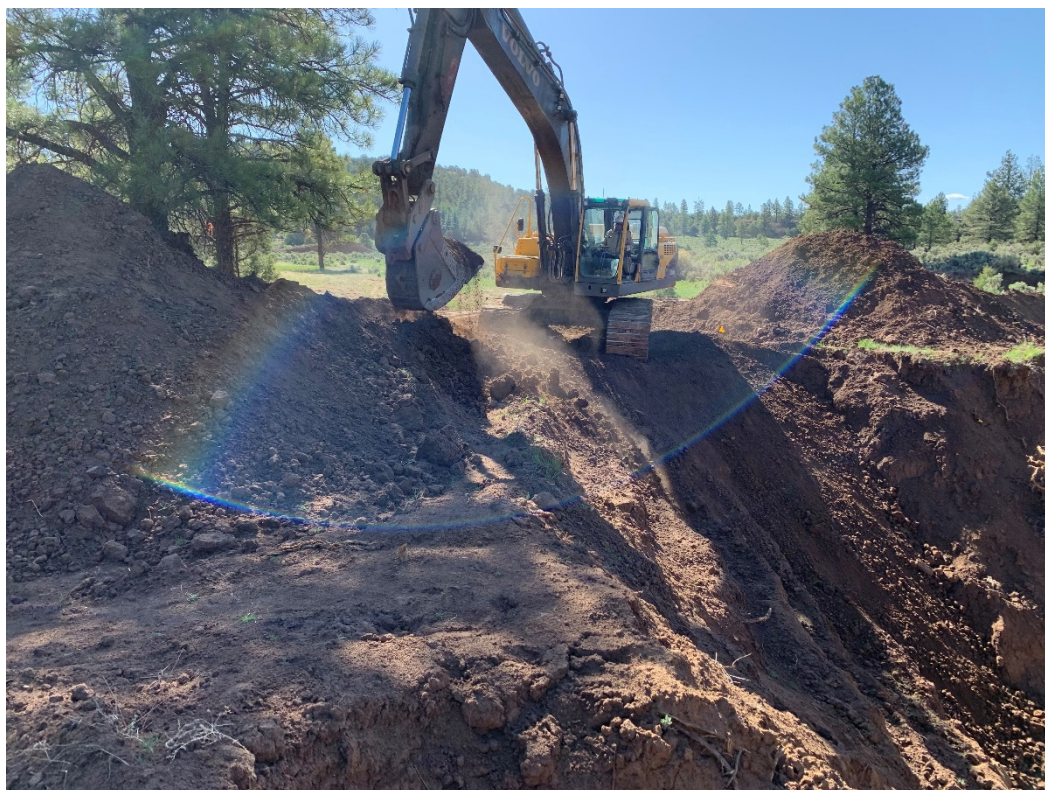
Photo 3: Pipeline excavation, March 11, 2021.

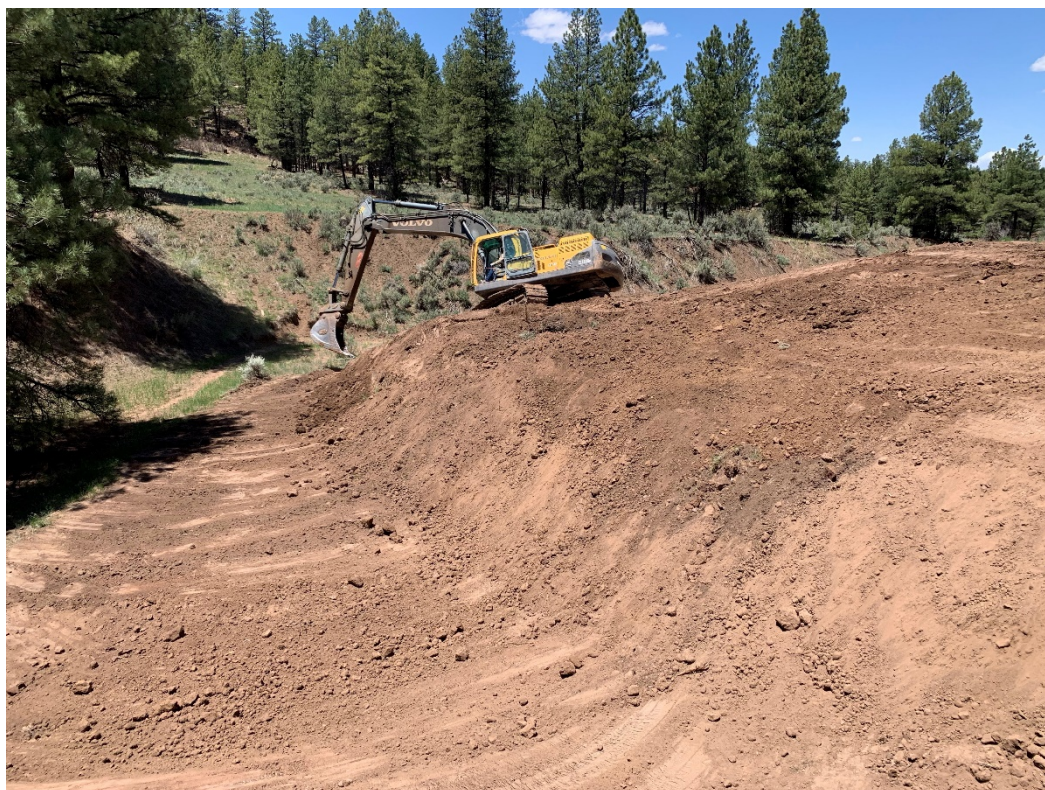
Photo 4: Excavation backfilling, May 2021.

- JJ Miller/USFS also directed Harvest to submit all spill reports and test data that had been created and reported as of that email.
April 6, 2021:
- Harvest completed a Master Services Agreement (MSA) with San Juan County Museum Division of Conservation Archaeology (DCA) to complete the required Arch. Survey. Other contractors with MSAs with Harvest were unavailable.
April 29, 2021:
- The Arch. Survey was completed and submitted to USFS.
May 12, 2021:
- Approval to proceed was granted by USFS.
May 20, 2021:
- Harvest backfilled the excavation.

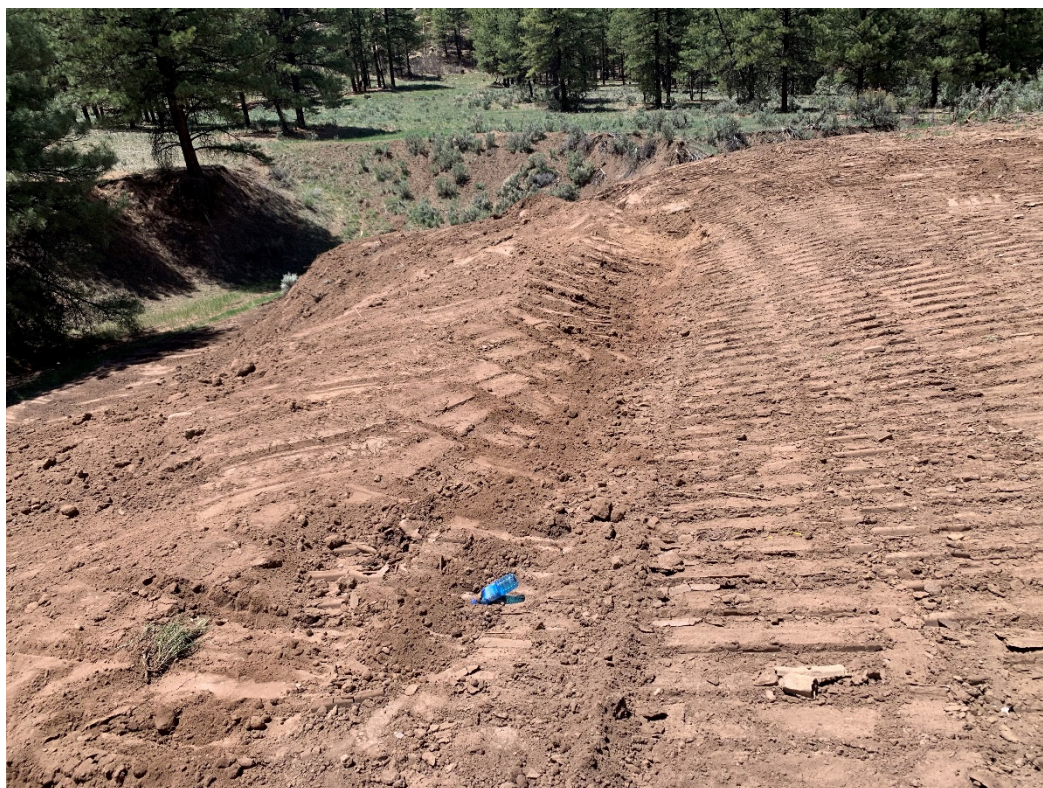
Photo 5: Backfilled excavation, May 20, 2021.

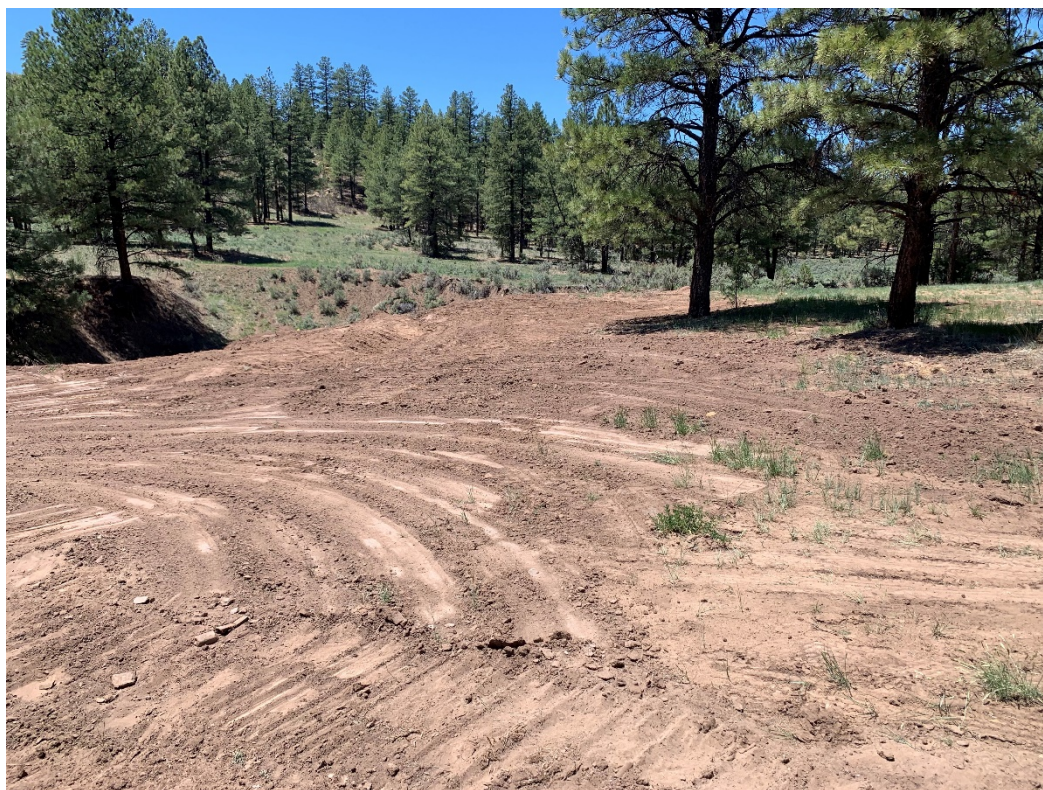
Photo 6: Backfilled excavation, May 20, 2021.
