Closure Report

Luke BAV Federal Com #1
Eddy County, New Mexico
Incident # nAPP2207748537
J-3-21S-22E

Subject: **Closure Report**
Luke BAV Federal Com #1
Eddy County, New Mexico
Incident # nAPP2207748537
J-3-21S-22E

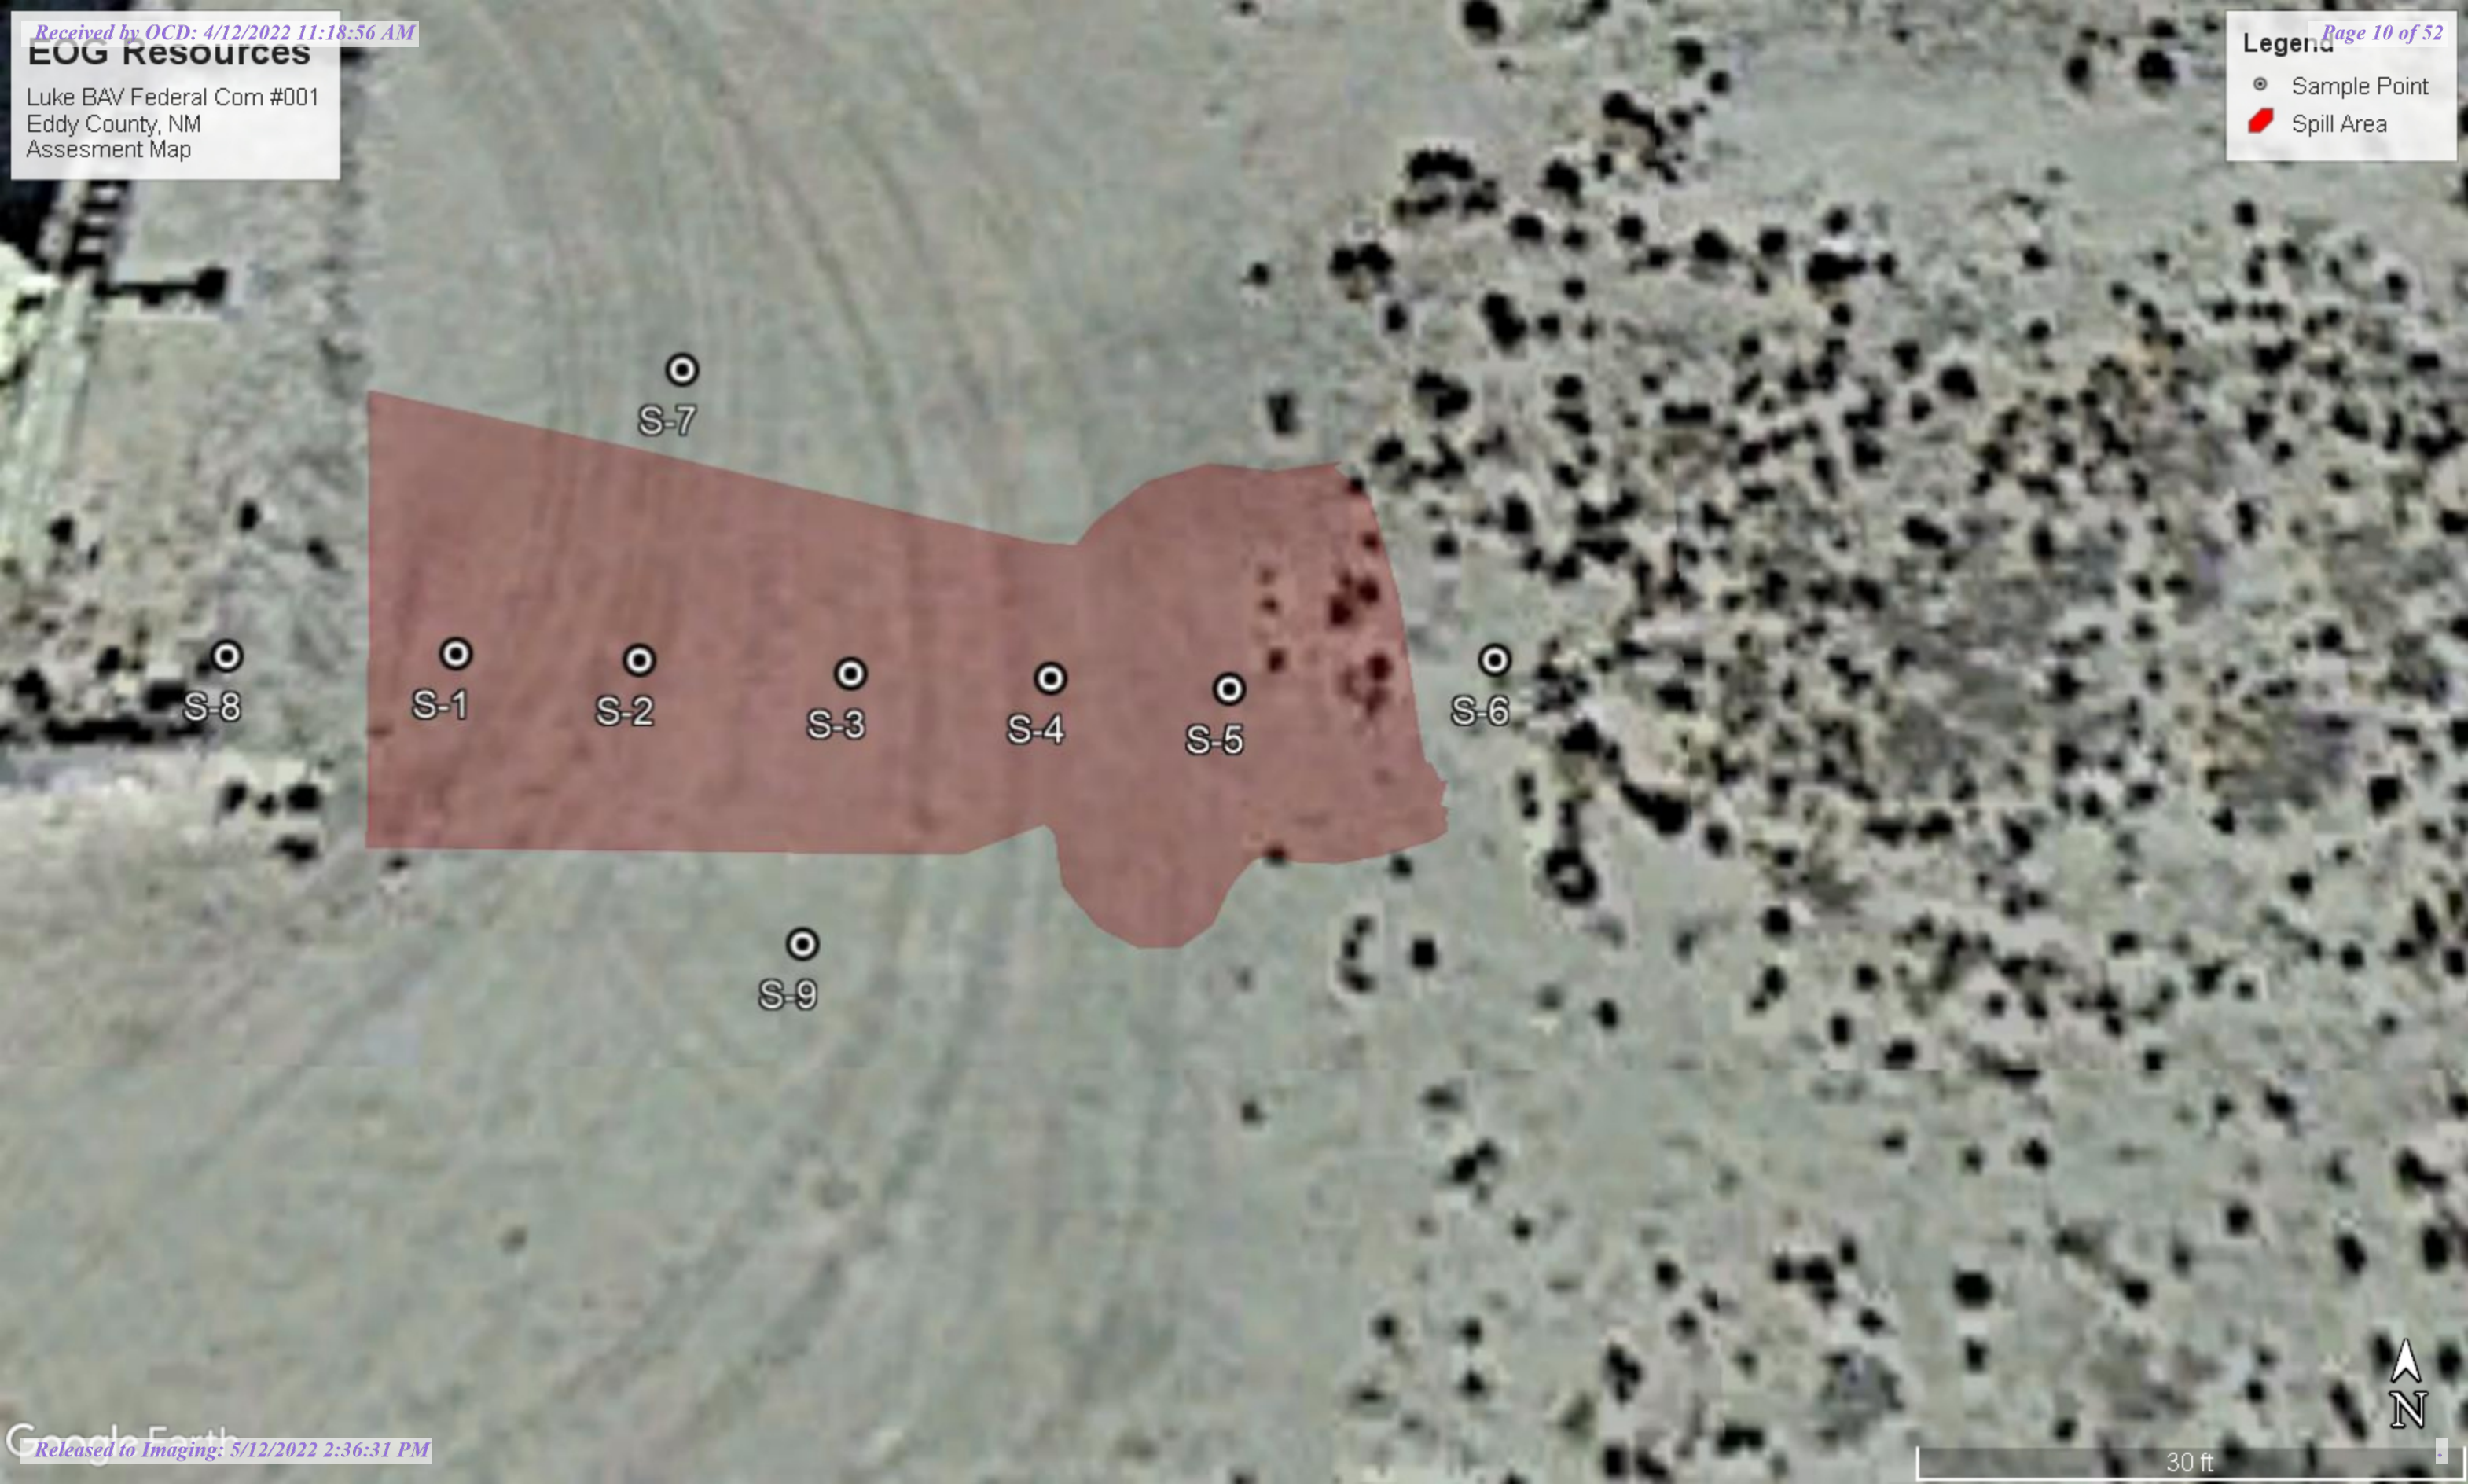
Luke BAV Federal Com #001
Eddy County, NM
Assesment Map

- Sample Point
- Spill Area

On March 07, 2022 Talon mobilized personnel to the site to conduct an initial site assessment. The impacted area was mapped utilizing a Trimble Juno 3B, photographed and sampled utilizing a hand auger. All soil samples were properly packaged, preserved, and transported to Cardinal, Laboratories via chain of custody for analysis of Total Chlorides (SM4500Cl-B), TPH (EPA Method 8015M), and BTEX (EPA Method 8021B). Sample locations are shown on the attached Figure 2 ([Appendix I](#)) and the results of our sampling event are presented on the following data table.

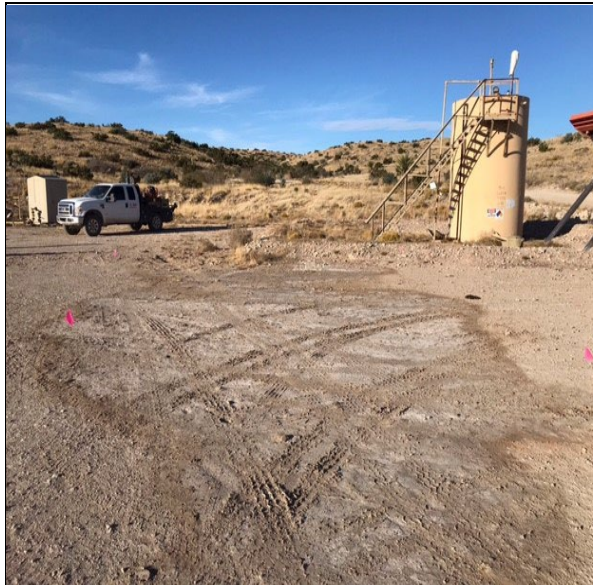
Photograph No.1 Description:

Historical impact at wellhead

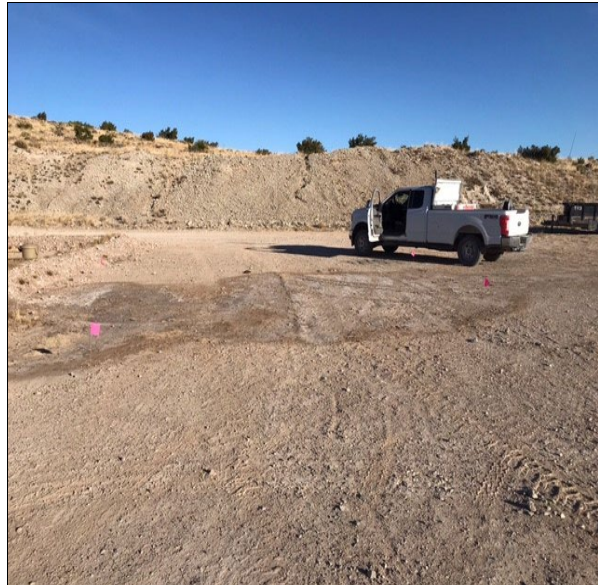
Photograph No.2 Description:

Pad Impact

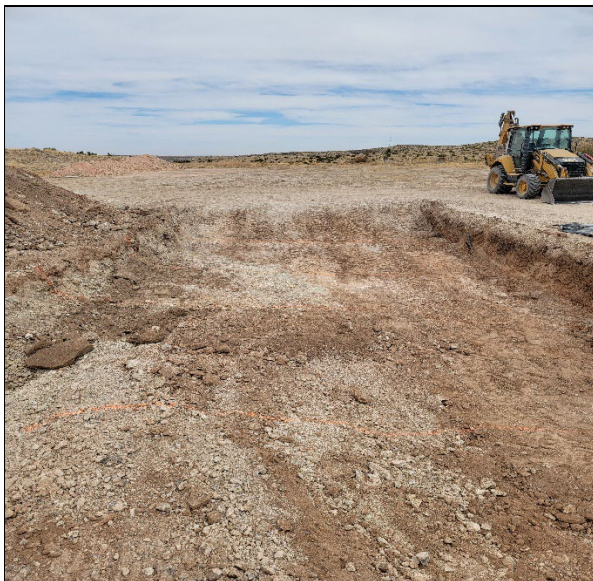
Photograph No.3 Description:

Excavation

- The spill footprint was excavated to depths of 3 feet bgs and to the horizontal extent that all surface staining and hydrocarbon odors were removed. Laboratory analysis confirms that NMOCD closure criteria for soil remediation has been achieved.
- Background (S4 through S6) and sidewall samples were obtained in order to confirm horizontal delineation.
- All contaminated soil was transported to Lea Land, LLC, a NMOCD approved solid waste disposal facility.
- The excavated area was backfilled with clean caliche, compacted and restored to grade.

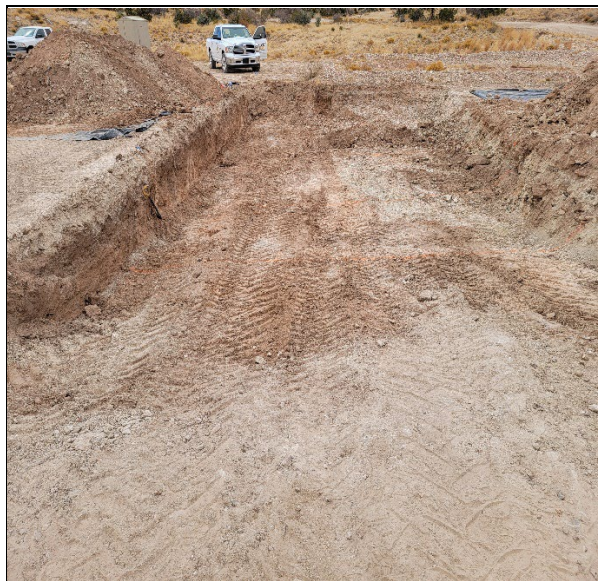
Photograph No.4 Description:

Excavation looking West

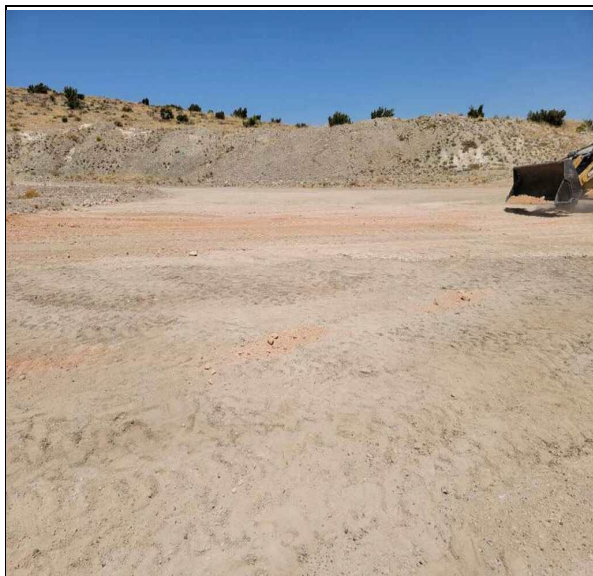
Photograph No.5 Description:

Backfill of excavation

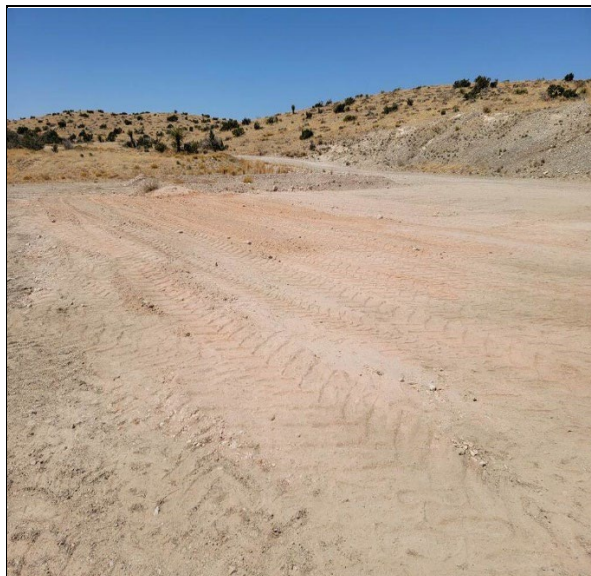
Photograph No.6 Description:

Backfilled to grade
