Release Notification

CLOSURE REPORT

Val Verde Plant Train 7 Release (April 2019)
NE ¼, S14 T29N R11W
San Juan County, New Mexico

December 4, 2019
Ensolum Project No. 05A1226054

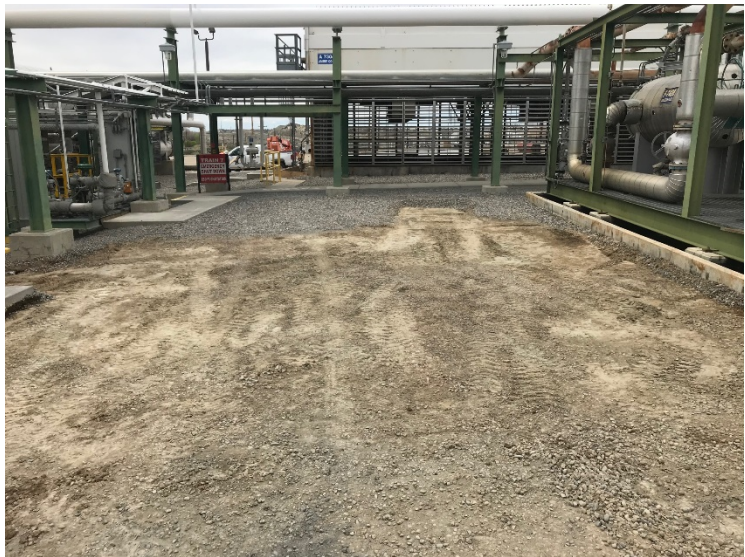
**Photograph 1**

Photograph Description: View of the initial scraped/excavated area, facing west.

To remediate the impact from the release, the area was scraped utilizing heavy equipment and hand tools. The final scraped excavation measured approximately 101 feet long and 42 feet wide at the maximum extents. The maximum depth of the excavation measured approximately 30 inches bgs.

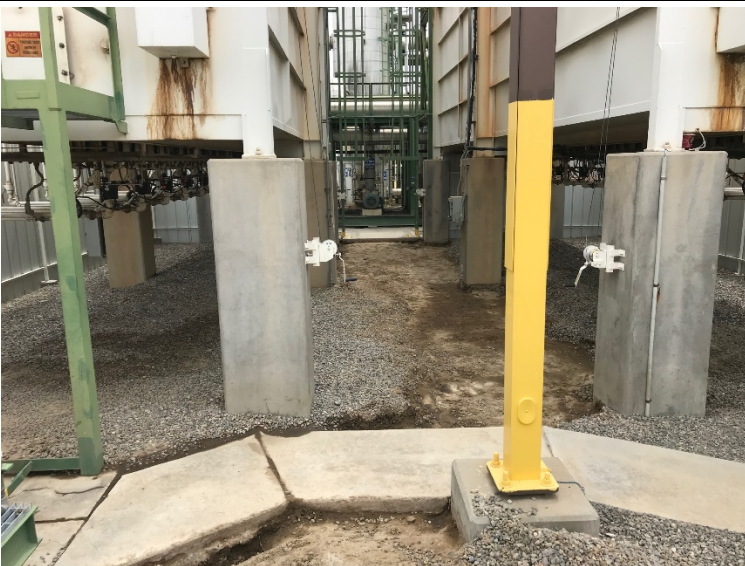
**Photograph 2**

Photograph Description: View of the initial scraped/excavated area, facing south.

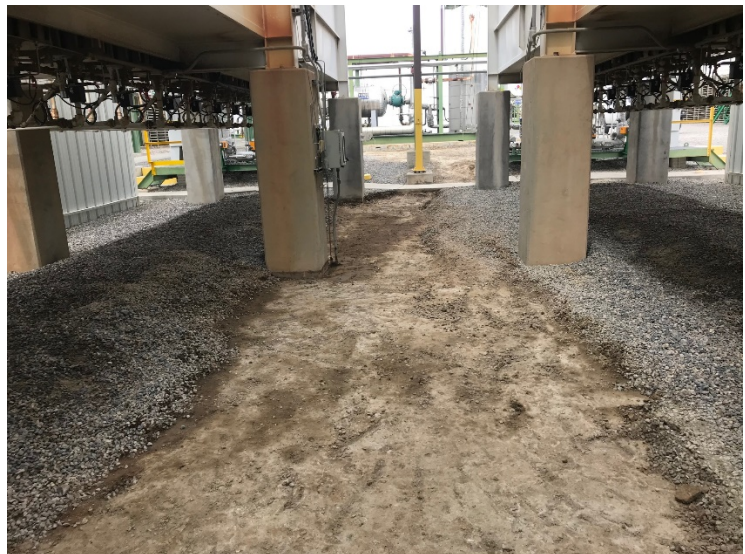
**Photograph 3**

Photograph Description: View of the initial scraped/excavated area, facing north.

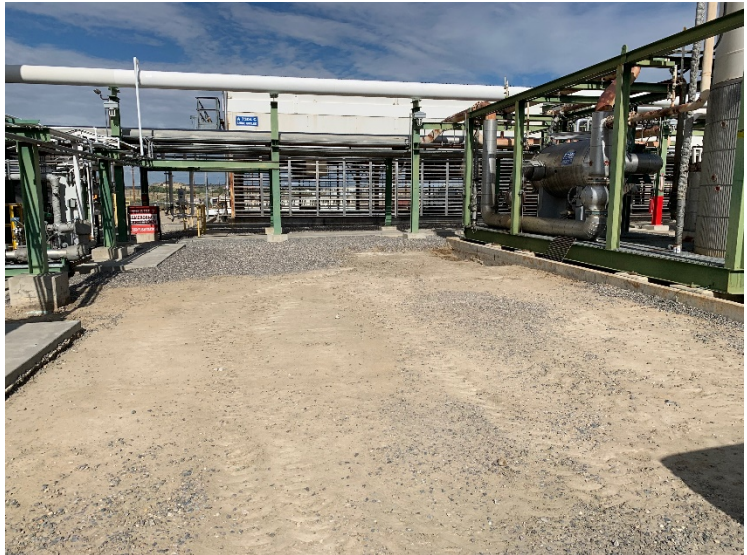
**Photograph 4**

Photograph Description: View of the final scraped/excavated area and part of the carbon vessel skid/concrete containment, facing west.

Enterprise backfilled the excavation with imported fill and resurfaced it with gravel to provide a suitable driving surface.

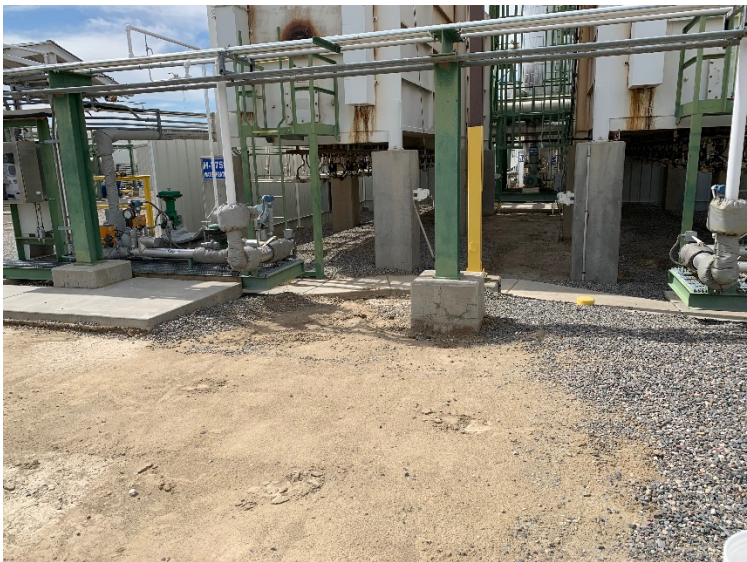
**Photograph 5**

Photograph Description: View of the final scraped/excavated area, facing southeast.

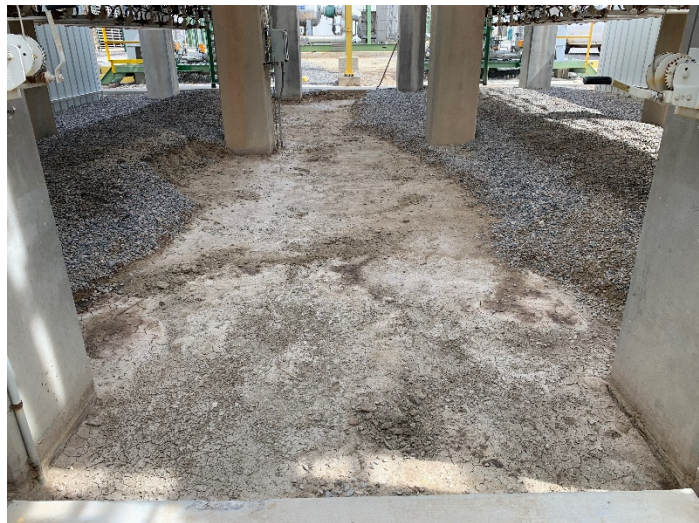
**Photograph 6**

Photograph Description: View of the final scraped/excavated area, facing north.

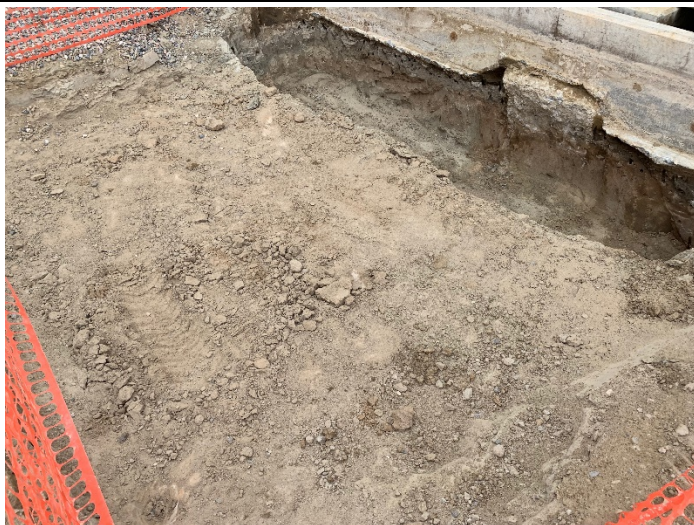
Photograph 7

Photograph Description: View of the final scraped/excavated area, facing northwest.

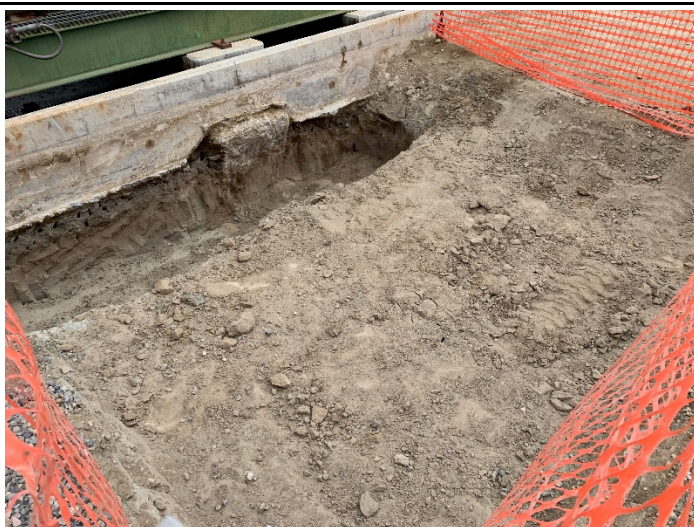
Photograph 8

Photograph Description: View of the final scraped/excavated area, facing northeast.
