Release Notification

Lateral H-35 Pipeline Release Closure Report

Unit Letter E, Section 29, Township 30 North, Range 10 West
San Juan County, New Mexico

July 17, 2020

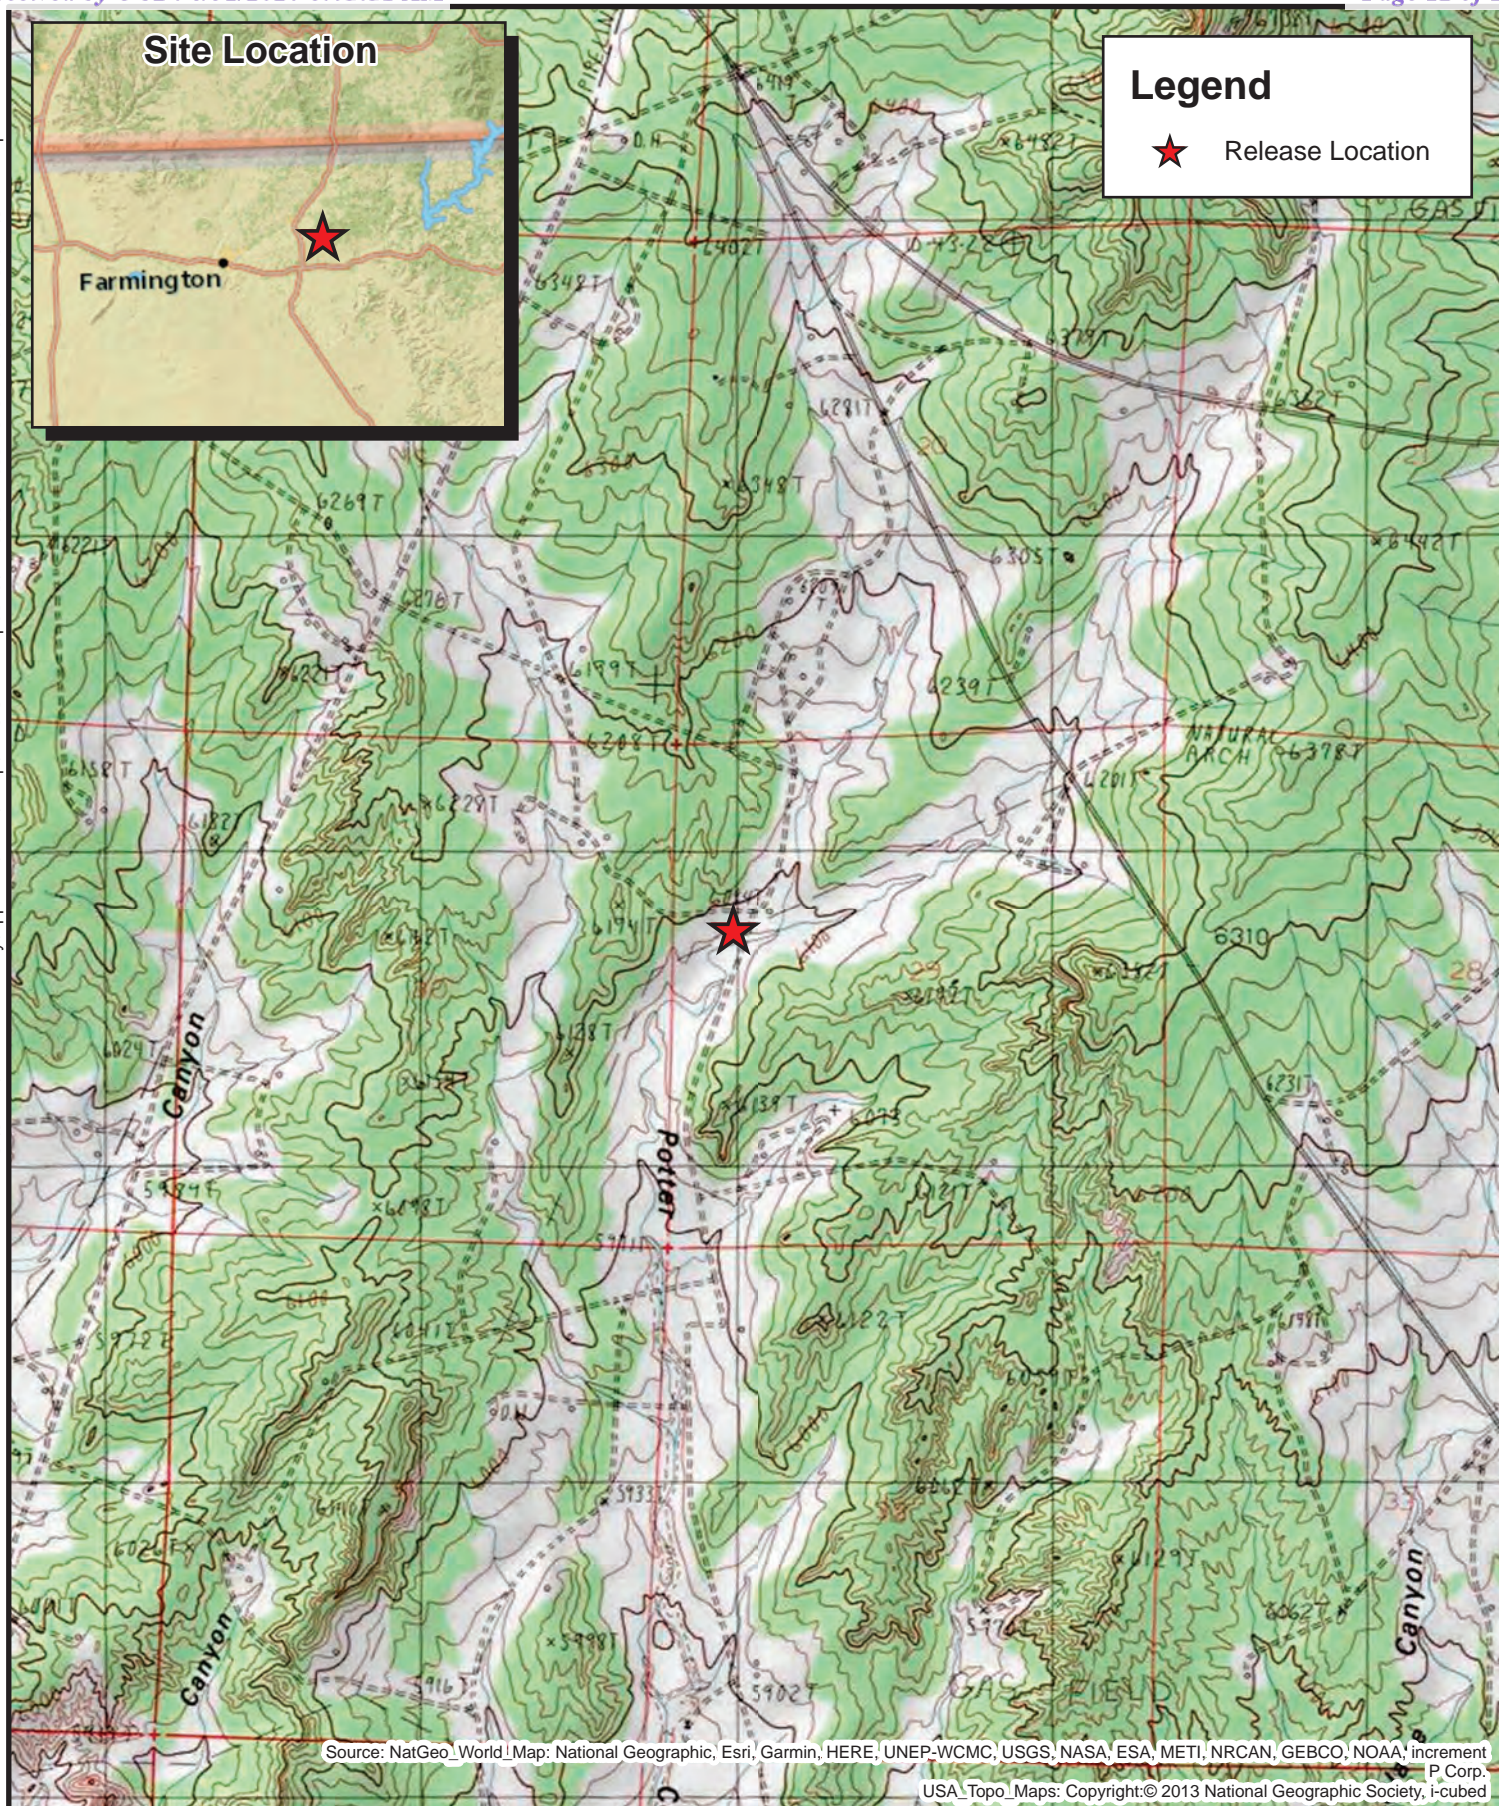
Figure 1
Topographic Site Map
Lateral H-35

A topographic map of the location reproduced from the United States Geological Society quadrangle map of the area is included as Figure 1 and an aerial site map is included as Figure 2.

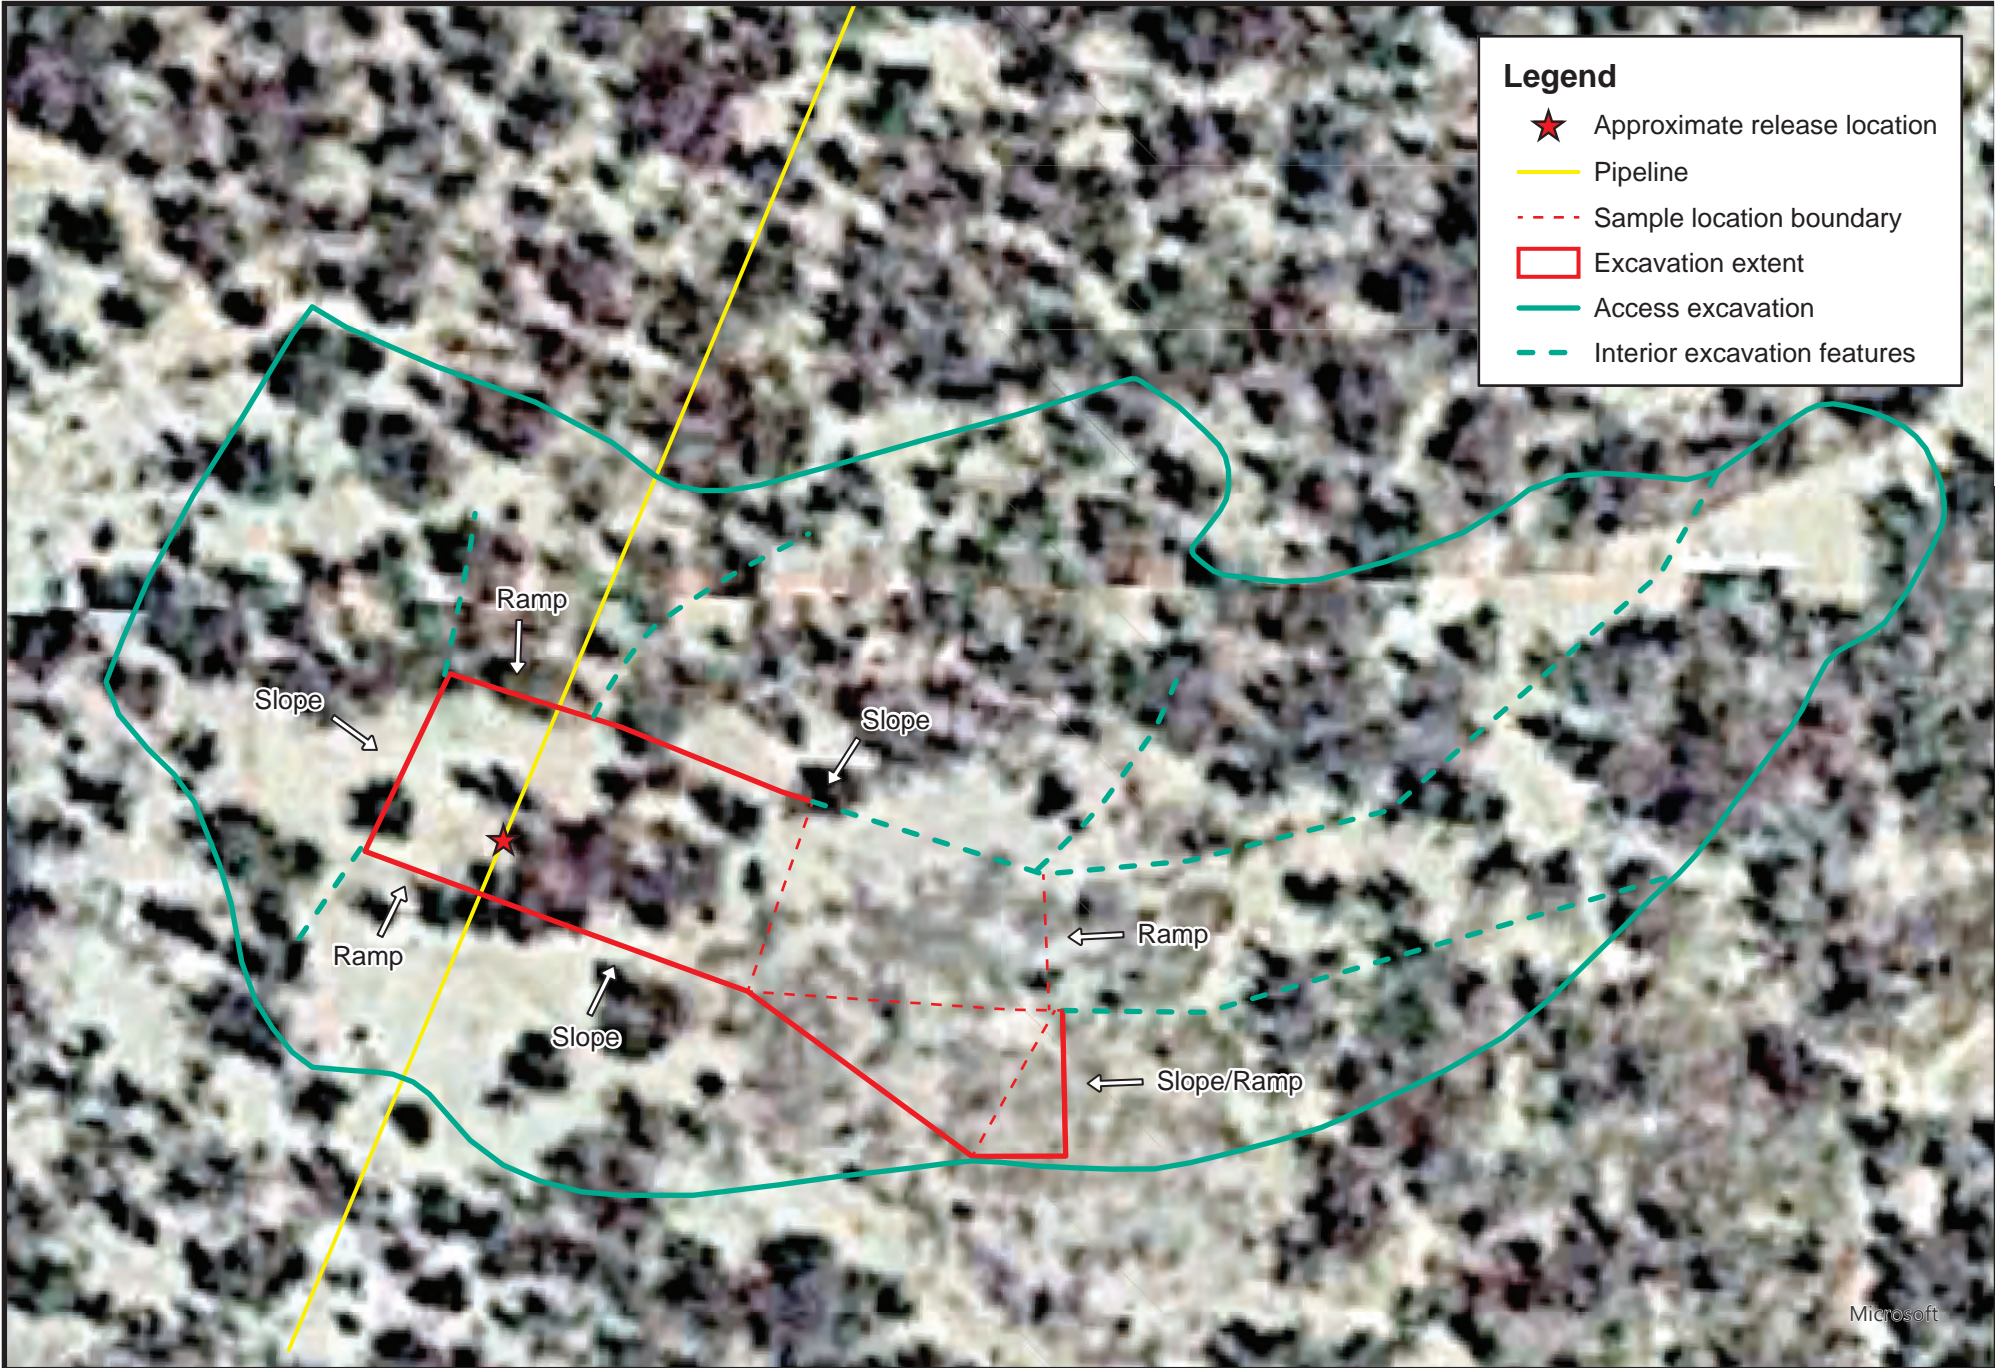
Figure 2
Aerial Site Map
Lateral H-35

A depiction of the remedial and access areas of the excavation is included as Figure 2. A copy of the executed C-138 Solid Waste Acceptance Form is included in Appendix B. A photograph log is included in Appendix C. A copy of regulatory correspondence is included in Appendix D.

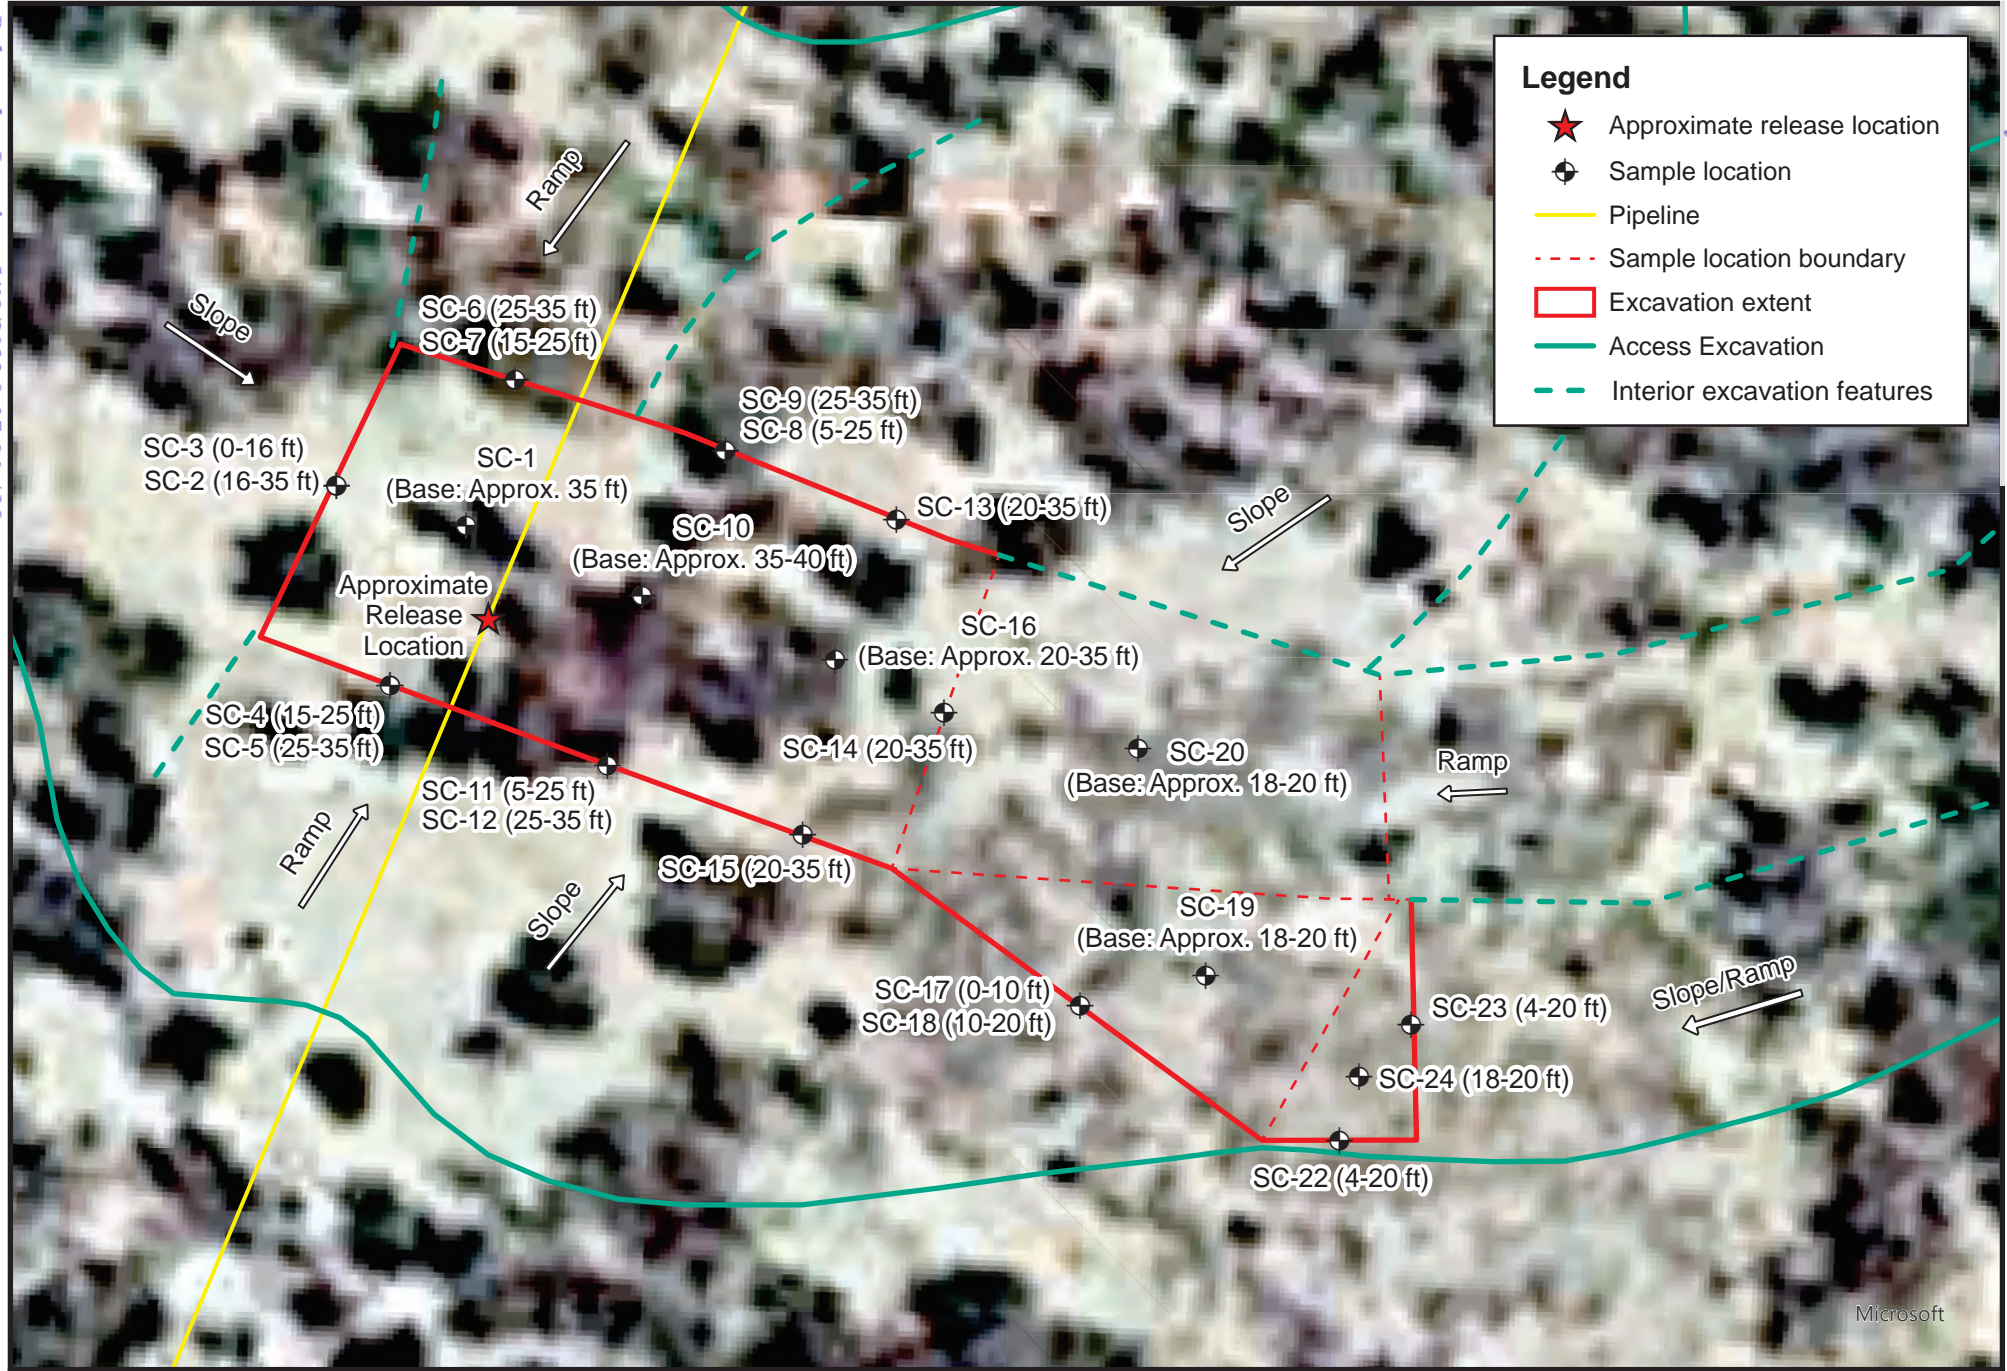
Figure 3
Sample Location Map
Lateral H-35

Rule collected confirmation excavation soil samples (SC-1 through SC-24) from the sidewalls and bases/slopes of the excavation during several sampling events throughout the completion of the excavation as access would allow. Each confirmation soil sample is a representative composite comprised of five equivalent portions of soil collected from the sampled area. Figure 3 shows each composite sample location.

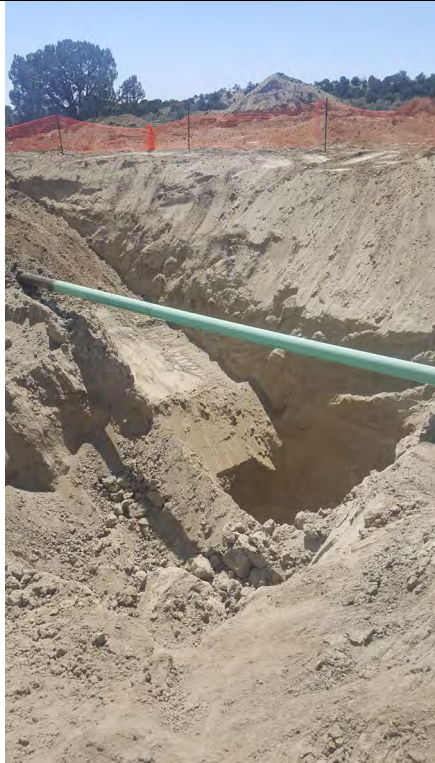
Photograph #1

Client: Enterprise	
Site Name: Lateral H-35 Pipeline Release	
Date Photo Taken: June 10, 2019	
Release Location: N36.784705, W107.914212 E-29-30N-10W San Juan County, NM	
Photo Taken by: Heather Woods	Description: Facing west-southwest, view of excavation extents in the area of samples SC-1 through SC-3.

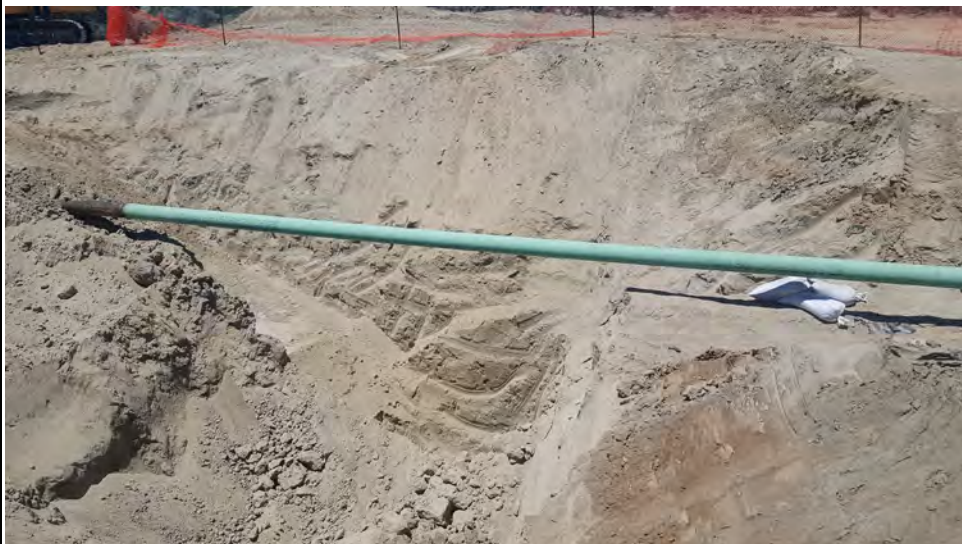
Photograph #2

Client: Enterprise	
Site Name: Lateral H-35 Pipeline Release	
Date Photo Taken: June 11, 2019	
Release Location: N36.784705, W107.914212 E-29-30N-10W San Juan County, NM	
Photo Taken by: Heather Woods	Description: Facing west, view of excavation extents in the area of samples SC-1 through SC-3.

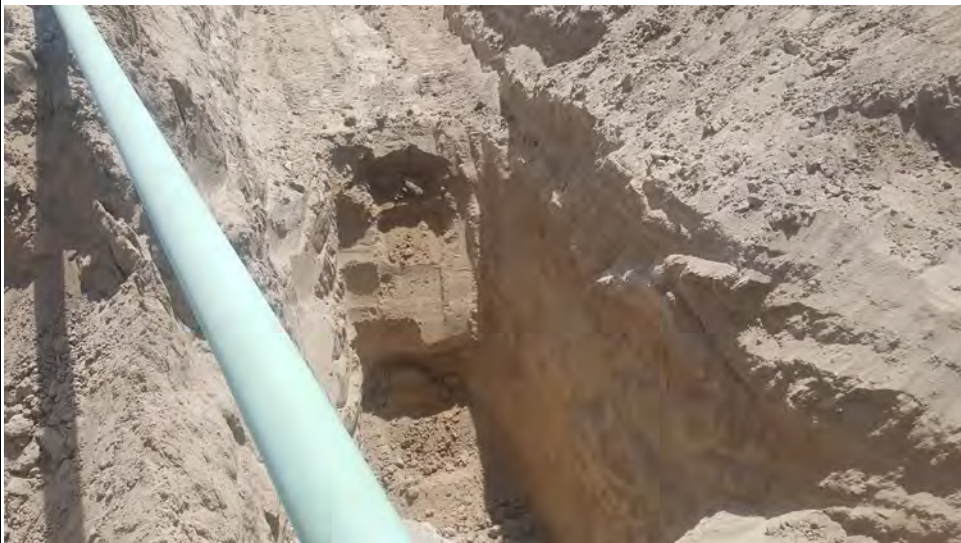
Photograph #3

Client: Enterprise	
Site Name: Lateral H-35 Pipeline Release	
Date Photo Taken: June 13, 2019	
Release Location: N36.784705, W107.914212 E-29-30N-10W San Juan County, NM	
Photo Taken by: Heather Woods	Description: Facing south-southwest, view of the excavation extents in the area of samples SC-4 and SC-5

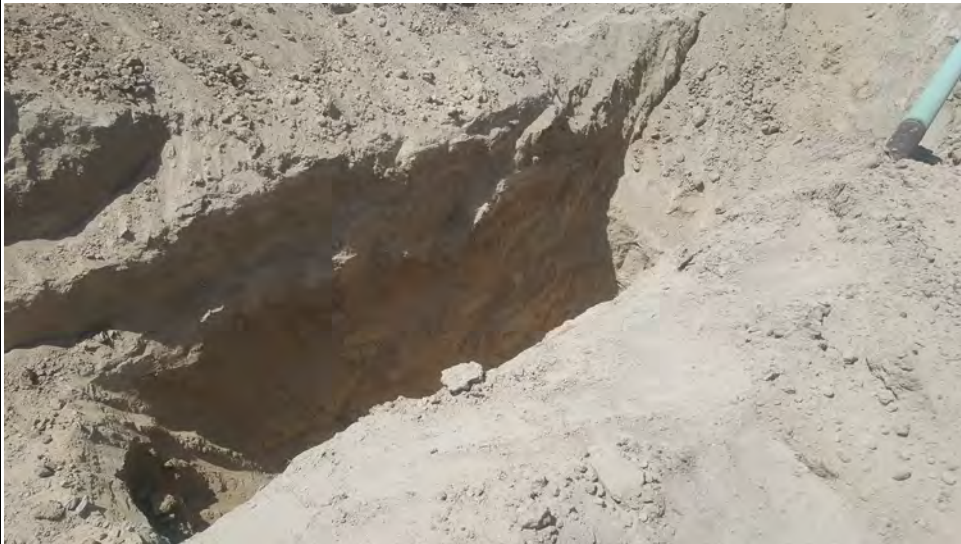
Photograph #4

Client: Enterprise	
Site Name: Lateral H-35 Pipeline Release	
Date Photo Taken: June 14, 2019	
Release Location: N36.784705, W107.914212 E-29-30N-10W San Juan County, NM	
Photo Taken by: Heather Woods	Description: Facing east, view of the excavation extents in the area of samples SC-6 and SC-7.

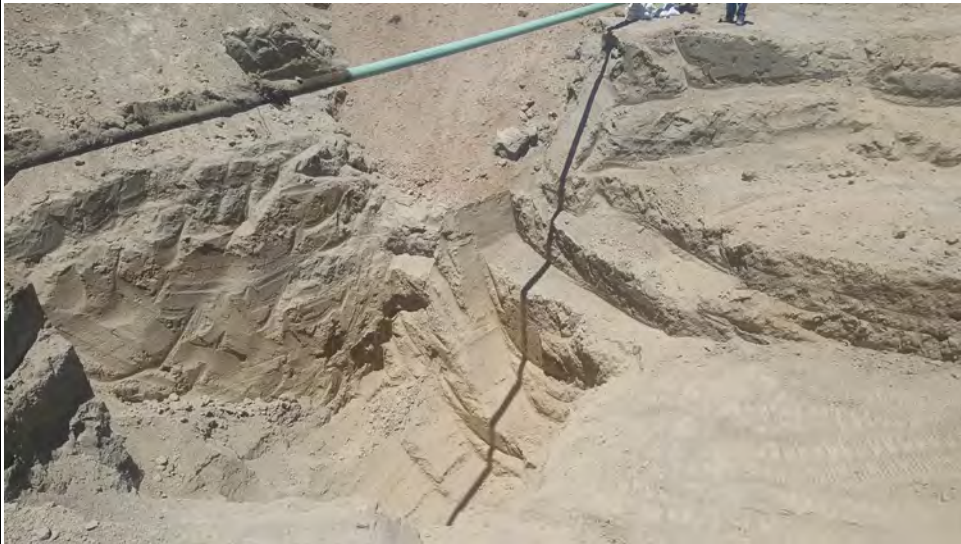
Photograph #5

Client: Enterprise	
Site Name: Lateral H-35 Pipeline Release	
Date Photo Taken: June 24, 2019	
Release Location: N36.784705, W107.914212 E-29-30N-10W San Juan County, NM	
Photo Taken by: Heather Woods	Description: Facing north, view of the excavation extents in the area of samples SC-8 and SC-9.

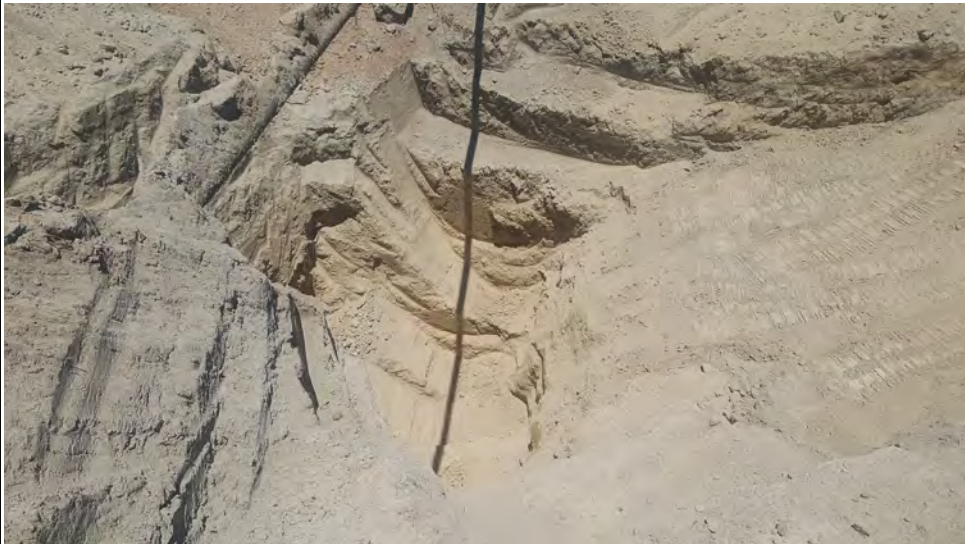
Photograph #6

Client: Enterprise	
Site Name: Lateral H-35 Pipeline Release	
Date Photo Taken: June 24, 2019	
Release Location: N36.784705, W107.914212 E-29-30N-10W San Juan County, NM	
Photo Taken by: Heather Woods	Description: Facing north-northeast, view of the excavation extents in the area of samples SC-8, SC-9, and SC-10.

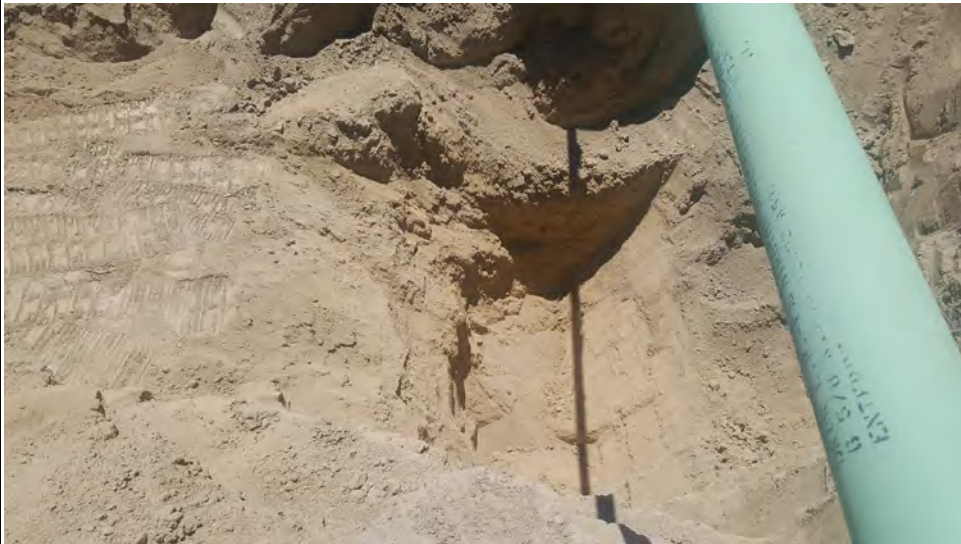
Photograph #7

Client: Enterprise	
Site Name: Lateral H-35 Pipeline Release	
Date Photo Taken: June 24, 2019	
Release Location: N36.784705, W107.914212 E-29-30N-10W San Juan County, NM	
Photo Taken by: Heather Woods	Description: Facing south-southwest, view of the excavation extents in the area of sample SC-10.

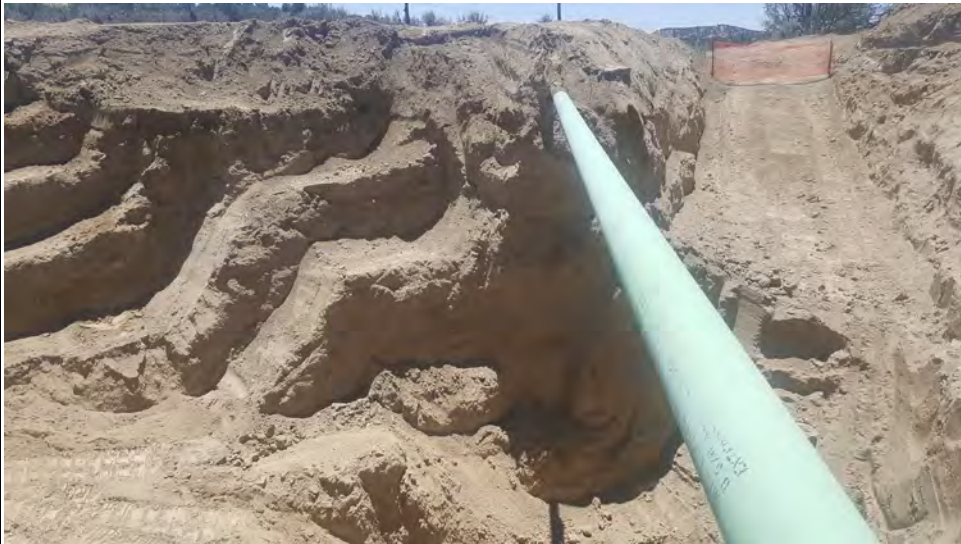
Photograph #8

Client: Enterprise	
Site Name: Lateral H-35 Pipeline Release	
Date Photo Taken: June 24, 2019	
Release Location: N36.784705, W107.914212 E-29-30N-10W San Juan County, NM	
Photo Taken by: Heather Woods	Description: Facing south-southwest, view of the excavation extents in the area of sample SC-11.

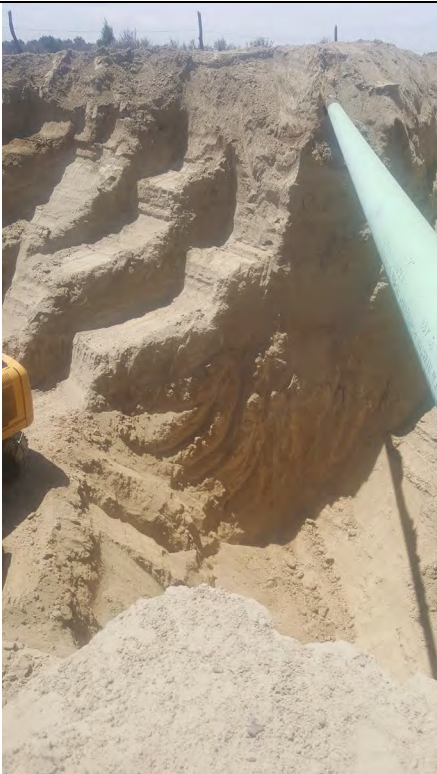
Photograph #9

Client: Enterprise	
Site Name: Lateral H-35 Pipeline Release	
Date Photo Taken: June 26, 2019	
Release Location: N36.784705, W107.914212 E-29-30N-10W San Juan County, NM	
Photo Taken by: Heather Woods	Description: Facing south-southwest, view of the excavation extents in the area of samples SC-11 and SC-12.

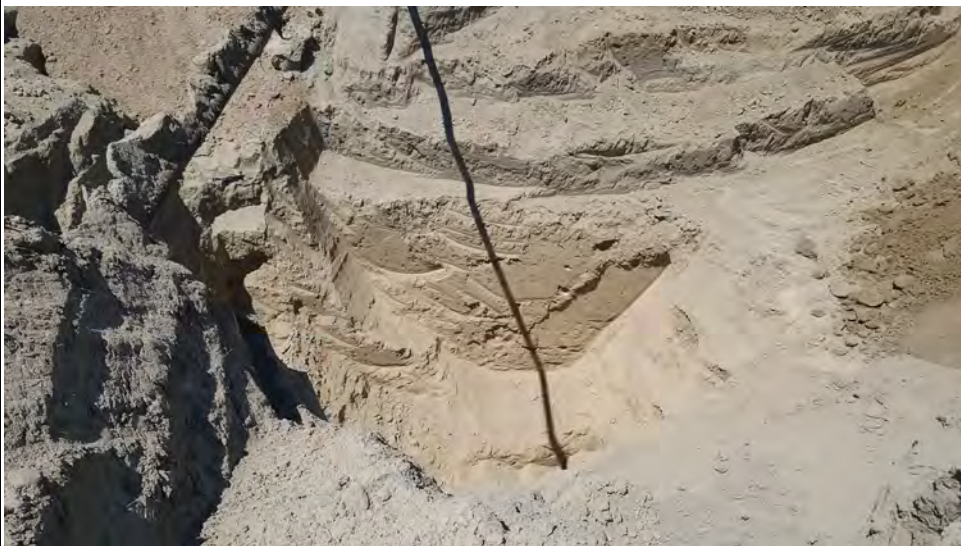
Photograph #10

Client: Enterprise	
Site Name: Lateral H-35 Pipeline Release	
Date Photo Taken: July 1, 2019	
Release Location: N36.784705, W107.914212 E-29-30N-10W San Juan County, NM	
Photo Taken by: Heather Woods	Description: Facing north, view of the excavation extents in the area of samples SC-13, SC-14, and SC-16.

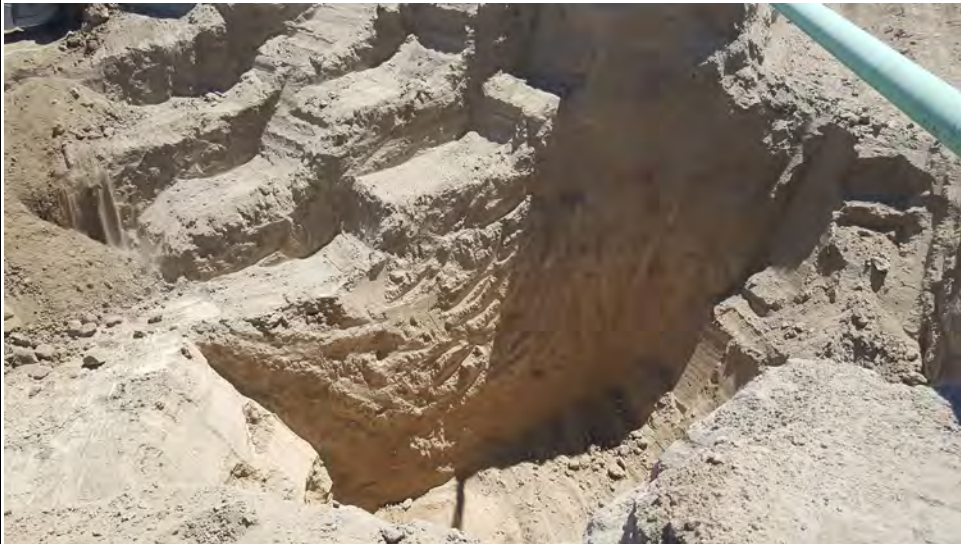
Photograph #11

Client: Enterprise	
Site Name: Lateral H-35 Pipeline Release	
Date Photo Taken: July 1, 2019	
Release Location: N36.784705, W107.914212 E-29-30N-10W San Juan County, NM	
Photo Taken by: Heather Woods	Description: Facing south, view of the excavation extents in the area of samples SC-14, SC-15, and SC-16.

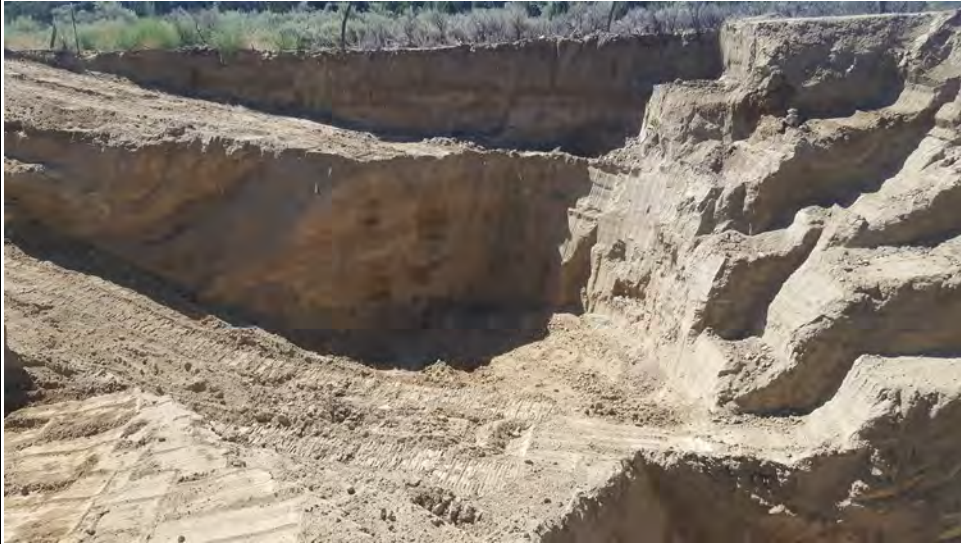
Photograph #12

Client: Enterprise	
Site Name: Lateral H-35 Pipeline Release	
Date Photo Taken: July 3, 2019	
Release Location: N36.784705, W107.914212 E-29-30N-10W San Juan County, NM	
Photo Taken by: Heather Woods	Description: Facing south, view of the excavation extents in the area of samples SC-17 through SC-21.

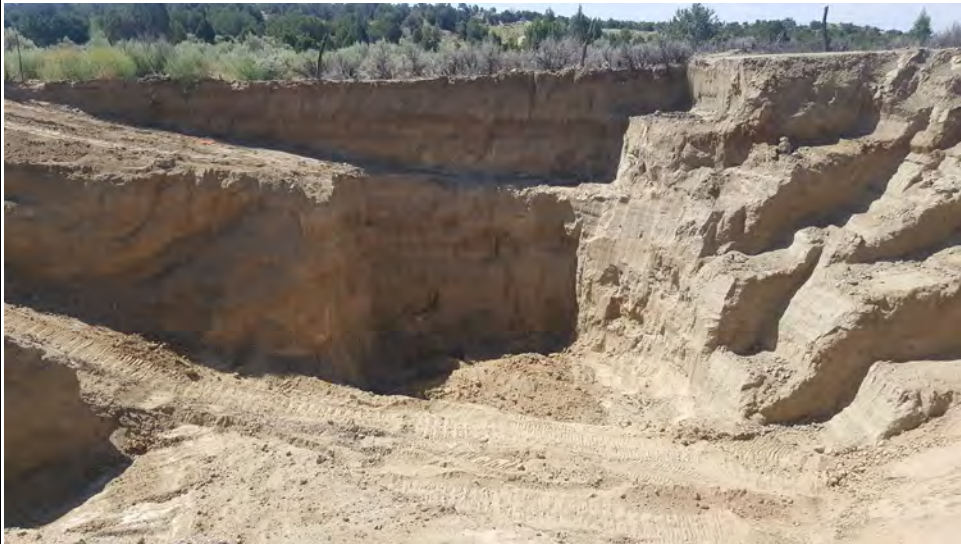
Photograph #13

Client: Enterprise	
Site Name: Lateral H-35 Pipeline Release	
Date Photo Taken: July 11, 2019	
Release Location: N36.784705, W107.914212 E-29-30N-10W San Juan County, NM	
Photo Taken by: Heather Woods	Description: Facing south, view of the excavation extents in the area of samples SC-22 through SC-24.
