## **Jicarilla #6 Well Tie Pipeline Release Closure Report**

Unit Letter I, Section 28, Township 24 North, Range 5 West  
Rio Arriba County, New Mexico

July 15, 2020

Prepared by:  
Rule Engineering, LLC  
501 Airport Drive, Suite 205  
Farmington, New Mexico 87401

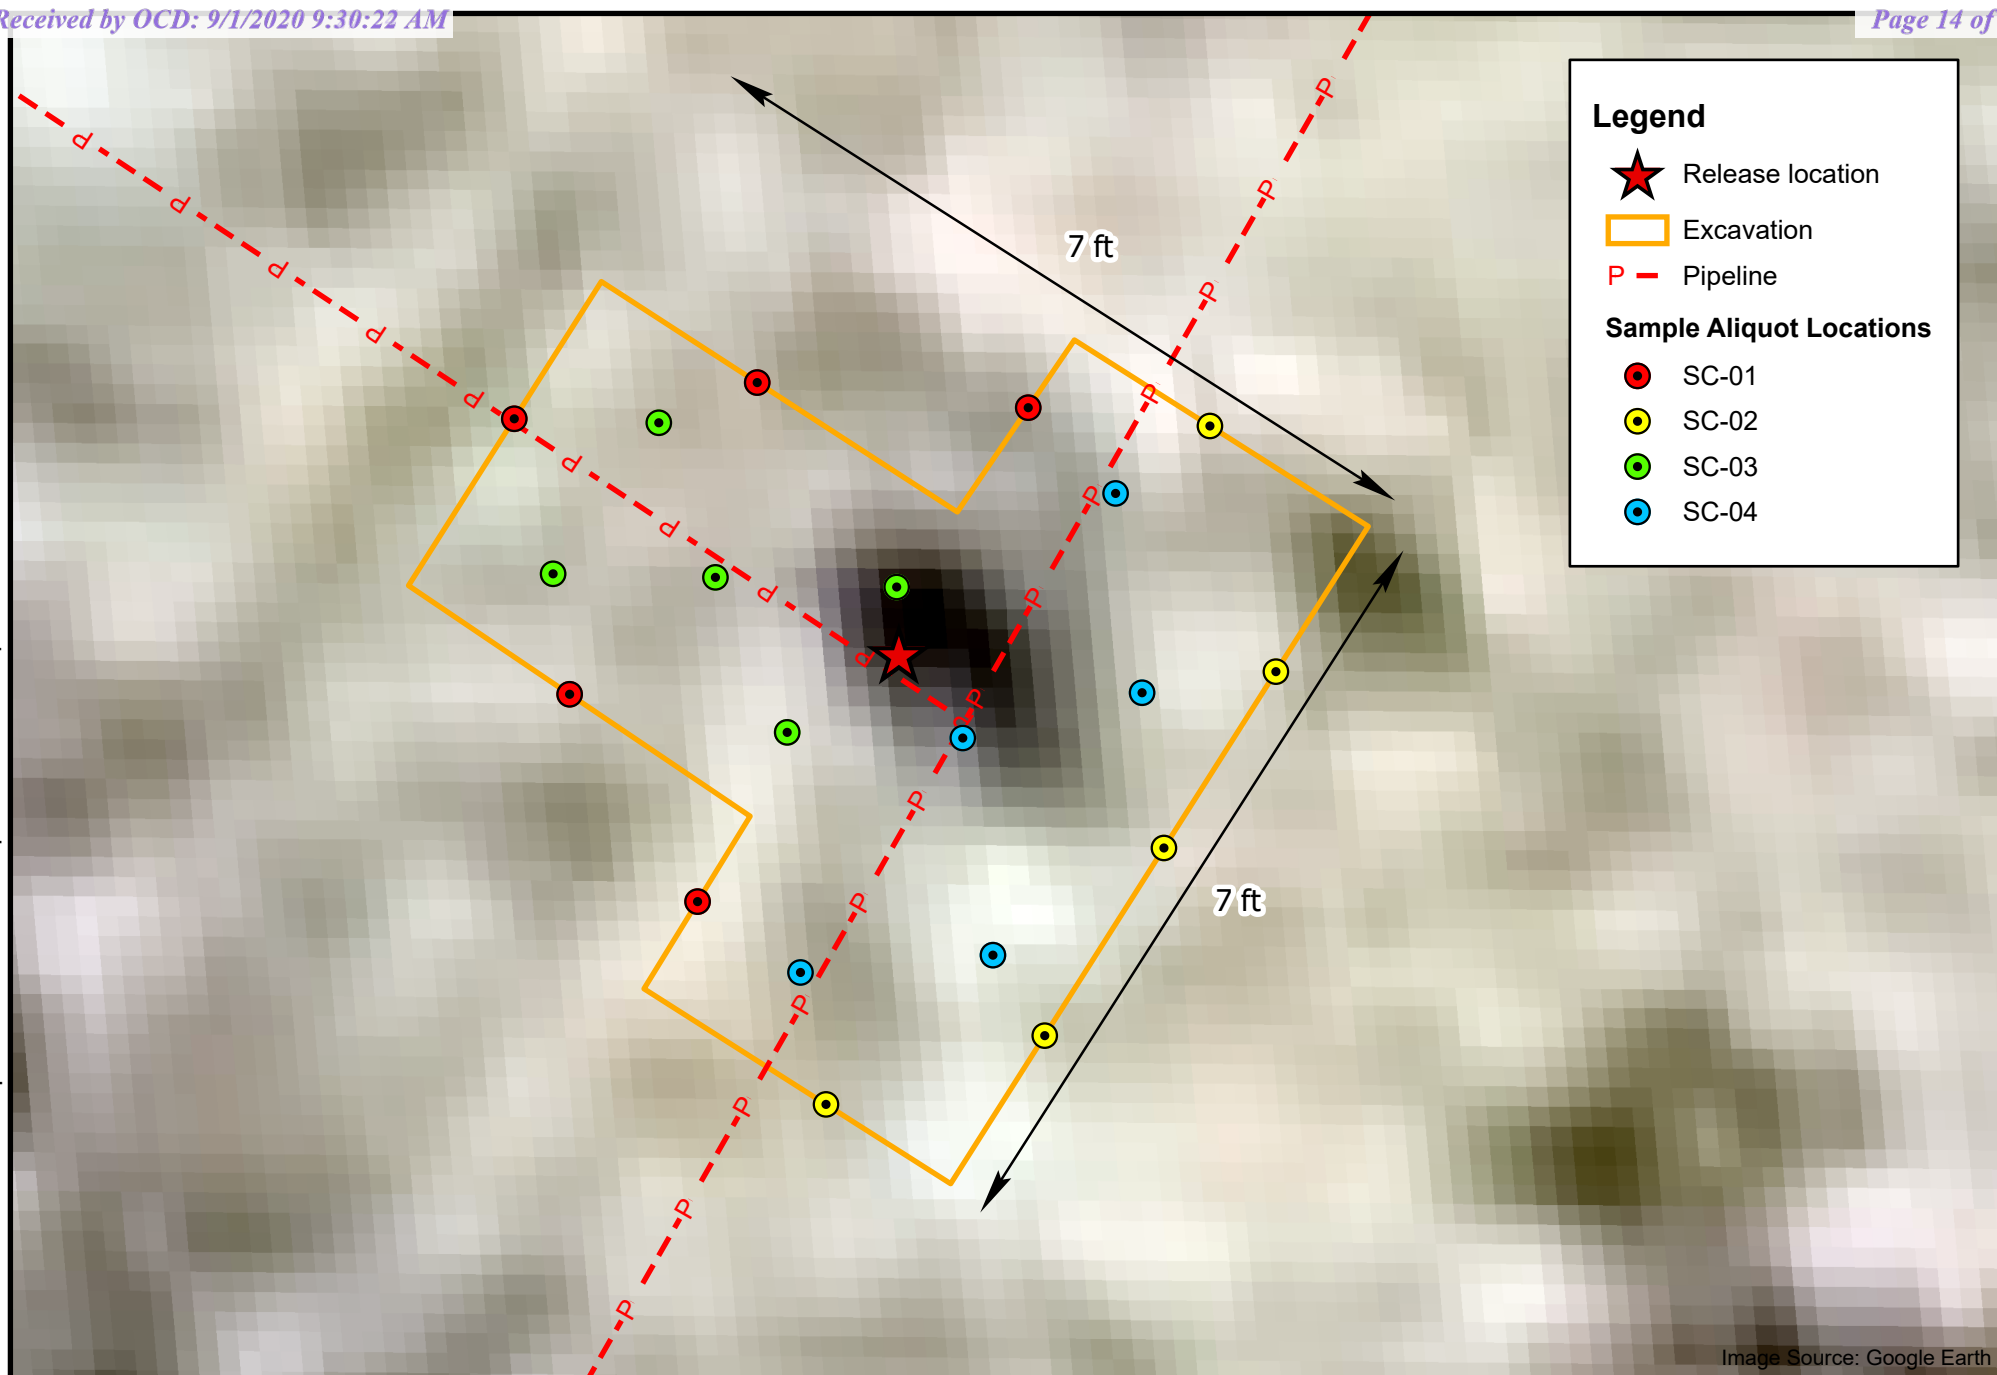
**Figure 3**  
**Sample Location Map**  
Jicarilla #6

Rule collected confirmation excavation soil samples (SC-1 through SC-4) from the sidewalls and base of the excavation. Each confirmation soil sample is a representative composite comprised of five equivalent portions of soil collected from the sampled area.

Laboratory analytical results are summarized in Table 1, confirmation sample locations are illustrated on Figure 3, and the analytical laboratory report is included in Appendix E.

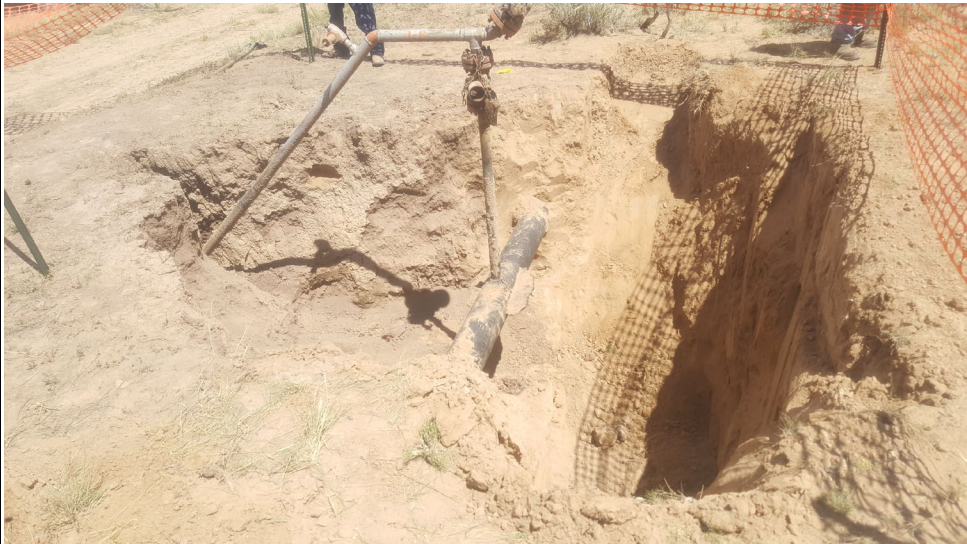
Photograph #1

Client: Enterprise	
Site Name:  Jicarilla #6 Well Tie Pipeline Release	
Date Photo Taken: August 14, 2019	
Release Location: N36.280306, W107.359030  I-28-24N-5W Rio Arriba County, NM	
Photo Taken by: Heather Woods	Description: Facing north, view of the final excavation extents.

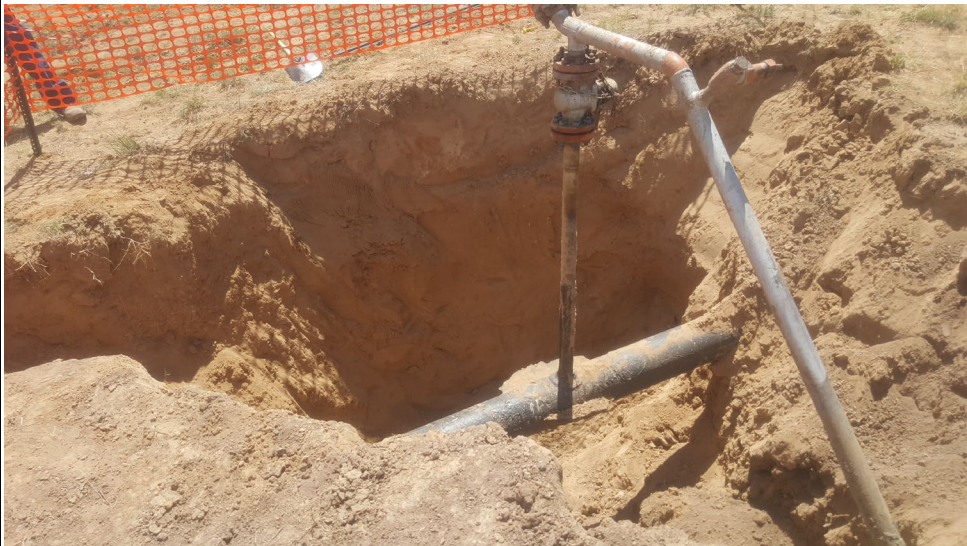
Photograph #2

Client: Enterprise	
Site Name:  Jicarilla #6 Well Tie Pipeline Release	
Date Photo Taken: August 14, 2019	
Release Location: N36.280306, W107.359030  I-28-24N-5W Rio Arriba County, NM	
Photo Taken by: Heather Woods	Description: Facing south, view of the final excavation extents.

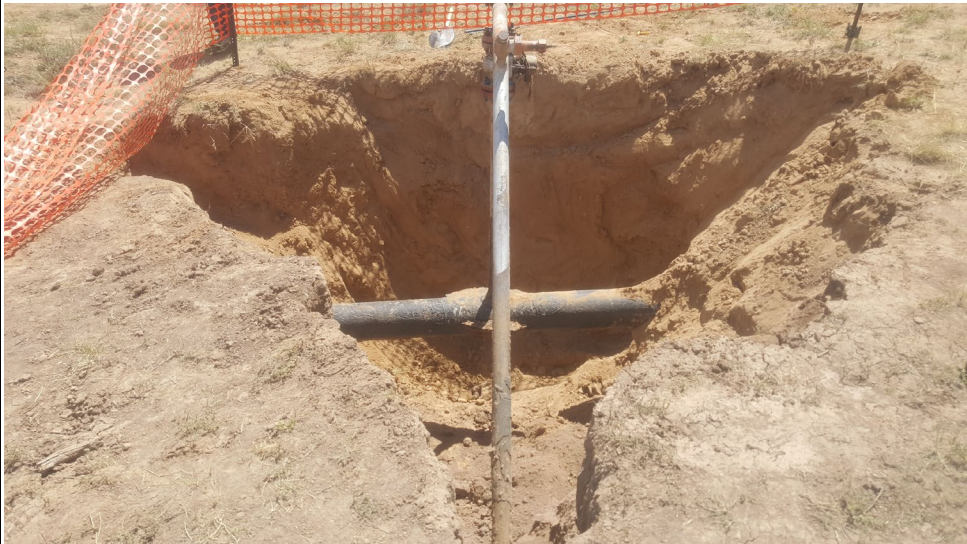
Photograph #3

Client: Enterprise	
Site Name:  Jicarilla #6 Well Tie Pipeline Release	
Date Photo Taken: August 14, 2019	
Release Location: N36.280306, W107.359030  I-28-24N-5W Rio Arriba County, NM	
Photo Taken by: Heather Woods	Description: Facing southeast, view of the final excavation extents.

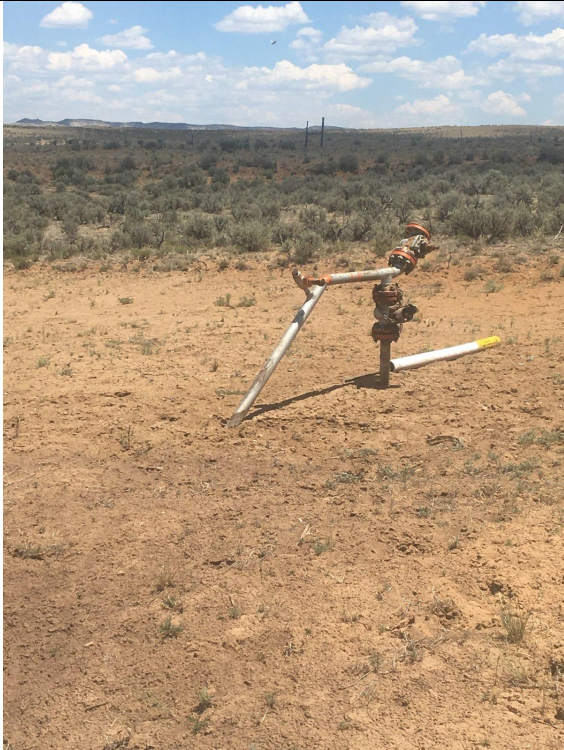
Photograph #4

Client: Enterprise	
Site Name:  Jicarilla #6 Well Tie Pipeline Release	
Date Photo Taken: June 4, 2020	
Release Location: N36.280306, W107.359030  I-28-24N-5W Rio Arriba County, NM	
Photo Taken by: Brian Roberts	Description: Facing east, view of the backfilled and recontoured excavation location.

The excavation was backfilled with clean, imported material from a nearby stockpond as directed by JANEPO staff. The area was contoured as near as possible to original grade and will be re-seeded with a JANEPO approved seed mixture.
