**CLOSURE REPORT**

**Blanco A-28 (2/3/22)  
Unit Letter M, S11 T30N R7W  
Rio Arriba County, New Mexico**

**New Mexico EMNRD OCD Incident ID No. NAPP2204526979**

April 22, 2022  
Ensolum Project No. 05A1226183

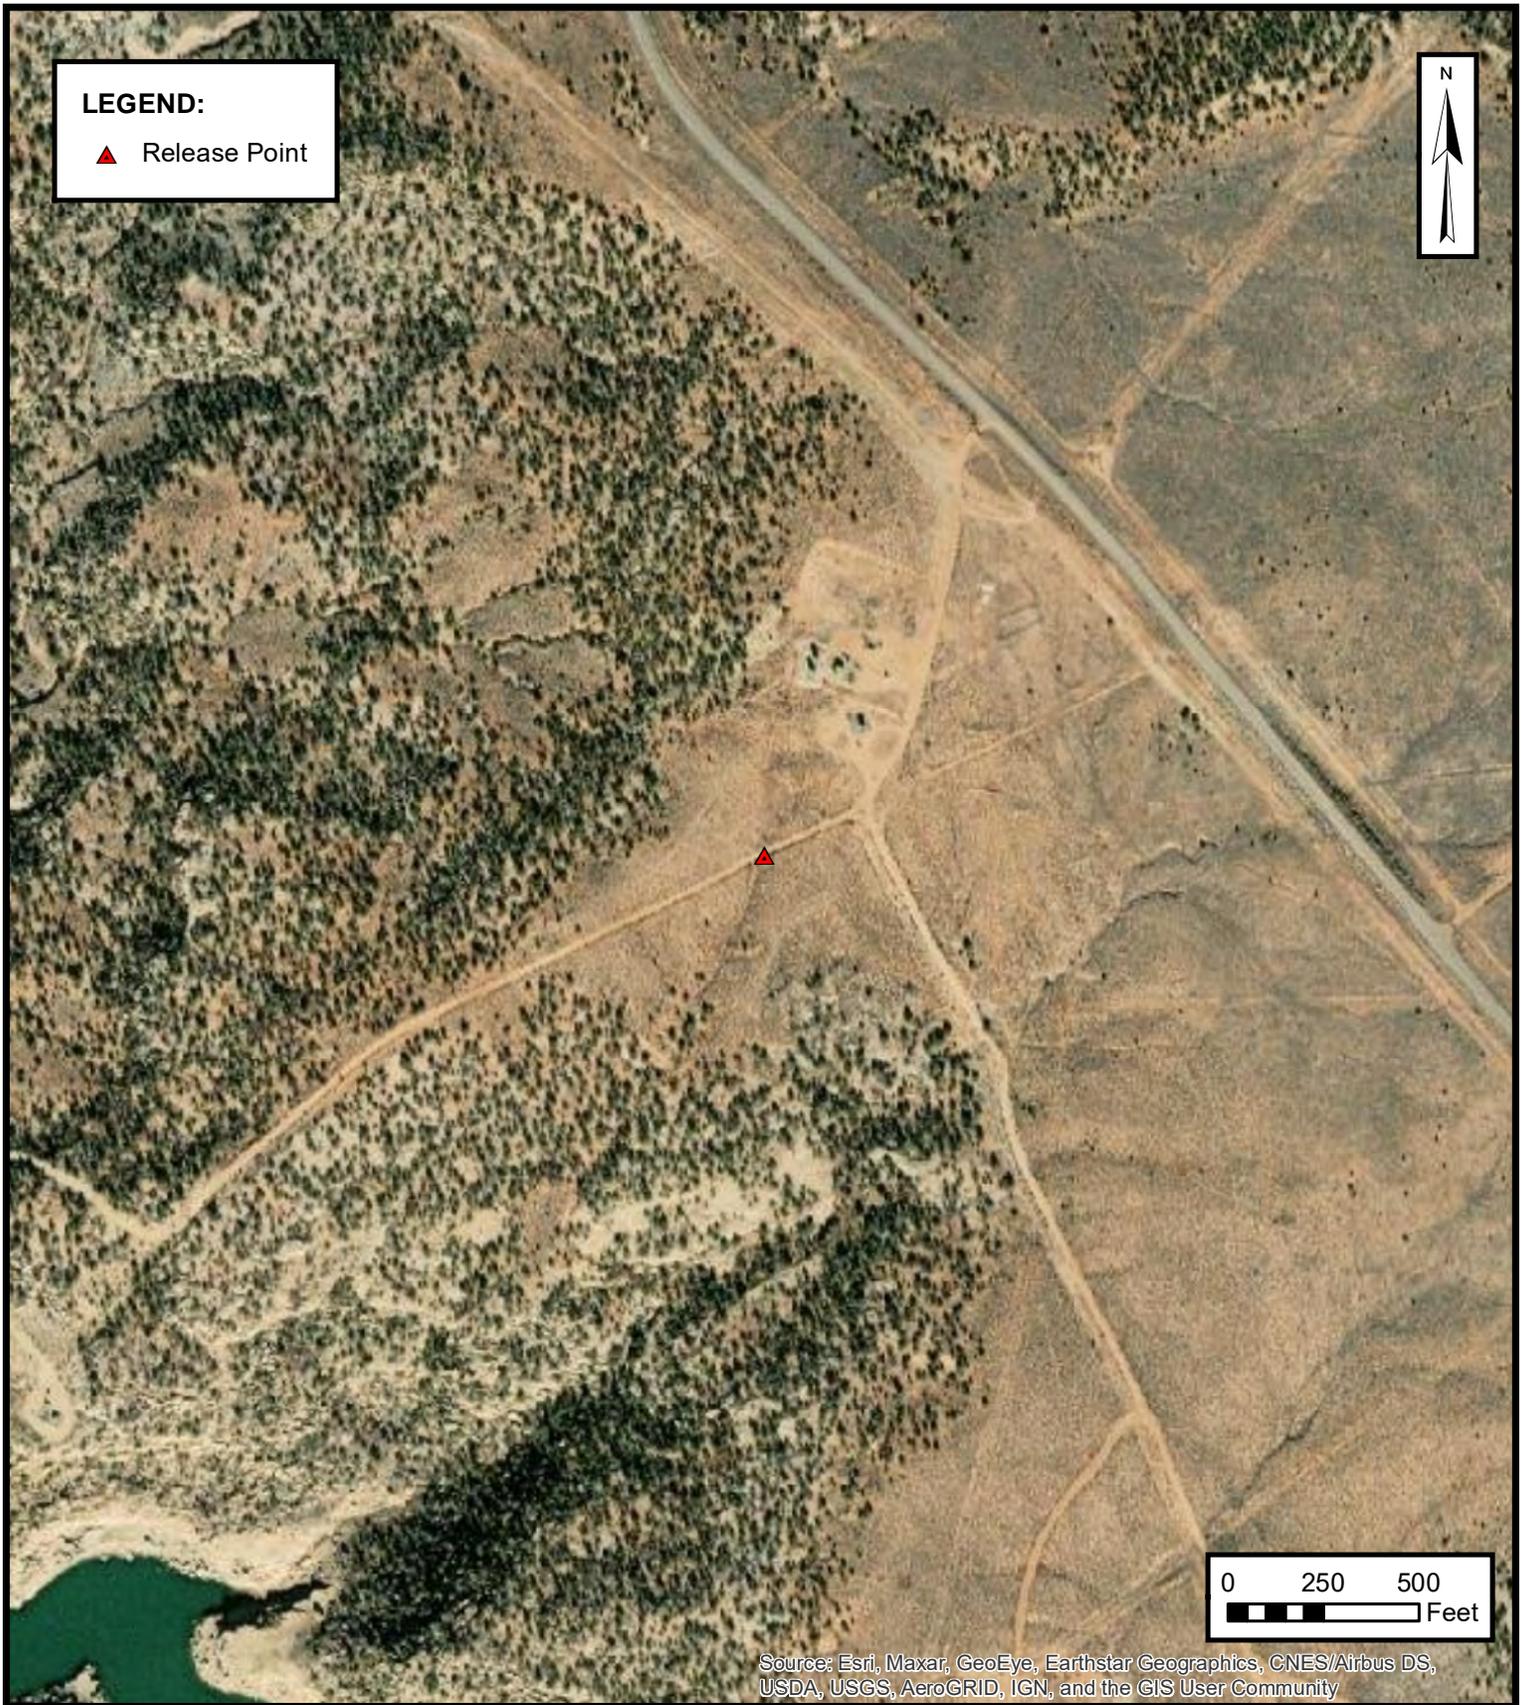
**FIGURE**  
**1**

**TOPOGRAPHIC MAP**  
 ENTERPRISE FIELD SERVICES, LLC  
 BLANCO A-28 (2/3/22)  
 Unit Letter M, S11 T30N R7W, Rio Arriba County, New Mexico  
 36.82173° N, 107.54646° W  
 PROJECT NUMBER: 05A1226183

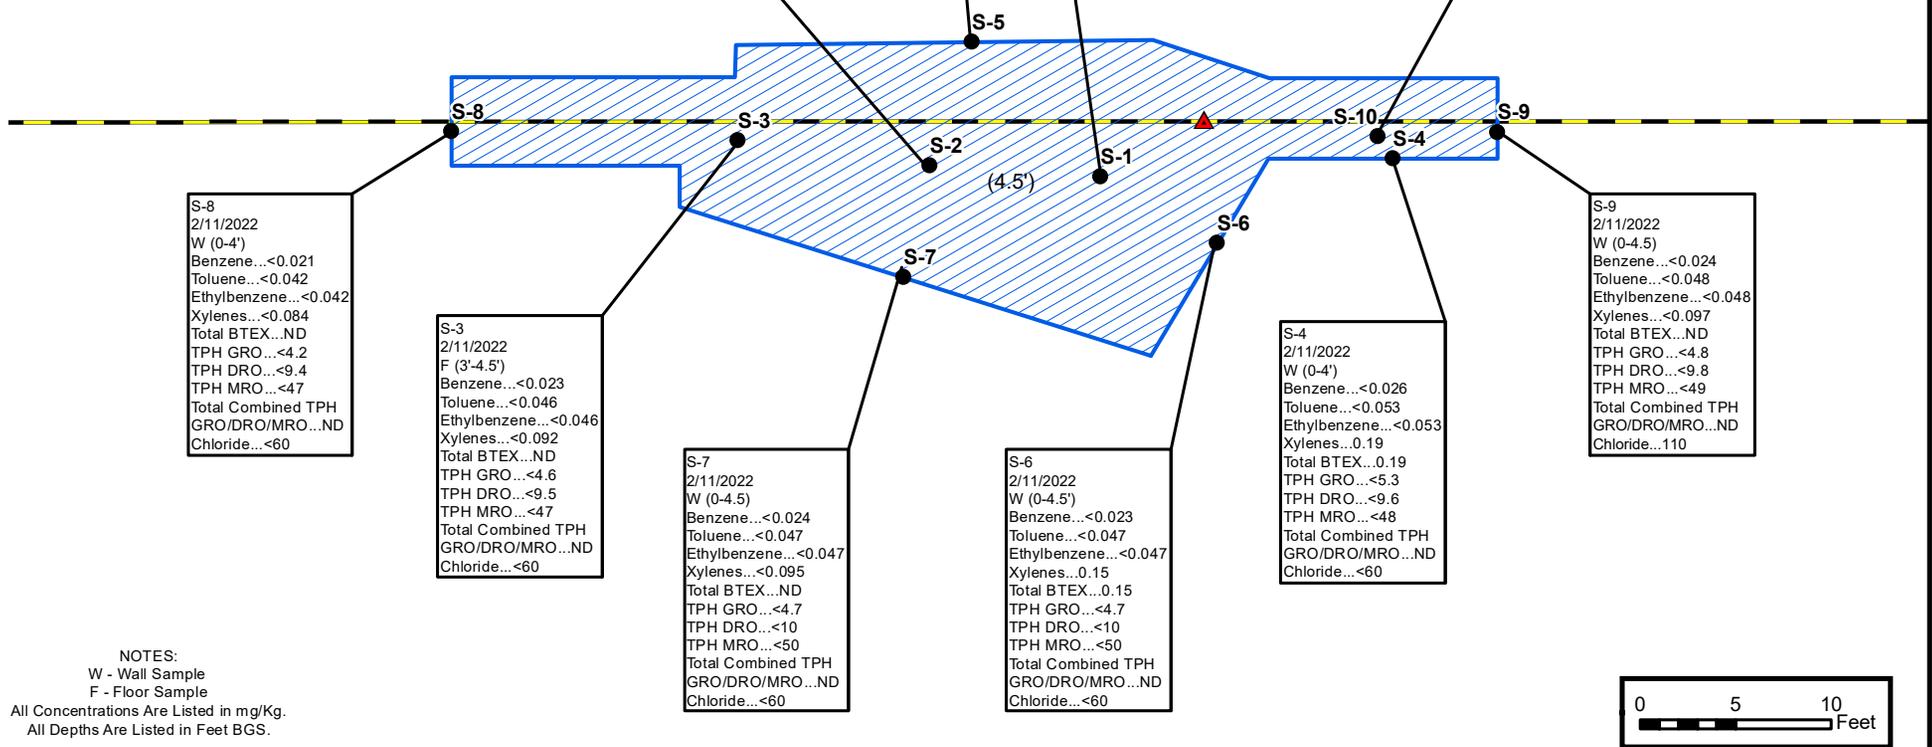
**SITE MAP WITH SOIL ANALYTICAL RESULTS**

The final excavation measured approximately 54 feet long and 16 feet wide at the maximum extents. The maximum depth of the excavation measured approximately 4.5 feet bgs. The lithology encountered during the completion of remediation activities consisted primarily of silty/clayey sand underlain by sandstone.

**Figure 3** is a map that identifies approximate soil sample locations and depicts the approximate dimensions of the excavation with respect to the pipeline (**Appendix A**). Photographic documentation of the field activities is included in **Appendix D**.

S-4  
2/11/2022  
W (0-4')  
Benzene...<0.026  
Toluene...<0.053  
Ethylbenzene...<0.053  
Xylenes...0.19  
Total BTEX...0.19  
TPH GRO...<5.3  
TPH DRO...<9.6  
TPH MRO...<48  
Total Combined TPH  
GRO/DRO/MRO...ND  
Chloride...<60

S-9  
2/11/2022  
W (0-4.5)  
Benzene...<0.024  
Toluene...<0.048  
Ethylbenzene...<0.048  
Xylenes...<0.097  
Total BTEX...ND  
TPH GRO...<4.8  
TPH DRO...<9.8  
TPH MRO...<49  
Total Combined TPH  
GRO/DRO/MRO...ND  
Chloride...110

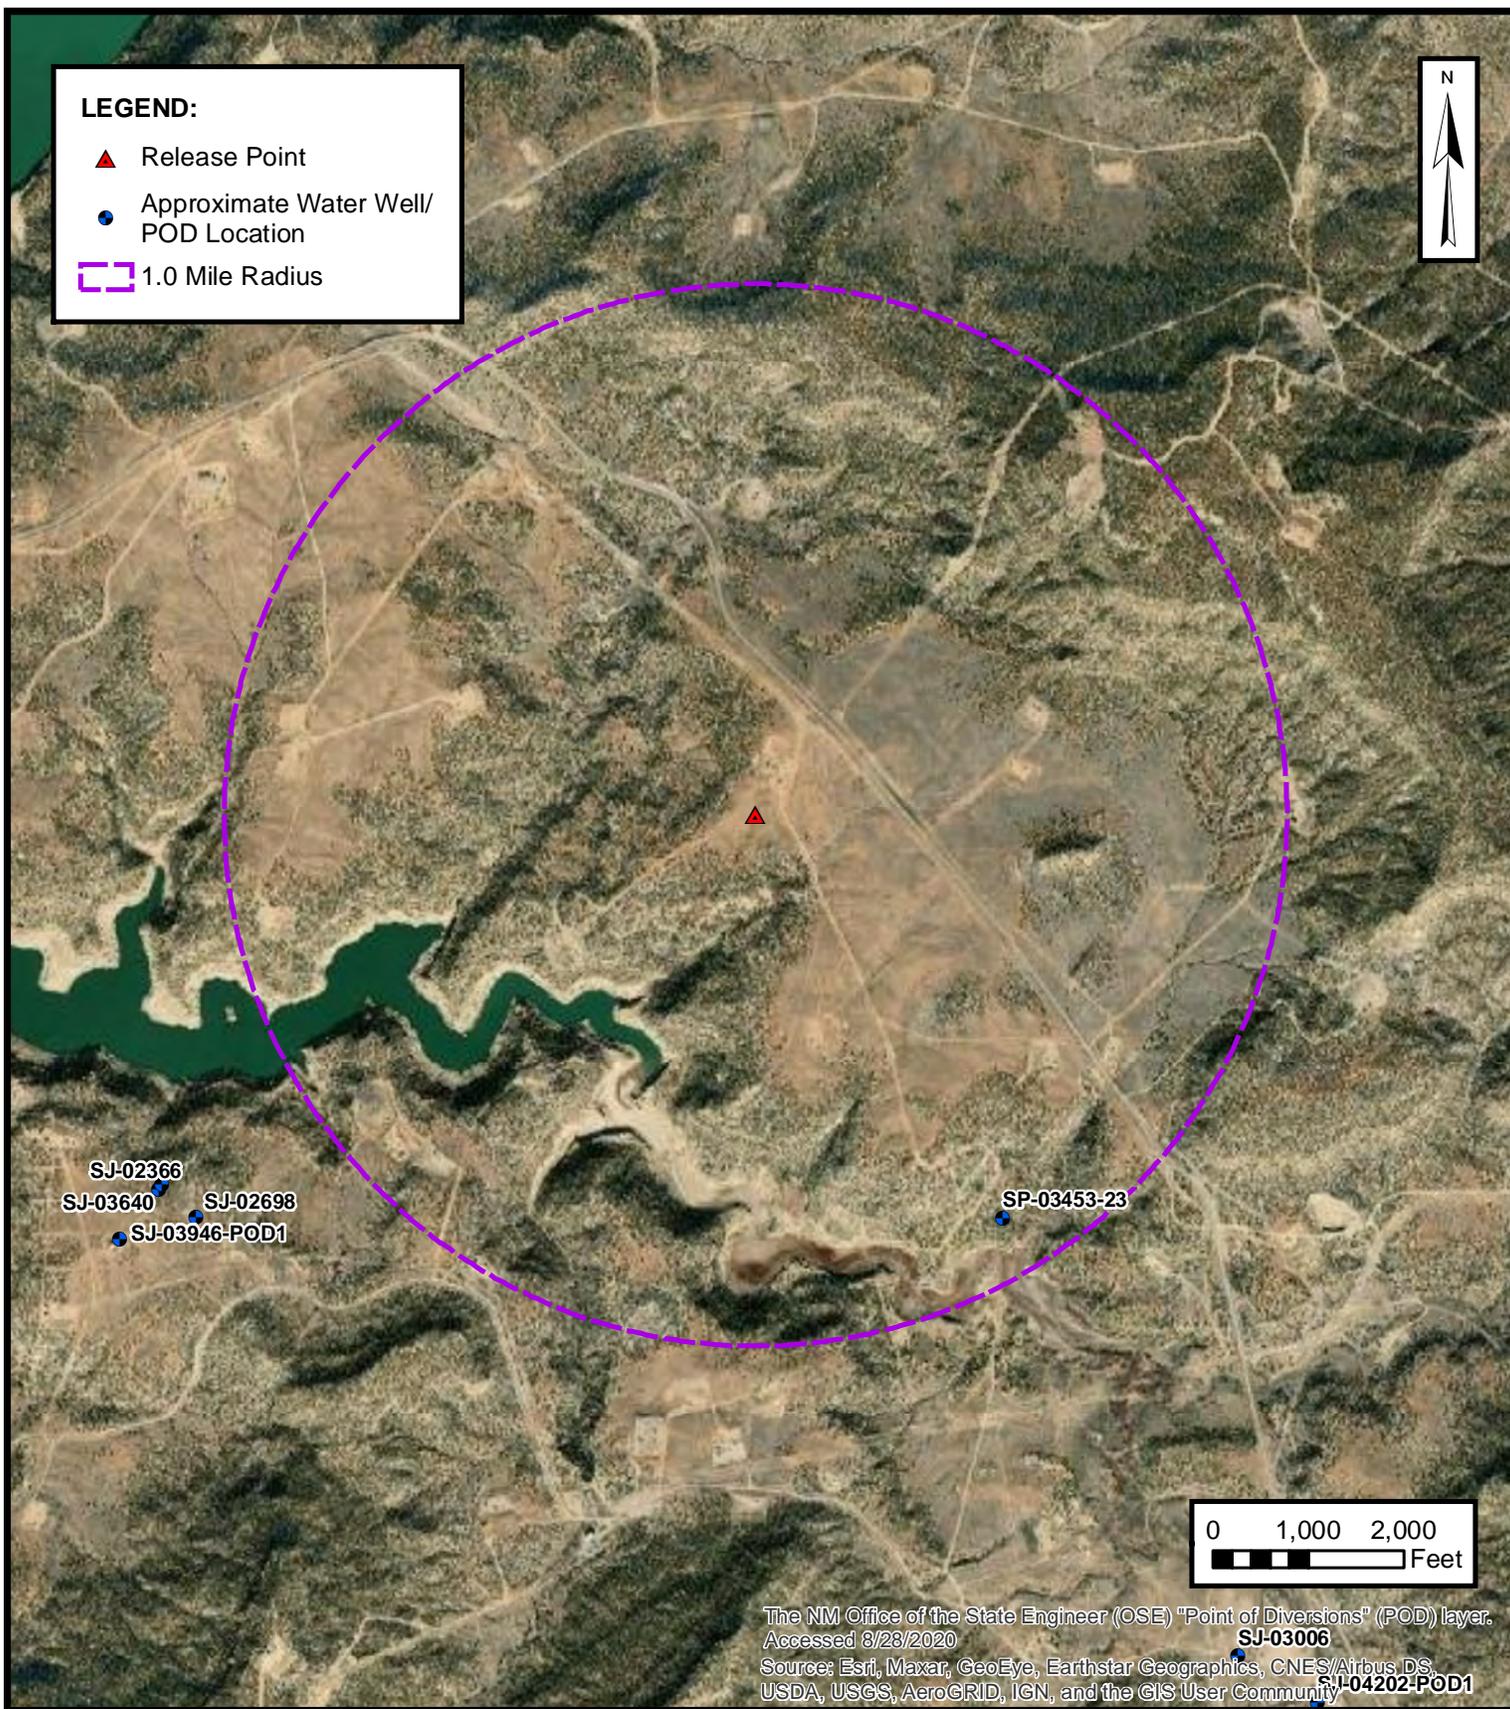
**FIGURE**  
**A**

- The OSE tracks the usage and assignment of water rights and water well installations and records this information in the Water Rights Reporting System (WRRS) database. Water wells and other points of diversion (PODs) are each assigned POD numbers in the database (which is searchable and includes an interactive map). No PODs were identified in the same Public Land Survey System (PLSS) section as the Site. Five PODs (SJ-02366, SJ-02698, SJ-03640, SJ-03946-POD1, and SP-03453-23) were identified in adjacent sections. The closest POD (SP-03453-23) is located approximately 0.9 miles southeast of the Site. POD SP-03453-23 is a surface permit for industrial purposes. The only record available for this POD is an approved *Application for Permit for Additional POD Surface Waters*. The average depth to water for the other four PODs is 251 feet bgs (**Figure A, Appendix B**).

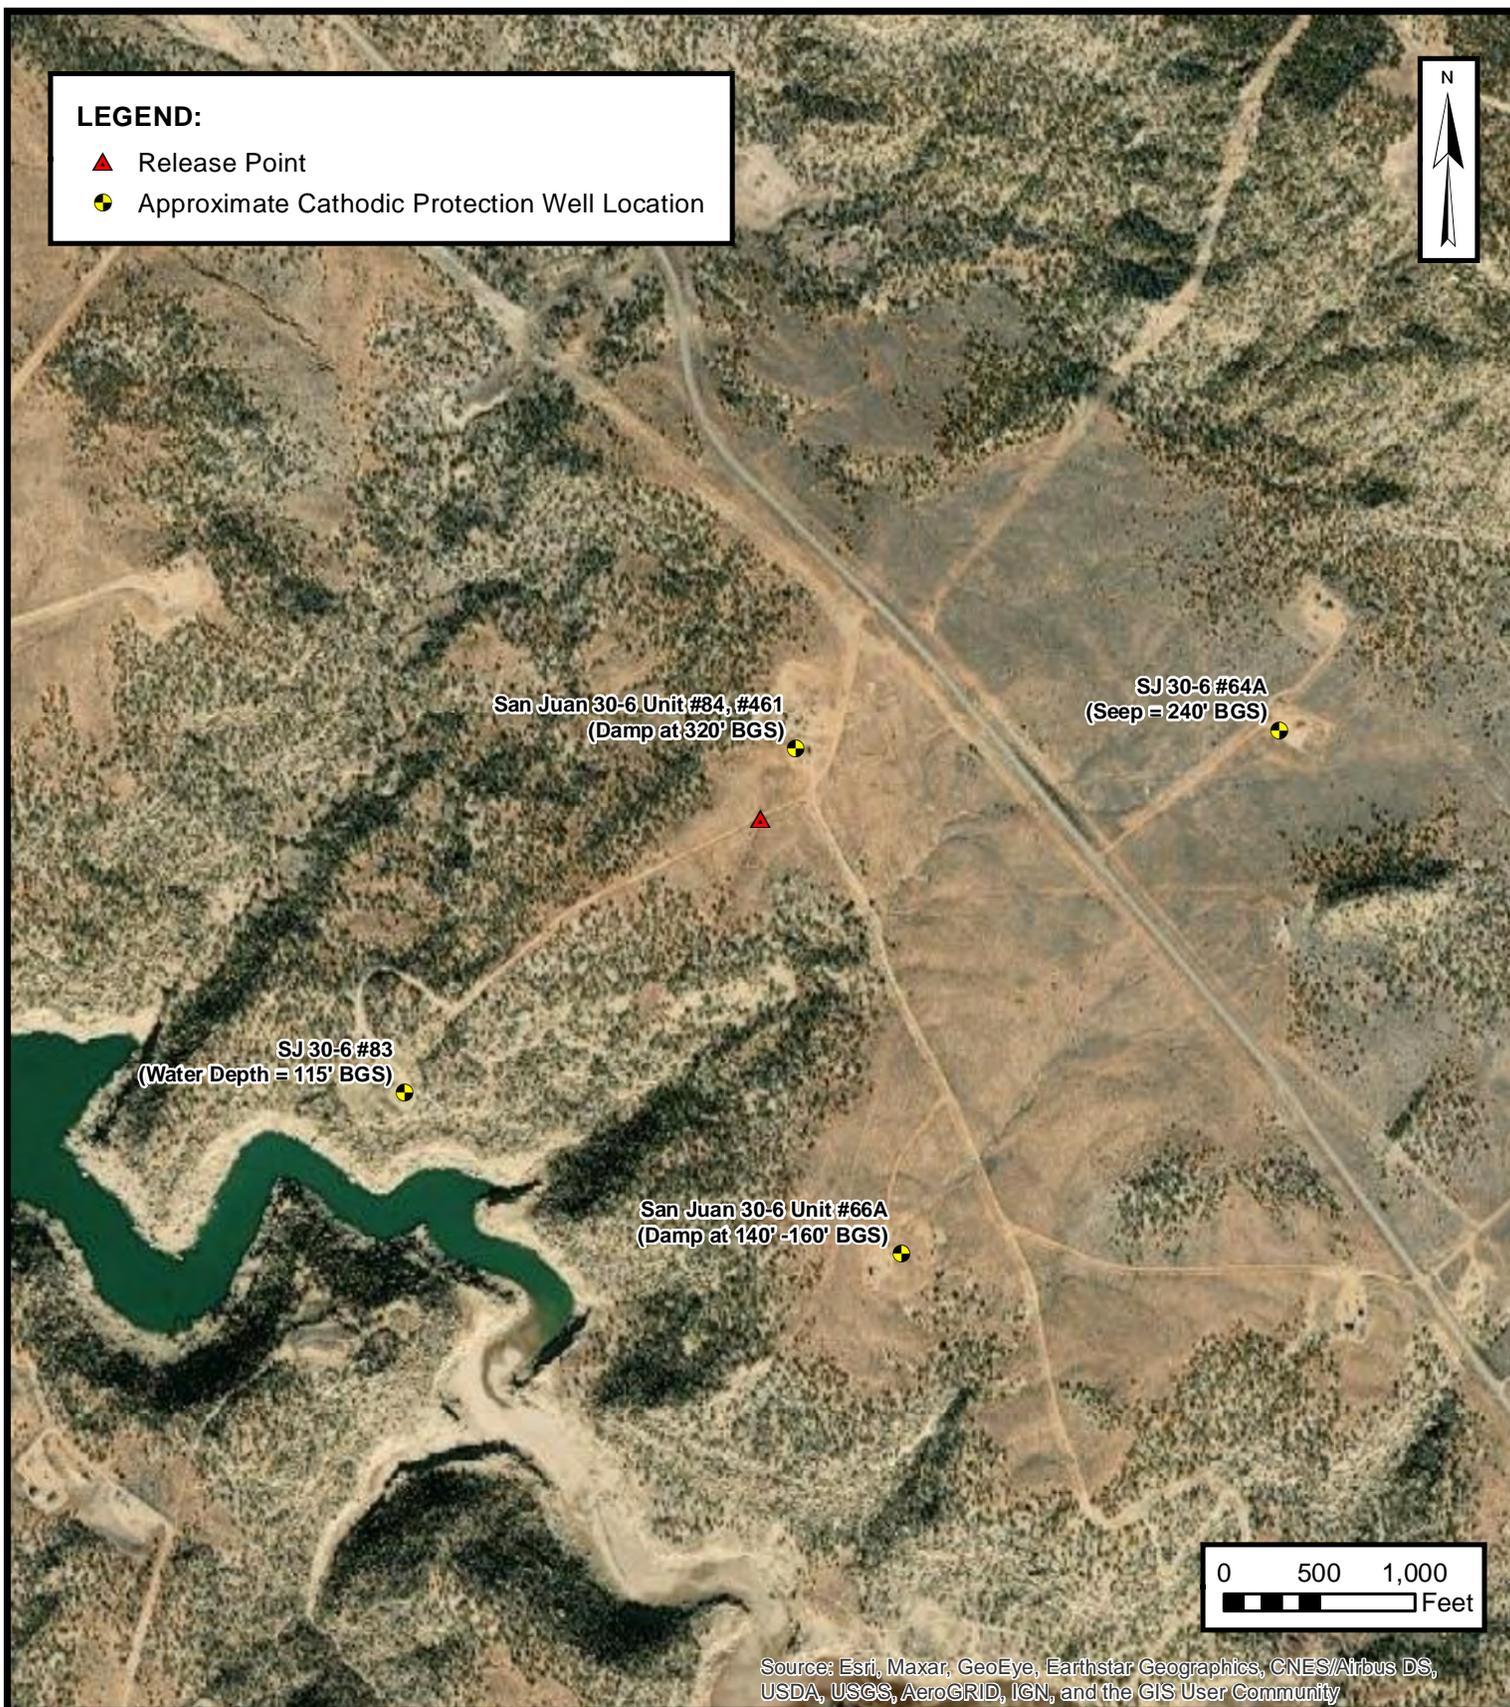
**FIGURE  
B**

- Numerous cathodic protection wells (CPWs) were identified in the same or adjacent PLSS sections in the NM EMNRD OCD imaging database. The four closest CPWs are depicted on **Figure B**

**(Appendix B)**. The record for the cathodic protection well located near the San Juan 30-6 Unit #84 and #461 well locations indicates dampness at approximately 320 feet bgs. This cathodic protection well is approximately 0.07 miles northwest of the Site and is at approximately the same elevation as the Site. The record for the cathodic protection well located near the San Juan 30-6 #66A well location indicates dampness at approximately 140 - 160 feet bgs. This cathodic protection well is approximately 0.4 miles southeast of the Site and is approximately 16 feet lower in elevation than the Site. The record for the cathodic protection well located near the San Juan 30-6 Unit #83 well location indicates a depth to water of approximately 115 feet bgs. This cathodic protection well is approximately 0.4 miles southwest of the Site and is approximately 90 feet lower in elevation than the Site. The records for the cathodic protection well located near the San Juan 30-6 #64A well location indicates a depth to water (seep) of approximately 240 feet bgs. This cathodic protection well is approximately 0.5 miles northeast of the Site and is approximately 58 feet higher in elevation than the Site.

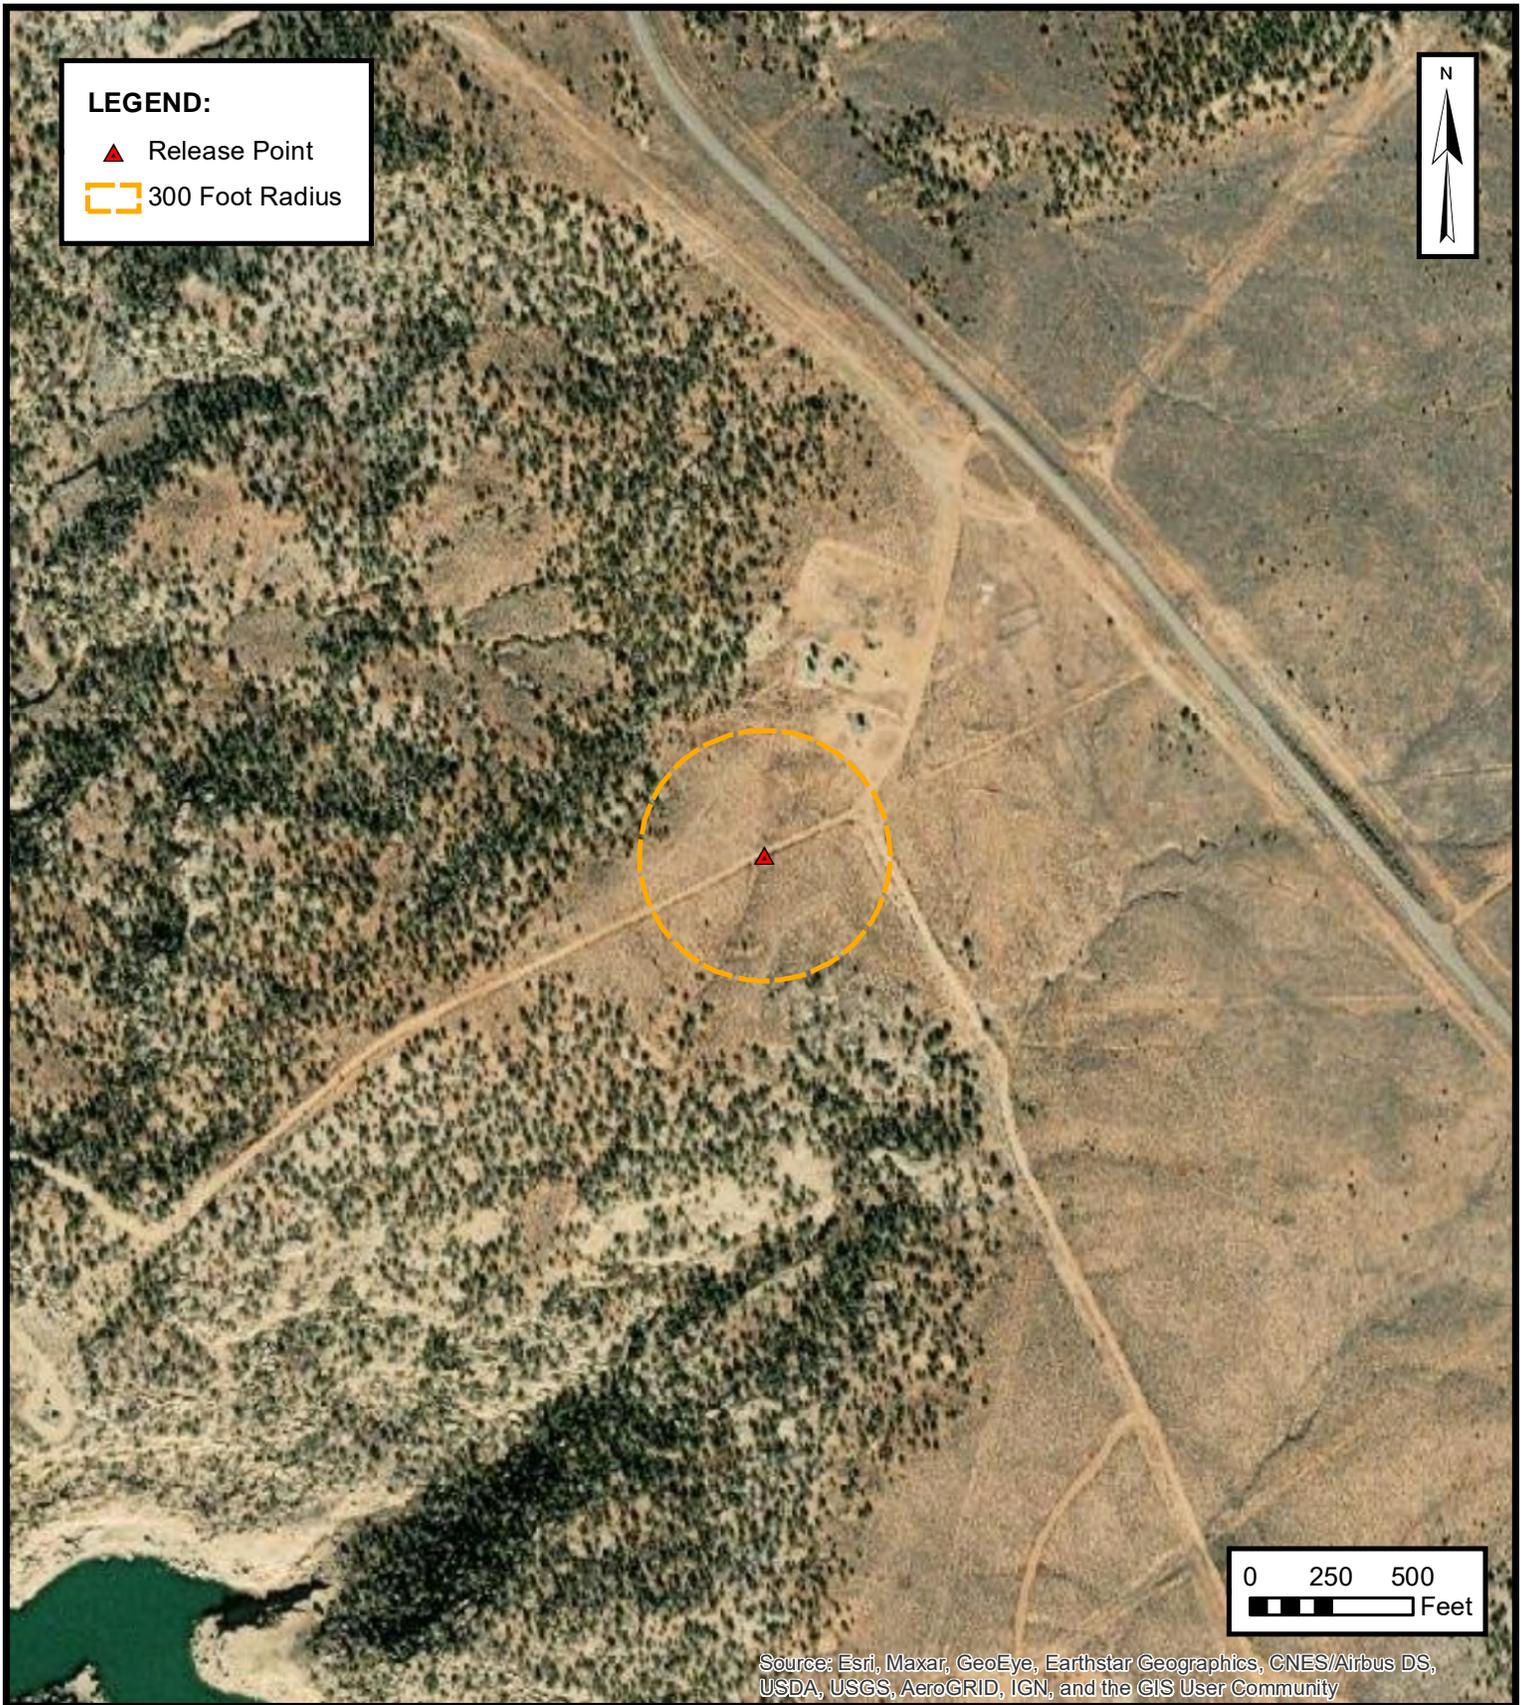
**FIGURE**  
**C**

**300 FOOT RADIUS**  
**WATERCOURSE AND DRAINAGE IDENTIFICATION**  
 ENTERPRISE FIELD SERVICES, LLC  
 BLANCO A-28 (2/3/22)  
 Unit Letter M, S11 T30N R7W, Rio Arriba County, New Mexico  
 36.82173° N, 107.54646° W  
 PROJECT NUMBER: 05A1226183

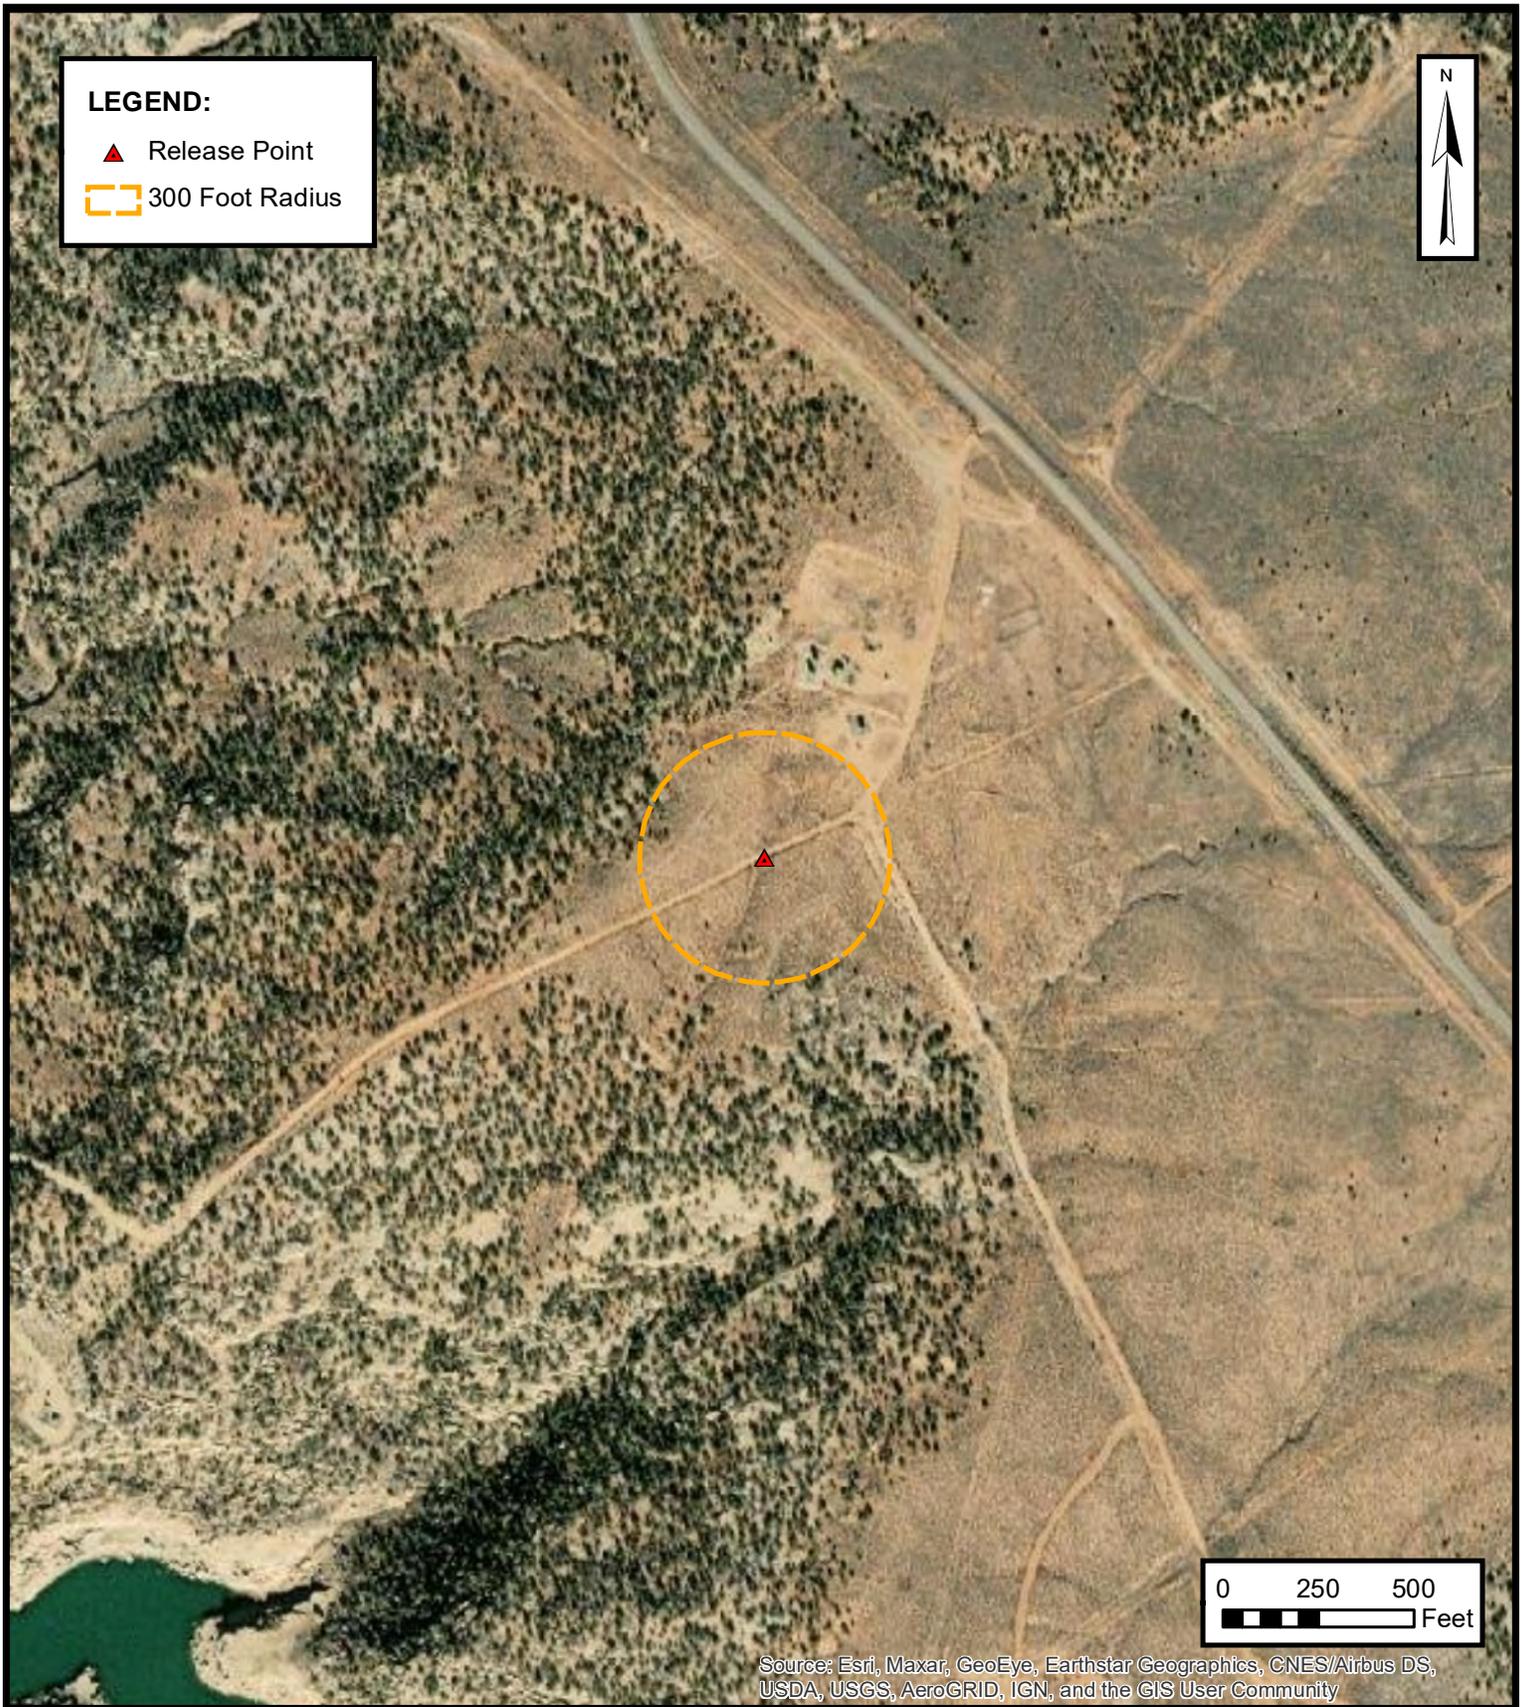
**300 FOOT RADIUS  
OCCUPIED STRUCTURE IDENTIFICATION**  
ENTERPRISE FIELD SERVICES, LLC  
BLANCO A-28 (2/3/22)  
Unit Letter M, S11 T30N R7W, Rio Arriba County, New Mexico  
36.82173° N, 107.54646° W

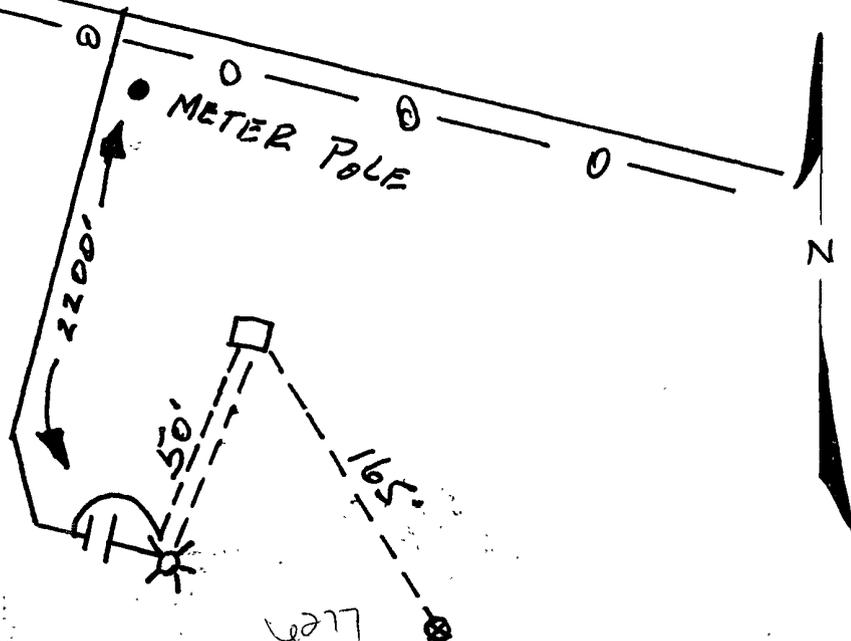
GROUND BED LAYOUT SKETCH

20' METER POLE  
 OFF LOCATION  
 STUB POLE  
 40/16 RECT  
 DITCH + 1 CABL = 215'  
 XTRA DITCH = 70'  
 HOLE = +30

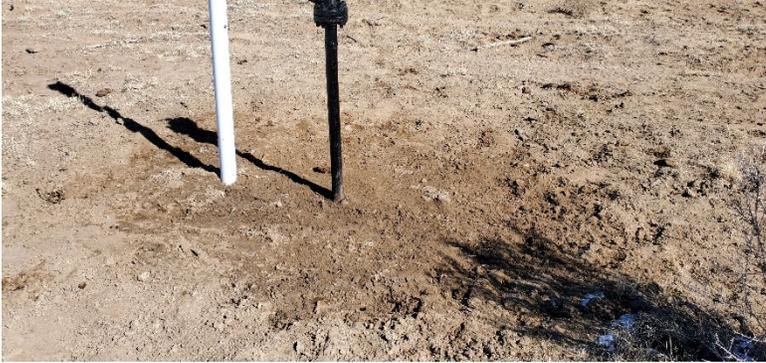
| <p><b>Photograph 1</b></p> <p>Photograph Description: View of the release area.</p> | A close-up photograph of a dirt surface. A white vertical pipe and a black vertical pipe are visible, both casting shadows on the ground. |

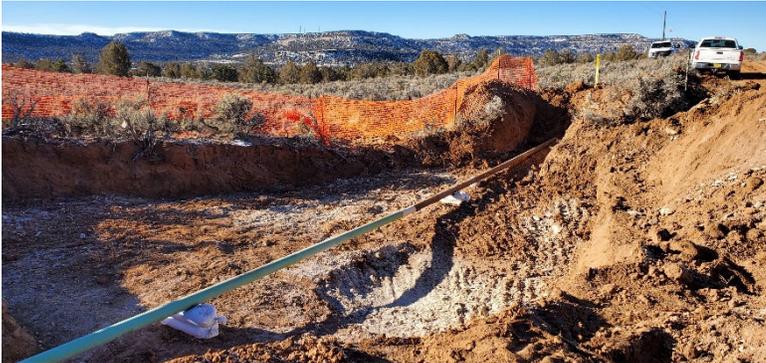
| <p><b>Photograph 2</b></p> <p>Photograph Description: View of the final excavation.</p> | A wide-angle photograph of a large, deep excavation site. A green pipe runs along the bottom of the pit. In the background, there is orange safety fencing, a white vehicle, and a clear blue sky with distant hills. |

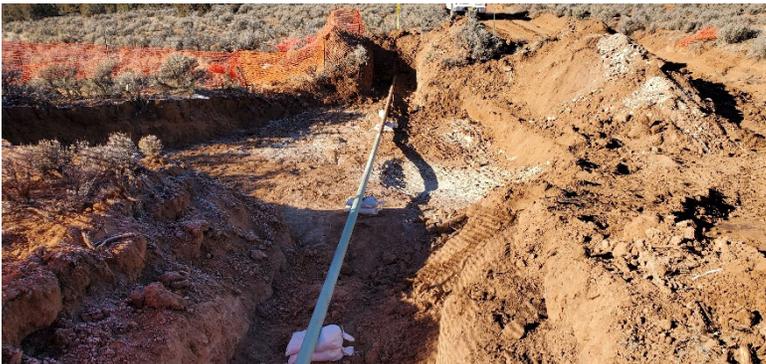
| <p><b>Photograph 3</b></p> <p>Photograph Description: View of the final excavation.</p> | A photograph showing a different angle of the excavation site. A green pipe is visible at the bottom of the pit, surrounded by reddish-brown soil and some sparse vegetation. |

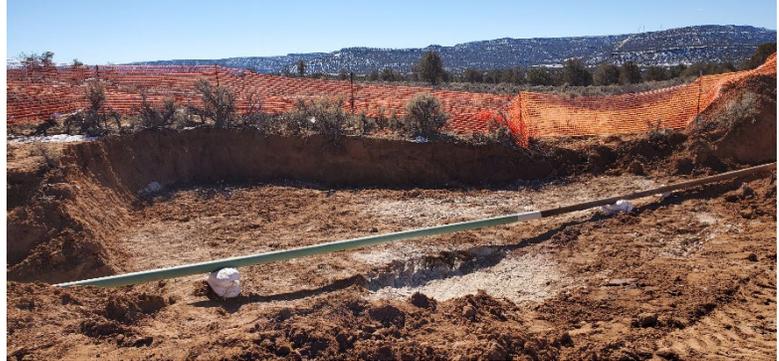
#### Photograph 4

Photograph Description: View of the final excavation.

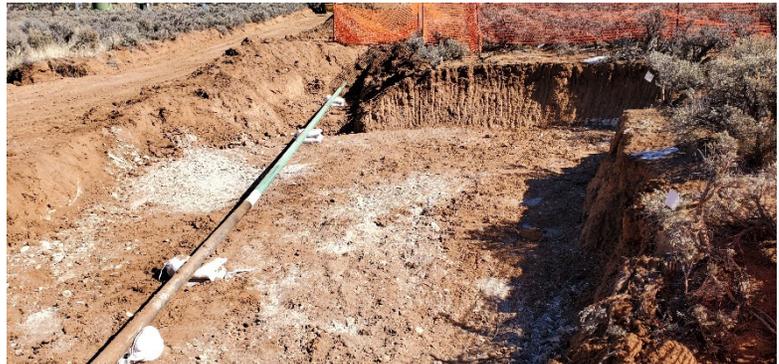
#### Photograph 5

Photograph Description: View of the final excavation.

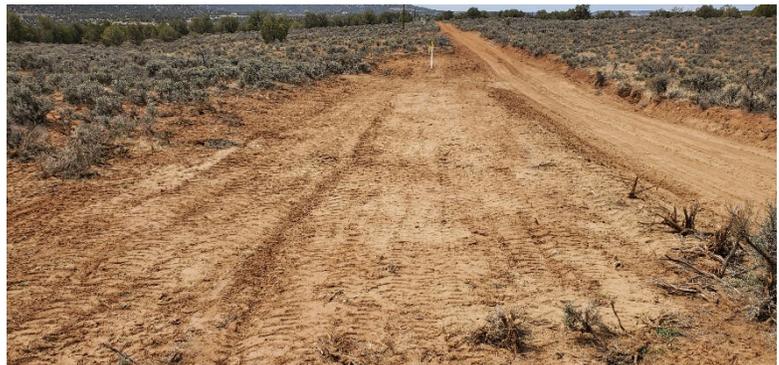
#### Photograph 6

Photograph Description: View of the site after initial restoration.
