April 28, 2022

**RE: Closure Report  
ConocoPhillips  
MCA 470 Flowline Release  
Unit Letter H, Section 33, Township 17 South, Range 32 East  
Lea County, New Mexico  
Incident ID: NRM1935447155**

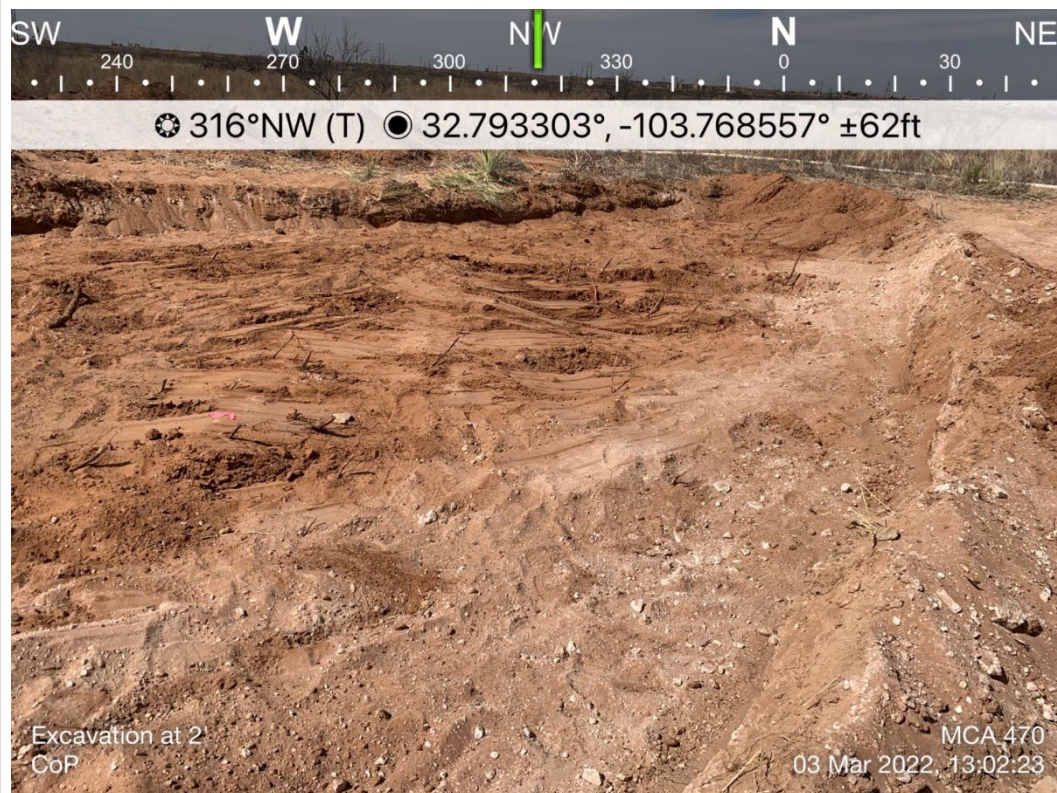
TETRA TECH, INC. PROJECT NO. 212C-MD-02617	DESCRIPTION	View northwest. 2' and 1' bgs excavations.	2
	SITE NAME	ConocoPhillips MCA 470 Flowline Remediation	4/4/2021

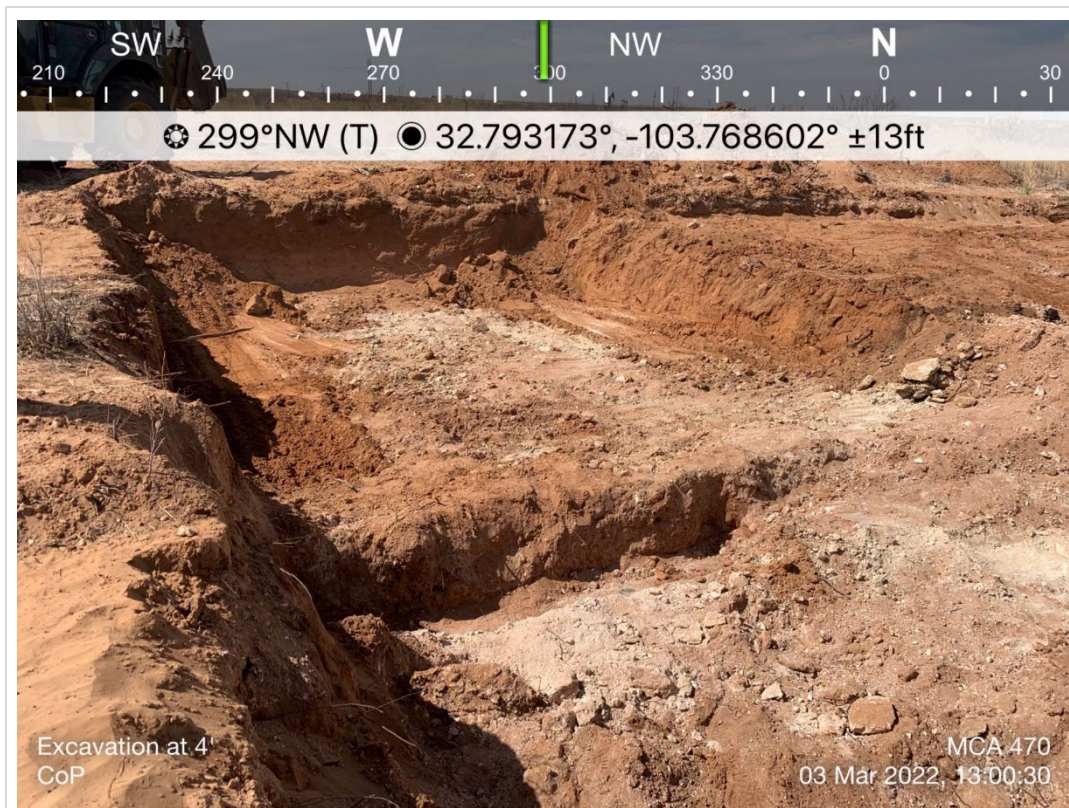
TETRA TECH, INC. PROJECT NO. 212C-MD-02617	DESCRIPTION	View west northwest. 4' and 1' bgs excavations.	3
	SITE NAME	ConocoPhillips MCA 470 Flowline Remediation	3/3/2022

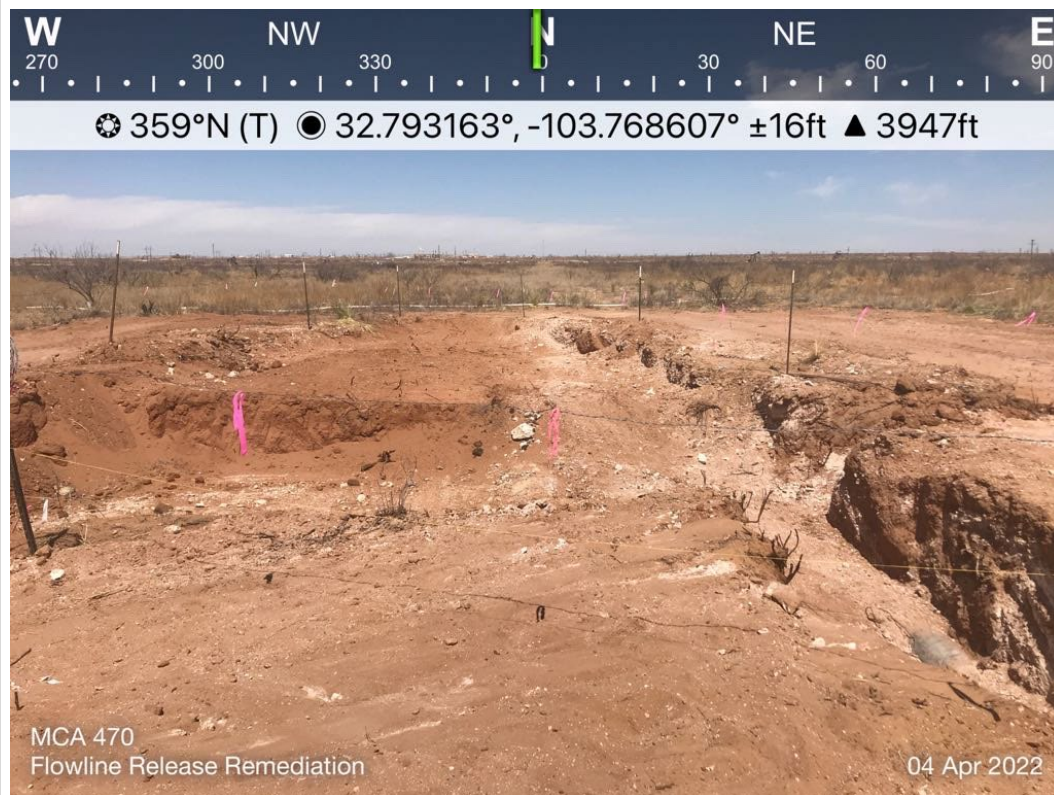
TETRA TECH, INC. PROJECT NO. 212C-MD-02617	DESCRIPTION	View north. 4', 2' & 1' bgs excavations.	4
	SITE NAME	ConocoPhillips MCA 470 Flowline Remediation	3/4/2022

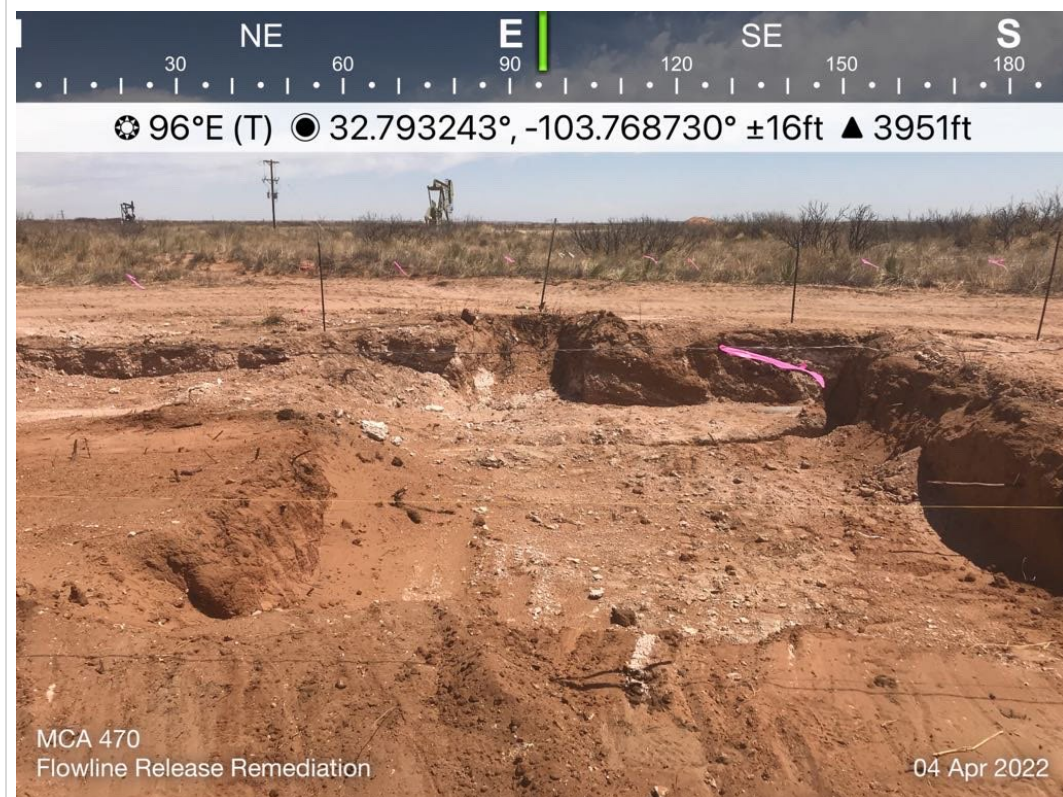
TETRA TECH, INC. PROJECT NO. 212C-MD-02617	DESCRIPTION	View east. 4' bgs excavation with eastern sidewall expansion, SW-1 (2').	6
	SITE NAME	ConocoPhillips MCA 470 Flowline Remediation	4/4/2022

Analytical results associated with sample locations SW-1 and SW-2 exceeded the reclamation requirement for TPH, as such, additional excavation was conducted at those locations. On April 4, 2022, Tetra Tech personnel returned to site to collect iterative confirmation samples. Iterative confirmation samples were located to encompass the original sample location that triggered removal (nomenclature defined in table 2) post-additional excavation. Thus, a total of two (2) additional sidewall samples were collected following the excavation work, and final laboratory analysis results confirmed constituents were below the established RRALs and/or reclamation requirement. After sampling and analysis, all final confirmation soil samples (floor and sidewall) were below the respective RRALs and/or reclamation requirement for chloride, BTEX, and TPH. The results of the March and April 2022 confirmation sampling events are summarized in Table 2. Laboratory analytical data is included in Appendix F. Excavated areas, depths and confirmation sample locations are shown in Figure 4.

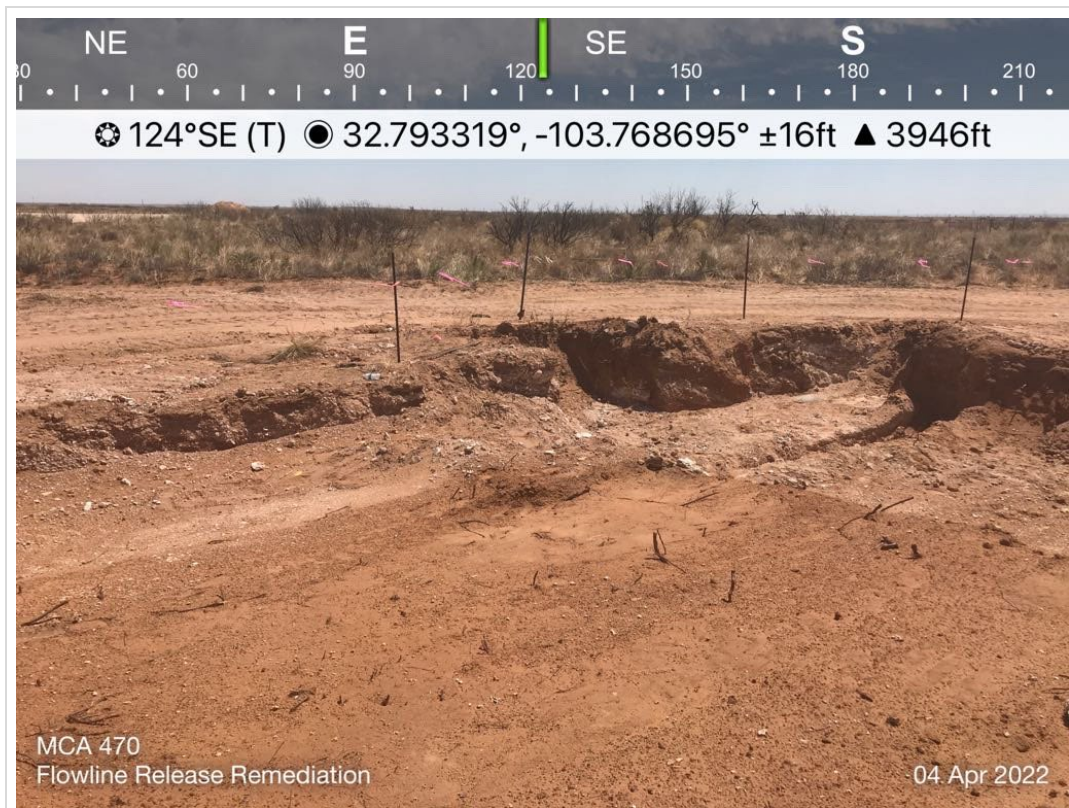
TETRA TECH, INC. PROJECT NO. 212C-MD-02617	DESCRIPTION	View southeast. 4' bgs excavation.	7
	SITE NAME	ConocoPhillips MCA 470 Flowline Remediation	4/4/2022

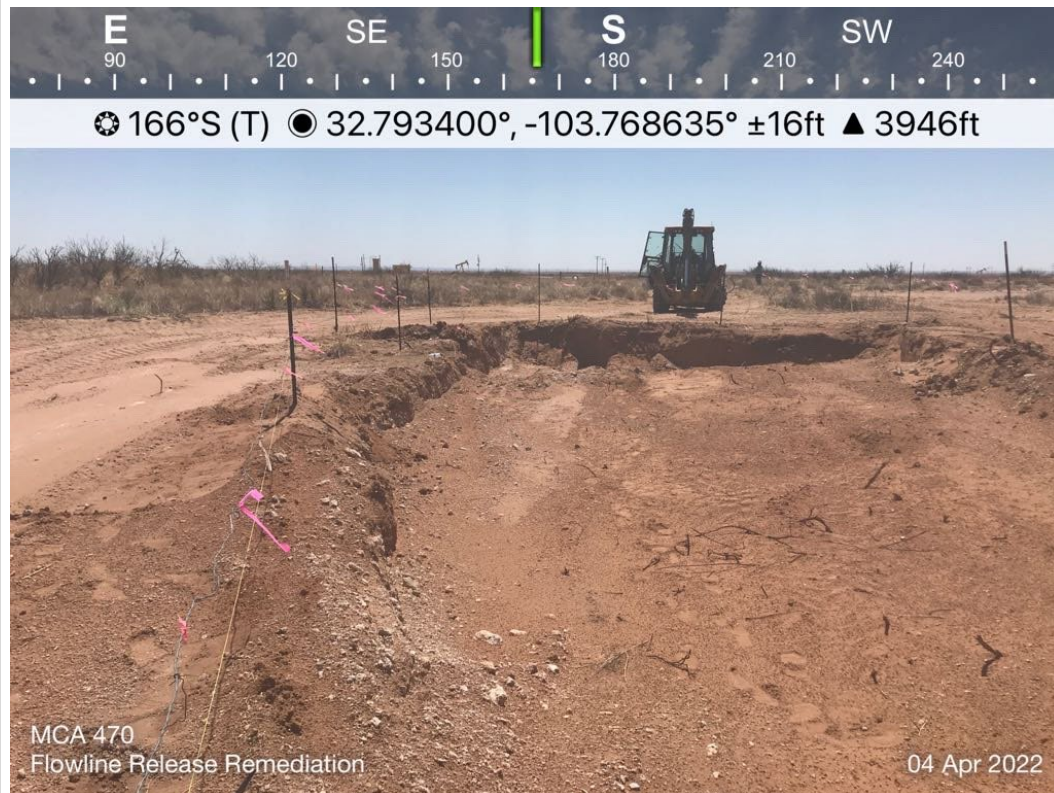
TETRA TECH, INC. PROJECT NO. 212C-MD-02617	DESCRIPTION	View south southeast. 4' bgs excavation.	8
	SITE NAME	ConocoPhillips MCA 470 Flowline Remediation	4/4/2022

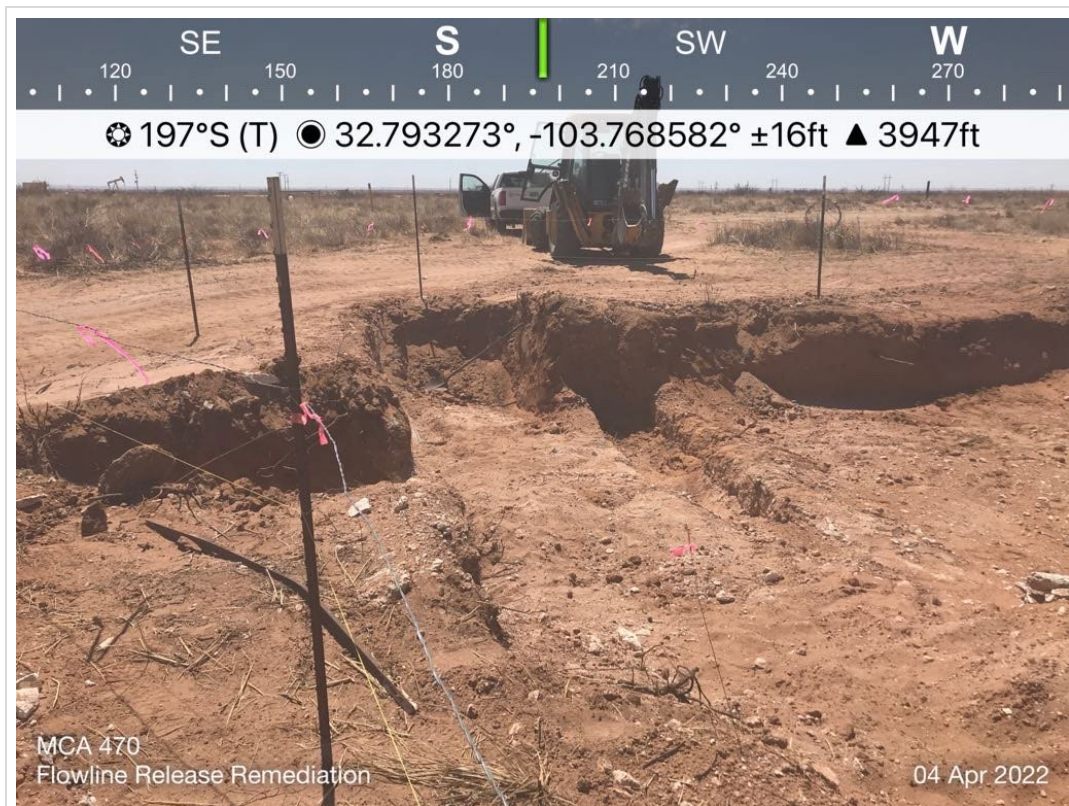
TETRA TECH, INC. PROJECT NO. 212C-MD-02617	DESCRIPTION	View south southwest. 4' bgs excavation with southern sidewall expansion, SW-2 (4').	9
	SITE NAME	ConocoPhillips MCA 470 Flowline Remediation	4/4/2022
