SOIL REMEDIATION ACTIVITIES REPORT AND CLOSURE REQUEST

PLAINS PIPELINE, L.P.

MALJAMAR TRUCK STATION RELEASE

NMOCD INCIDENT #: nAPP2205645858

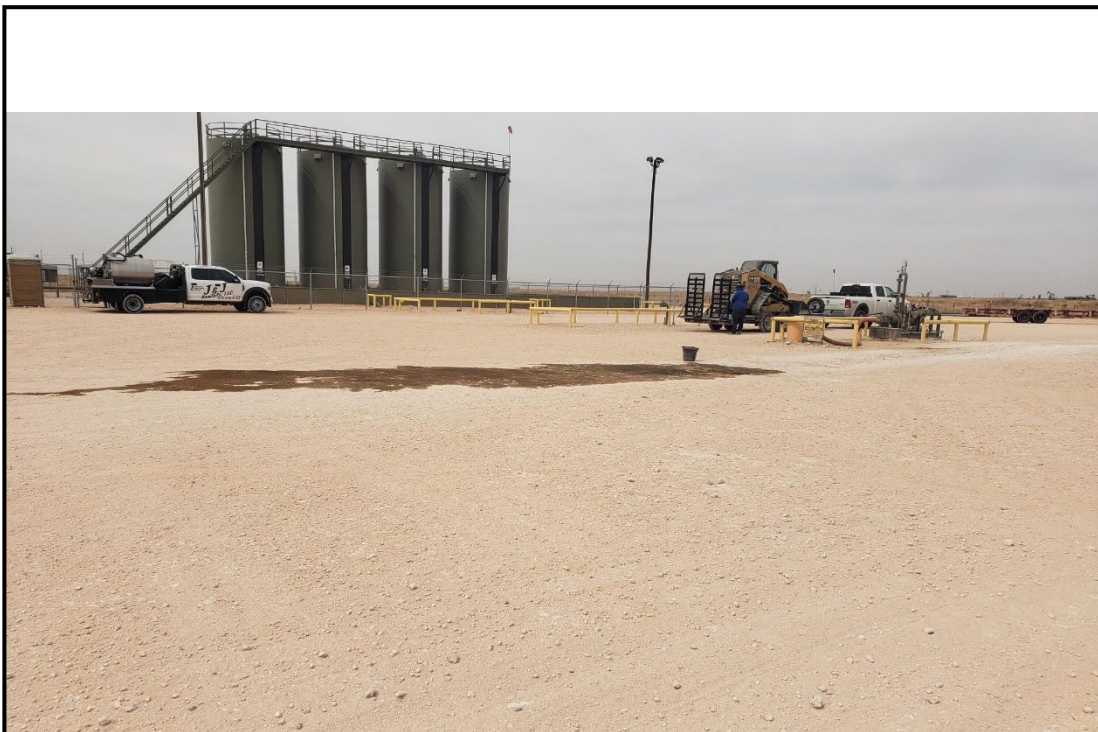
Direction: West view of release area, 02/25/2022.

On February 24, 2022, an operator error resulted in a release of crude oil from a transport trailer vent line. The release was contained onsite, adjacent to the truck station load out pad. Approximately 5.29 barrels (bbls) of crude oil was released with no recovery during initial response actions. The release was affected an area that measured approximately 67 feet (ft) in length by 15 ft in width with an estimated maximum depth of two (2) ft below ground surface (bgs).

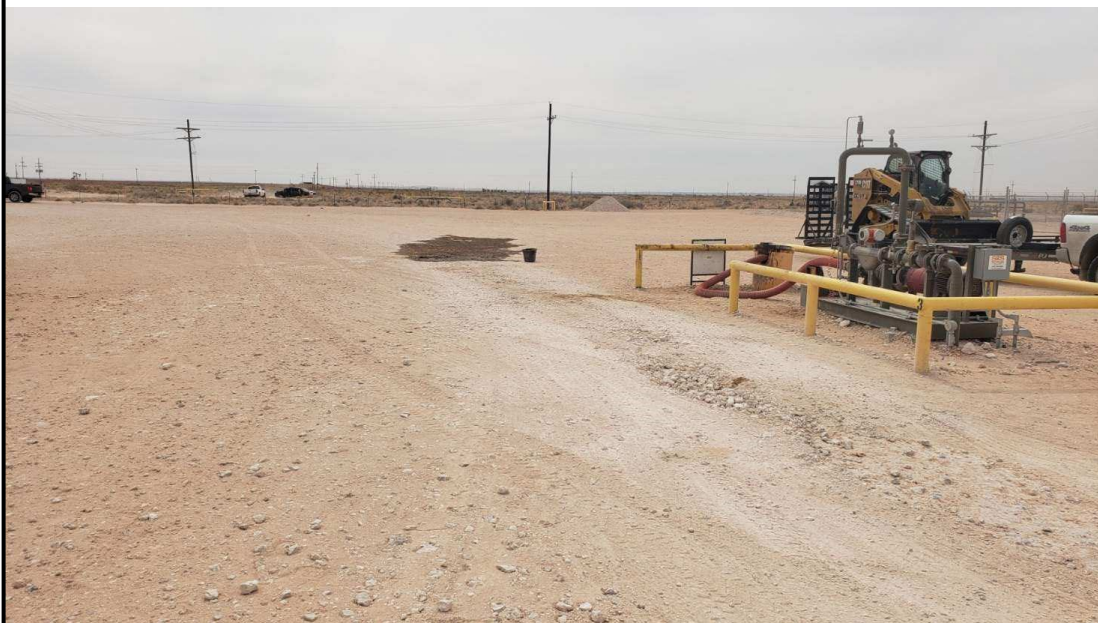
Direction: South view of release area, 02/25/2022.

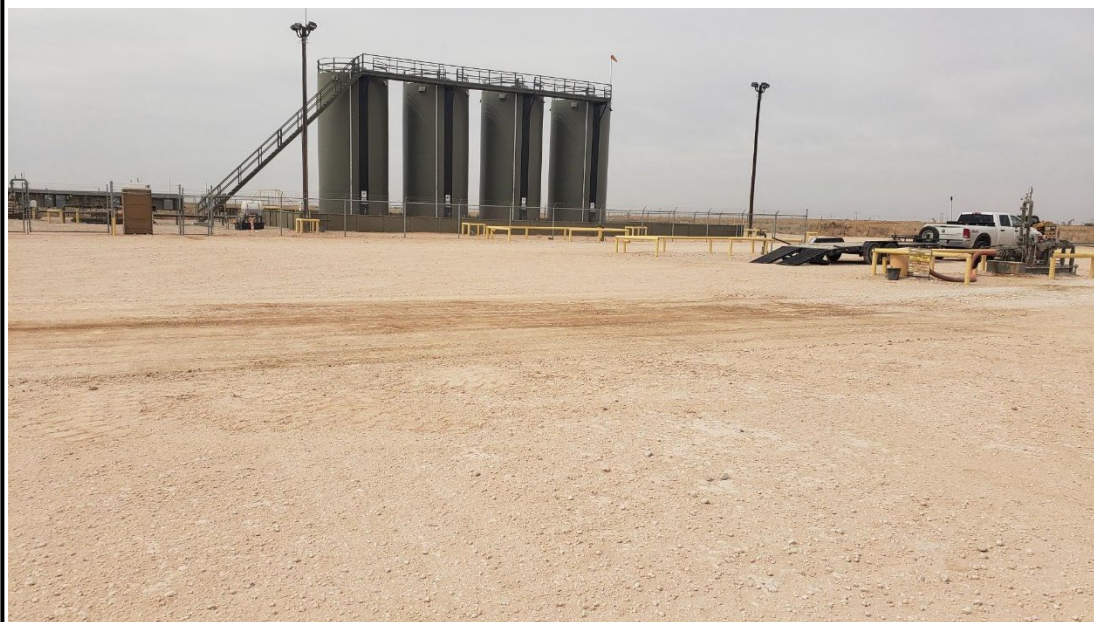
Direction: West view of release area after initial response, 02/25/2022.

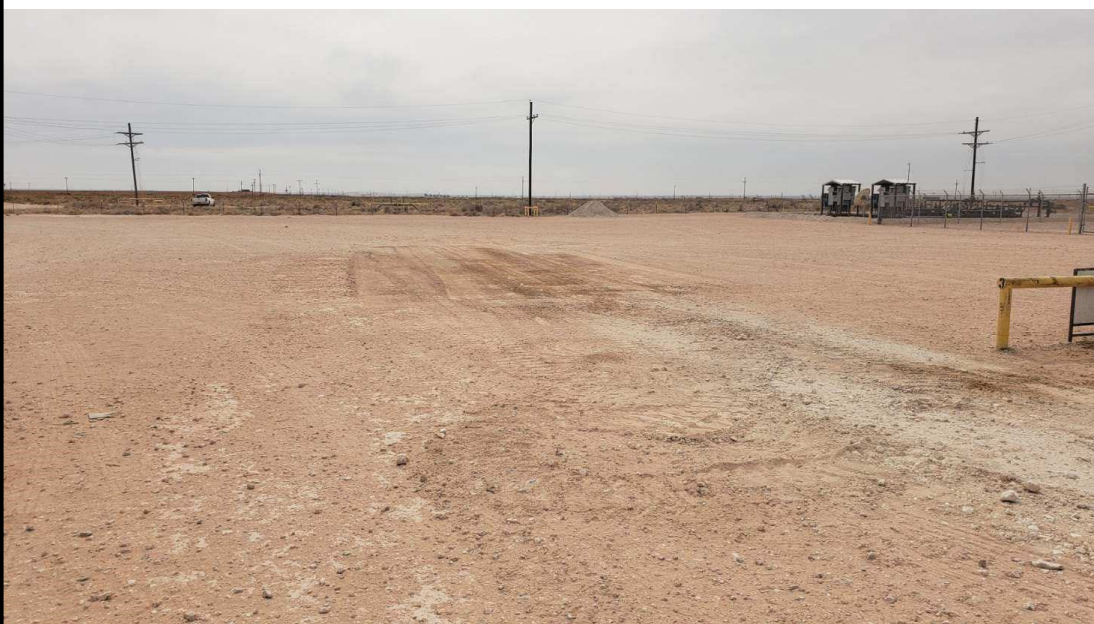
Direction: South view of release area after initial response, 02/25/2022.

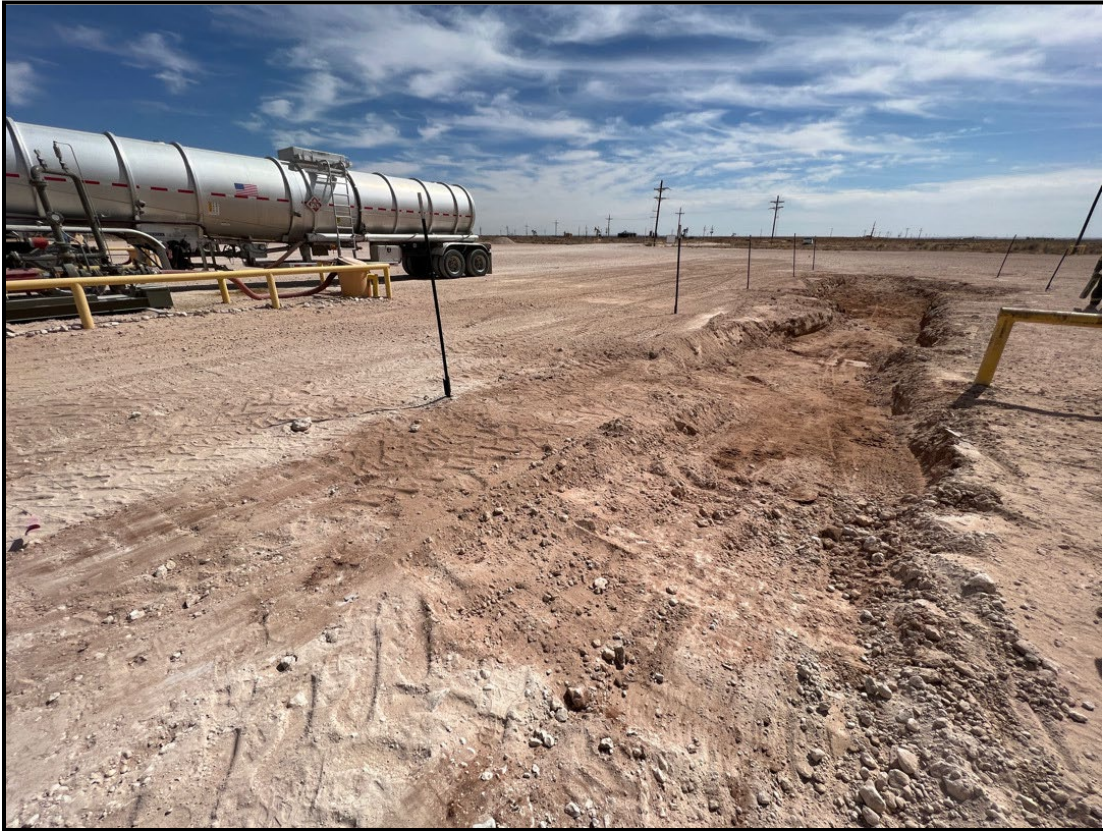
Direction: South view of remediation activities, 03/03/2022.

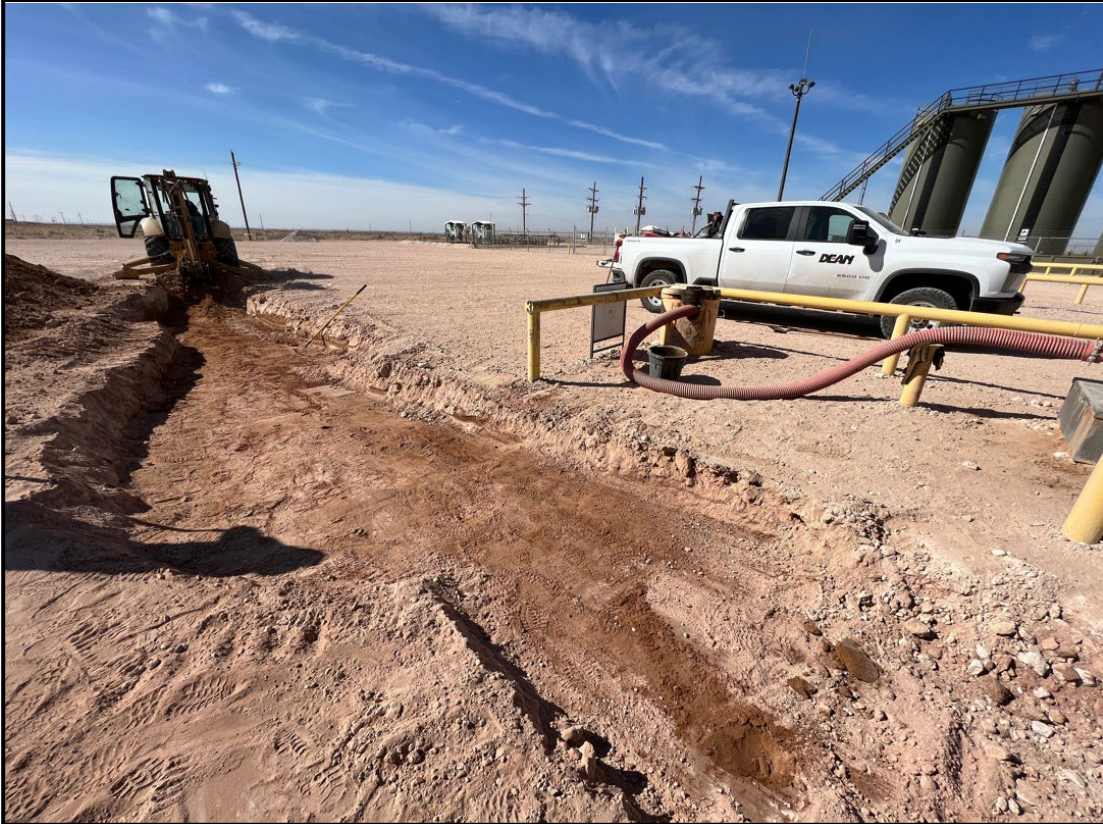
Direction: South view, note pad breakthrough to topsoil layer underneath facility, 03/03/2022.

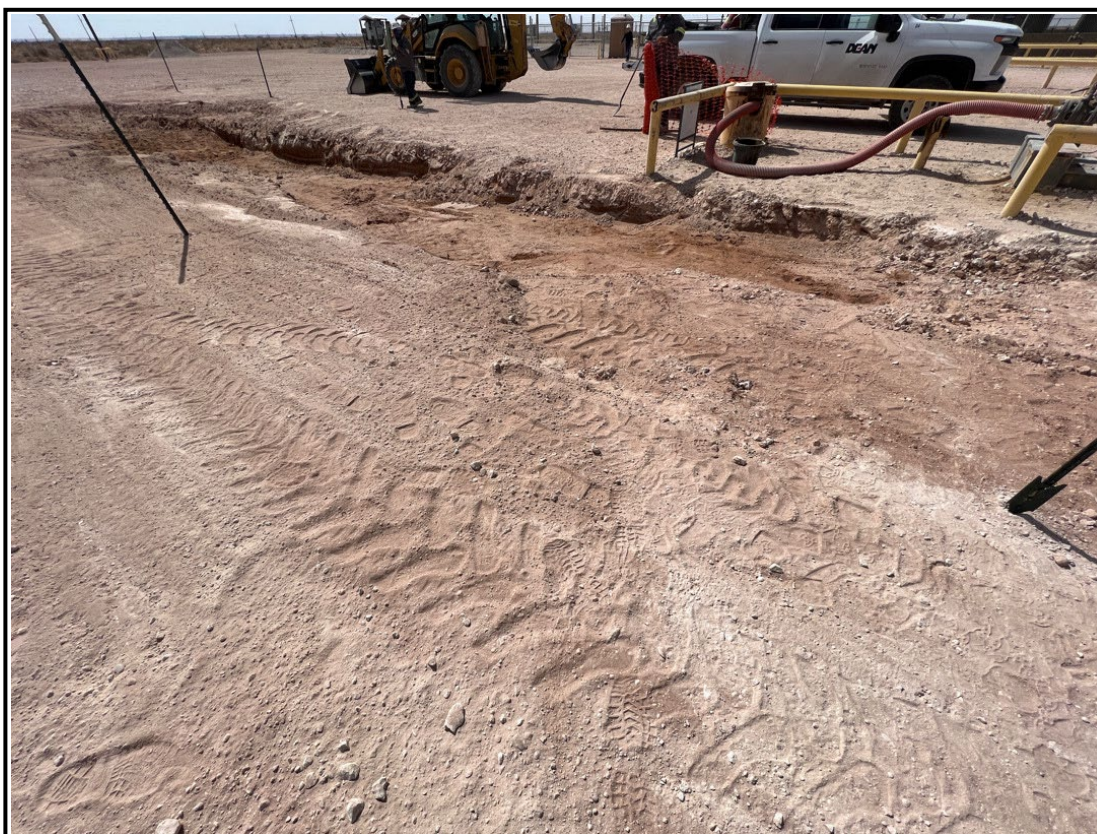
Direction: Southwest view of remediation activities, 03/03/2022.

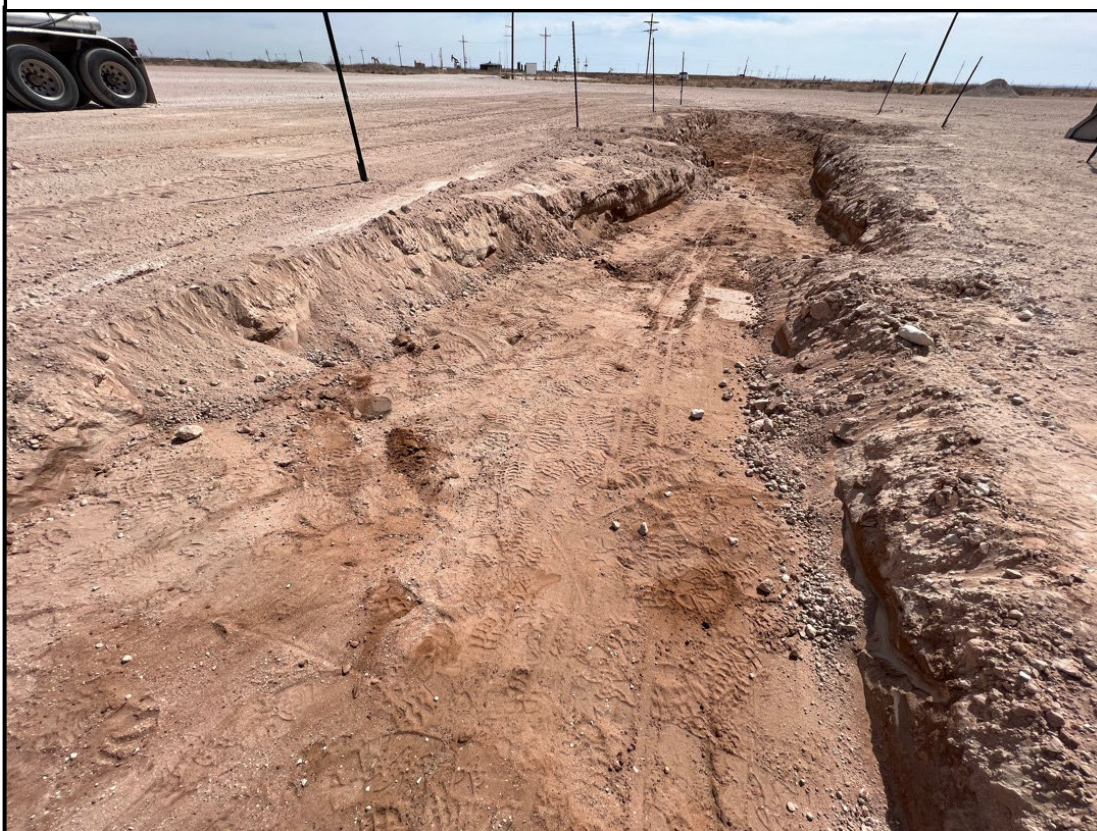
Direction: South view of remediation activities, 03/03/2022.

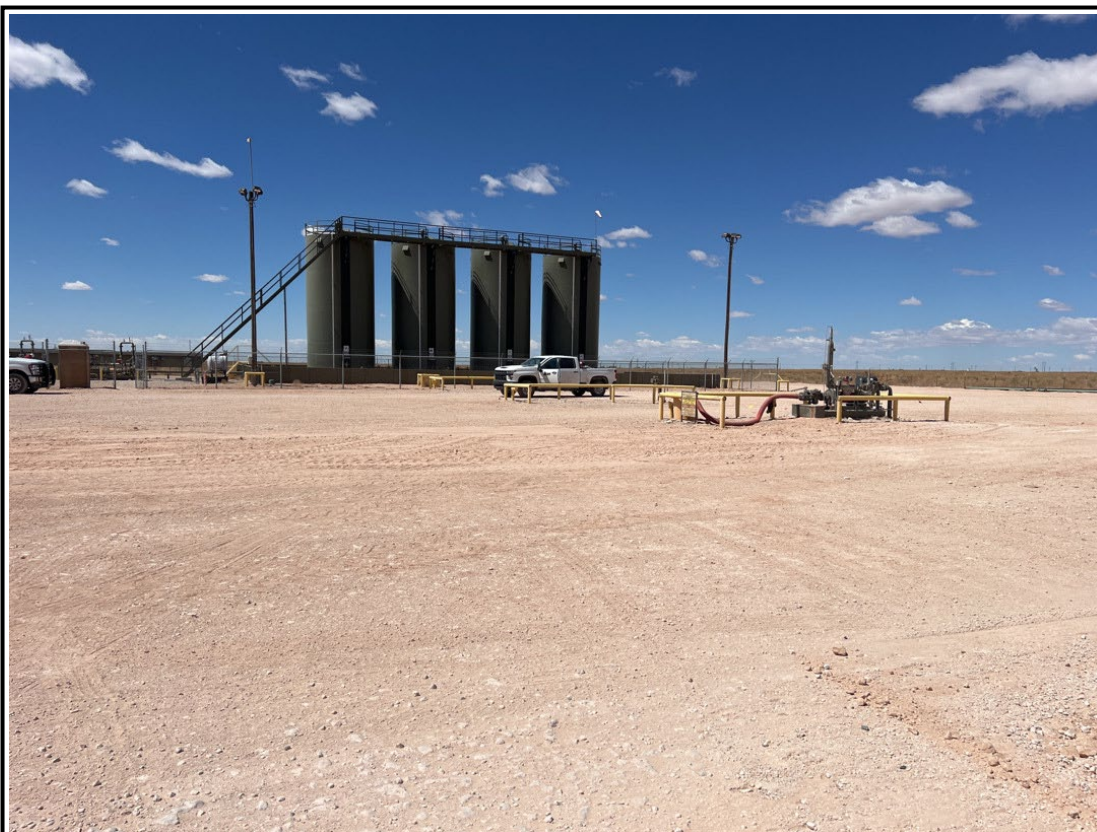
Direction: West view after backfill activities, 03/23/2022.

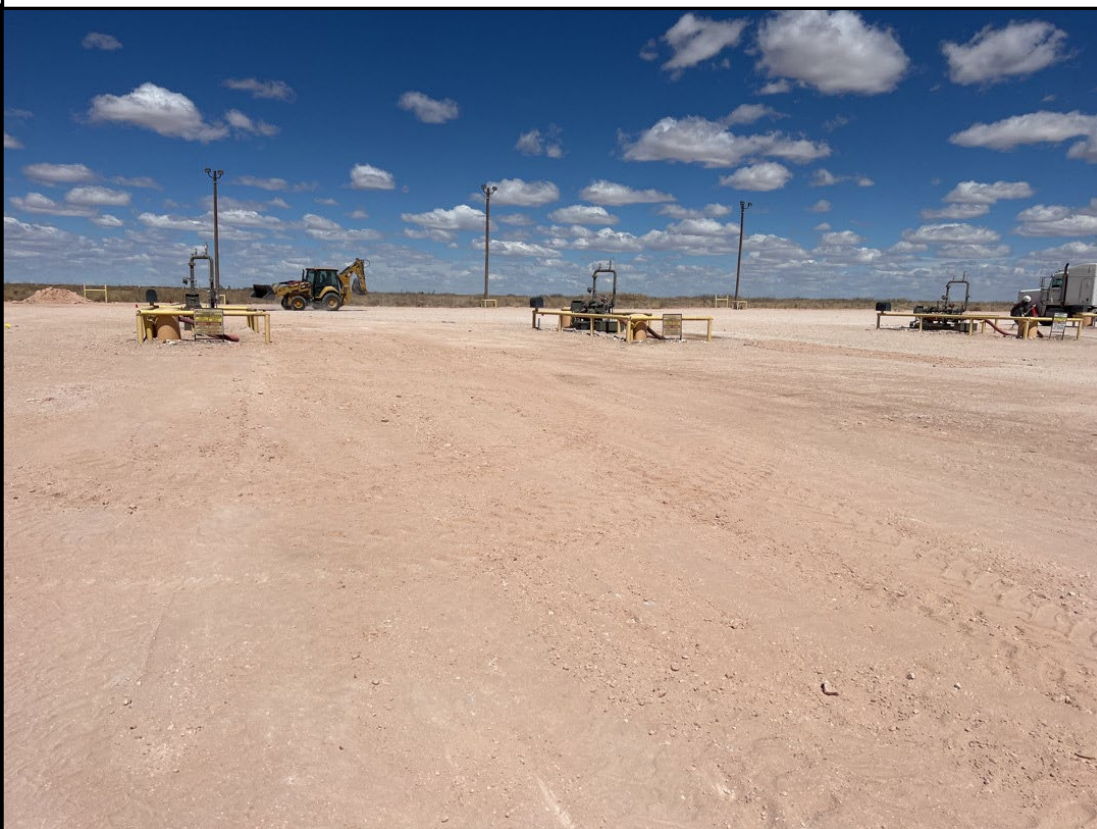
Direction: North view after backfill activities, 03/23/2022.

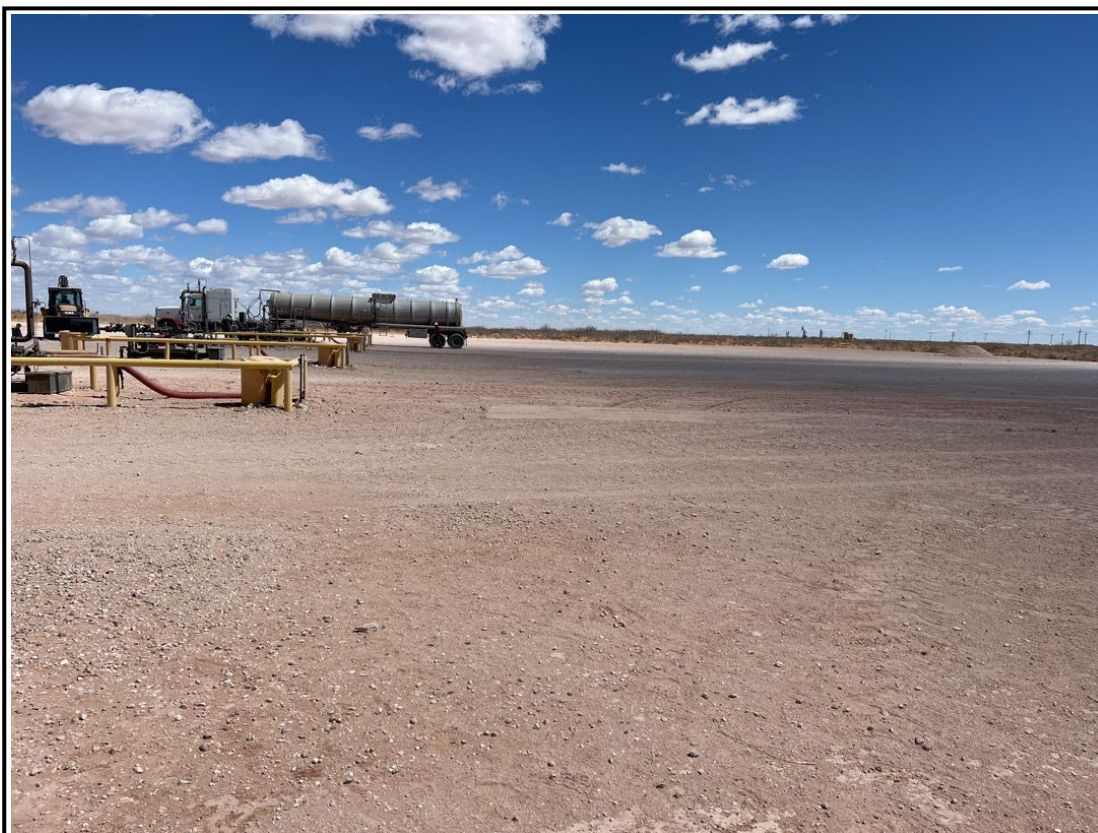
Direction: East view after backfill activities, 03/23/2022.

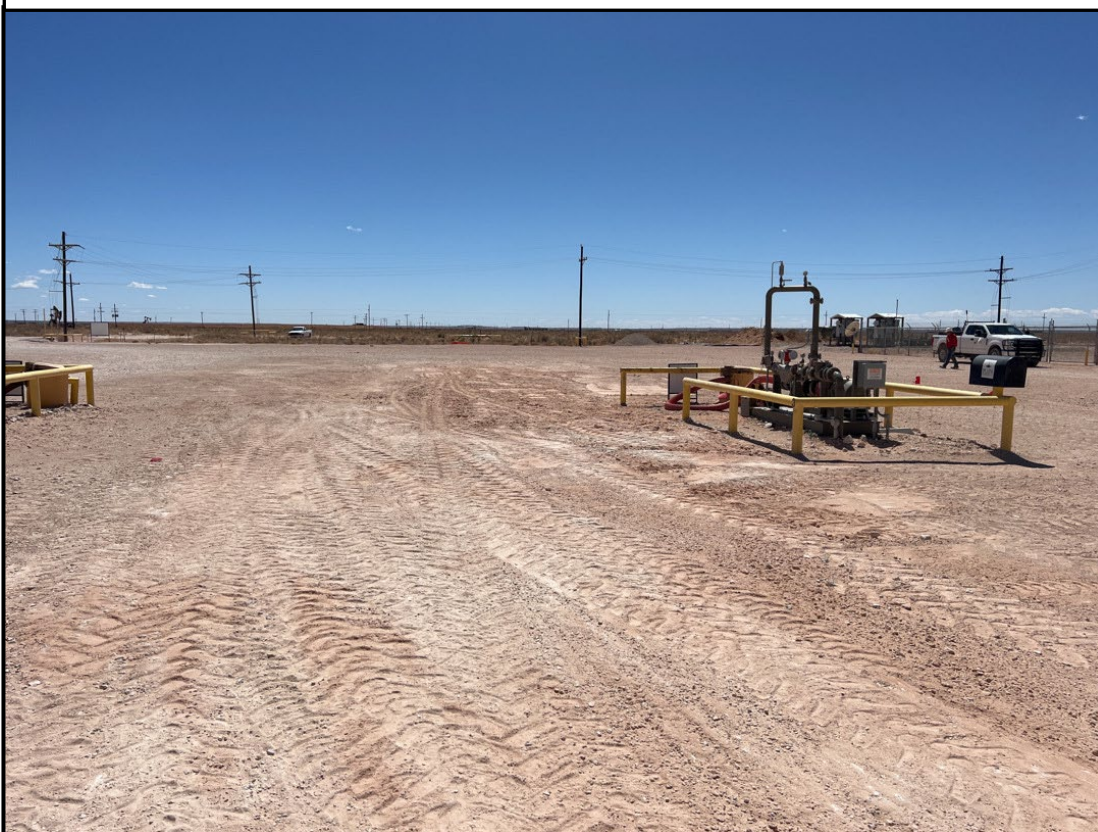
Direction: South view after backfill activities, 03/23/2022.
