Incident ID	nAPP2204530872
District RP	
Facility ID	
Application ID

## Site Assessment/Characterization

Charge pump transmitter fitting failure. The release affected areas adjacent to the facility and on the caliche pad measuring approximately 3,800 square feet.

Based on laboratory analytical results and field activities conducted to date, Etech recommends Goodnight provide copies of this *Remediation Summary & Soil Closure Request* to the appropriate agencies and request closure be granted to the Blueberry CRP release site.

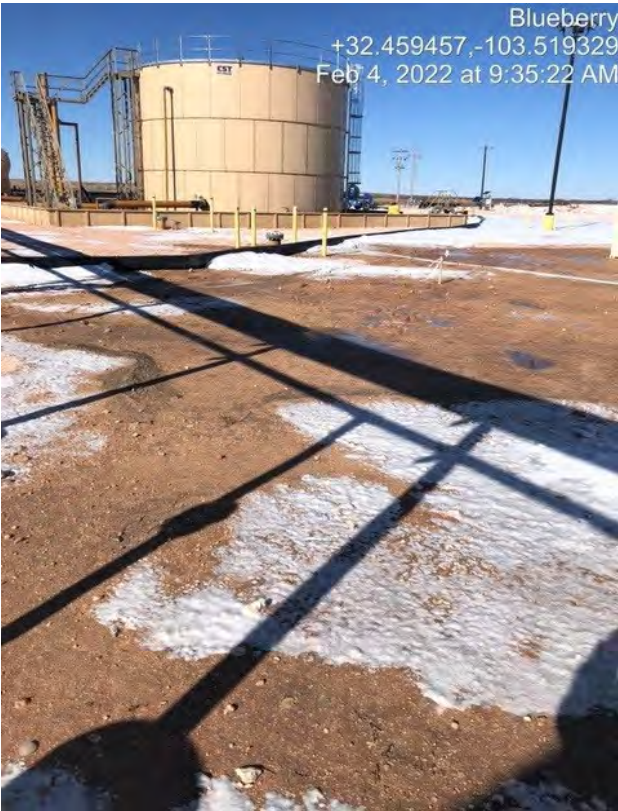
<b>Photo Number:</b> 1

<p>Blueberry +32.459457,-103.519329 Feb 4, 2022 at 9:35:22 AM</p>
<b>Date:</b> 2/4/2022	
<b>Photo Direction:</b> Northwest	
<b>Coordinates:</b> 32.459457,-103.519329	
<b>Photo Description:</b>	
View of the affected area.

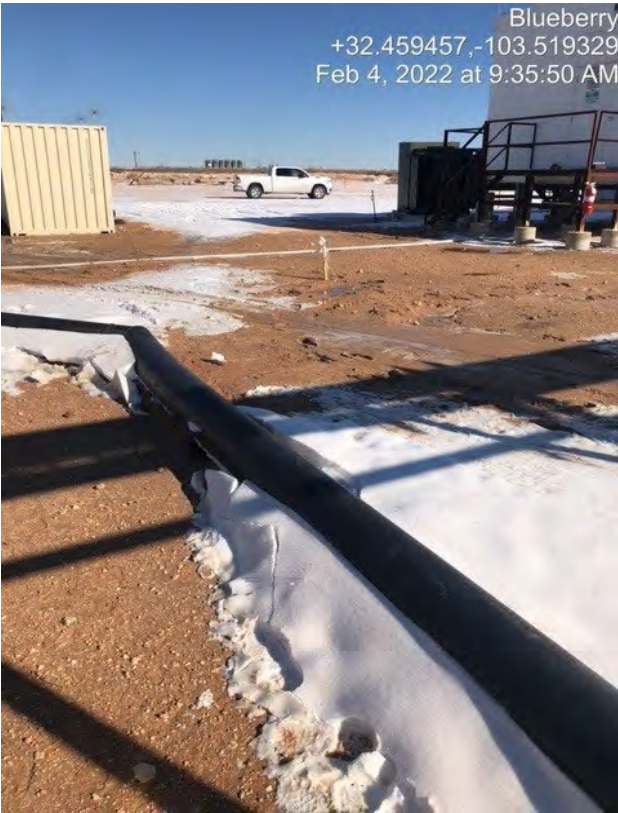
<b>Photo Number:</b> 2

<p>Blueberry +32.459457,-103.519329 Feb 4, 2022 at 9:35:50 AM</p>
<b>Date:</b> 2/4/2022	
<b>Photo Direction:</b> North	
<b>Coordinates:</b> 32.459457,-103.519329	
<b>Photo Description:</b>	
View of the affected area.

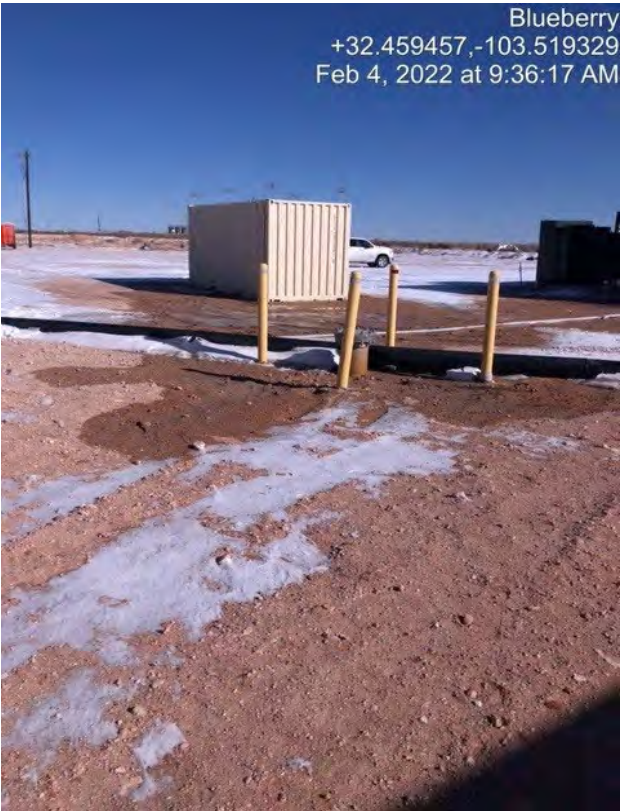
<b>Photo Number:</b> 3

<p>Blueberry +32.459457,-103.519329 Feb 4, 2022 at 9:36:17 AM</p>
<b>Date:</b> 2/4/2022	
<b>Photo Direction:</b> North-Northwest	
<b>Coordinates:</b> 32.459457,-103.519329	
<b>Photo Description:</b>  View of the affected area.

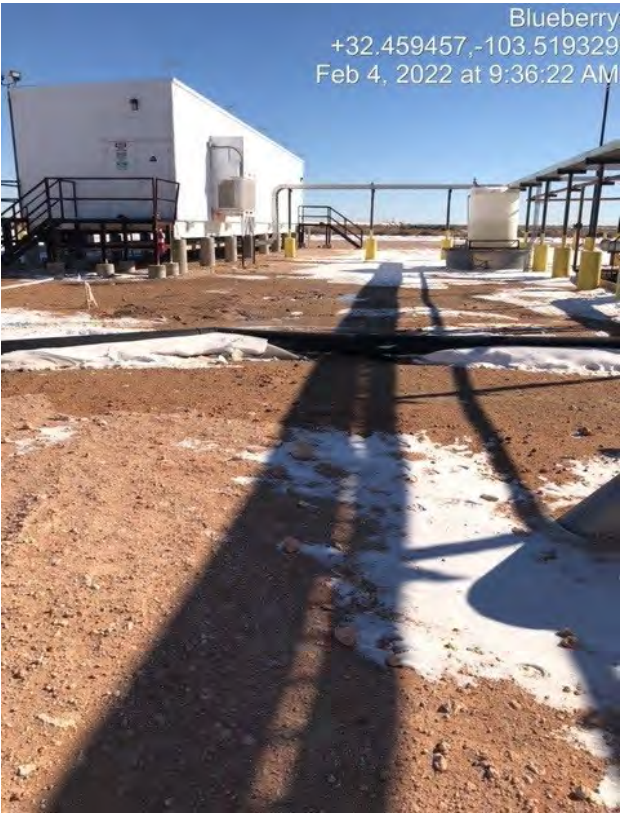
<b>Photo Number:</b> 4

<p>Blueberry +32.459457,-103.519329 Feb 4, 2022 at 9:36:22 AM</p>
<b>Date:</b> 2/4/2022	
<b>Photo Direction:</b> East	
<b>Coordinates:</b> 32.459457,-103.519329	
<b>Photo Description:</b>  View of the affected area.

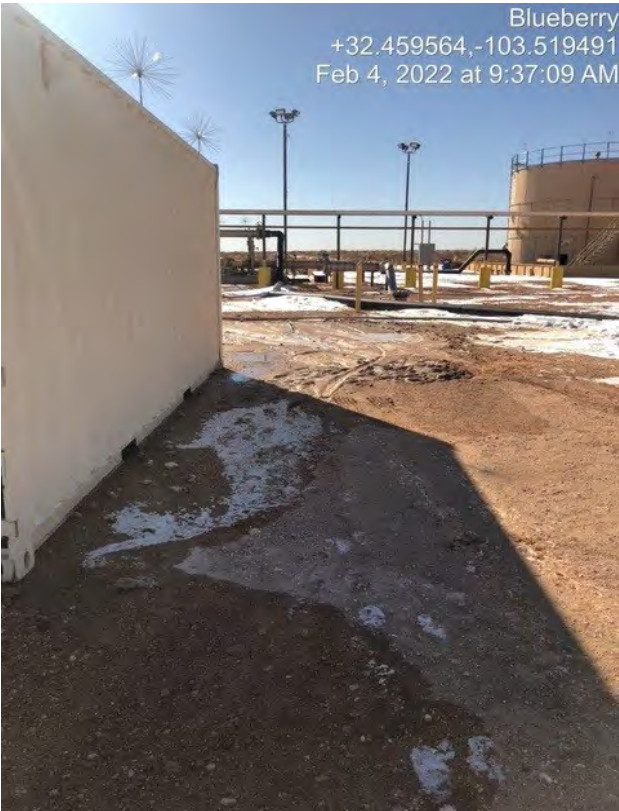
<b>Photo Number:</b> 5

<b>Date:</b> 2/4/2022	
<b>Photo Direction:</b> South	
<b>Coordinates:</b> 32.459564,-103.519491	
<b>Photo Description:</b>	
View of the affected area.

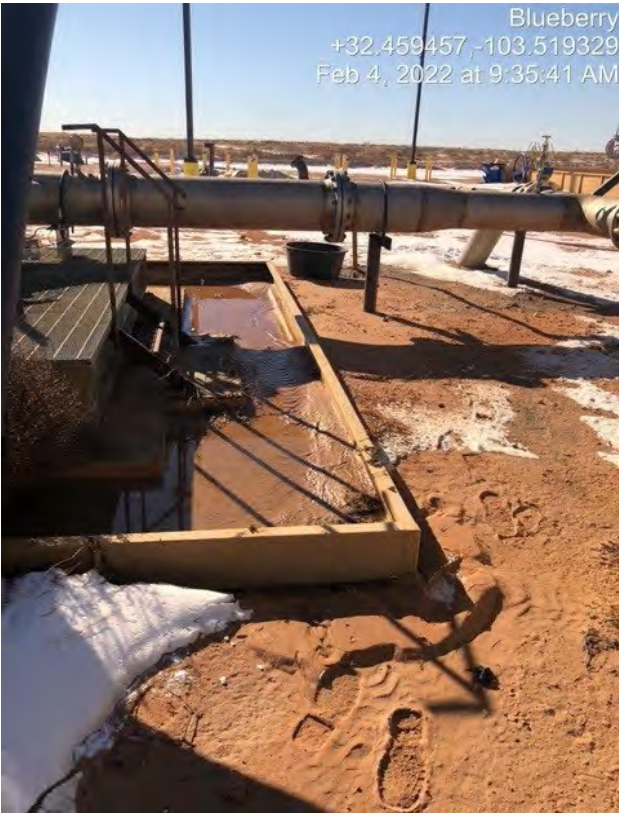
<b>Photo Number:</b> 6

<b>Date:</b> 2/4/2022	
<b>Photo Direction:</b> South	
<b>Coordinates:</b> 32.459382,-103.519354	
<b>Photo Description:</b>	
View of the affected area.

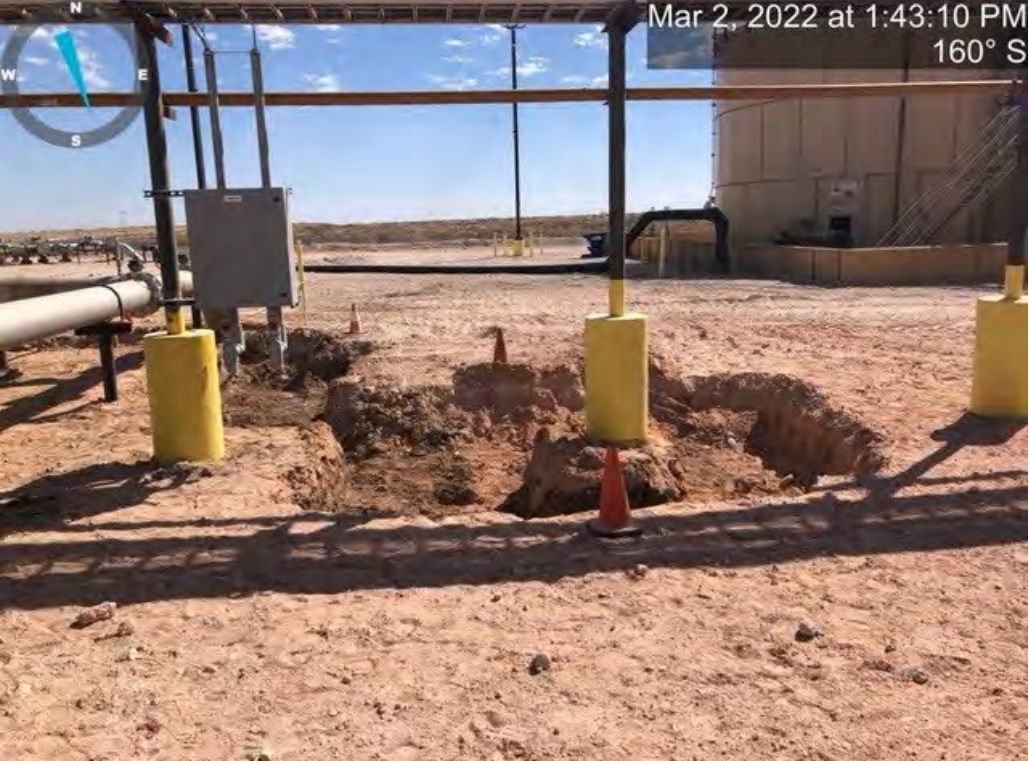
<b>Photo Number:</b> 10

<b>Date:</b> 3/2/2022	
<b>Photo Direction:</b> South	
<b>Coordinates:</b> 32.459412,-103.519418	
<b>Photo Description:</b>  View of the excavated area.

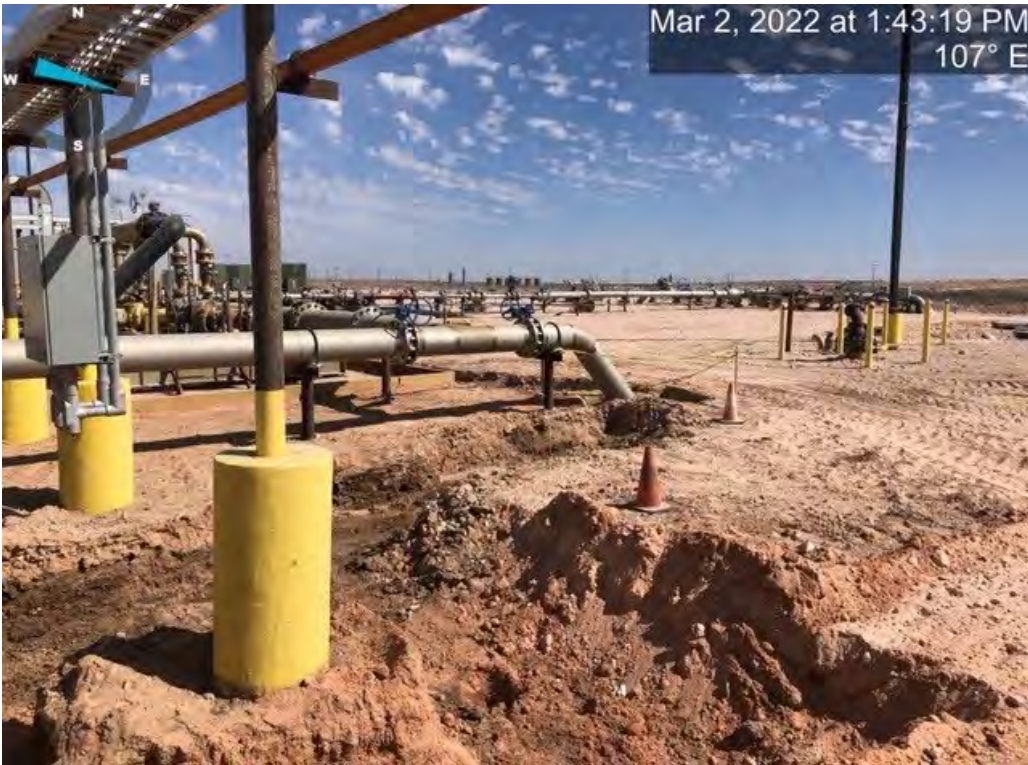
<b>Photo Number:</b> 11

<b>Date:</b> 3/2/2022	
<b>Photo Direction:</b> East	
<b>Coordinates:</b> 32.459350,-103.519455	
<b>Photo Description:</b>  View of the excavated area.

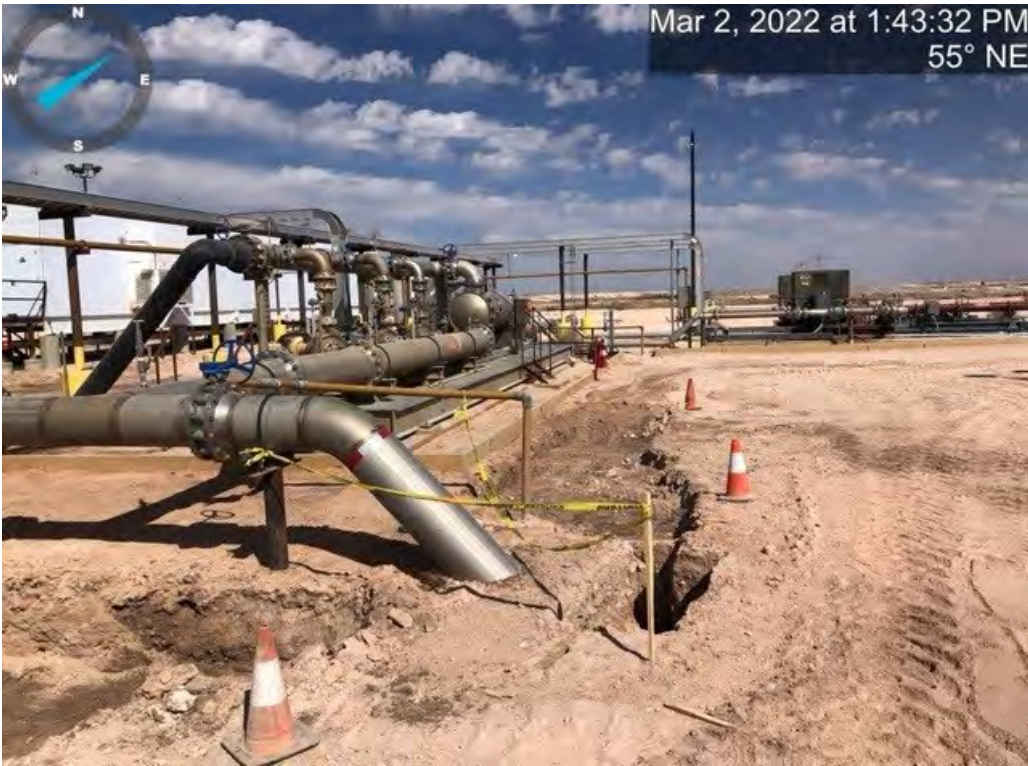
<b>Photo Number:</b> 12

<b>Date:</b> 3/2/2022	
<b>Photo Direction:</b> Northeast	
<b>Coordinates:</b> 32.459275,-103.519381	
<b>Photo Description:</b>  View of the excavated area.

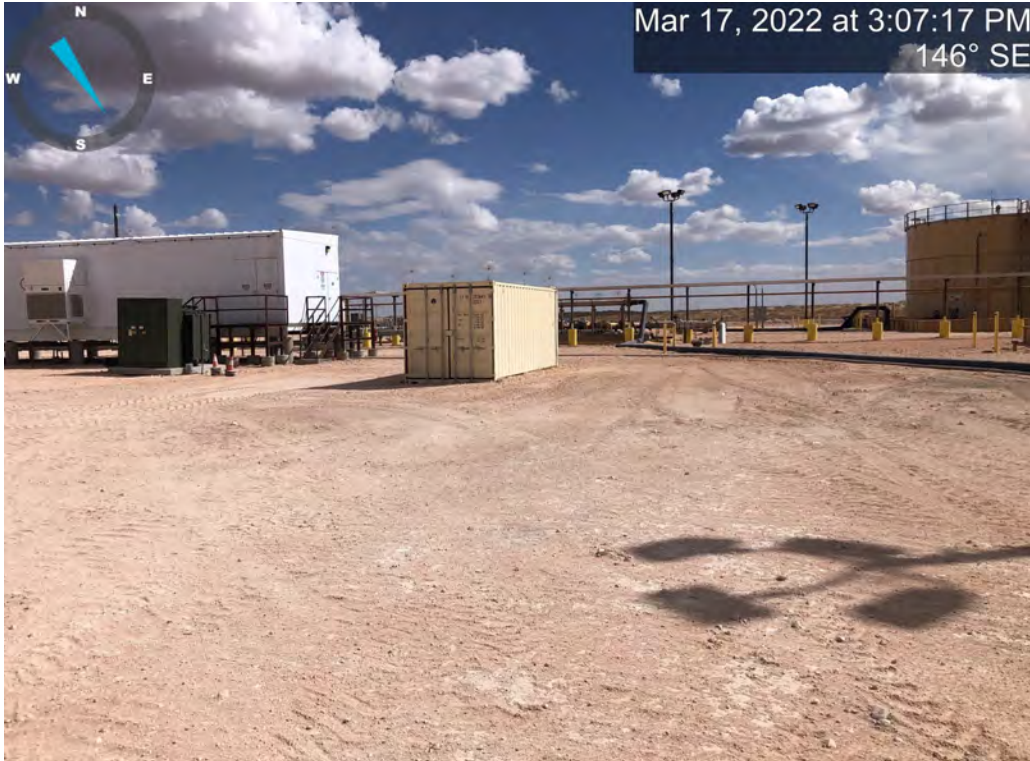
<b>Photo Number:</b> 13

<b>Date:</b> 3/17/2022	
<b>Photo Direction:</b> Southeast	
<b>Coordinates:</b> 32.459646,-103.519477	
<b>Photo Description:</b>	
View of the remediated area after backfilling and regrading.

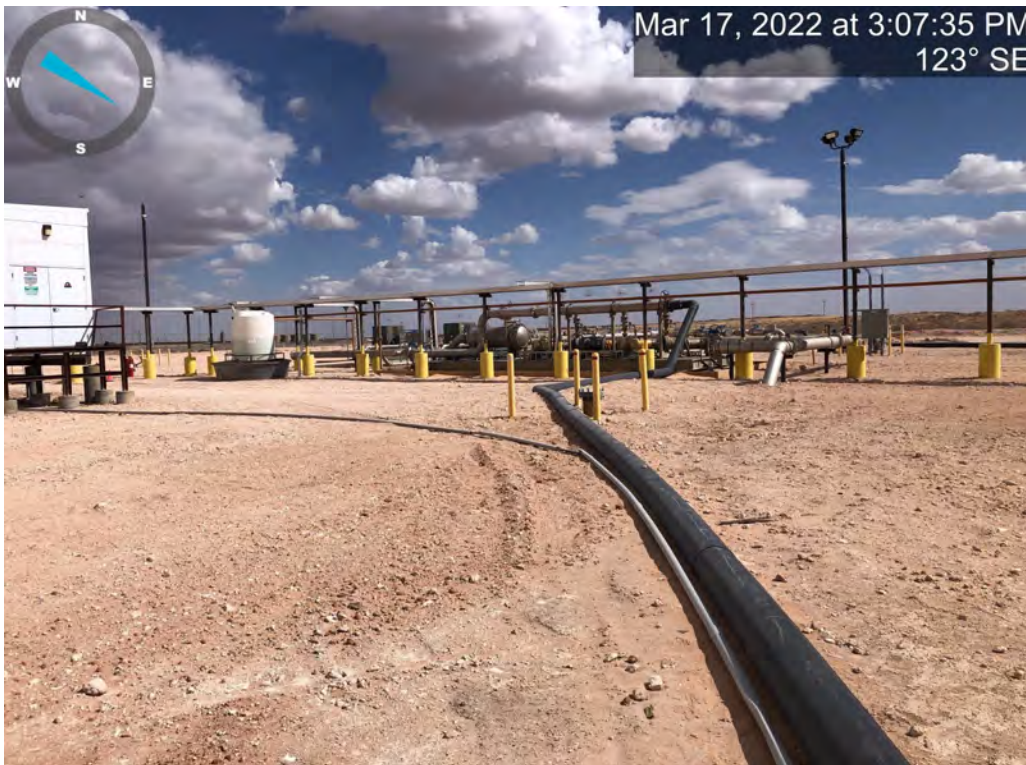
<b>Photo Number:</b> 14

<b>Date:</b> 3/17/2022	
<b>Photo Direction:</b> Southeast	
<b>Coordinates:</b> 32.459512,-103.519461	
<b>Photo Description:</b>	
View of the remediated area after backfilling and regrading.

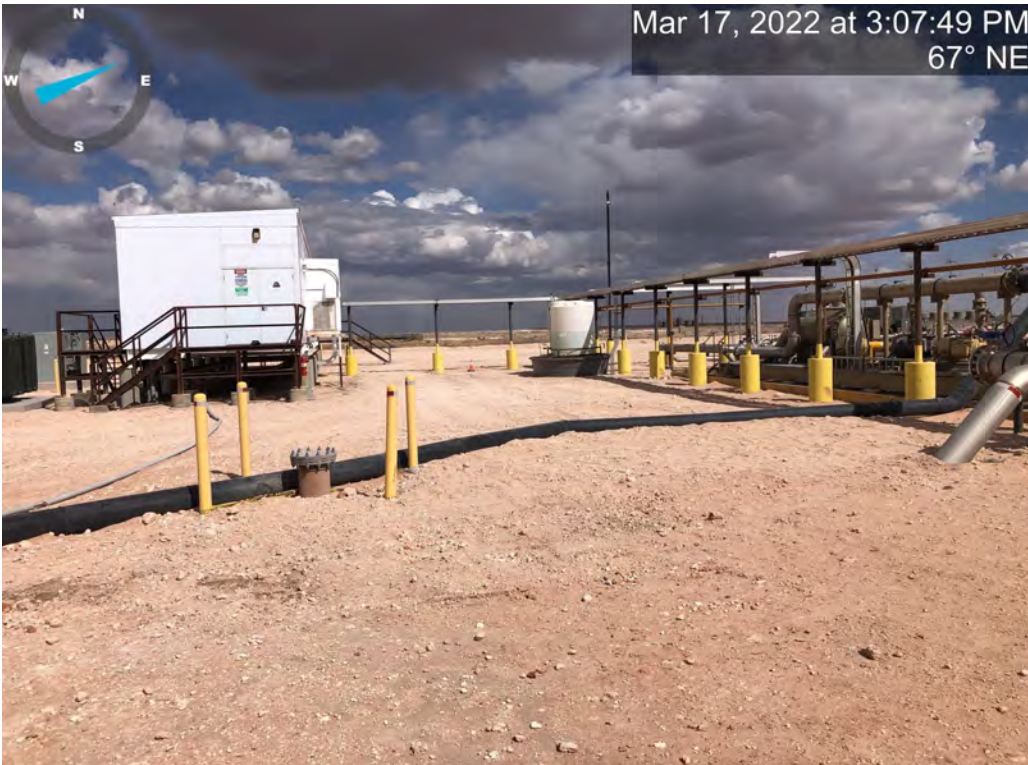
<b>Photo Number:</b> 15

<p>Mar 17, 2022 at 3:07:49 PM 67° NE</p> <p>View of the remediated area after backfilling and regrading.</p>
<b>Date:</b> 3/17/2022	
<b>Photo Direction:</b> Northeast	
<b>Coordinates:</b> 32.459447,-103.519457	
<b>Photo Description:</b>

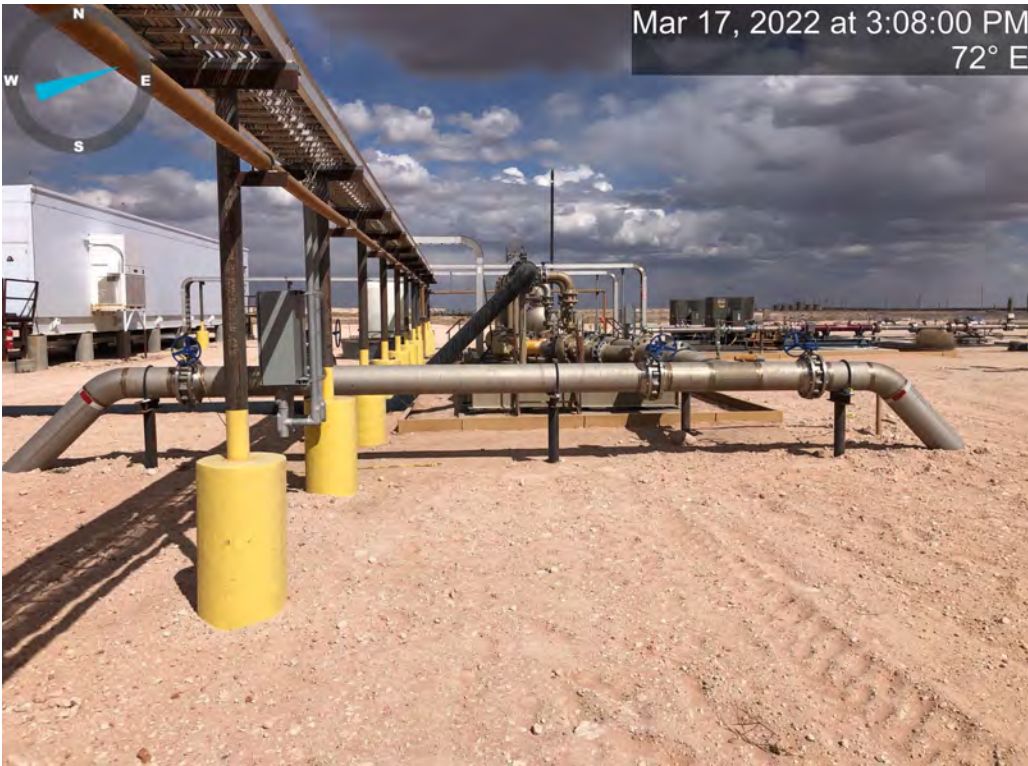
<b>Photo Number:</b> 16

<p>Mar 17, 2022 at 3:08:00 PM 72° E</p> <p>View of the remediated area after backfilling and regrading.</p>
<b>Date:</b> 3/17/2022	
<b>Photo Direction:</b> East	
<b>Coordinates:</b> 32.459320,-103.519437	
<b>Photo Description:</b>
