CLOSURE REQUEST REPORT

**Chevron Corporation
Baish Federal #012
Eddy County, New Mexico
Unit Letter "C", Section 09, Township 18 South, Range 31 East
Latitude 32.76659° North, Longitude 103.87780° West
NMOCD Reference #: nKMW1108946072**

March 25, 2022

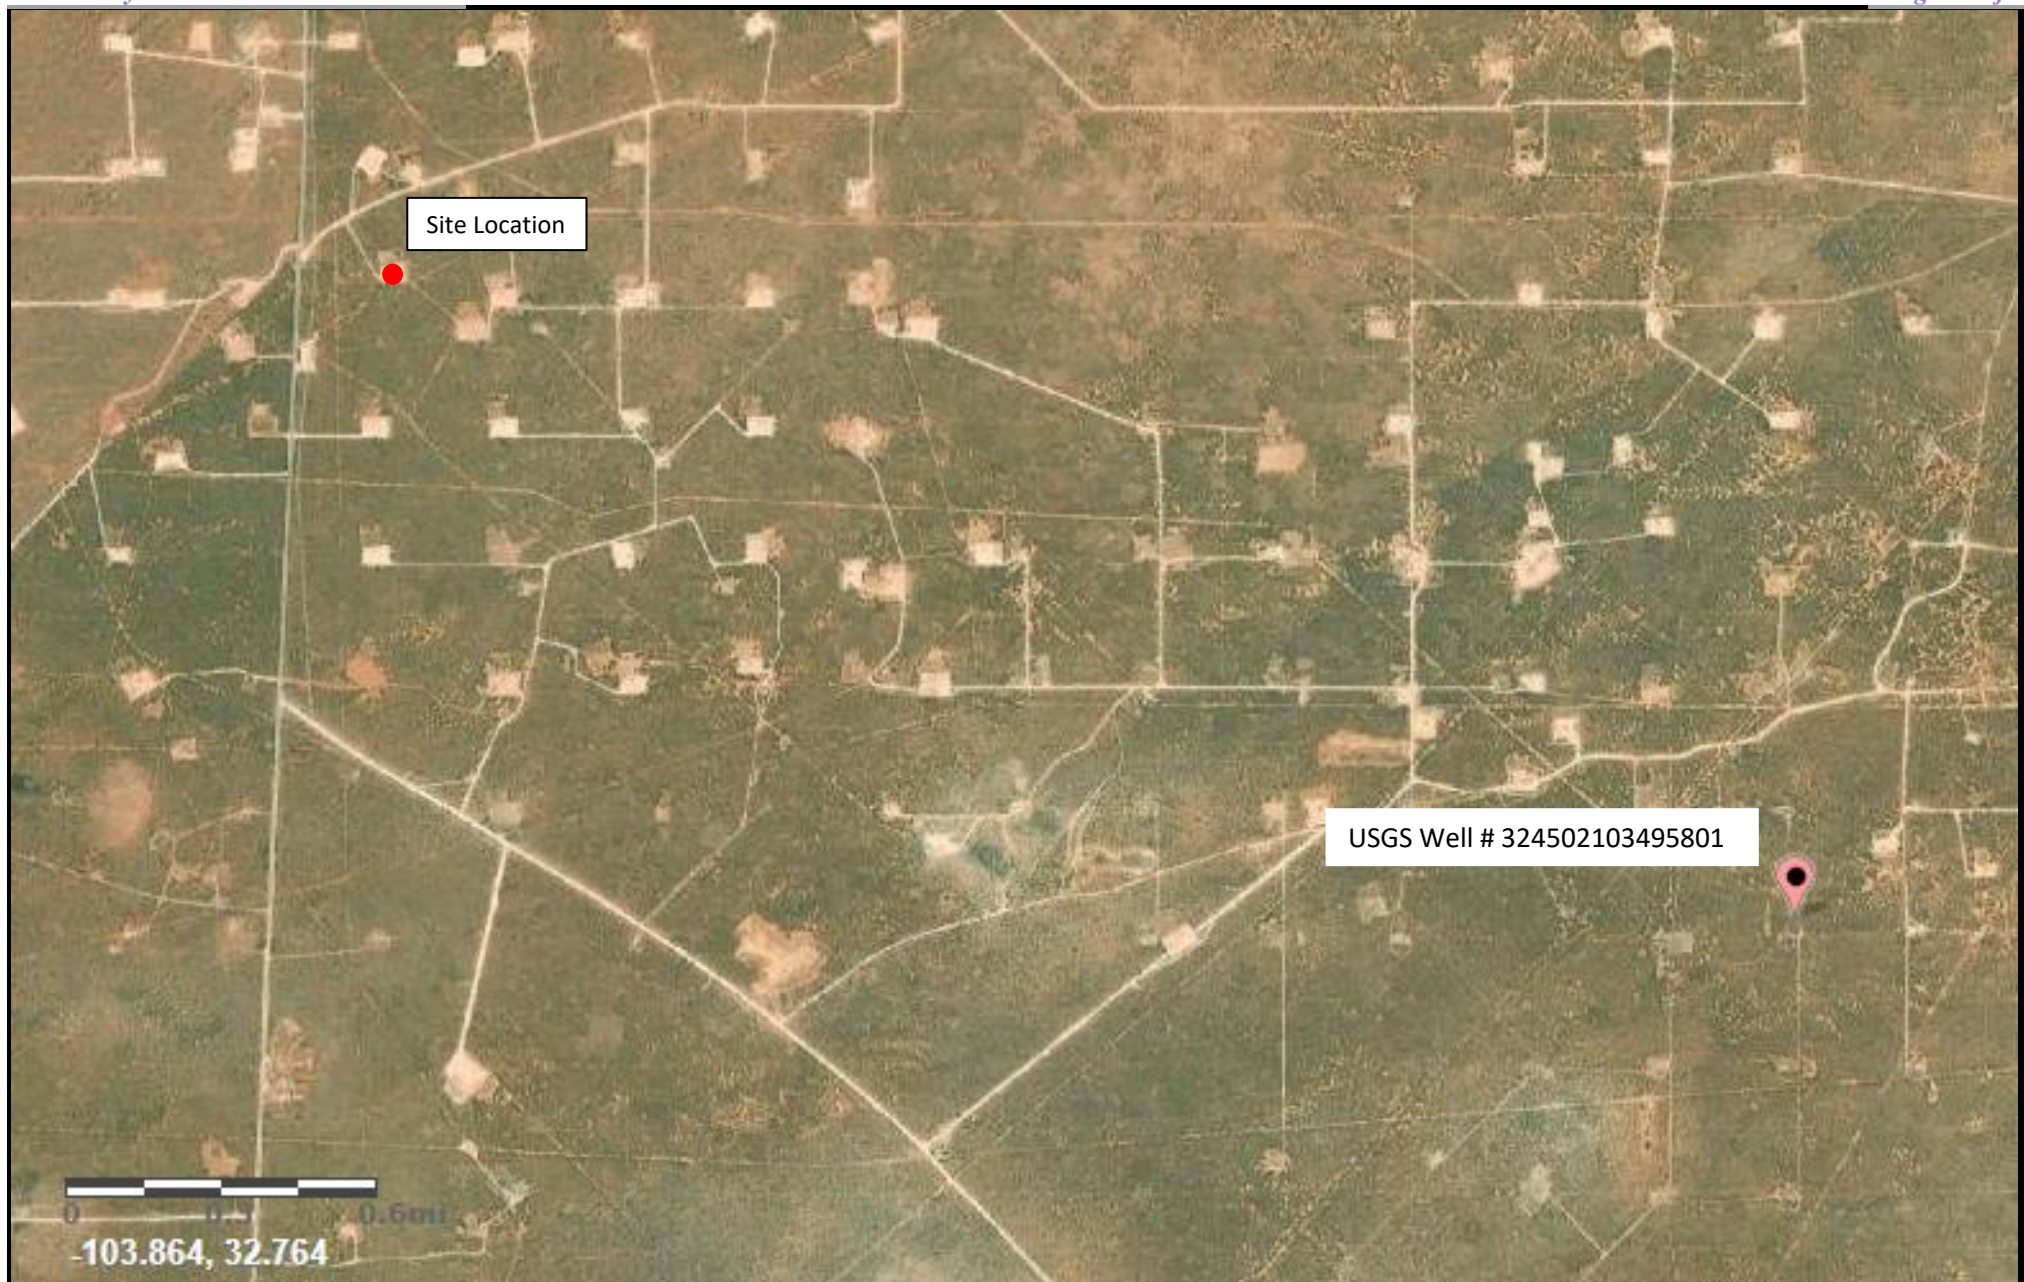
Figure 4

USGS Well Proximity Map
Chevron Corporation
Baish Federal #012
GPS: 32.76629, -103.87719
Eddy County

A search of the groundwater database maintained by United States Geological Survey (USGS) identified that there are no freshwater wells within a half (1/2) mile of the Release Site. The closest freshwater well (Well No.: 324502103495801) is approximately 2.74 miles to the southeast. The USGS database indicated groundwater should be encountered at approximately three hundred seventy-six (376) feet bgs. No surface water or water wells were observed within one thousand (1,000) feet of the release site. The Baish Federal #012 is not considered to be in a karst area and is considered stable. An "Aerial Proximity Map" is provided as Figure 2.
