**REPORT OF THE INVESTIGATION**

Etech Environmental & Safety Solutions, Inc. (Etech), on behalf of Chevron Corporation, has prepared this Closure Request for the Release Site known as Chesapeake Pronghorn State #001. The legal description of the Release Site is Unit Letter "G", Section 34, Township 23 South, Range 34 East, in Lea County, New Mexico. The Release Site GPS coordinates are 32.26289° North and 103.45580° West. A "Site Location Topographic Map" is provided as Figure 1.

**Project Name:** Chesapeake Pronghorn State #€€1  
**Project No:** 15310

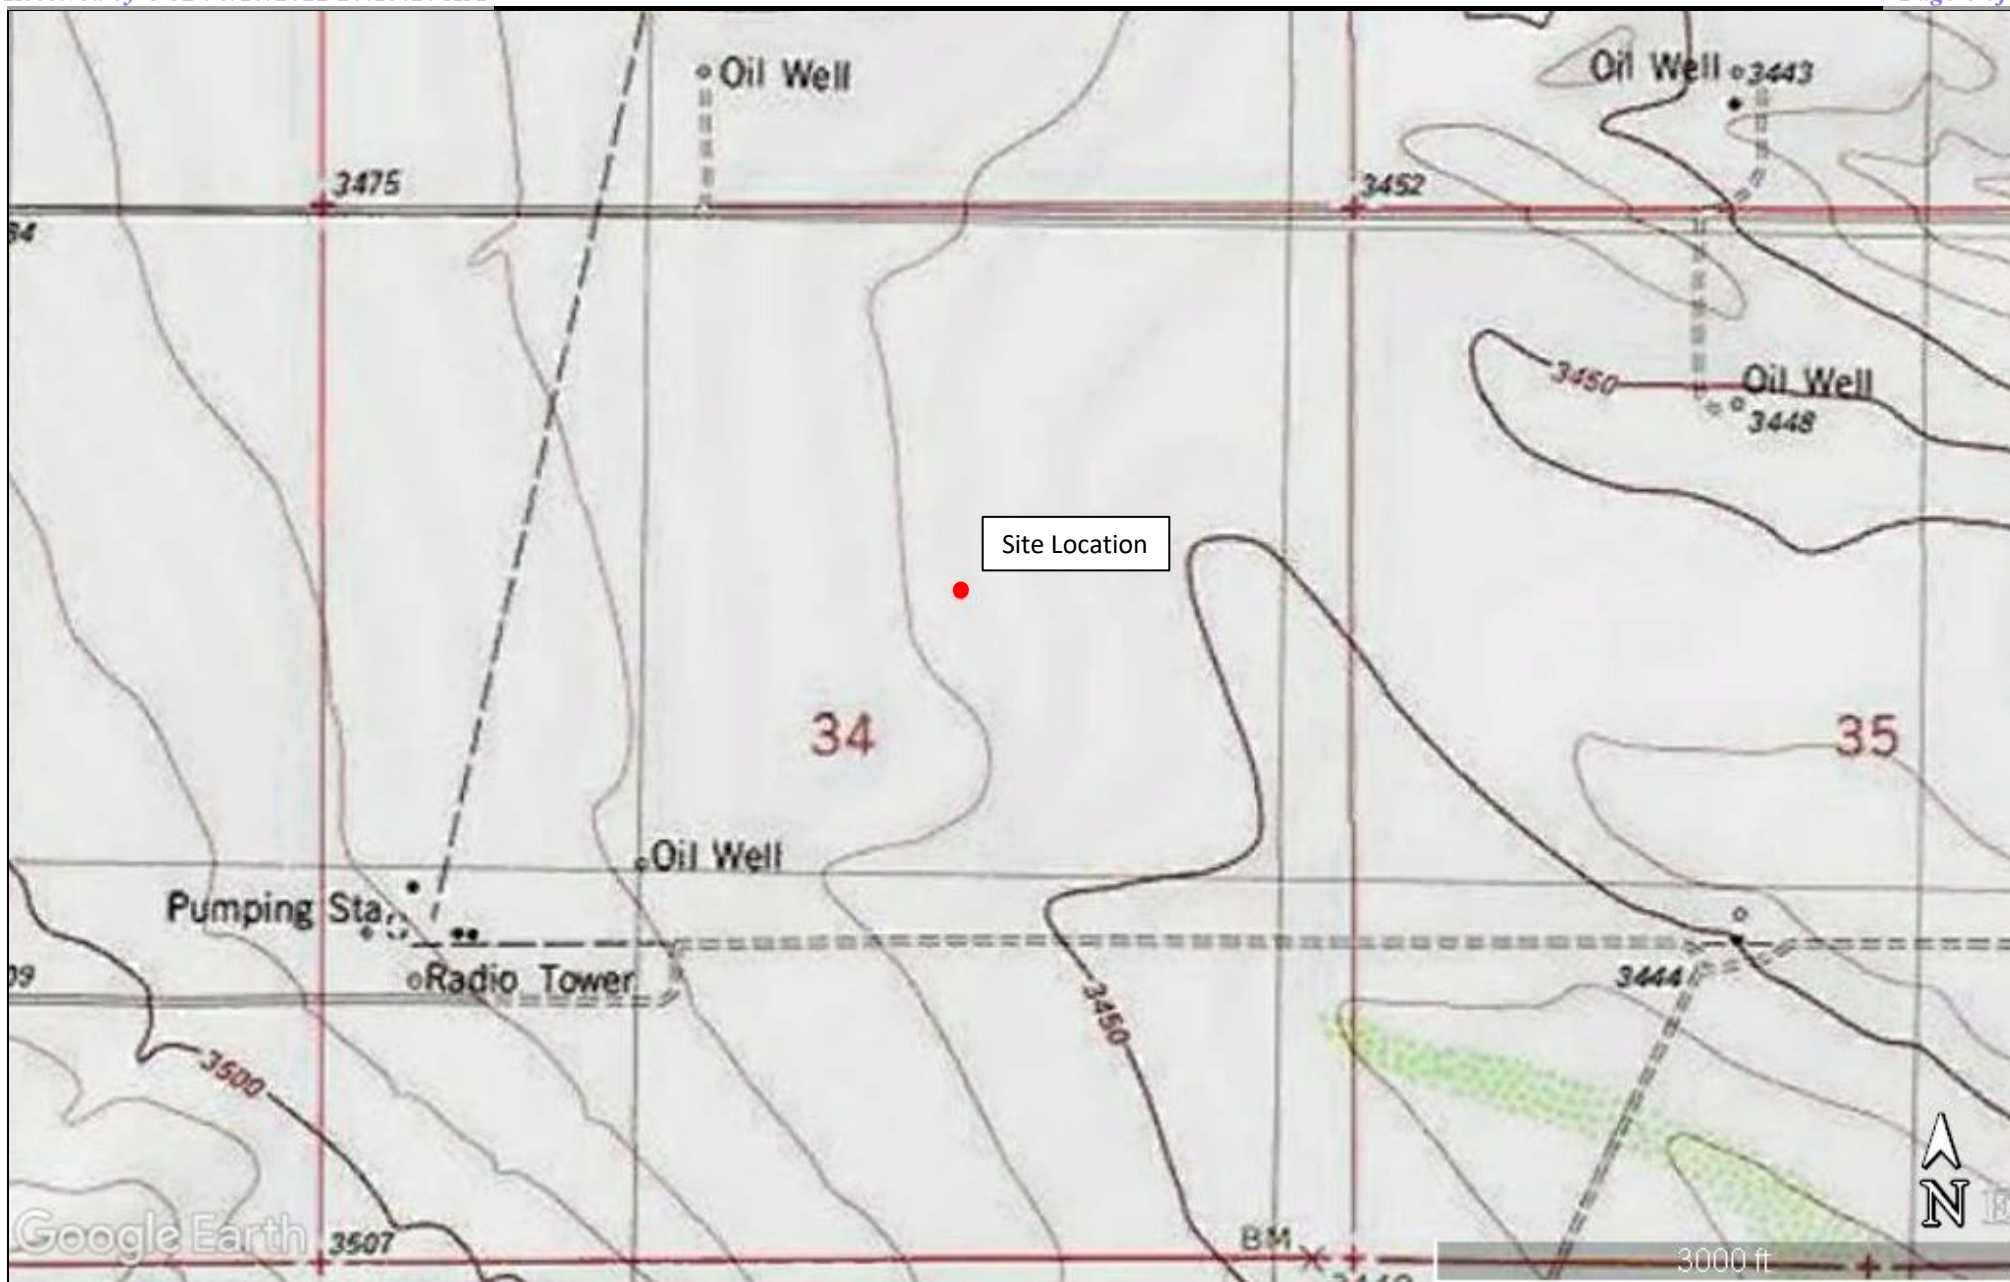
## Figure 1

Site Location Topographic Map  
Chevron Corporation  
Chesapeake Pronghorn State #  
GPS: 32.26289, -103.45580  
Lea County

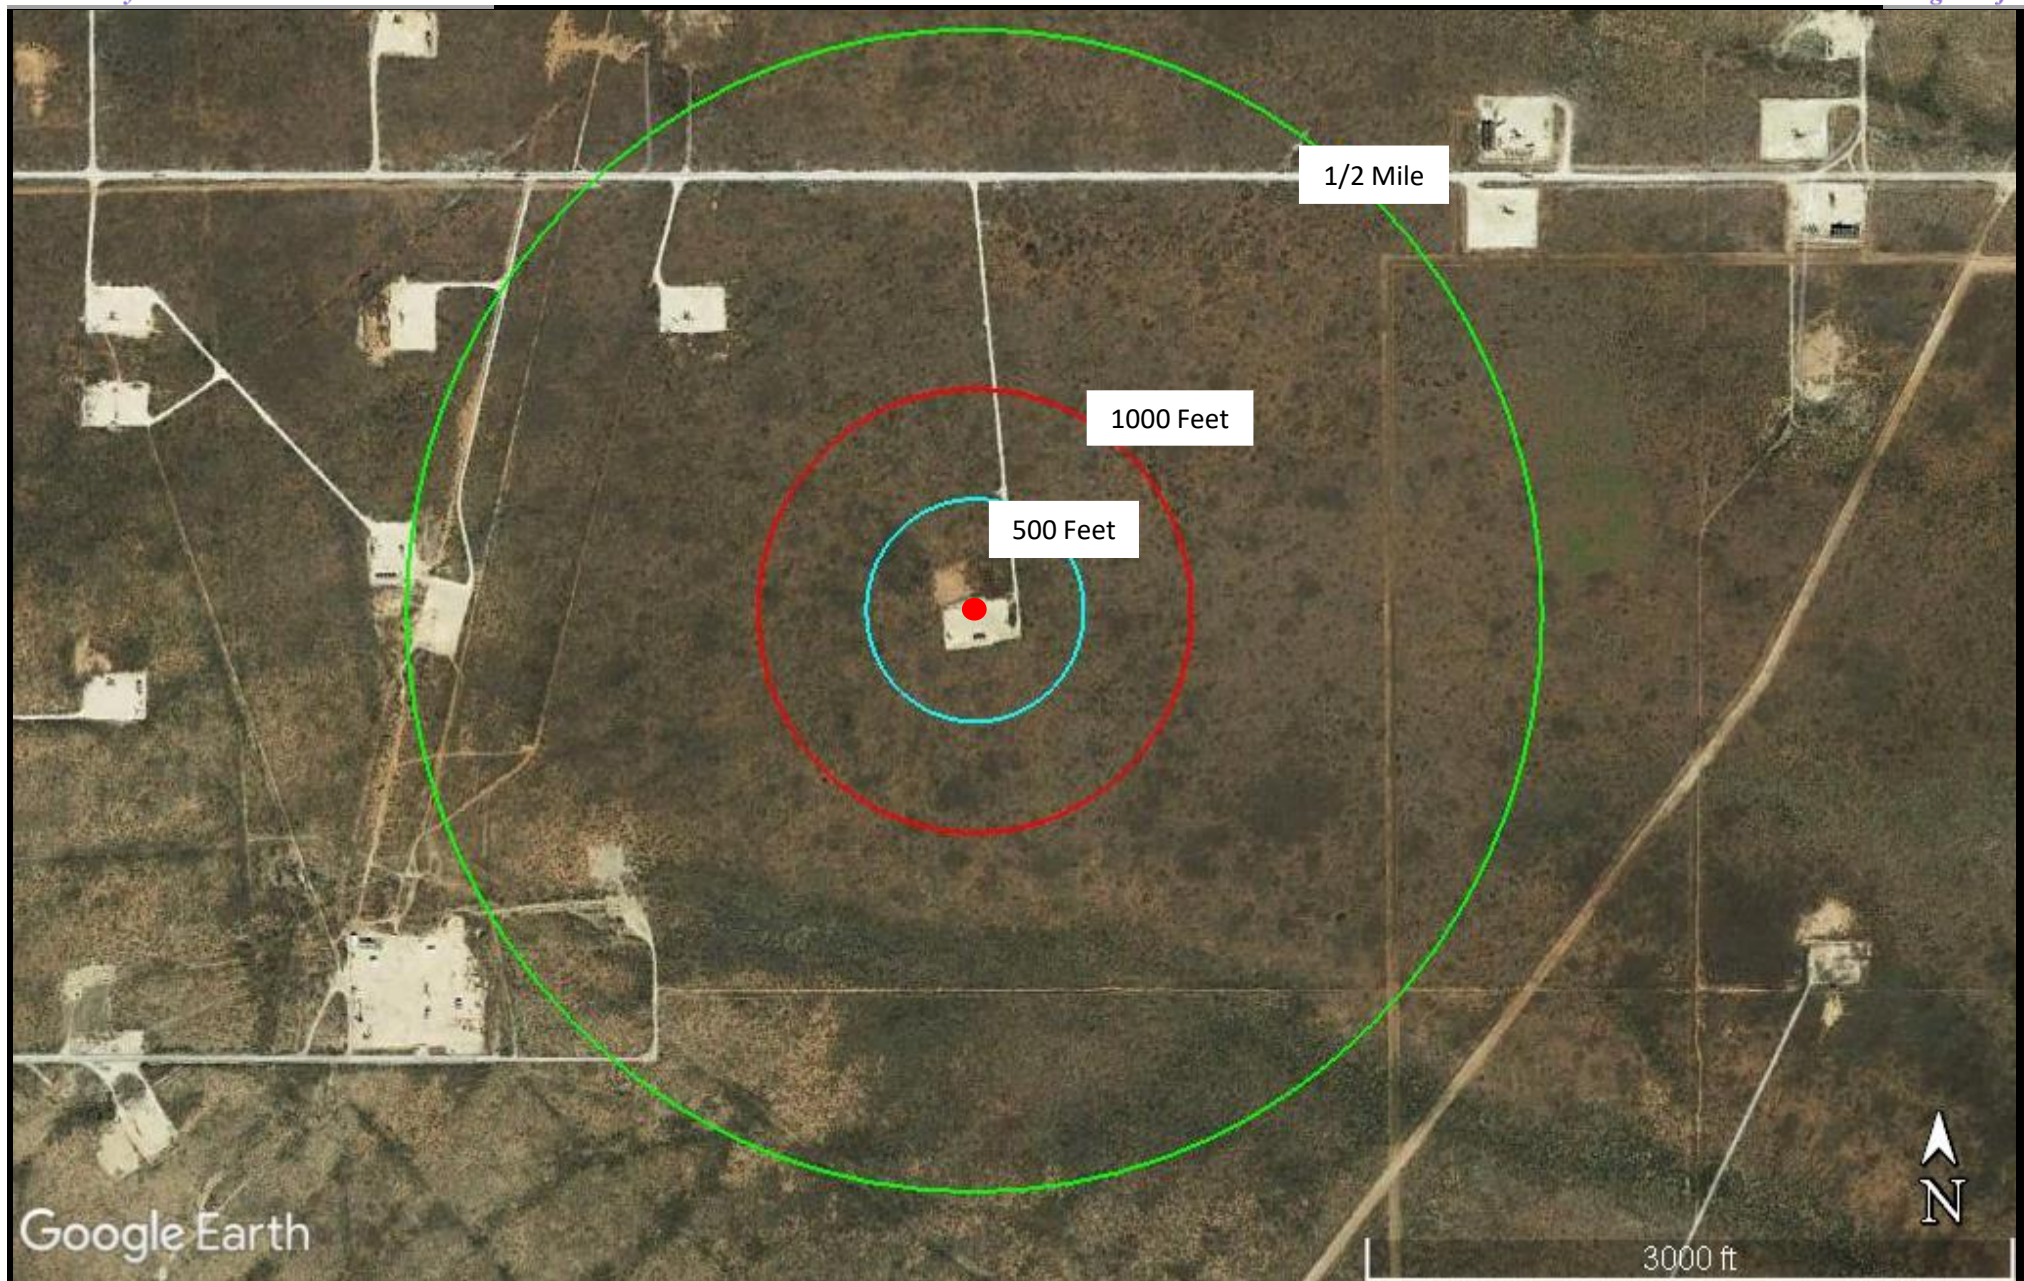
**Figure 2**

A search of the groundwater database maintained by United States Geological Survey (USGS) identified that there are no freshwater wells within a half (1/2) mile of the Release Site. The closest freshwater well (USGS Well # 321445103282301) is approximately 1.24 mile to the southwest. The USGS database indicated groundwater should be encountered at approximately four hundred forty (440) feet below ground surface (bgs). No surface water or water wells were observed within one thousand (1,000) feet of the Release Site. The Chesapeake Pronghorn State #001 is not considered to be in a karst area and is considered stable. An "Aerial Proximity Map" is provided as Figure 2. "

Aerial Proximity Map  
 Chevron Corporation  
 Chesapeake Pronghorn State # 1  
 GPS: 32.26289, -103.45580  
 Lea County

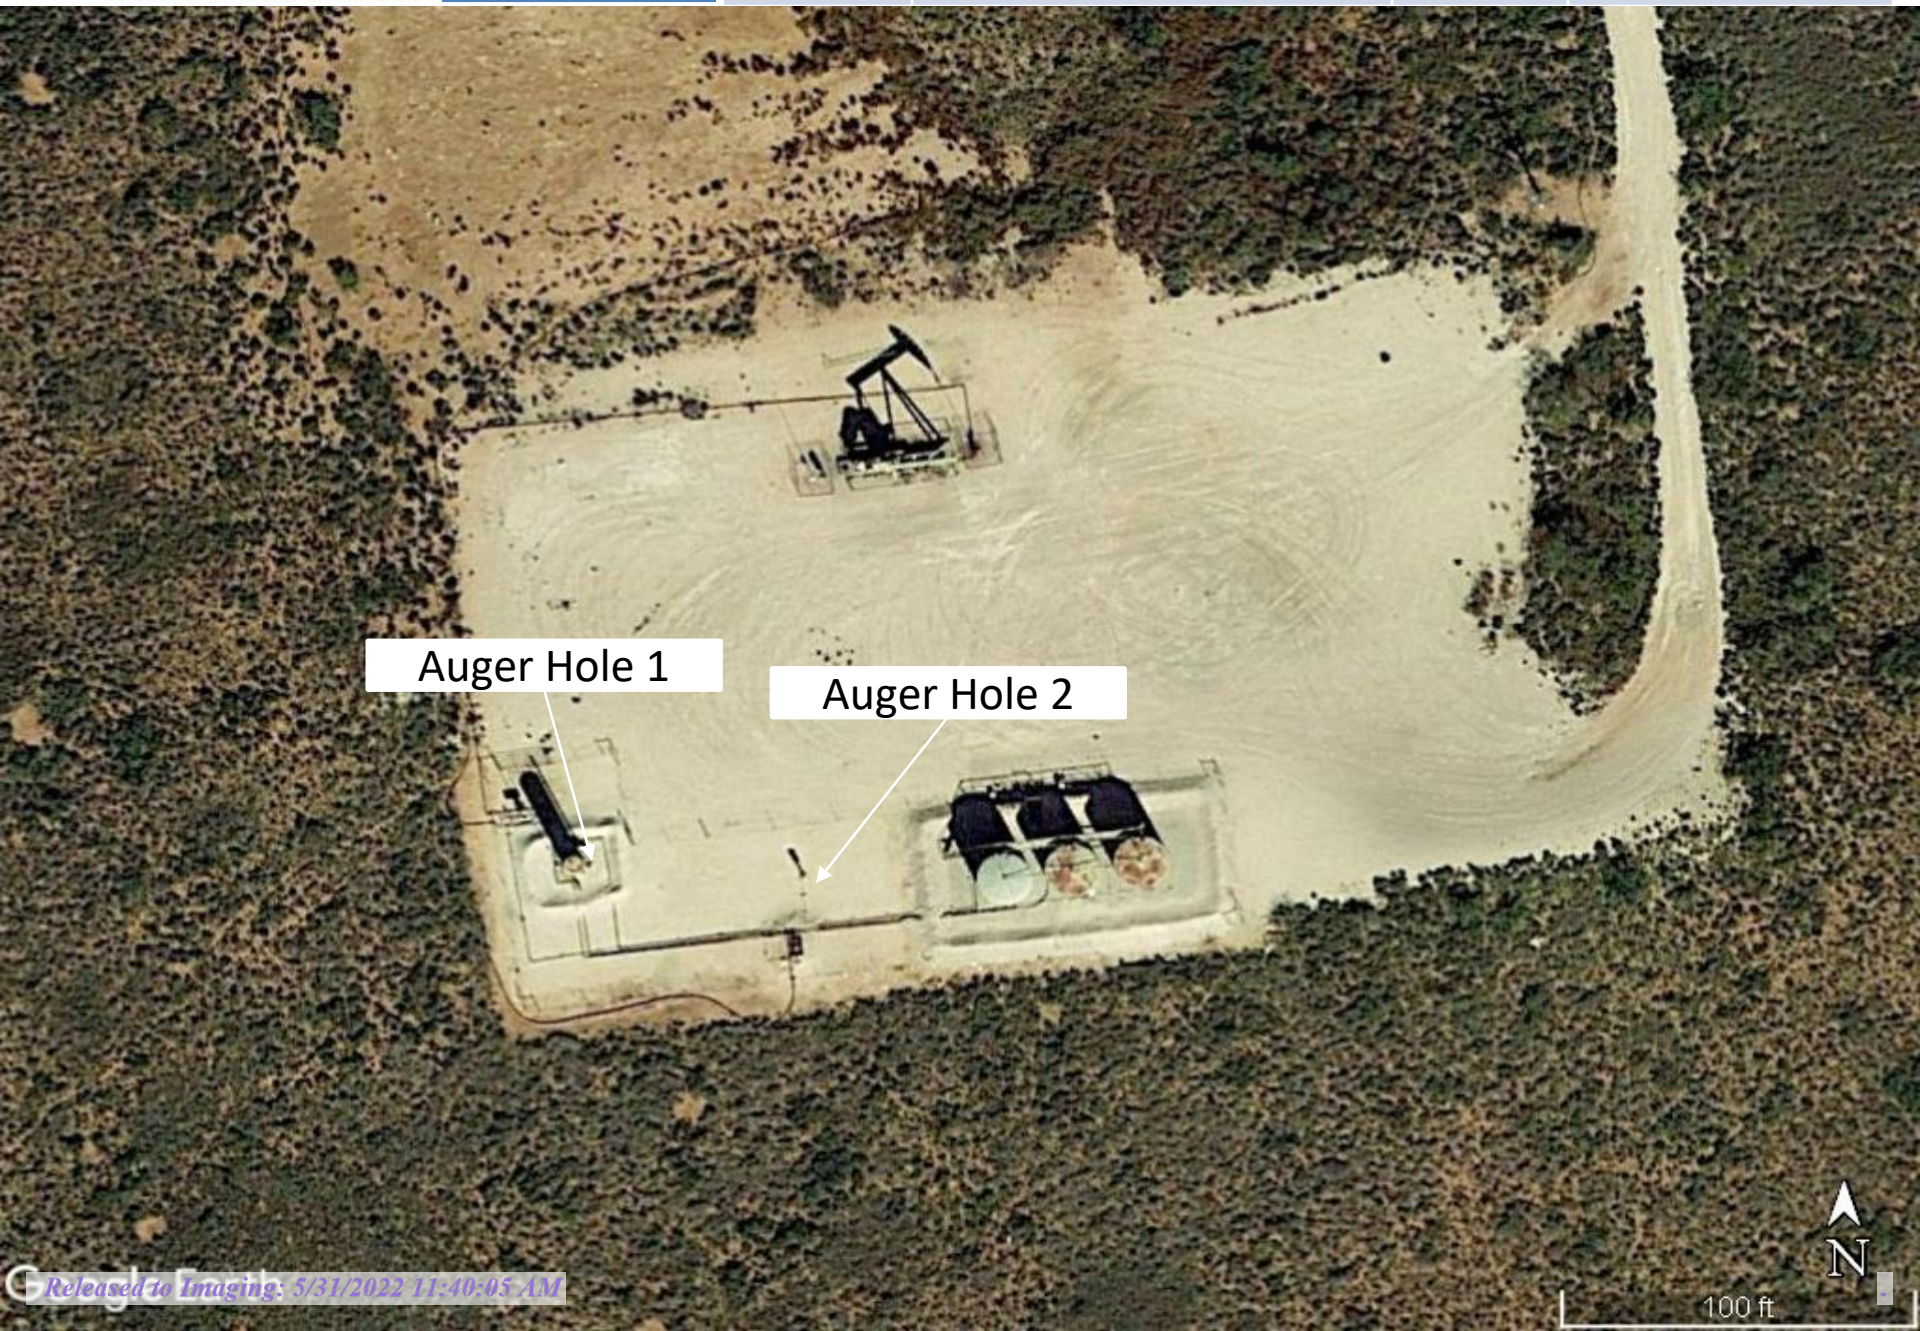
On February 15, 2022, Etech conducted an assessment and sampling event at the Release Site to determine the condition of the soil where it was inferred the spill had occurred. Two (2) soil borings were installed, and samples were collected at the six (6) inch and forty-eight (48) inch bgs intervals unless refusal was met (refer to Figure 3). Refusal was met at a depth of thirty (30) inches bgs in Auger Hole 1 (AH-1) and eighteen (18) inches bgs in Auger Hole 2 (AH-2). Samples were submitted to Xenco Eurofins to be analyzed for total petroleum hydrocarbons (TPH), chloride, and benzene, toluene, ethylbenzene & xylenes (BTEX) concentrations. A "Site and Sample Location Map" is provided as Figure 3.

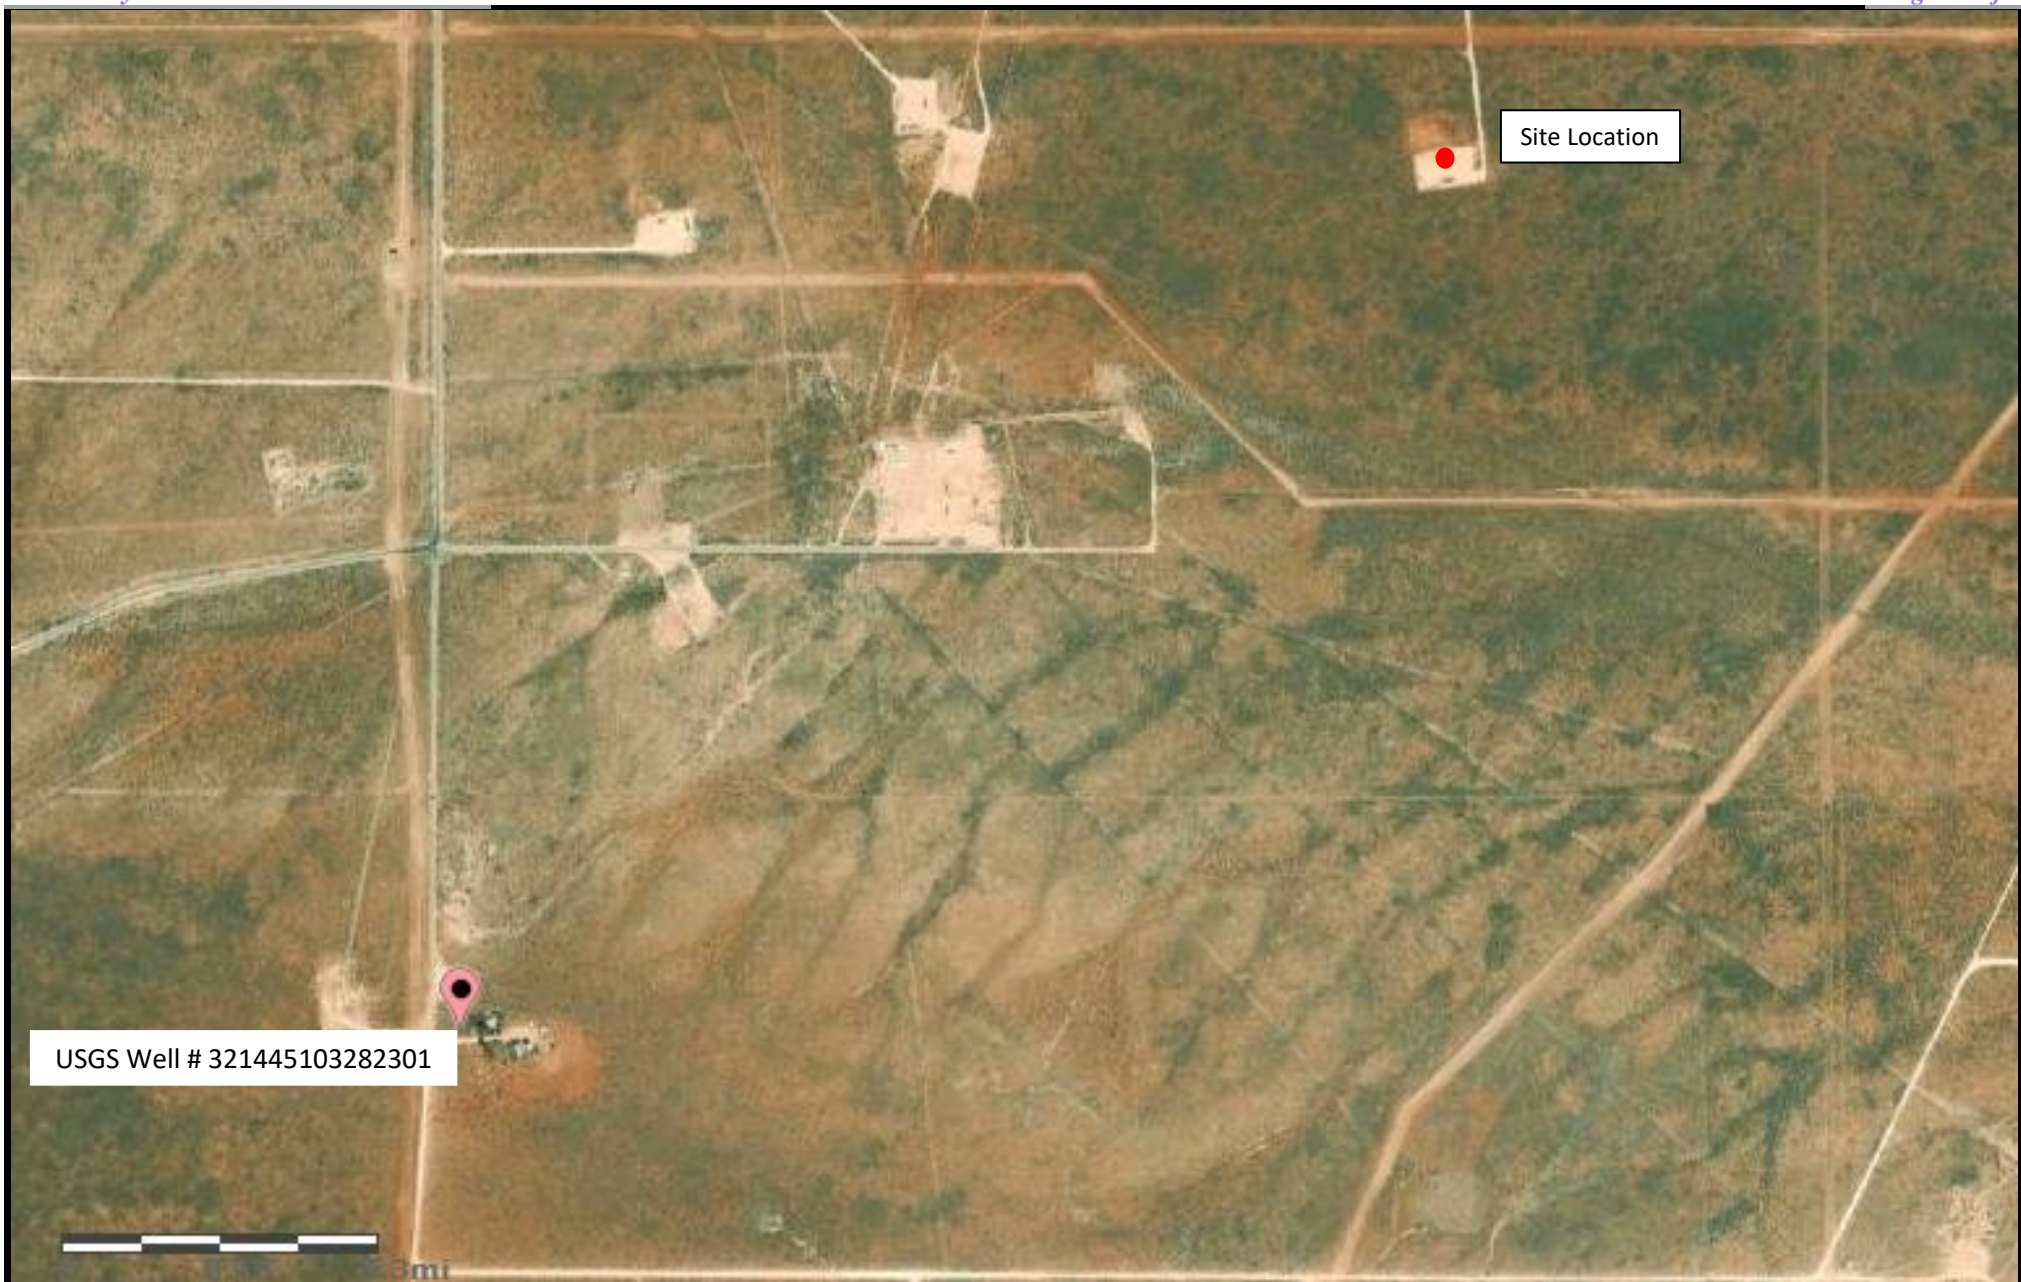
## Figure 4

USGS Well Proximity Map  
Chevron Corporation  
Chesapeake Pronghorn State # 1  
GPS: 32.26289, -103.45580  
Lea County

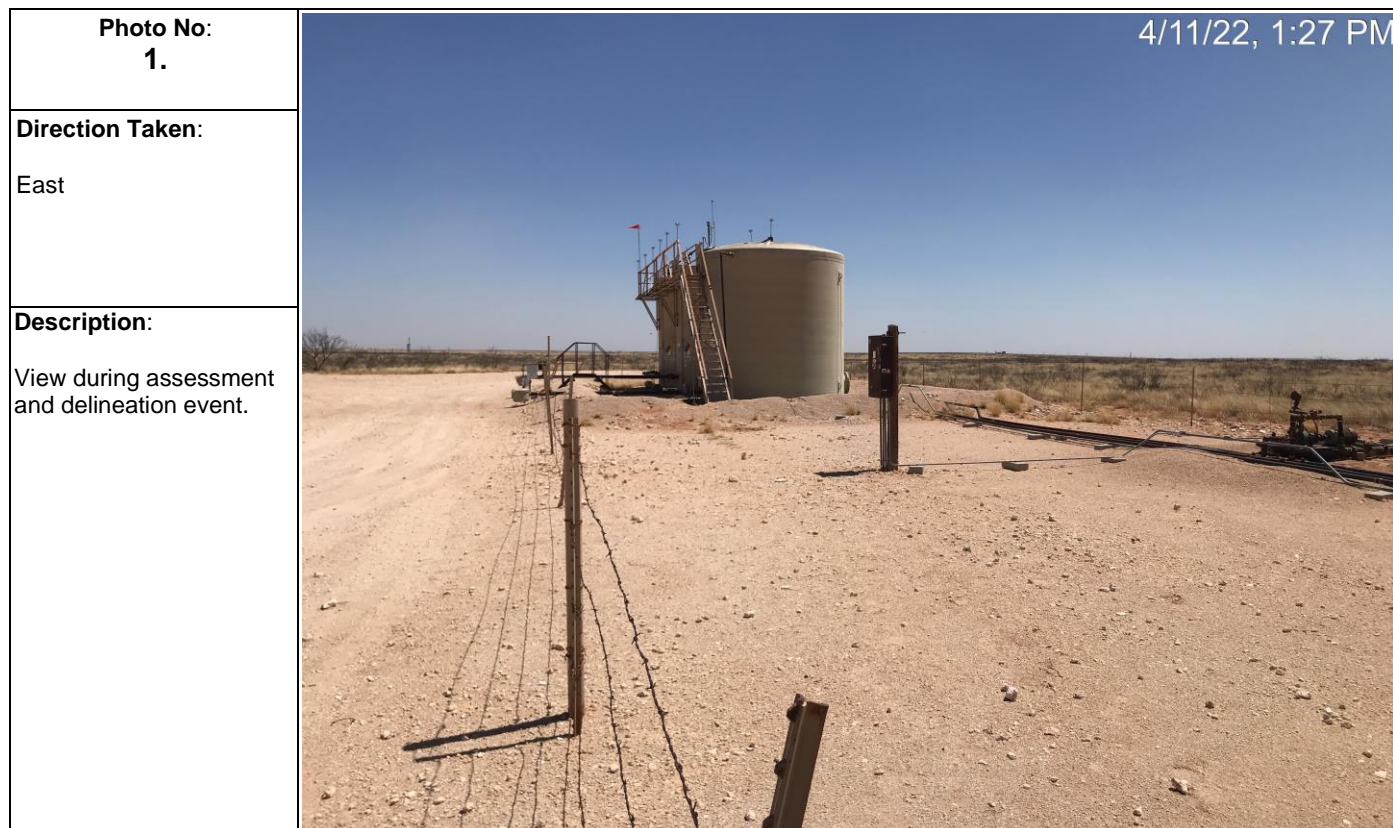
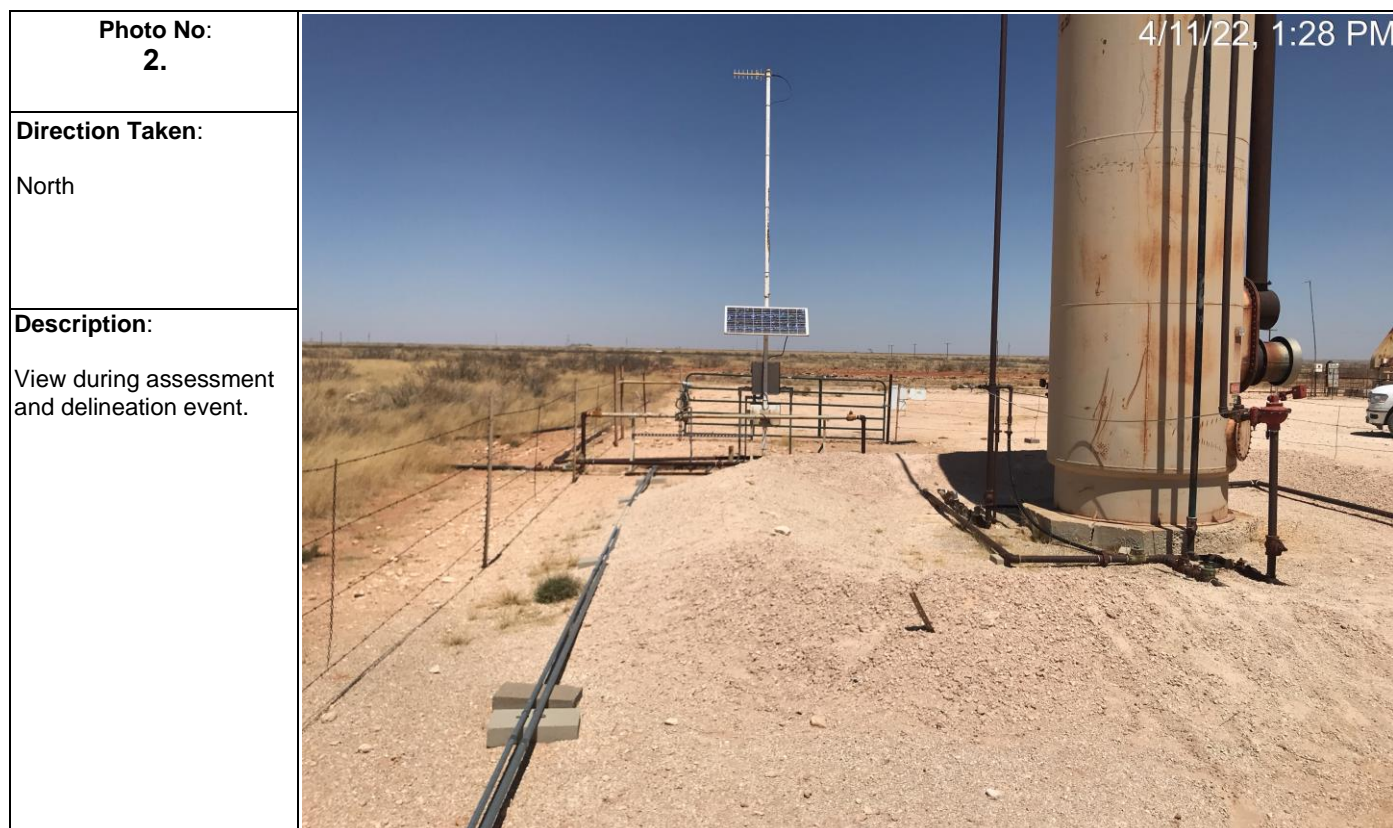
**Photographic Documentation**

Photographic documentation for the Release Site is provided as Appendix B.
