WSP USA

**RE: Closure Request  
Wolf Lateral PRV  
Incident Number NAPP2120957757  
Eddy County, New Mexico**

WSP USA Inc. (WSP), on behalf of Lucid Energy Delaware, LLC (Lucid), presents the following Closure Request detailing site assessment, excavation, and soil sampling activities at the Wolf Lateral PRV (Site) located in Unit I, Section 1, Township 22 South, Range 31 East, in Eddy County, New Mexico (Figure 1). The purpose of the site assessment, excavation, and soil sampling activities was to address impacts to soil following the release of natural gas and pipeline liquid from a pressure release valve (PRV) at the Site. Based on the excavation activities and confirmation soil sample laboratory analytical results, Lucid is submitting this Closure Request, and respectfully requesting no further action (NFA) status for Incident Number NAPP2120957757.

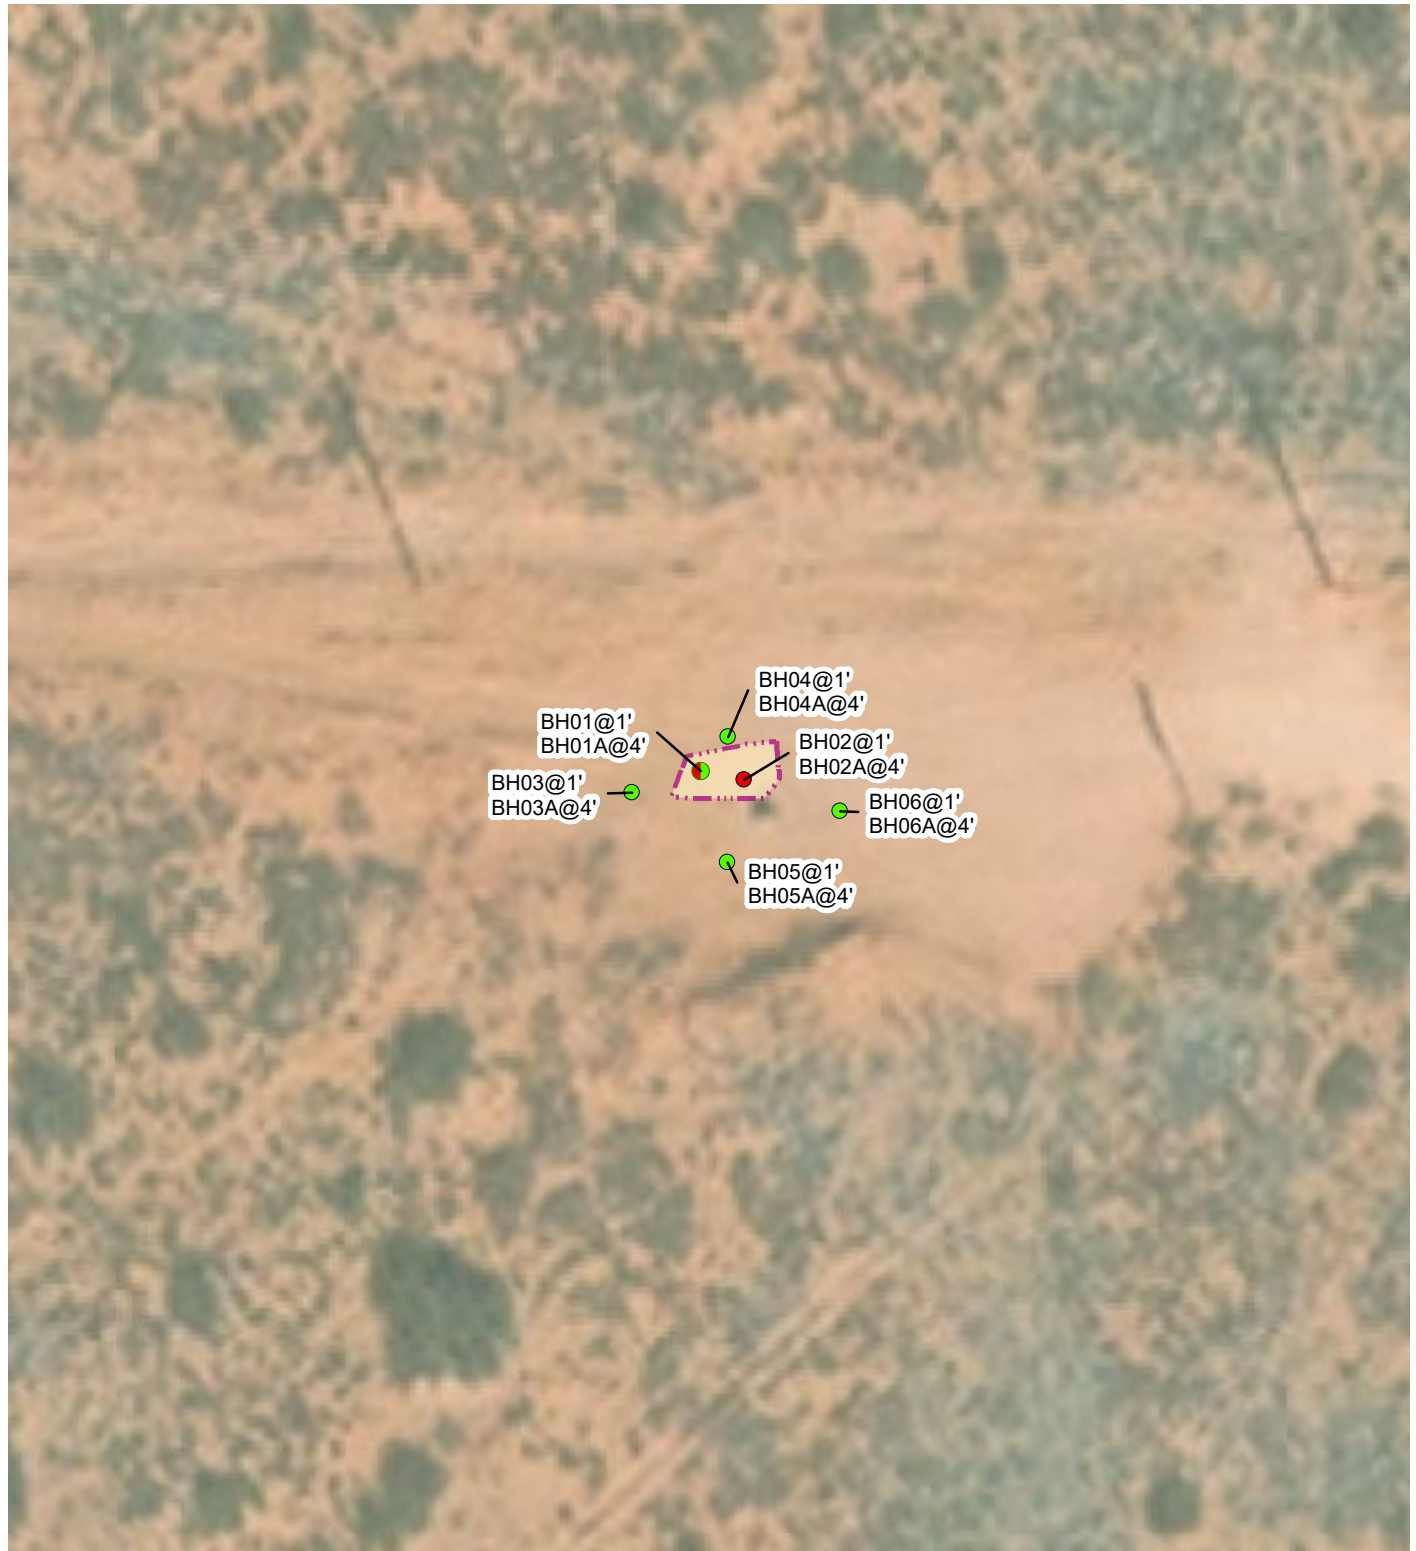
**FIGURE 2**  
**DELINEATION SOIL SAMPLE LOCATIONS**  
 WOLF LATERAL PRV  
 UNIT I SEC 1 T22S R31E  
 EDDY COUNTY, NEW MEXICO  
 WPX ENERGY PERMIAN, LLC

on lithologic/soil sampling logs, which are included in Attachment 2. The delineation soil samples were placed directly into pre-cleaned glass jars, labeled with the location, date, time, sampler initials, method of analysis, and immediately placed on ice. The soil samples were transported at or below 4 degrees Celsius (°C), under strict chain-of-custody (COC) procedures to Eurofins Laboratories (Eurofins) in Carlsbad, New Mexico, for analysis of BTEX following United States Environmental Protection Agency (EPA) Method 8021B; TPH following EPA Method 8015M/D; and chloride following EPA Method 300.0. The delineation sample locations were mapped utilizing a handheld GPS unit and are presented on Figure 2.

Laboratory analytical results for borehole delineation samples indicated BH01A at 4 feet bgs and BH02 and BH02A at 1 foot and 4 feet bgs, respectively, exceeded the TPH Closure Criteria. Concentration of benzene, BTEX, and chloride in all boreholes were compliant with the Site Closure Criteria.

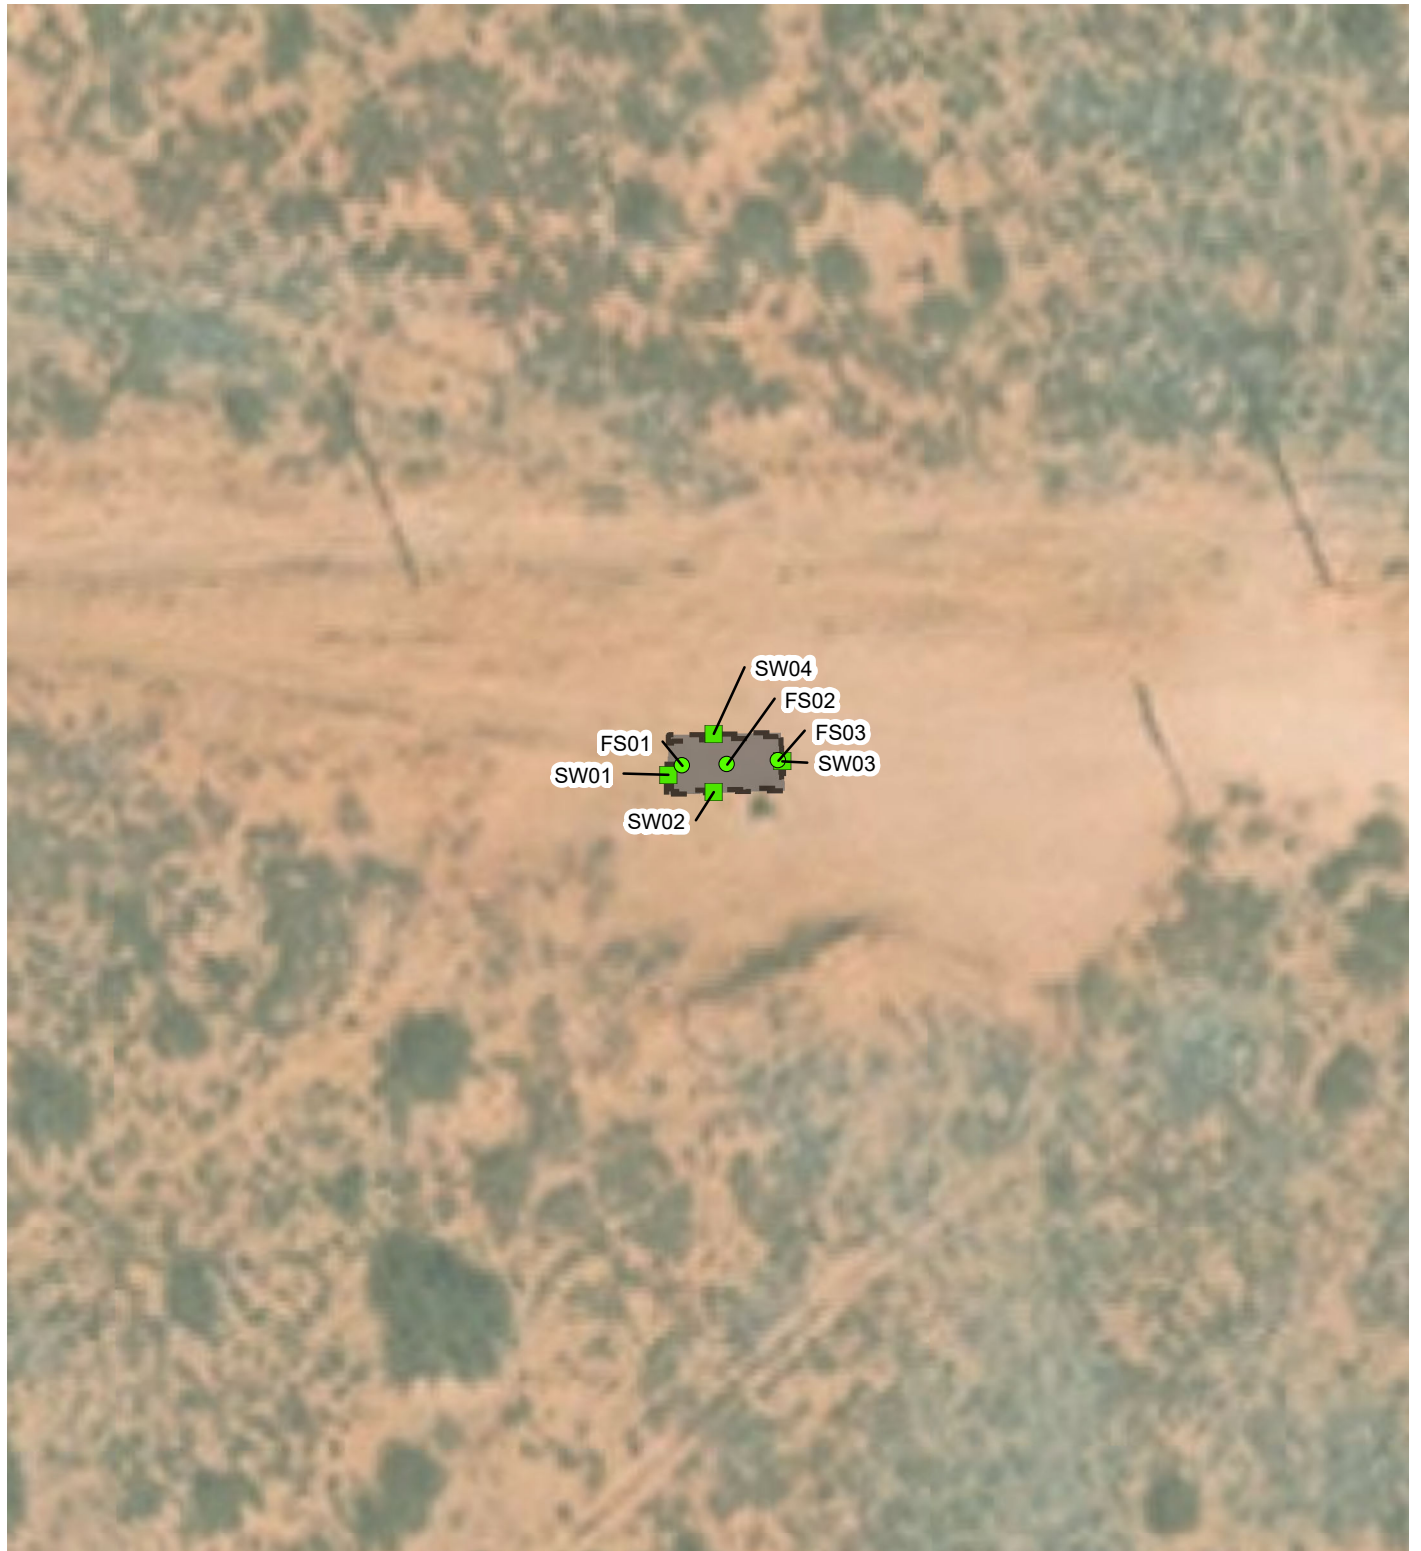
**FIGURE 3**  
EXCAVATION SOIL SAMPLE LOCATIONS  
WOLF LATERAL PRV  
UNIT I SEC 1 T22S R31E  
EDDY COUNTY, NEW MEXICO  
**WPX ENERGY PERMIAN, LLC**

On February 21, 2022, WSP personnel returned to the Site to oversee excavation and completion of activities, areas that exceeded Closure Criteria were excavated and sampled as FS01-FS03 and SW01-SW04. Field screening results for soil samples FS01-FS03 and SW01-SW04 indicated that chloride concentrations were compliant with the Closure Criteria; benzene, BTEX, TPH-GRO/TPH-DRO, and TPH were compliant with the Closure Criteria as well. The soil samples were placed directly into pre-cleaned glass jars, labeled with the location, date, time, sampler initials, method of analysis, and immediately placed on ice. The soil samples were transported at or below 4 degrees Celsius (°C), under strict chain-of-custody (COC) procedures to Eurofins Laboratories (Eurofins) in Carlsbad, New Mexico, for analysis of BTEX following United States Environmental Protection Agency (EPA) Method 8021B; TPH following EPA Method 8015M/D; and chloride following EPA Method 300.0. The delineation sample locations were mapped utilizing a handheld GPS unit and are presented on Figure 3.

Laboratory analytical results from excavation samples indicated all concentrations of benzene, BTEX, TPH, and chloride are compliant with the closure criteria. All surficial staining and impacted soil in the release area was removed. Excavation activities were performed using a backhoe and hydro-vacuum truck. To direct excavation activities, WSP screened soil for volatile aromatic hydrocarbons and chloride utilizing a PID and Hach® chloride QuanTab® test strips, respectively. The excavation was completed to an approximate depth of 5-foot bgs.

from the floor of the excavation, from a depth of 5-foot bgs. Due to the depth of the excavation, soil samples were taken for the sidewalls (SW) of the excavation (SW01 through SW04). The excavation SW soil samples were collected, handled, and analyzed following the same procedures as described above. The excavation extent and excavation soil sample locations are presented on Figure 3. Photographic documentation was completed during the Site visits and a photographic log is included in Attachment 3.

Laboratory analytical results for excavation soil samples FS01 through FS03 and SW01 through SW04 indicated benzene, BTEX, TPH, and chloride concentrations were compliant with the Closure Criteria. Laboratory analytical results are summarized in Table 1 and the complete laboratory analytical reports are included as Attachment 4.

The excavation area measured approximately 464 square feet. A total of approximately 86 cubic yards of impacted soil was removed during the excavation activities. The impacted soil was transported and properly disposed of at the R360 Facility in Hobbs, New Mexico. After completion of confirmation sampling, the excavation area was backfilled.

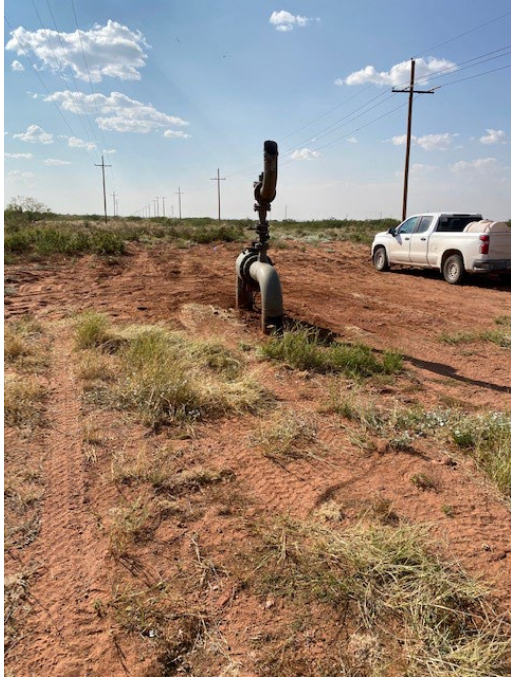
Photo No.	Date	
1	September 29, 2021	
View of the Release area and Riser

A photograph showing a dirt road in a rural area. In the foreground, there is a metal riser pipe sticking out of the ground. To the right, a white pickup truck is parked. In the background, there are power lines and a clear blue sky with some clouds.

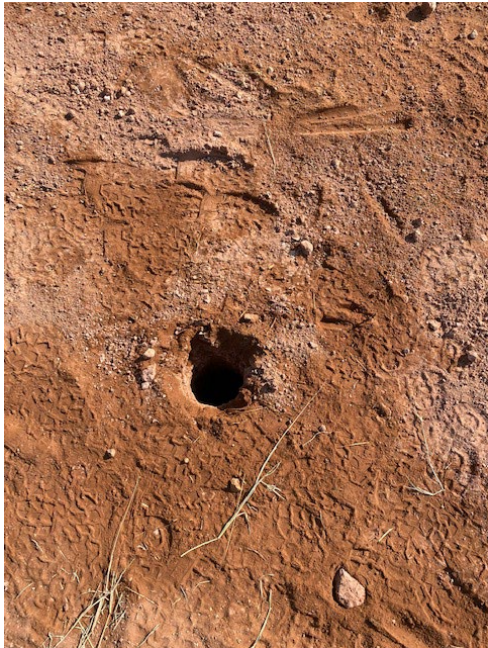
Photo No.	Date	
2	September 29, 2021	
View of BH01

A close-up photograph of a hole in the ground. The soil is reddish-brown and appears to be dry and crumbly. The hole is circular and goes down into the earth.

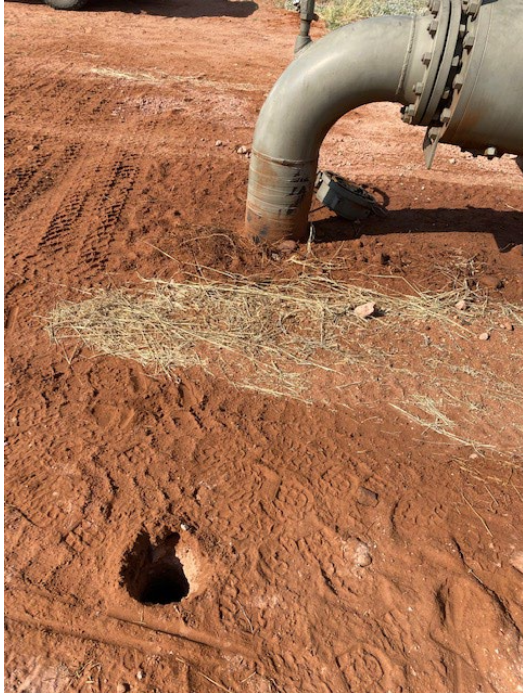
<b>Photo No.</b>	<b>Date</b>	
3	September 29, 2021	
View of BH02

A photograph showing a large, dark, circular hole in the ground, likely a borehole. The ground is reddish-brown soil. A large, curved metal pipe or valve is visible in the upper right corner of the frame.

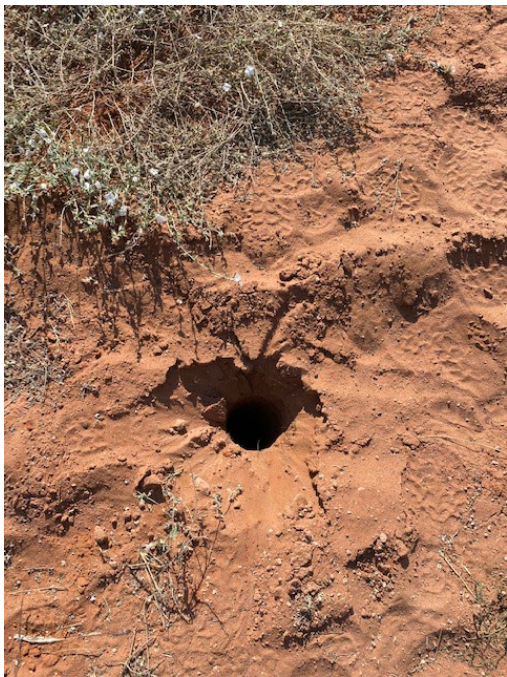
<b>Photo No.</b>	<b>Date</b>	
4	September 29, 2021	
View of BH03

A photograph showing a large, dark, circular hole in the ground, likely a borehole. The ground is reddish-brown soil. There is some sparse, dry vegetation around the hole.

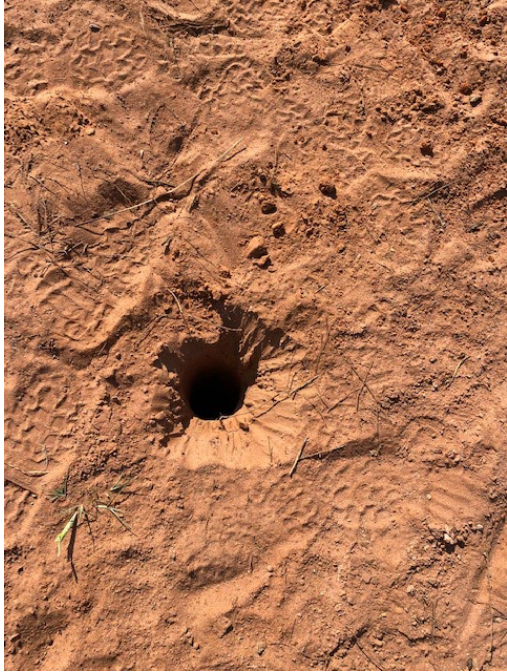
5	September 29, 2021	
View of BH04

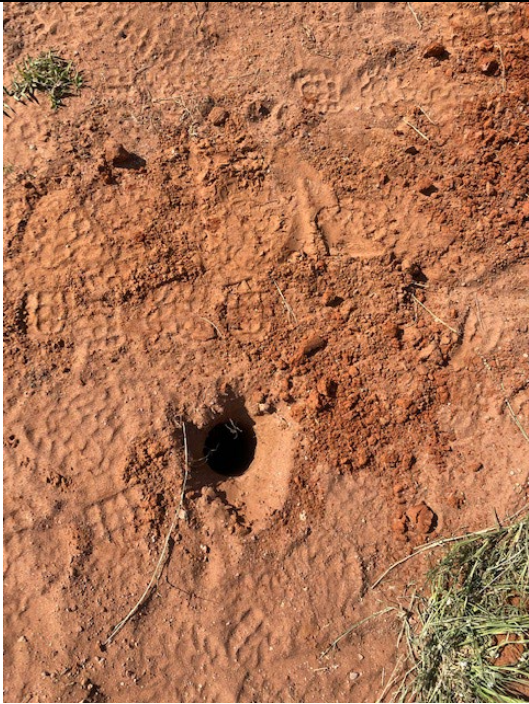
6	September 29, 2021	
View of BH05

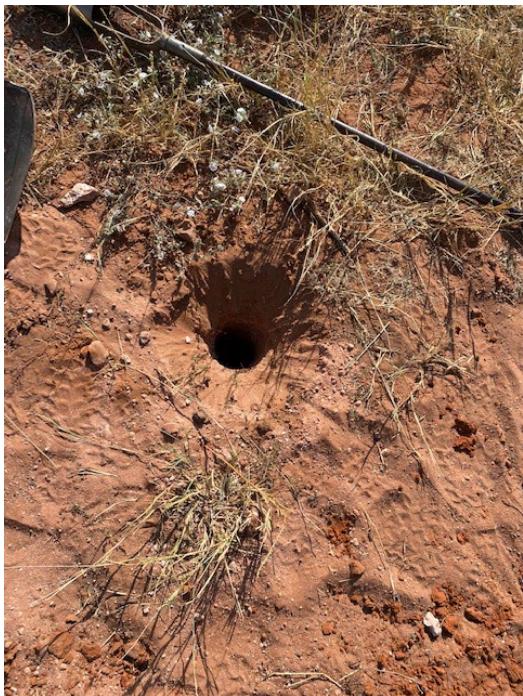
Photo No.	Date	
7	September 29, 2021	
View of BH06

A photograph showing a deep, circular hole (BH06) dug into reddish-brown soil. The hole is surrounded by dry, yellowish-brown grass and some small rocks. A black pipe or rod is visible extending from the top of the hole.
