**Re: Release Characterization and Remediation Work Plan
ConocoPhillips
Zia Hills 20 Trunkline Release
Unit Letter J, Section 20, Township 26 South, Range 32 East
Lea County, New Mexico
Incident ID NAPP2208248869**

TETRA TECH, INC. PROJECT NO. 212C-MD-02714A	DESCRIPTION	View west. Hydrovac excavation at the release point.	1
	SITE NAME	COP – Zia Hills 20 Trunkline Release	3/10/2022

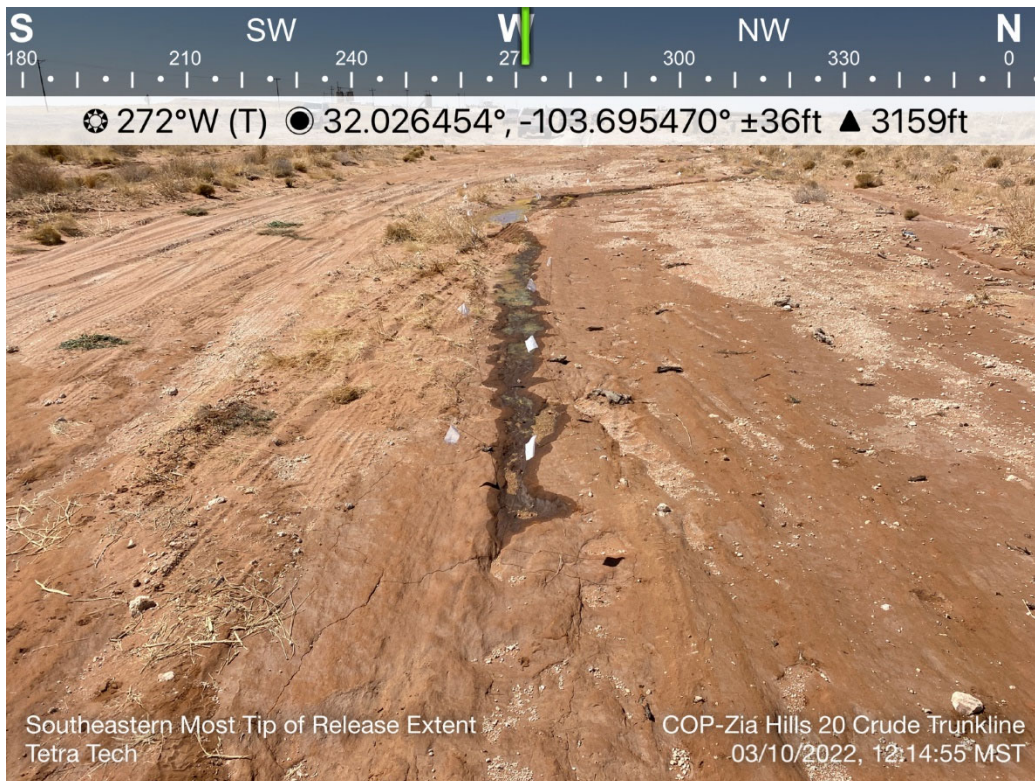
TETRA TECH, INC. PROJECT NO. 212C-MD-02714A	DESCRIPTION	View west. Southeastern extent of the release footprint.	2
	SITE NAME	COP – Zia Hills 20 Trunkline Release	3/10/2022

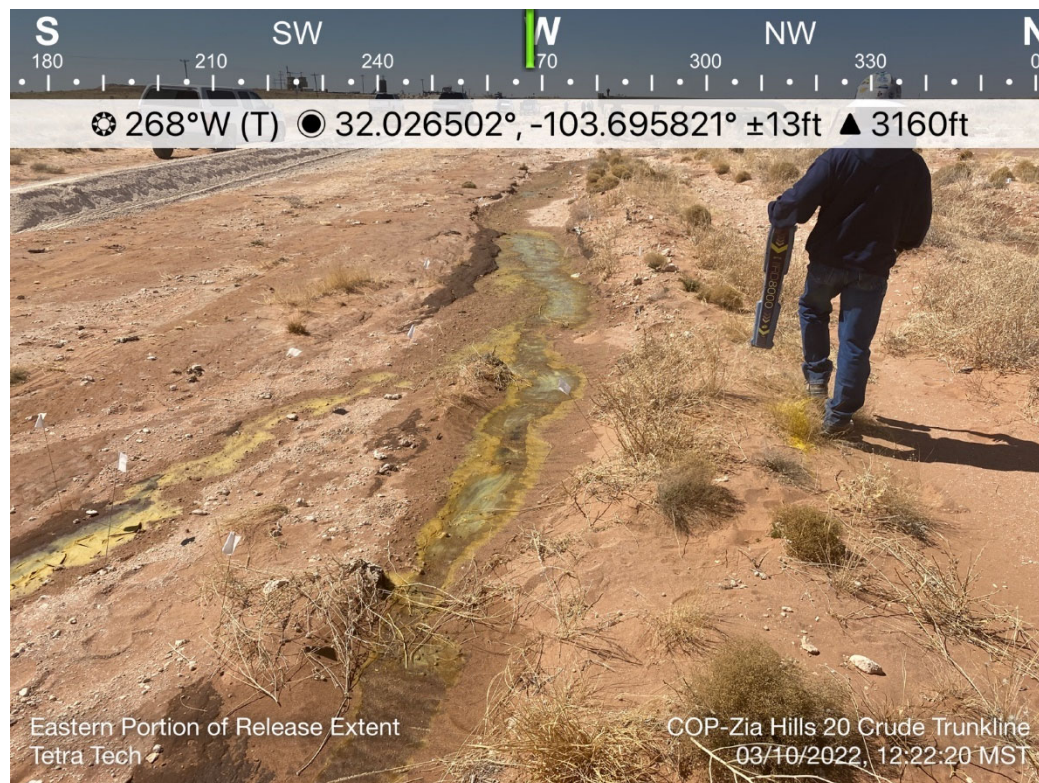
TETRA TECH, INC. PROJECT NO. 212C-MD-02714A	DESCRIPTION	View west. Eastern portion of the release footprint.	4
	SITE NAME	COP – Zia Hills 20 Trunkline Release	3/10/2022

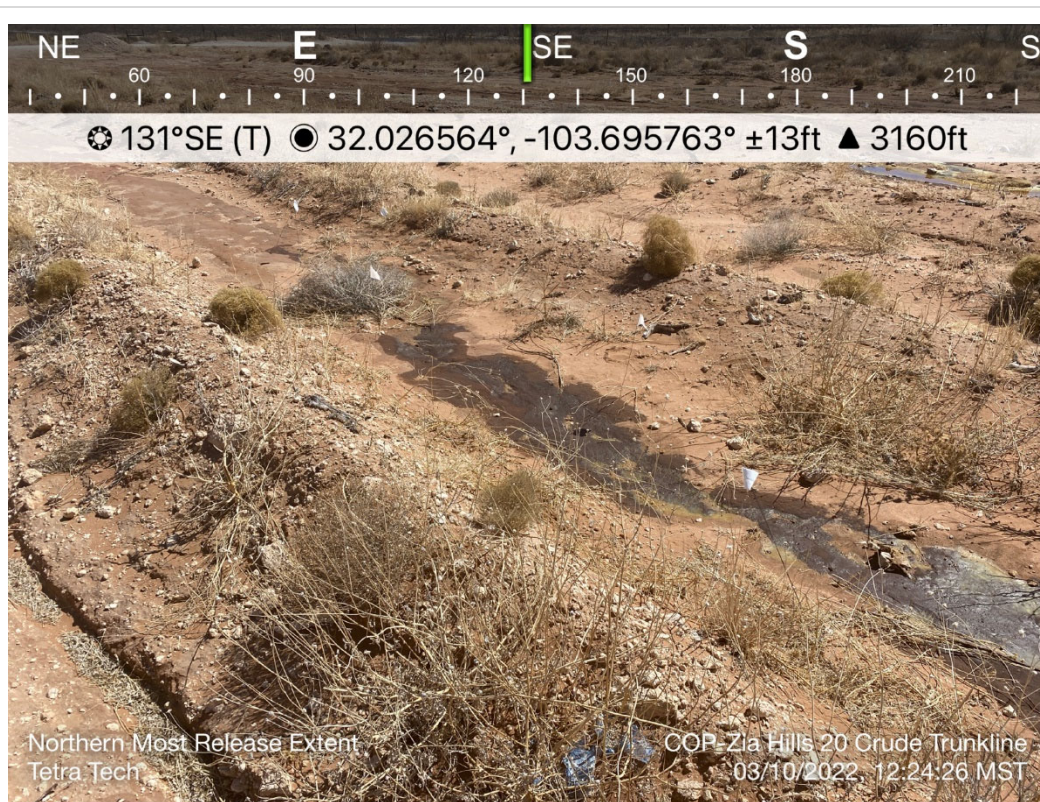
TETRA TECH, INC. PROJECT NO. 212C-MD-02714A	DESCRIPTION	View southeast. Northern extent of the release footprint.	5
	SITE NAME	COP – Zia Hills 20 Trunkline Release	3/10/2022

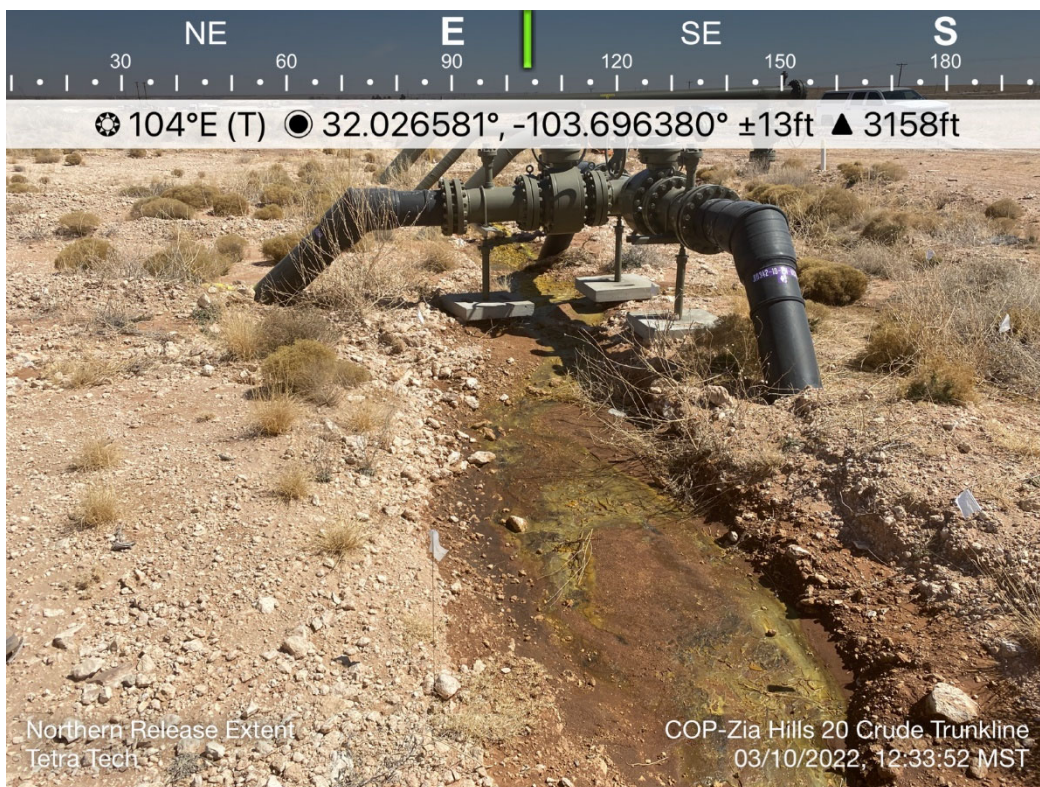
TETRA TECH, INC. PROJECT NO. 212C-MD-02714A	DESCRIPTION	View east. Release footprint near production piping.	6
	SITE NAME	COP – Zia Hills 20 Trunkline Release	3/10/2022

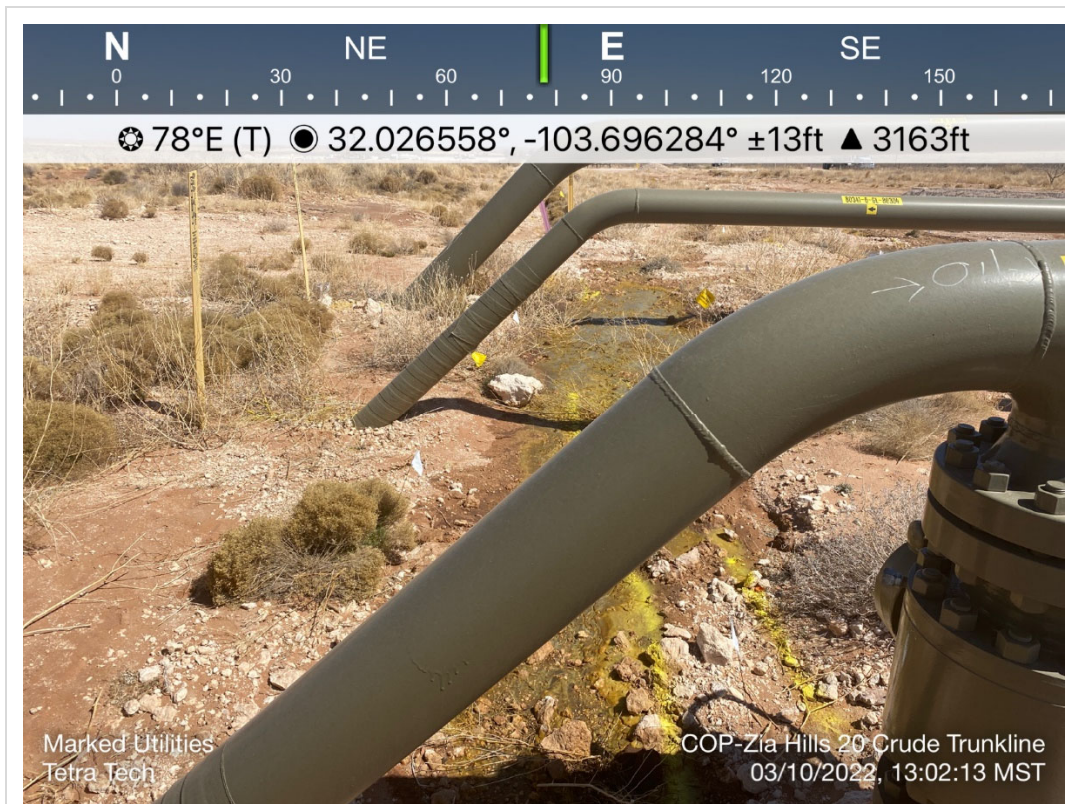
TETRA TECH, INC. PROJECT NO. 212C-MD-02714A	DESCRIPTION	View east. Release footprint near production piping.	7
	SITE NAME	COP – Zia Hills 20 Trunkline Release	3/10/2022

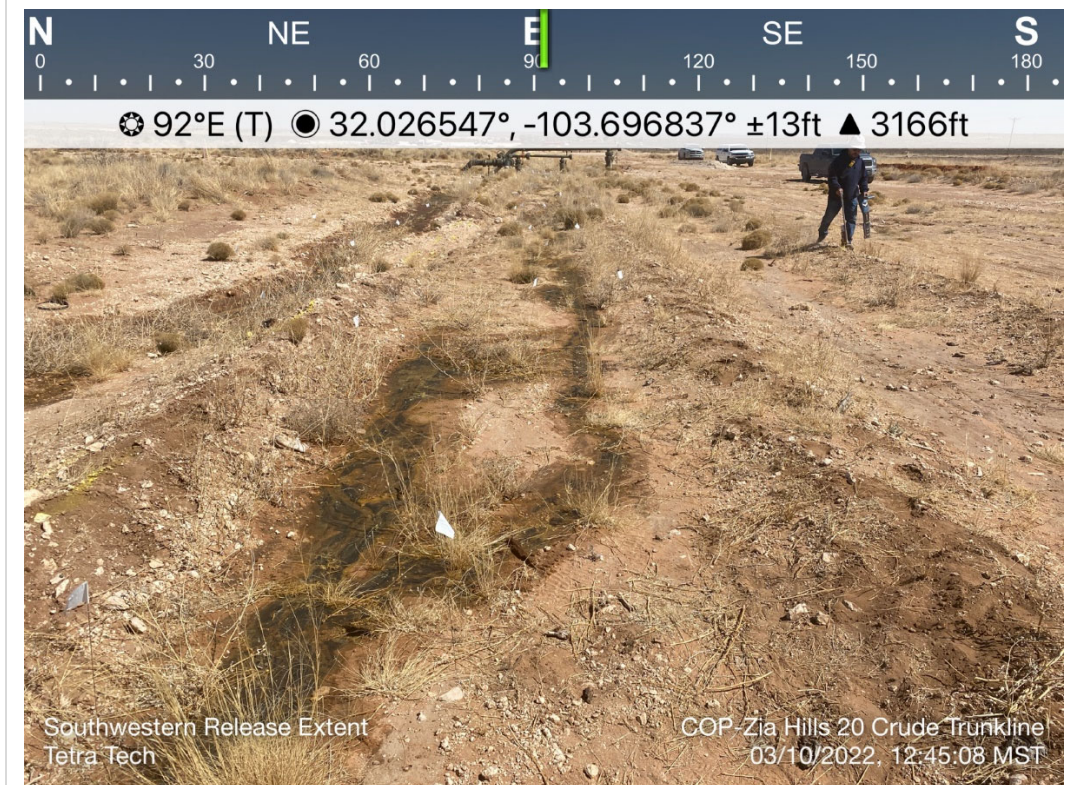
TETRA TECH, INC. PROJECT NO. 212C-MD-02714A	DESCRIPTION	View east. Western portion of the release footprint.	8
	SITE NAME	COP – Zia Hills 20 Trunkline Release	3/10/2022

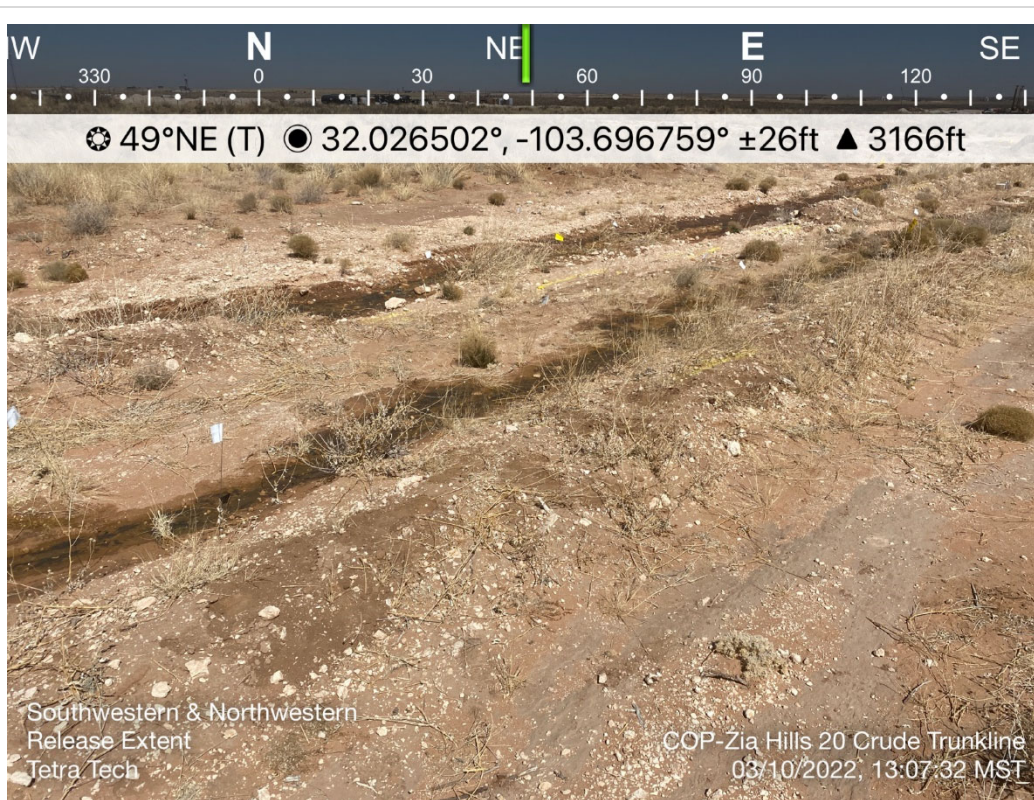
TETRA TECH, INC. PROJECT NO. 212C-MD-02714A	DESCRIPTION	View northeast. Western portion of the release footprint.	9
	SITE NAME	COP – Zia Hills 20 Trunkline Release	3/10/2022

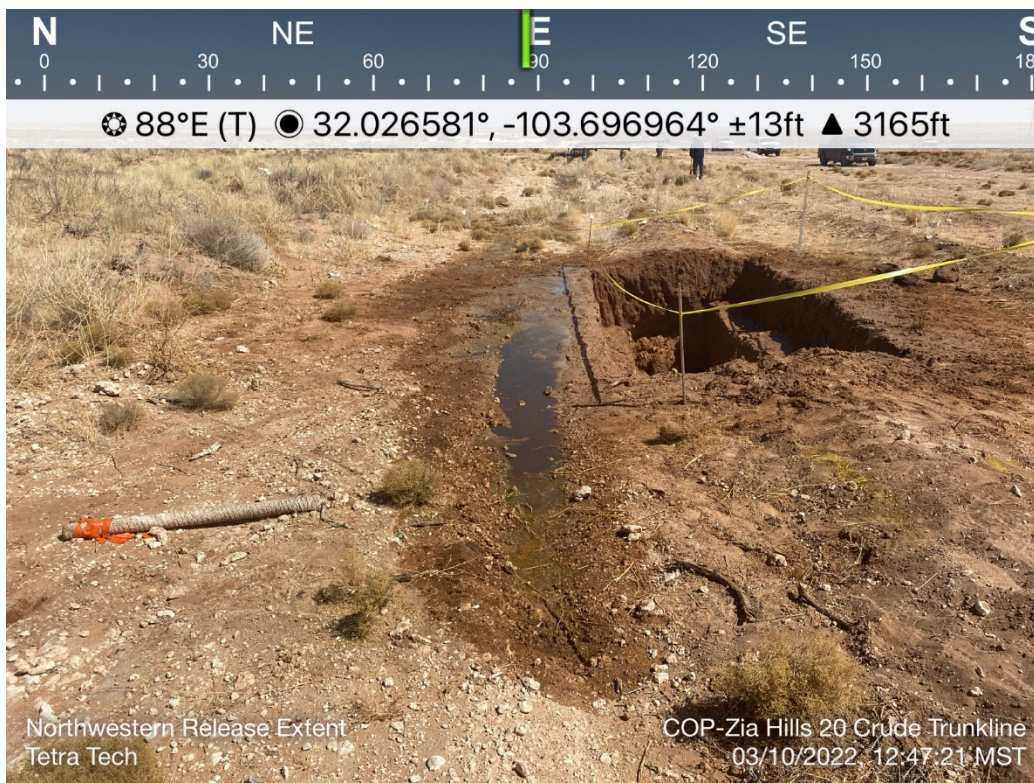
TETRA TECH, INC. PROJECT NO. 212C-MD-02714A	DESCRIPTION	View east. Completed hydrovac excavation at release point.	10
	SITE NAME	COP – Zia Hills 20 Trunkline Release	3/10/2022
