CLOSURE REPORT

Aztec Gas Com 4#2 (11/16/21) Unit Letter B, S21 T30N R11W San Juan County, New Mexico

New Mexico EMNRD OCD Incident ID No. NAPP2132227694

February 2, 2022 Ensolum Project No. 05A1226167

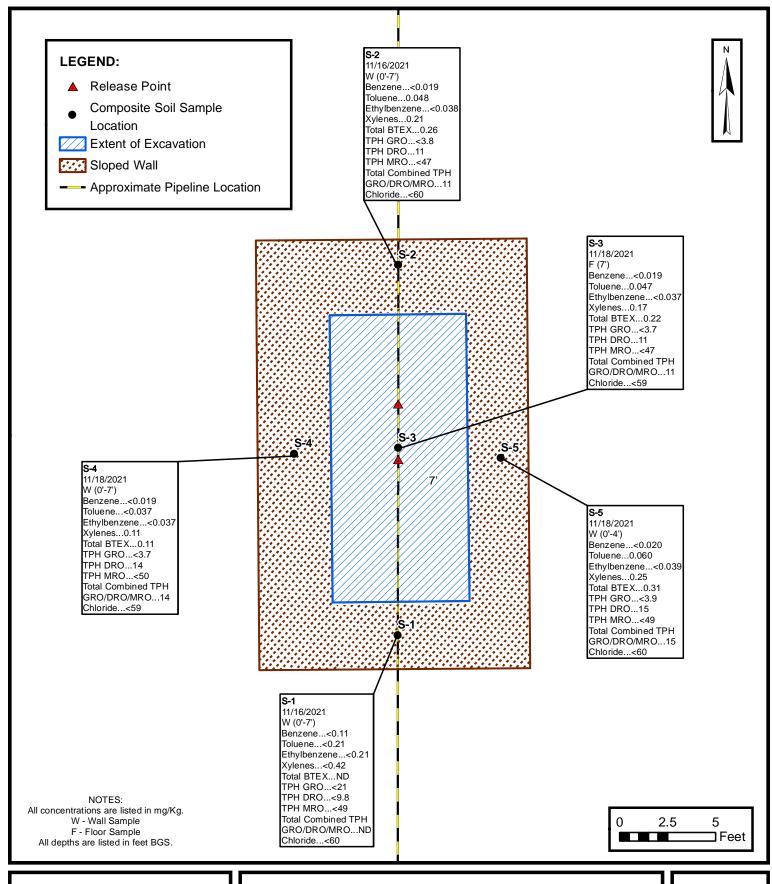
SITE MAP WITH SOIL ANALYTICAL RESULTS

The final excavation measured approximately 22.5 feet long and 14 feet wide at the maximum extents. The maximum depth of the excavation measured approximately seven feet bgs. The lithology encountered during the completion of remediation activities consisted primarily of sand and gravel underlain by sandstone.

Figure 3 is a map that identifies approximate soil sample locations and depicts the approximate dimensions of the excavation with respect to the pipeline (**Appendix A**). Photographic documentation of the field activities is included in **Appendix D**.

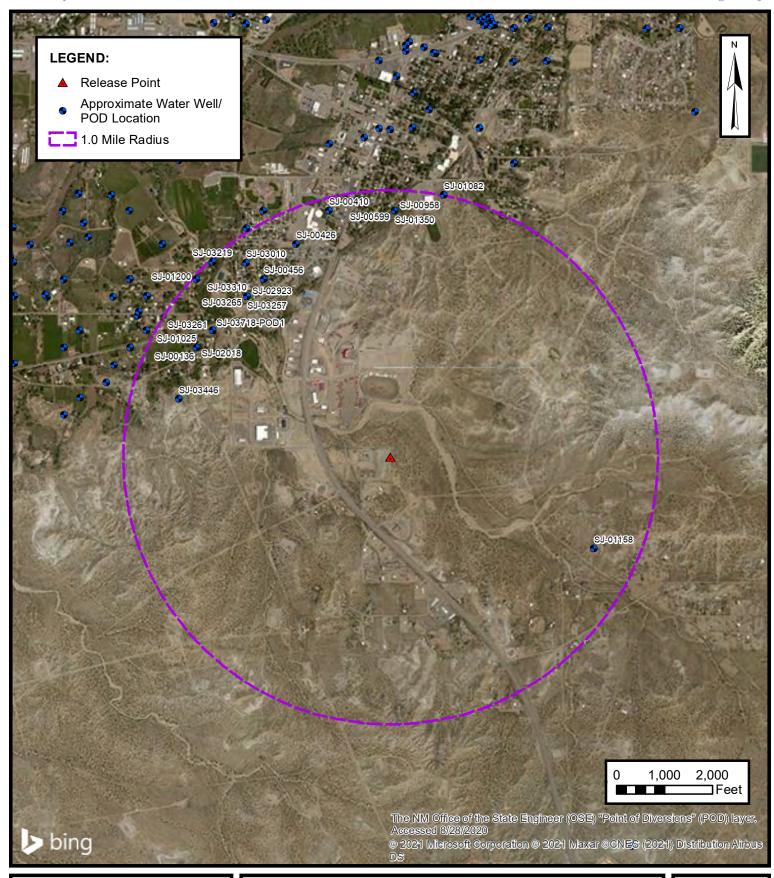
1.0 MILE RADIUS WATER WELL/ POD LOCATION MAP

• The OSE tracks the usage and assignment of water rights and water well installations and records this information in the Water Rights Reporting System (WRRS) database. Water wells and other points of diversion (PODs) are each assigned POD numbers in the database (which is searchable and includes an interactive map). Numerous PODS were identified in the same Public Land Survey System (PLSS) section as the Site and in adjacent sections. The average depth to water for the PODs located in this PLSS section and in adjacent PLSS sections is approximately 21 feet below grade surface (bgs). The closest PODs (SJ-02923, SJ-03257, SJ-03265, and SJ-03310) are located approximately 0.8 miles from the Site. The average depth to water for these four PODS is 43 feet bgs (Figure A, Appendix B).

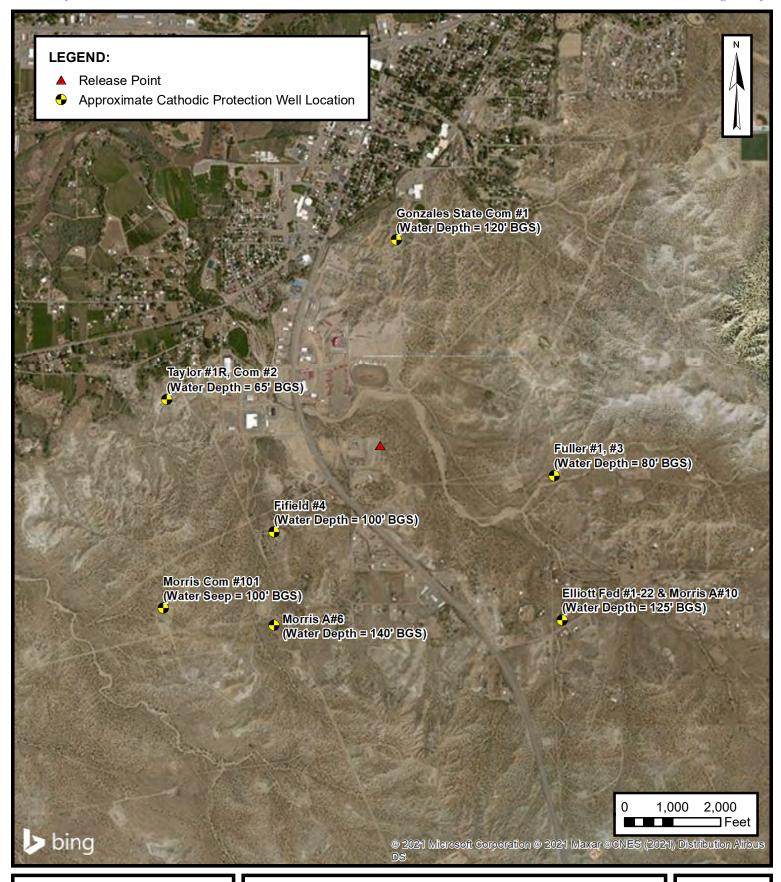
CATHODIC PROTECTION WELL RECORDED DEPTH TO WATER

- Numerous cathodic protection wells (CPWs) were identified in the same PLSS section and in the adjacent PLSS sections in the NM EMNRD OCD imaging database. Seven CPWs are located within one mile of the Site and are depicted on Figure B (Appendix B). The records for the cathodic protection well located near the Fifield #4 well location indicate a depth to water of approximately 100 feet bas. This cathodic protection well is located approximately 0.5 miles southwest of the Site and is approximately four feet lower in elevation than the Site. The records for the cathodic protection well located near the Fuller #1, #3 well locations indicate a depth to water of approximately 80 feet bgs. This cathodic protection well is located approximately 0.6 miles southeast of the Site and is approximately 31 feet higher in elevation than the Site. The records for the cathodic protection well located near the Gonzales State Com #1 well location indicate a depth to water of approximately 120 feet bgs. This cathodic protection well is located approximately 0.75 miles north of the Site and is approximately 58 feet lower in elevation than the Site. The records for the cathodic protection well located near the Morris A#6 well location indicate a depth to water of approximately 140 feet bgs. This cathodic protection well is located approximately 0.75 miles southwest of the Site and is approximately 33 feet higher in elevation than the Site. The records for the cathodic protection well located near the Taylor #1R, Com #2 well locations indicate a depth to water of approximately 65 feet bgs. This cathodic protection well is located approximately 0.80 miles west of the Site and is approximately 78 feet lower in elevation than the Site. The records for the cathodic protection well located near the Elliott Fed #1-22 and Morris A#10 well locations indicate a depth to water of approximately 125 feet bgs. This cathodic protection well is located approximately 0.90 miles southeast of the Site and is approximately 63 feet higher in elevation than the Site. The records for the cathodic protection well located near the Morris Com #101 well location indicate a "seep" at 100 feet bgs. This cathodic protection well is located approximately one mile southwest of the Site and is approximately 49 feet higher in elevation than the Site.

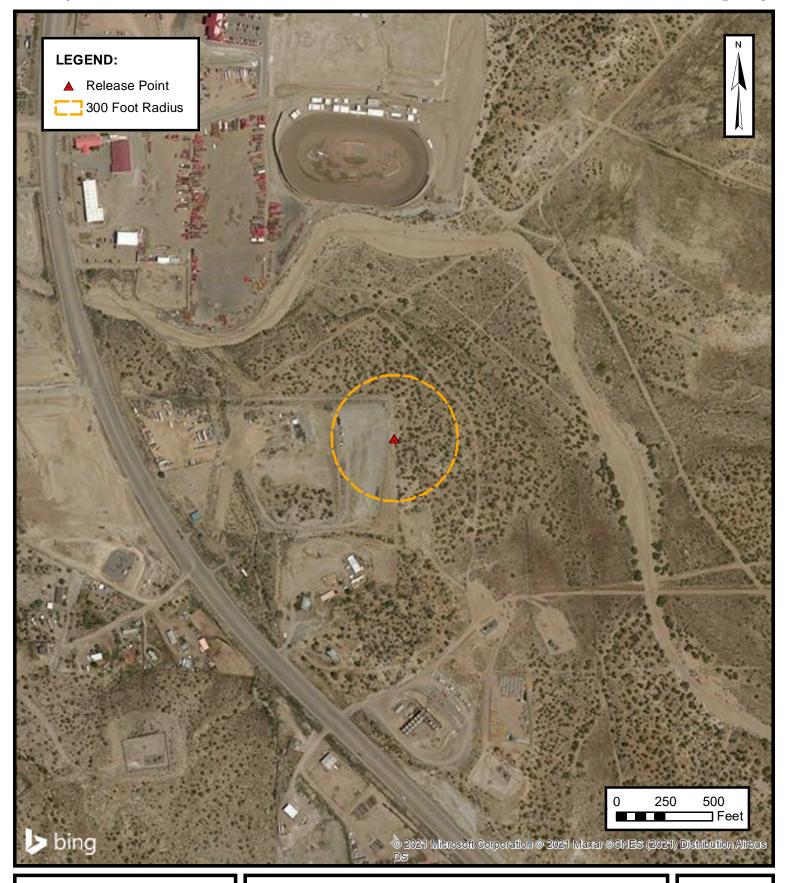
300 FOOT RADIUS WATERCOURSE AND DRAINAGE IDENTIFICATION

- The Site is not located within 300 feet of a NM EMNRD OCD-defined continuously flowing watercourse or significant watercourse. The Site is located approximately 795 feet southeast of Williams Arroyo (Figure C, Appendix B).

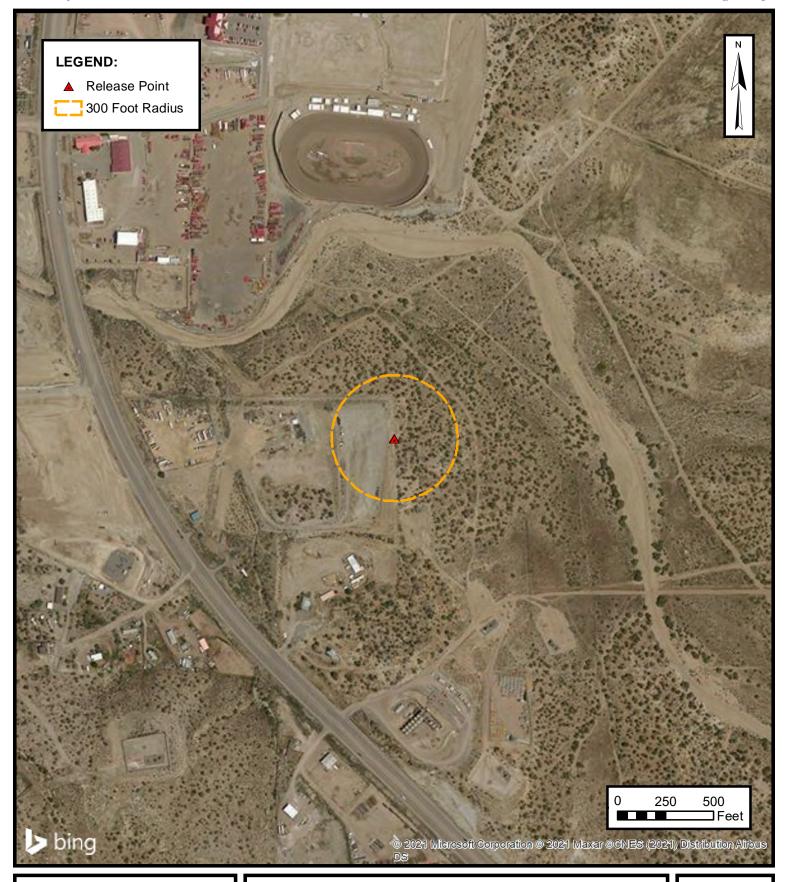
300 FOOT RADIUS OCCUPIED STRUCTURE IDENTIFICATION

- The Site is not located within 200 feet of a lakebed, sinkhole, or playa lake.
- The Site is not located within 300 feet of a permanent residence, school, hospital, institution, or church (Figure D, Appendix B).

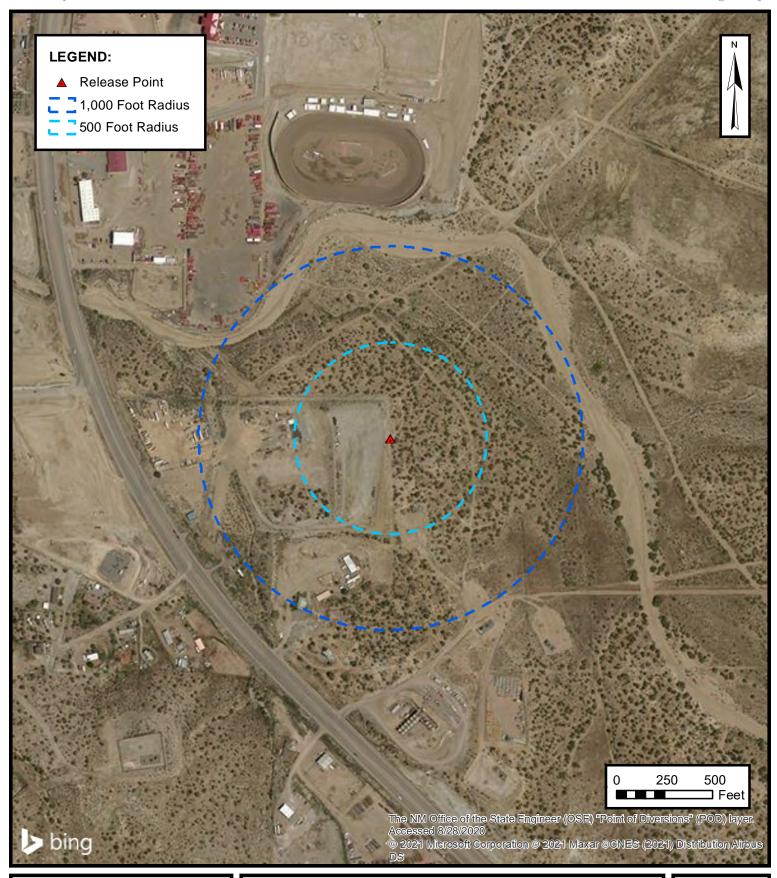
WATER WELL AND NATURAL SPRING LOCATION

- No springs, or private domestic fresh water wells used by less than five households for domestic or stock watering purposes were identified within 500 feet of the Site (**Figure E**, **Appendix B**).

- No fresh water wells or springs were identified within 1,000 feet of the Site. The residences located within the 1,000 feet may have unregistered water wells (**Figure E**, **Appendix B**).

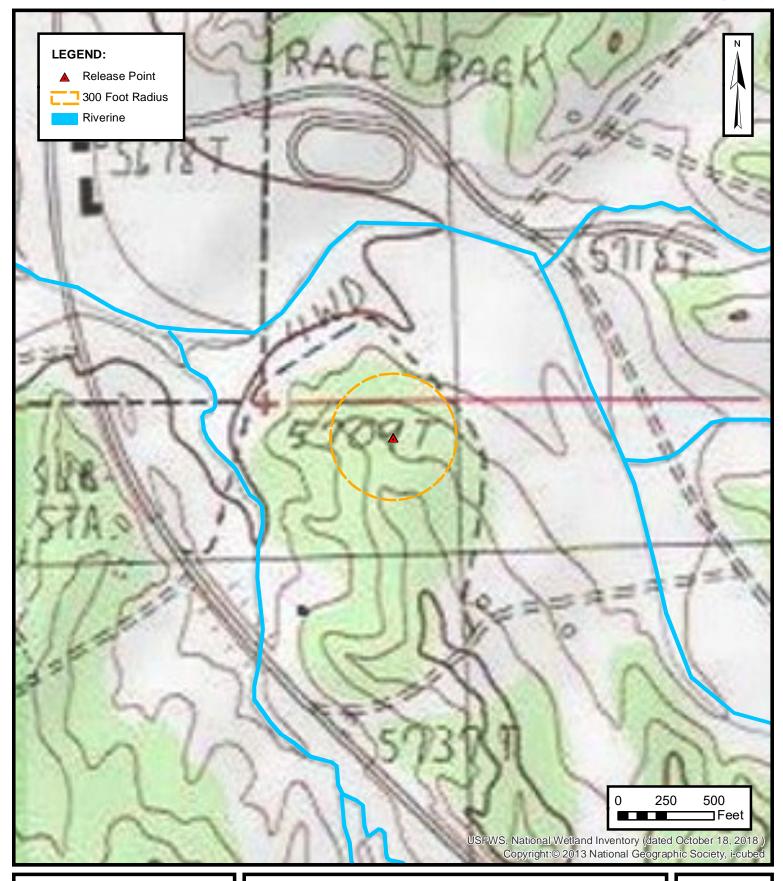
WETLANDS

- Based on information identified in the U.S. Fish & Wildlife Service National Wetlands Inventory Wetlands Mapper, the Site is not located within 300 feet of a wetland (**Figure F**, **Appendix B**).

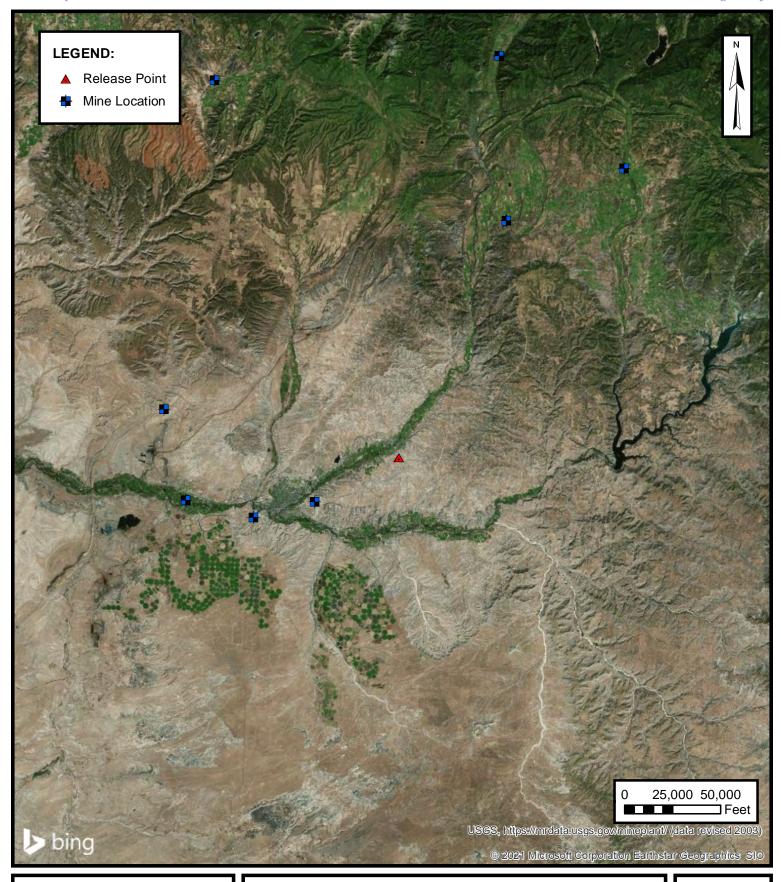
MINES, MILLS AND QUARRIES

- Based on information identified in the NM Mining and Minerals Division's Geographic Information System (GIS) Maps and Mine Data database, the Site is not located within an area overlying a subsurface mine (**Figure G**, **Appendix B**).

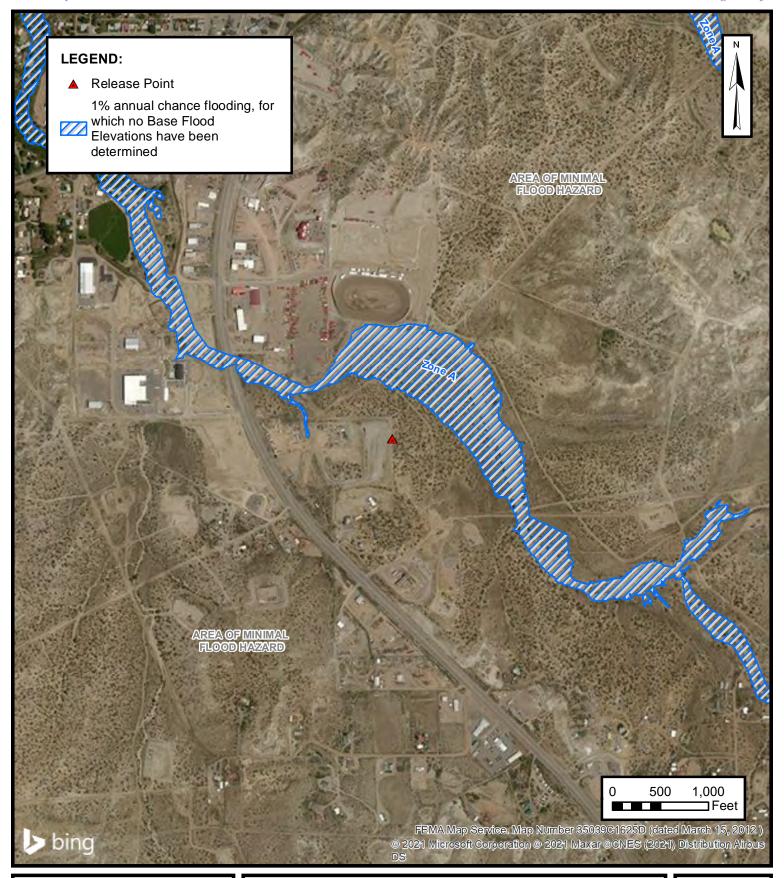
100-YEAR FLOOD PLAIN MAP

Based on information provided by the Federal Emergency Management Agency (FEMA) National Flood Hazard Layer (NFHL) geospatial database the location of the Site is not located within a 100year floodplain (Figure H, Appendix B).

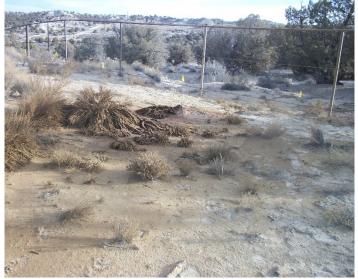
Photograph 2

Photograph Description: View of the excavation.
