**Opal Operating
Mescalero ARL #002**

**Remediation Report
O-02-10S-32E
Lea County, New Mexico**

NAPP2201043390

February 4, 2022

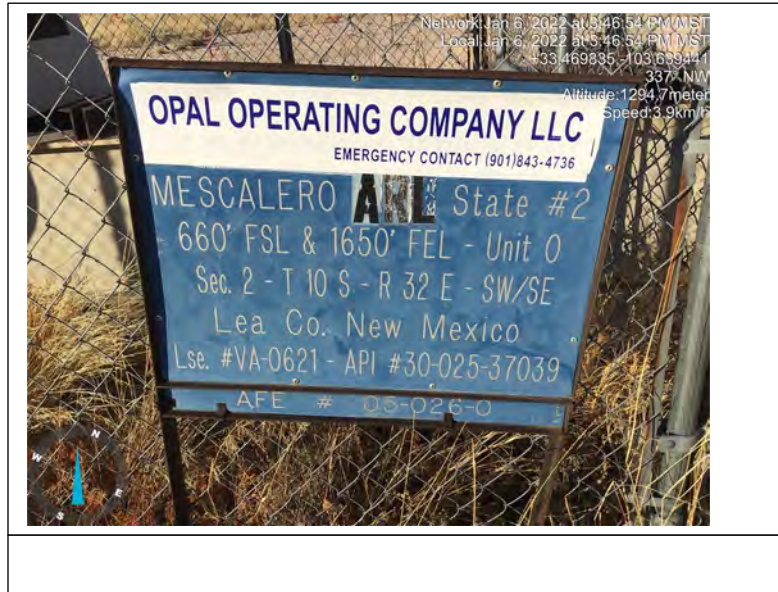
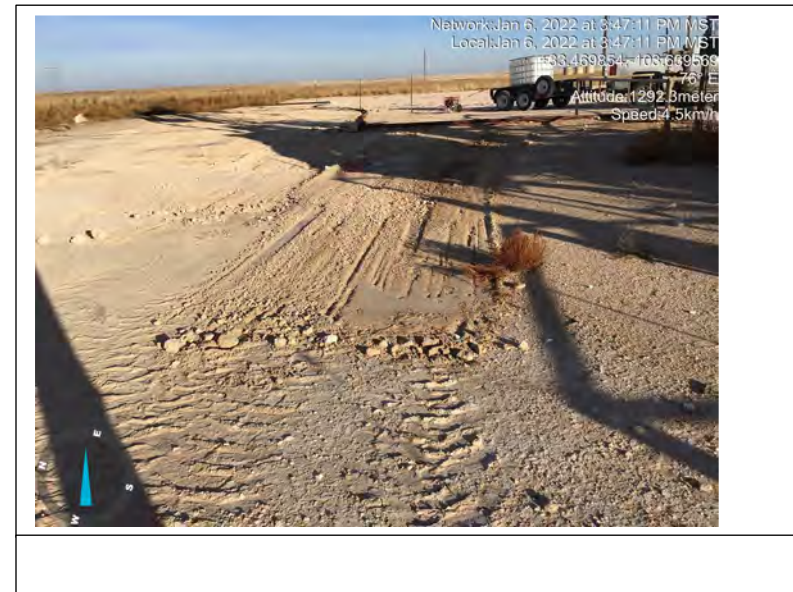
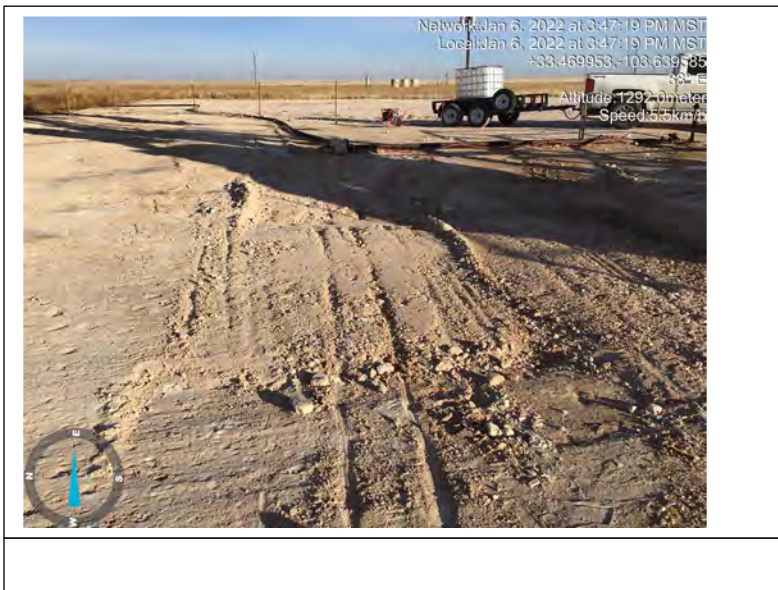
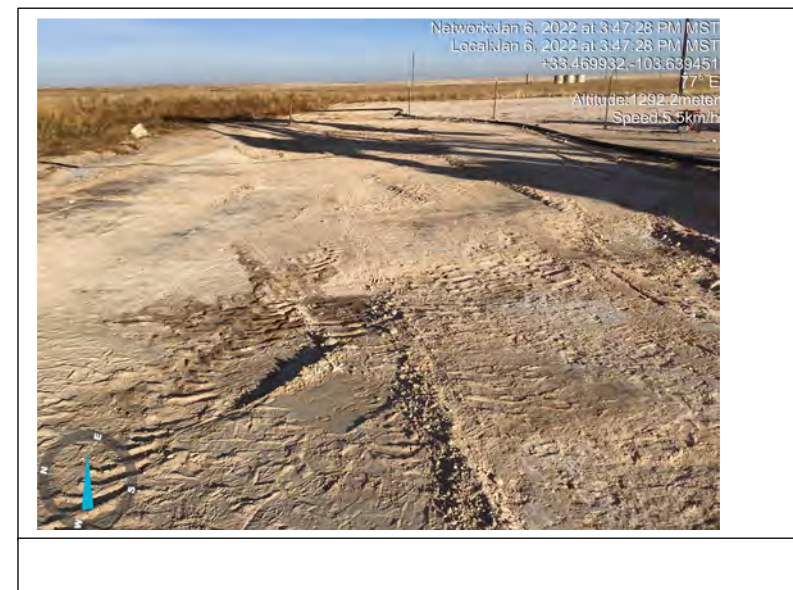
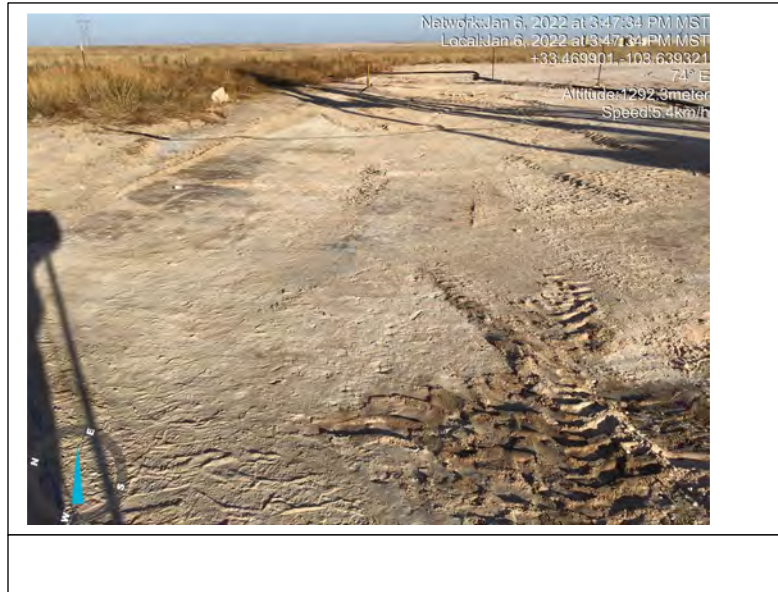
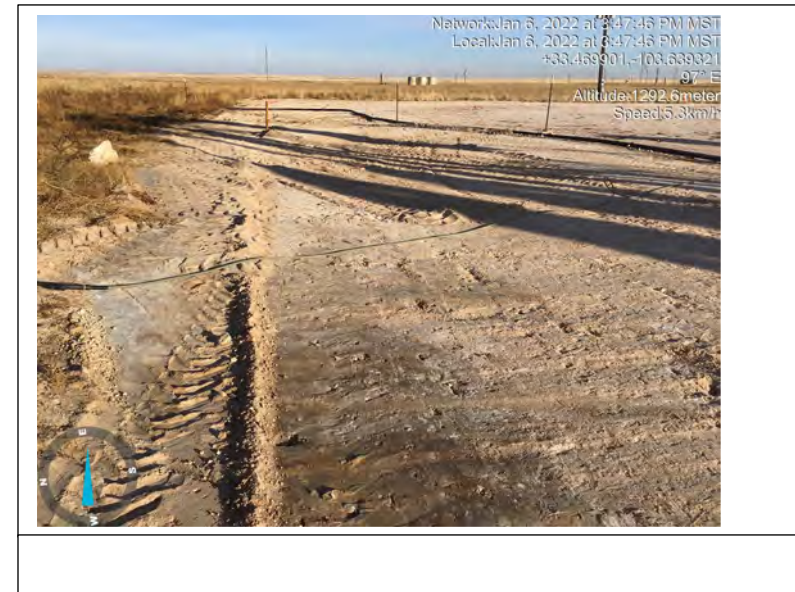
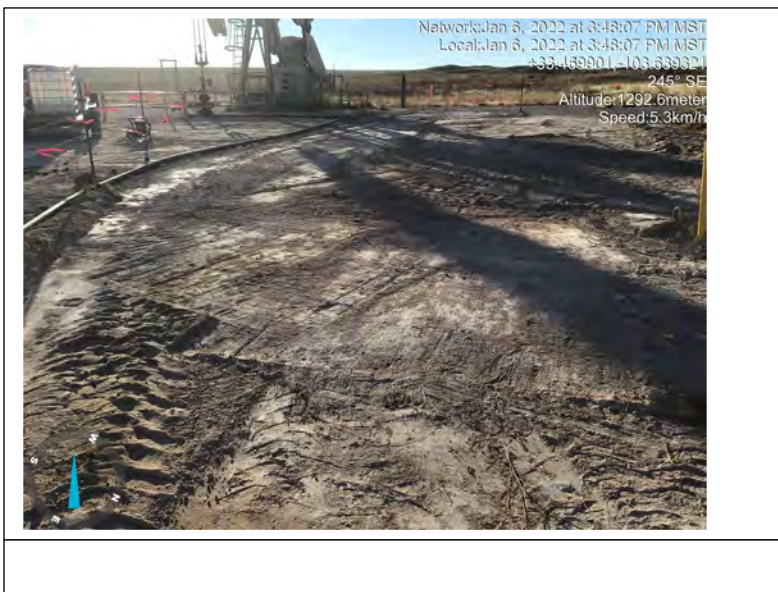
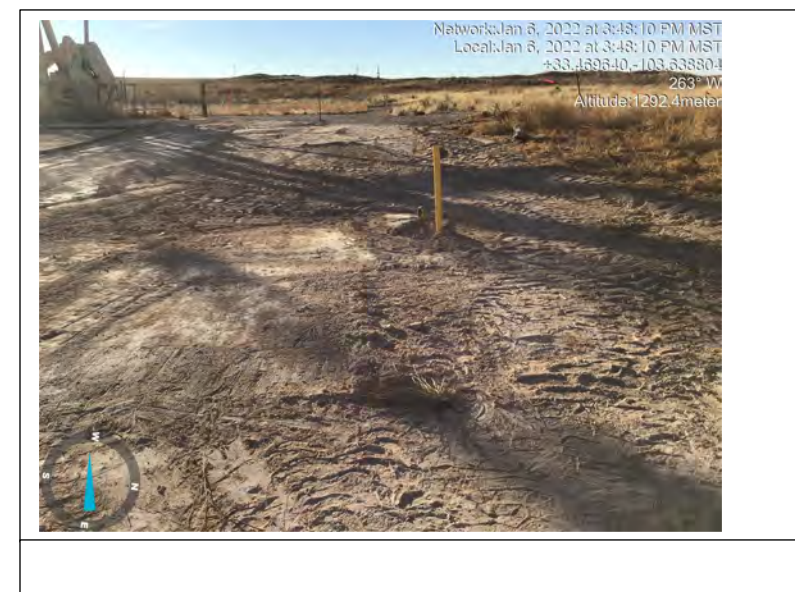
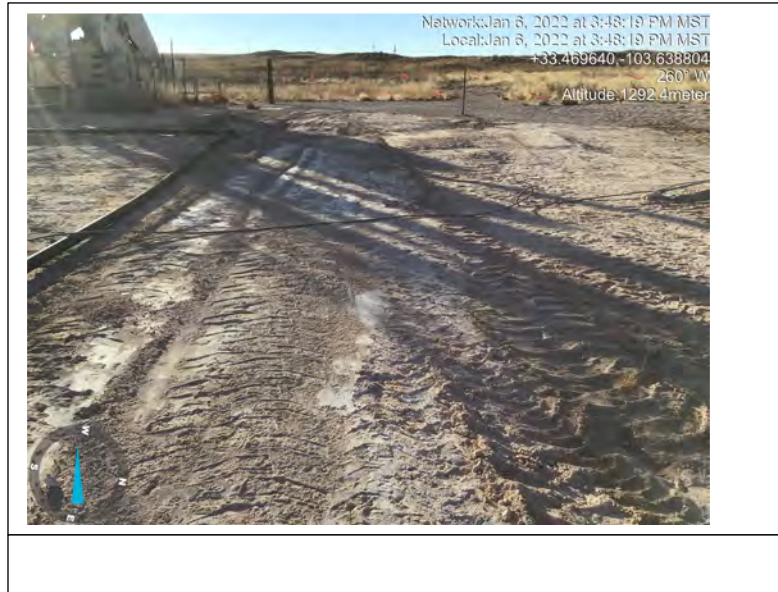
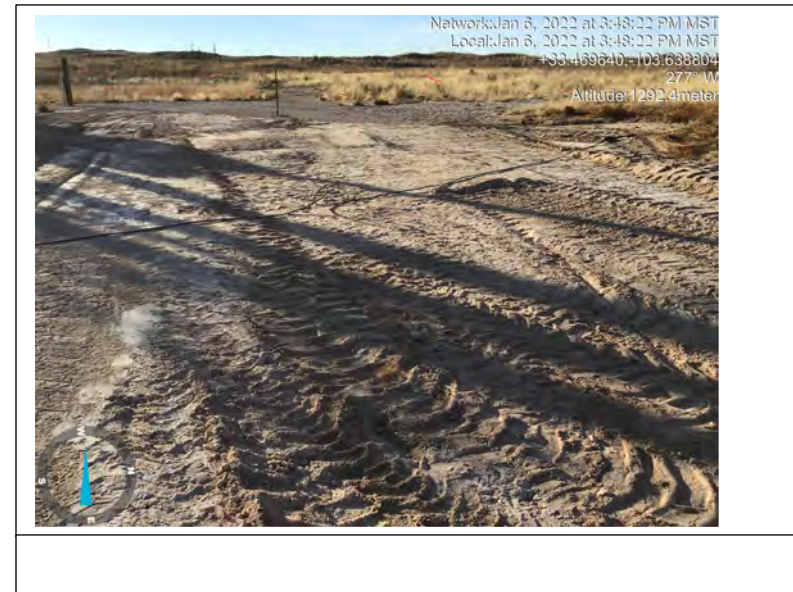
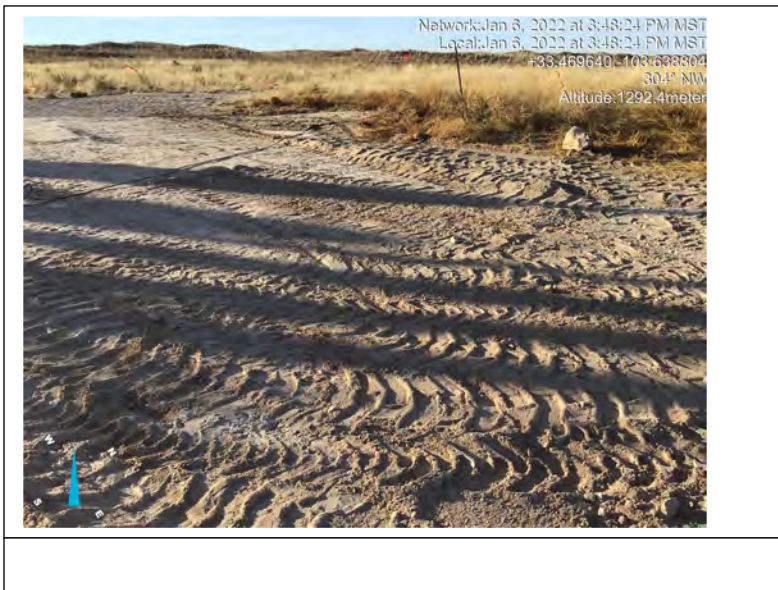
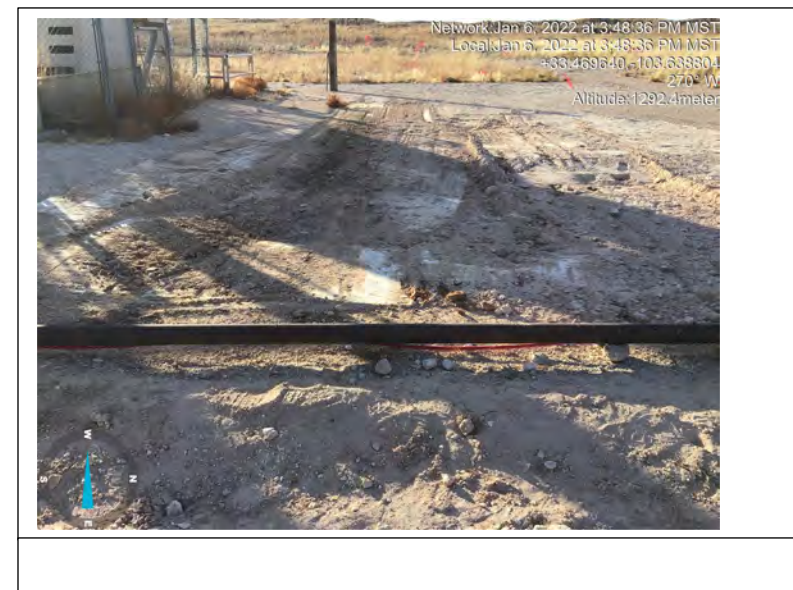
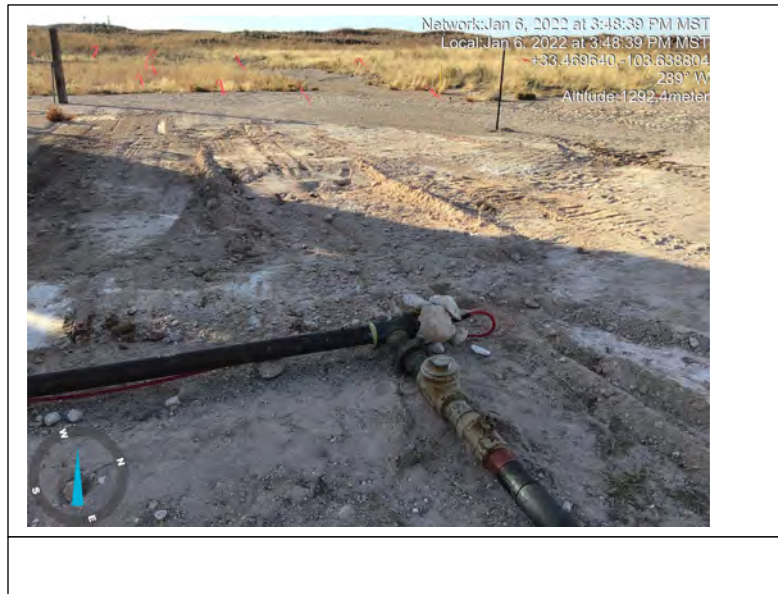
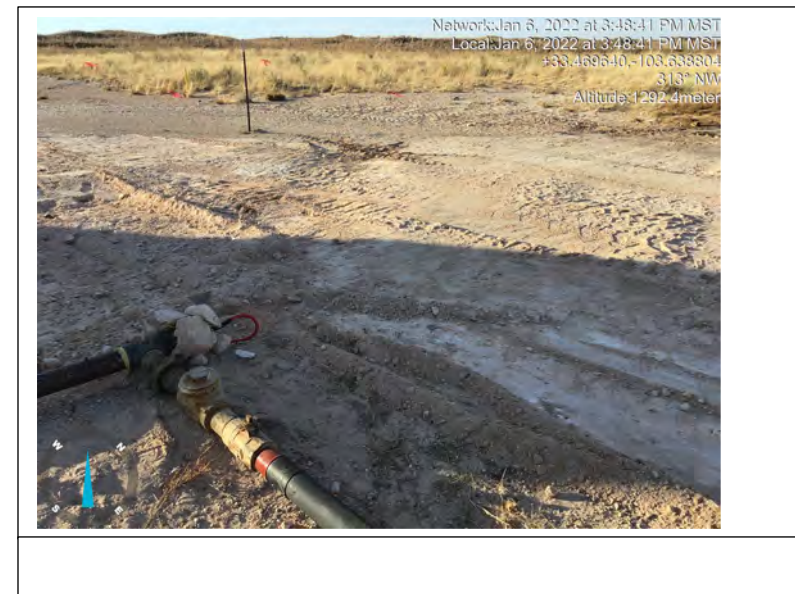
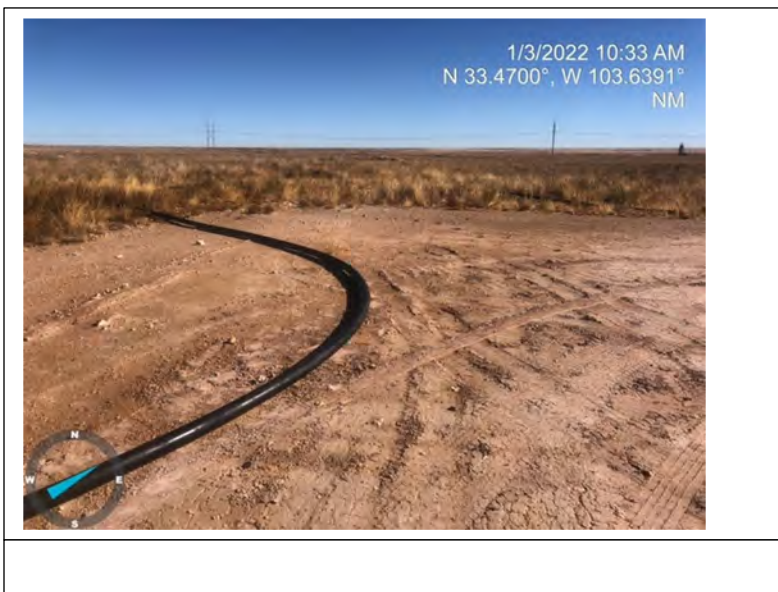
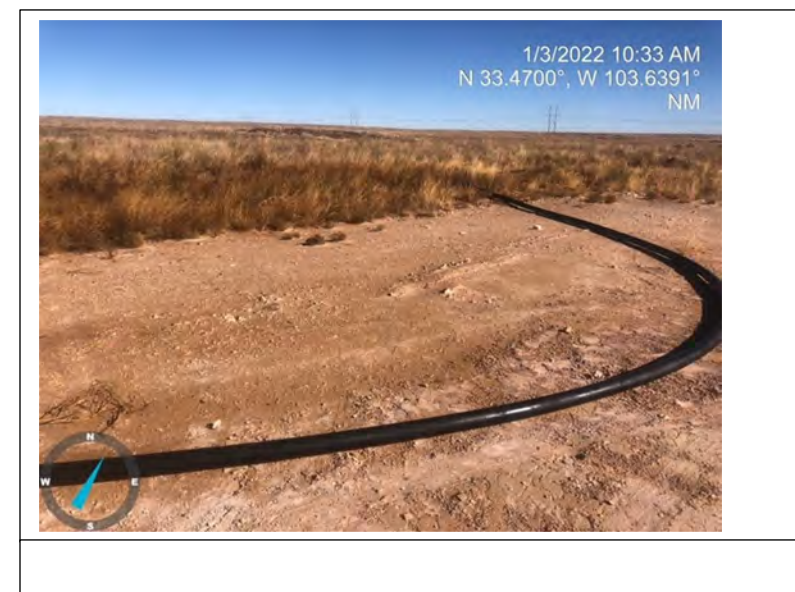
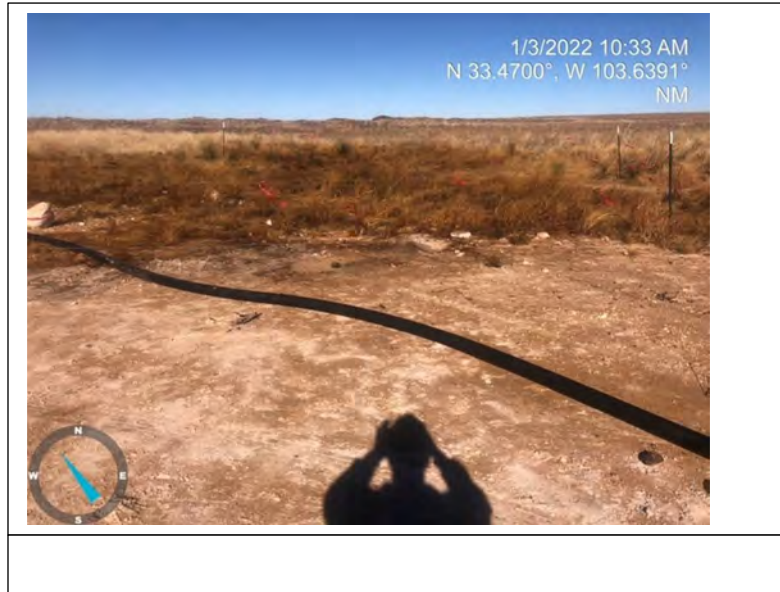
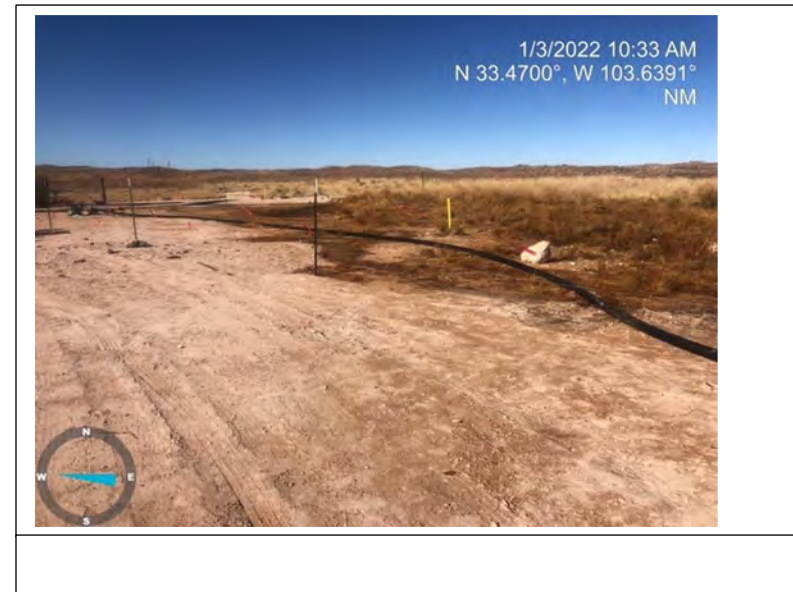
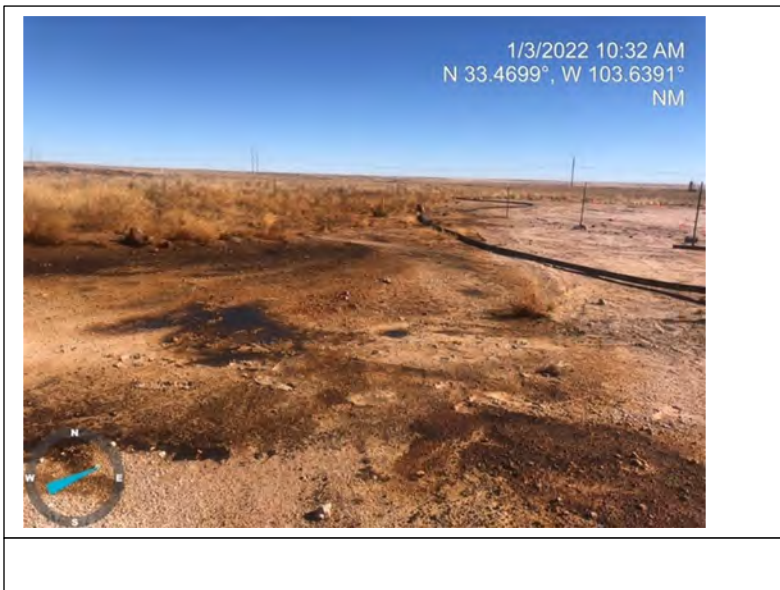
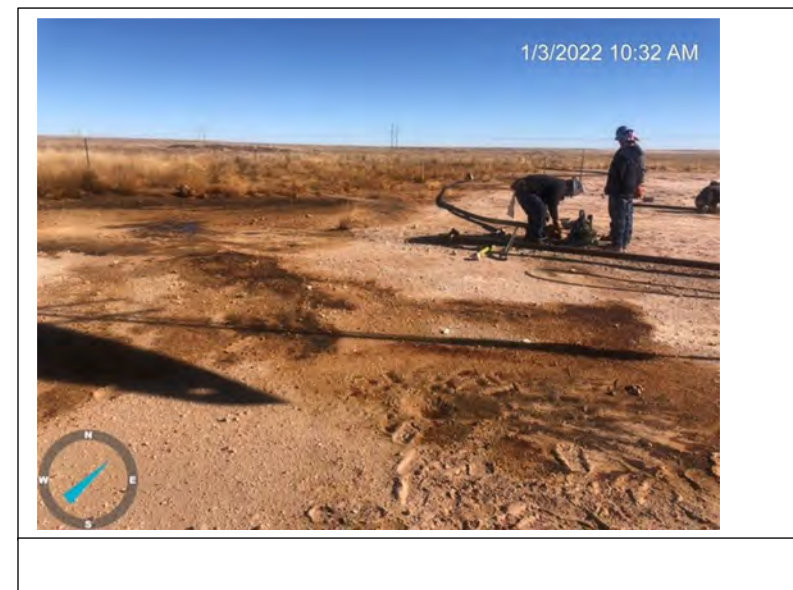
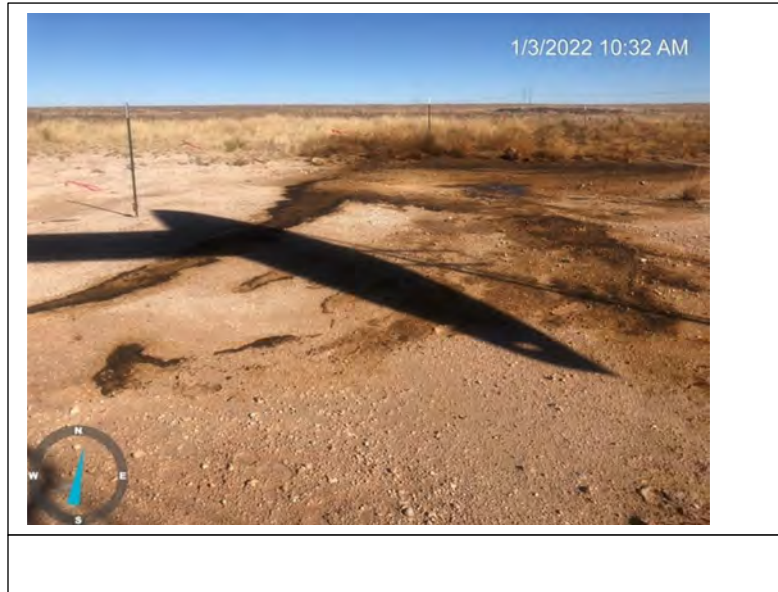
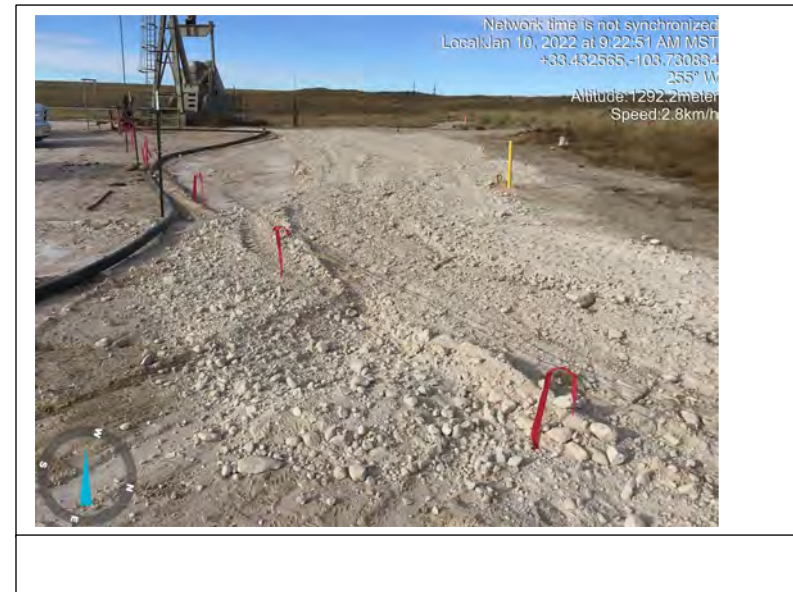
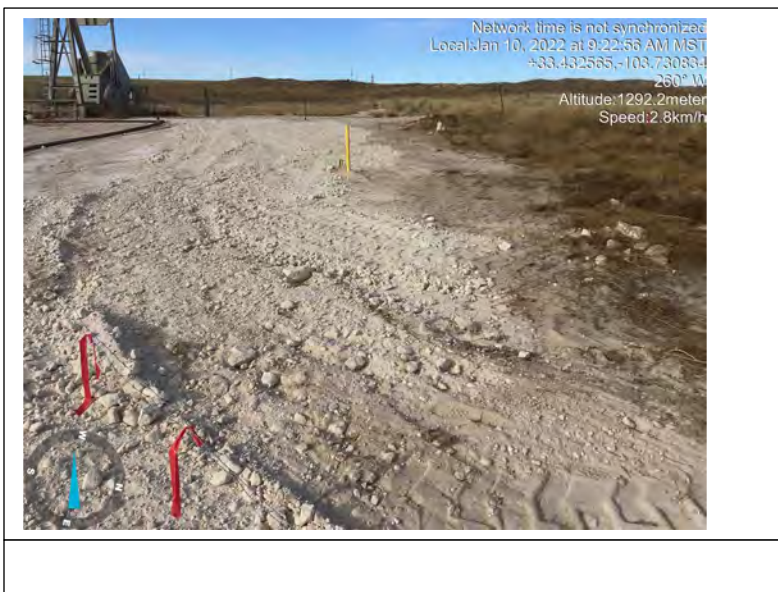
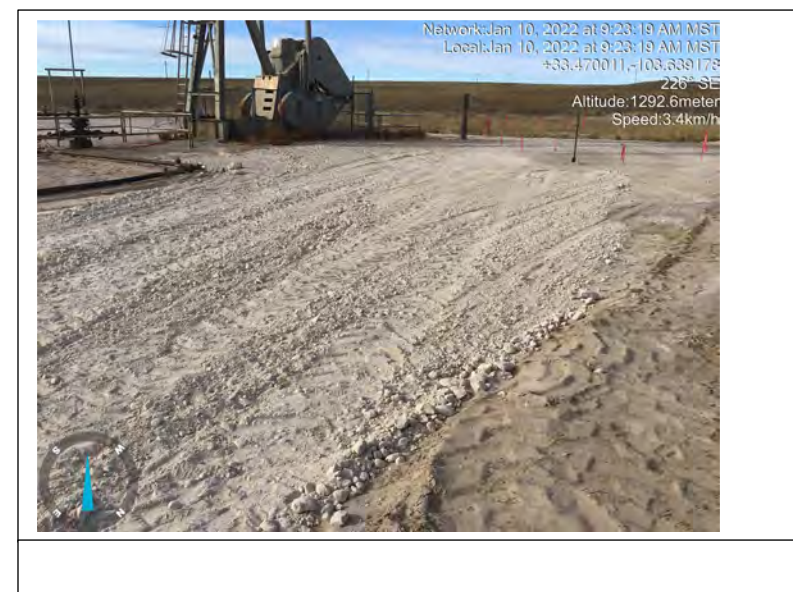
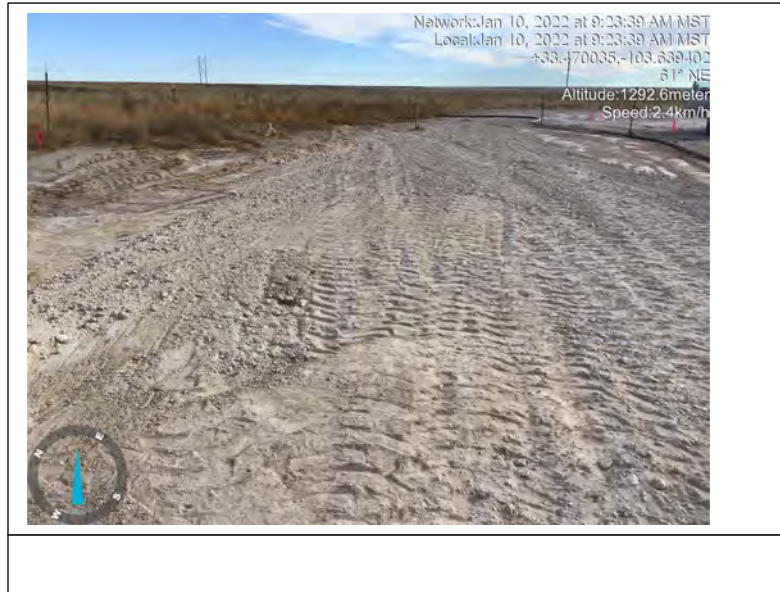
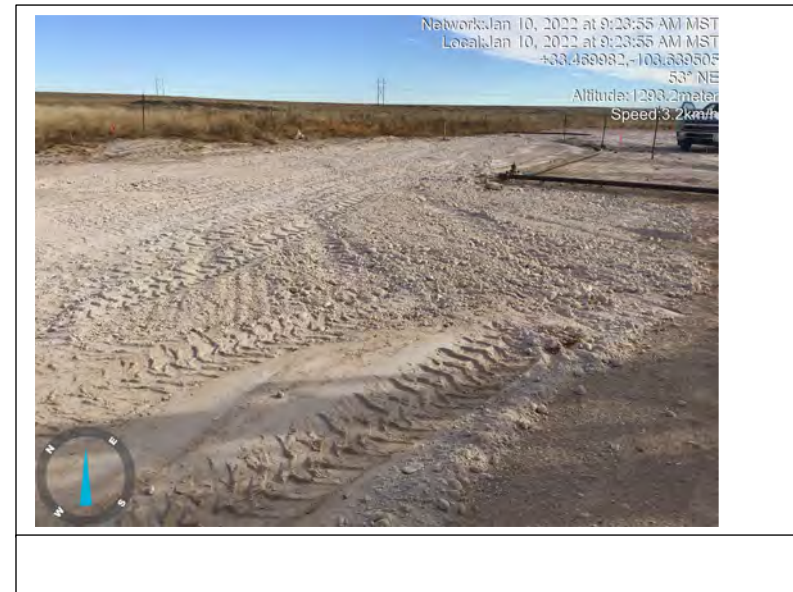
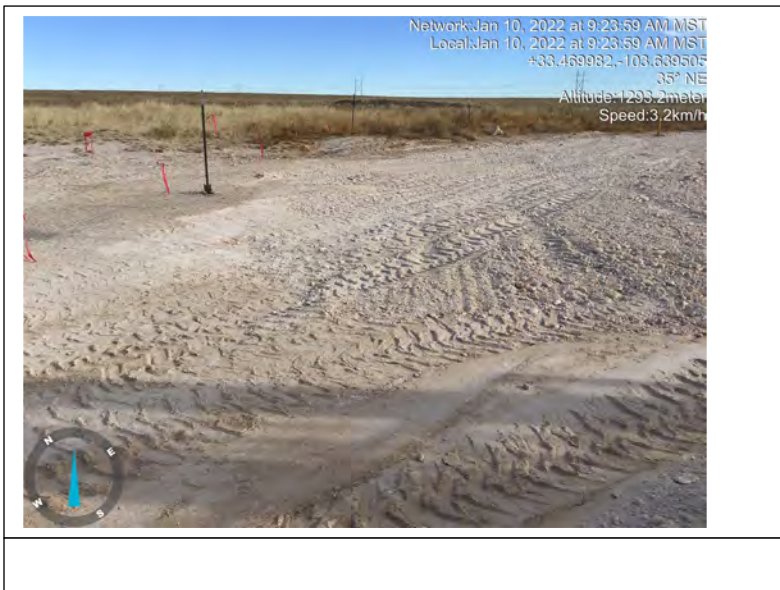
Opal Operating – Mescalero ARL St #2 Site Photos – Excavation & Remediation

Once sample results verified both successful remediation and horizontal extent, the site was backfilled with clean soil. Pictures of the remediation are included in this report.

Based on the results of the field delineation, initial site visit, and the use of the Micro Blaze treatment, SESI, determined the best course of action is to use a second application of the Micro Blaze treatment. In January of 2022, contaminated material was removed by excavating the affected area, Confirmation samples were taken to ensure remediation was successful and that the vertical and horizontal extent of the location had been established.
