**Re: Release Characterization, Remediation, and Closure Report
ConocoPhillips
Jazzbass 34 Federal #003H Release
Unit Letter O, Section 34, Township 25 South, Range 35 East
Lea County, New Mexico
Incident ID: NAPP2209136398**

**JAZZBASS 34 FEDERAL #003H
APPROXIMATE RELEASE EXTENT**

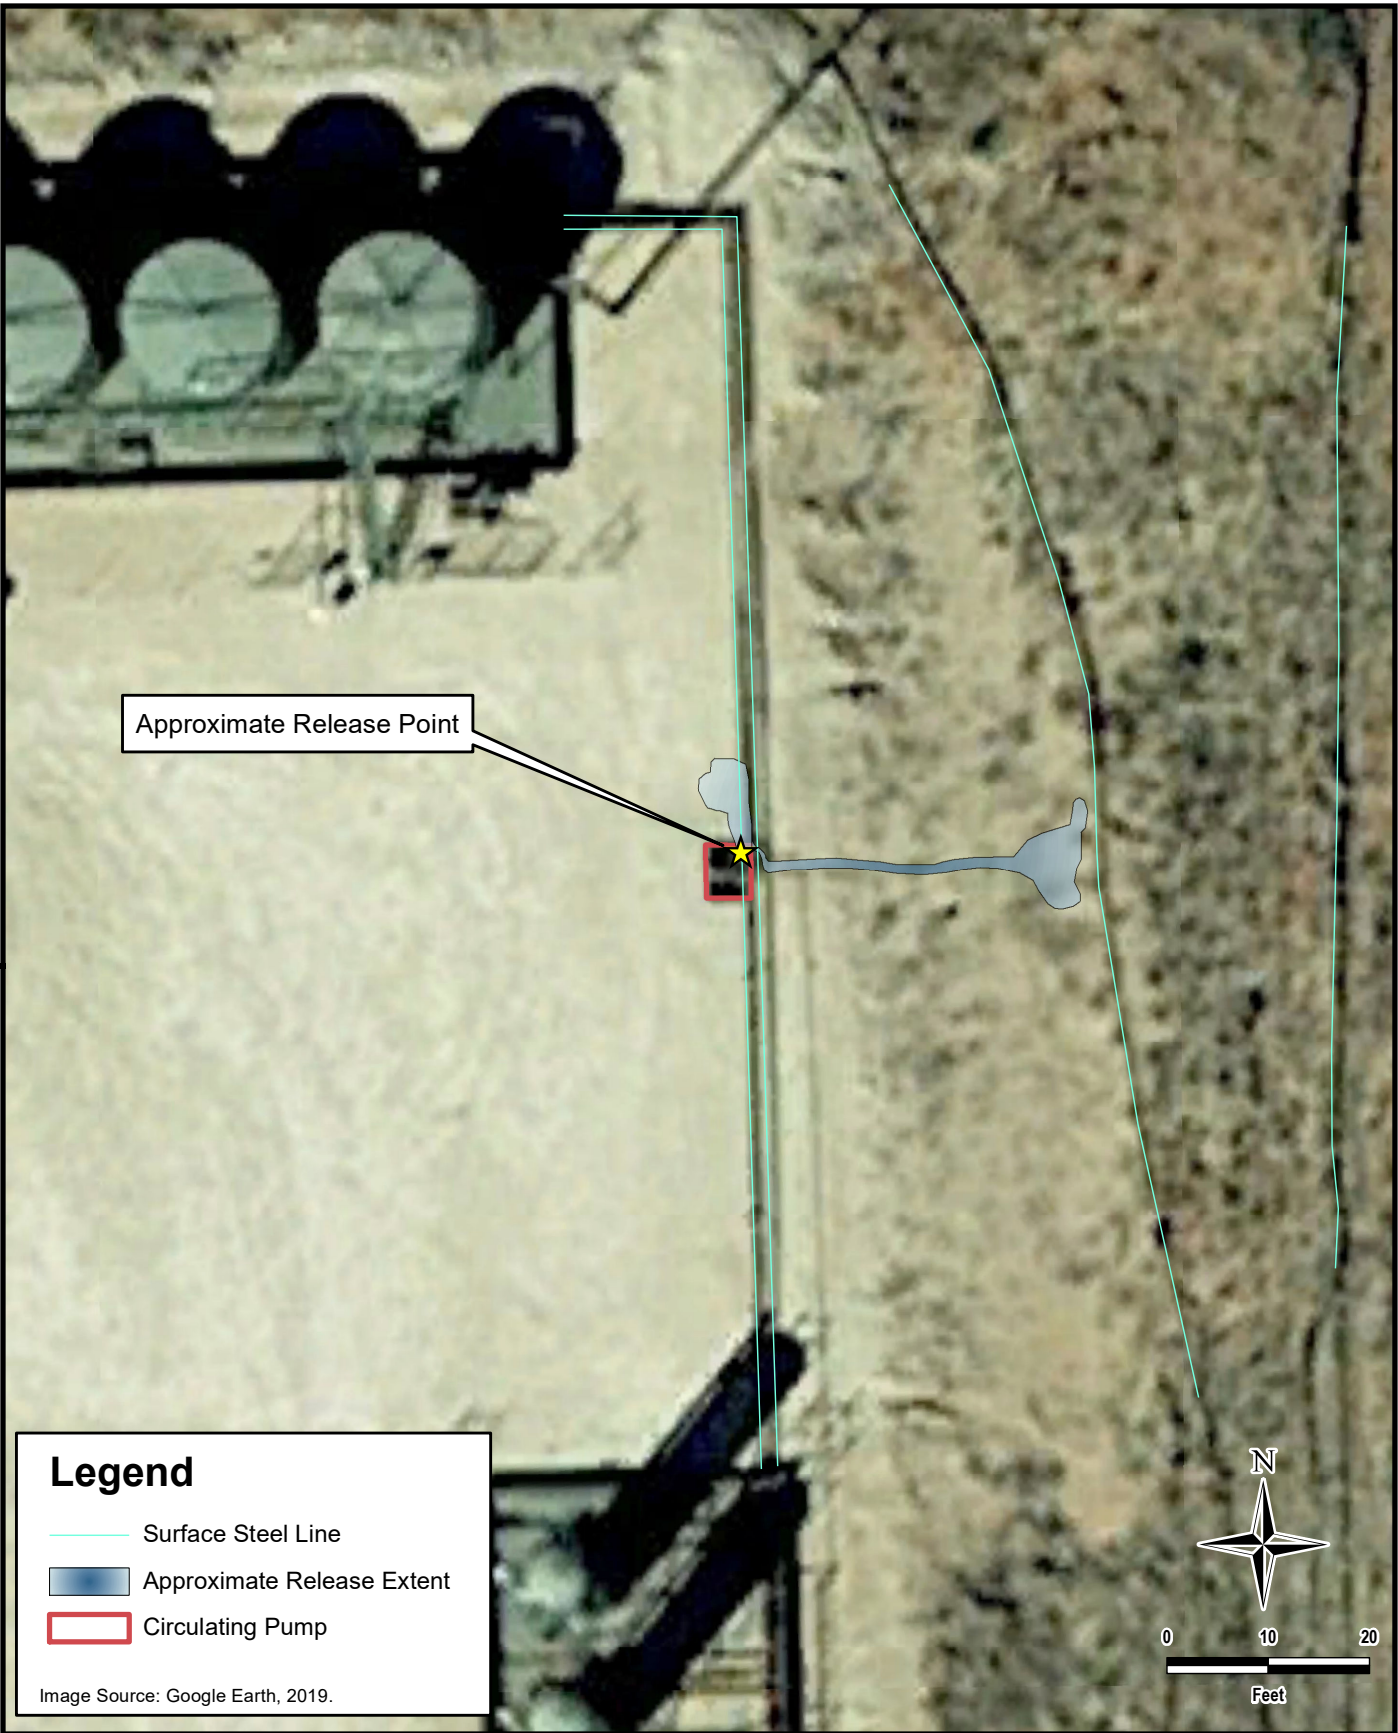
Figure No.

According to ConocoPhillips, the release originated from the tank battery and flowed into the pasture. No free liquids were recovered immediately following the release. The spill calculator included with the C-141 indicated that the release impacted approximately 98 square feet of lease pad and pasture. This release extent was corroborated by a review of photographs taken following the release and observations made in the field. The approximate release extent is presented in Figure 3.

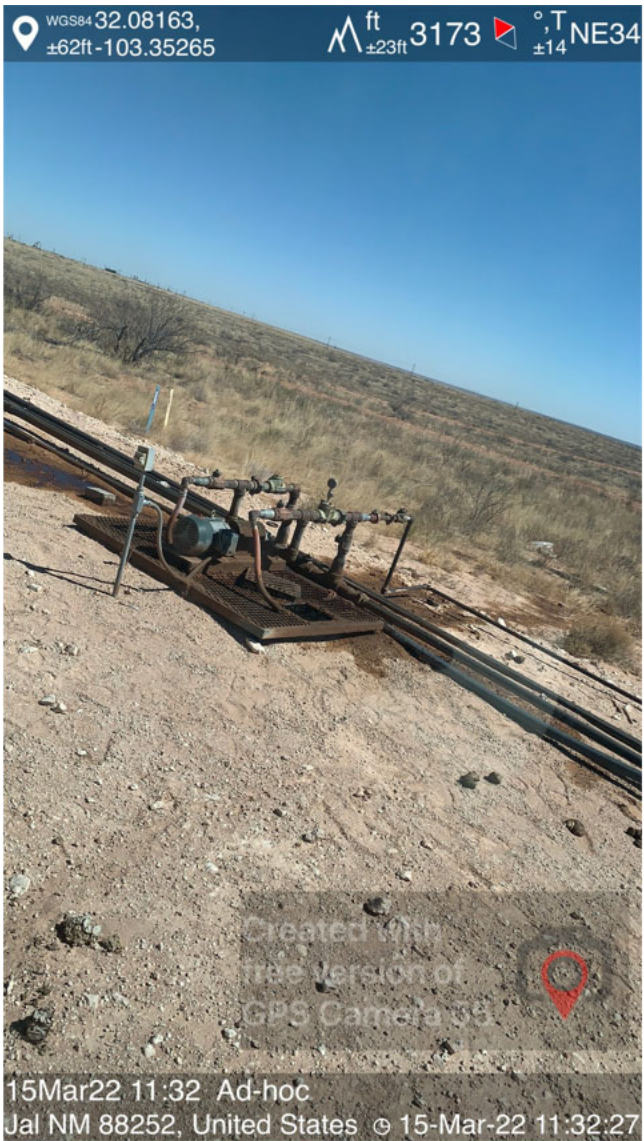
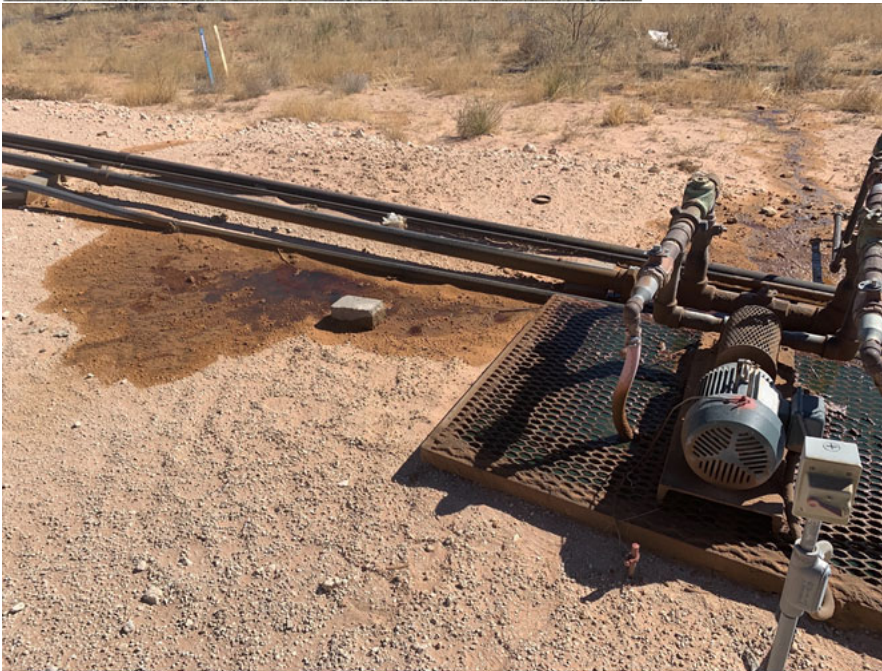
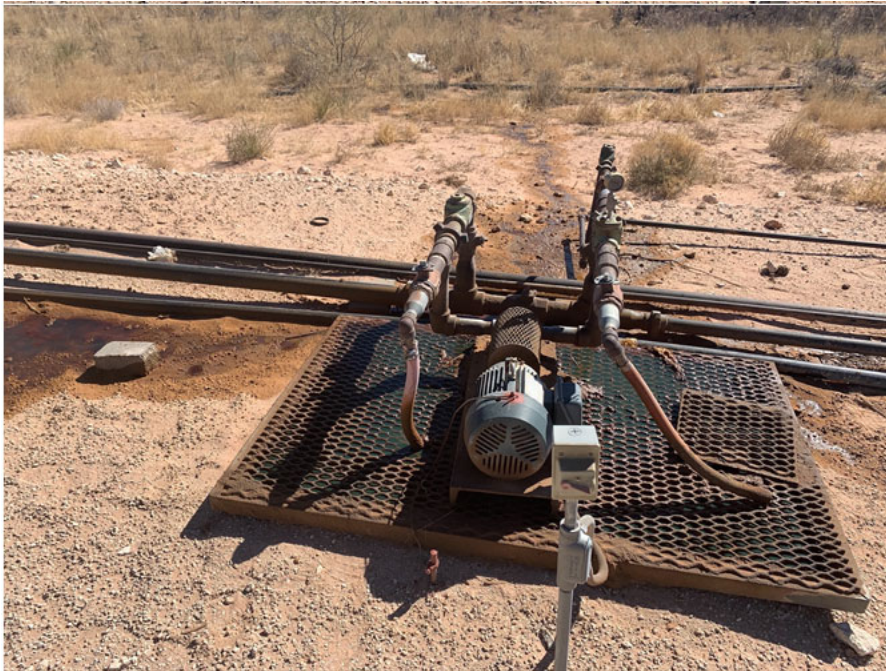
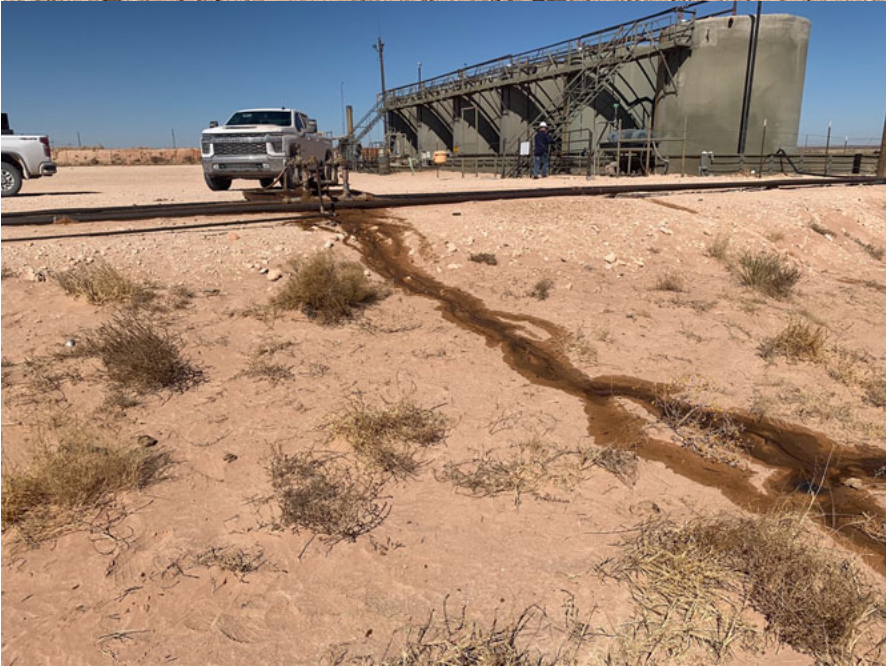
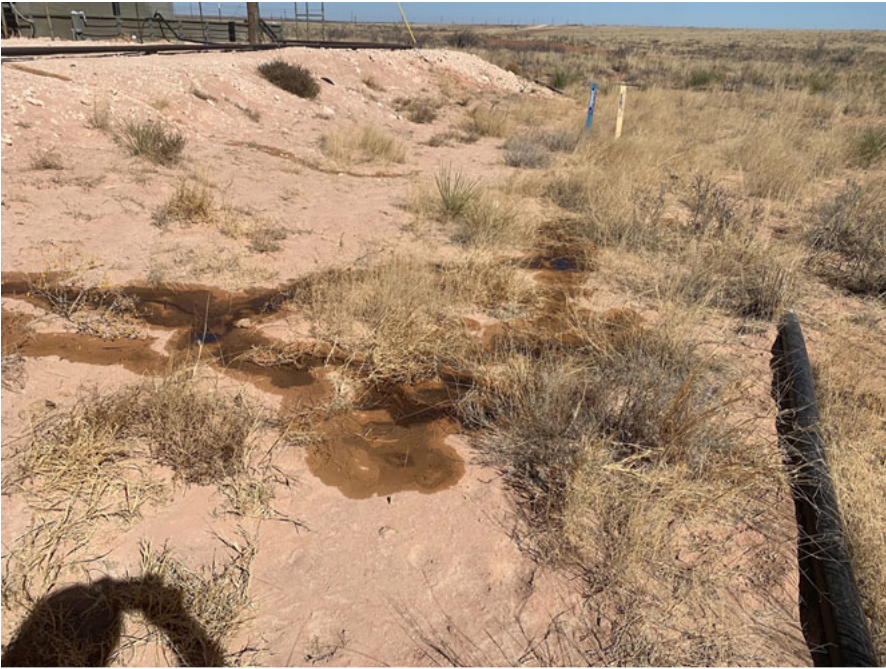
Volume Released: The release occurred as the result of a sump pump failure located at the surface and encompasses an area of 200 square feet. Approximately 0.2 barrels (bbls) of oil were reported released.

Area: The observed impacted area in the field is approximately 200 square feet. Both on and off pad.

Remediation will be conducted by hand dig over footprint, in and around areas of buried flowlines.

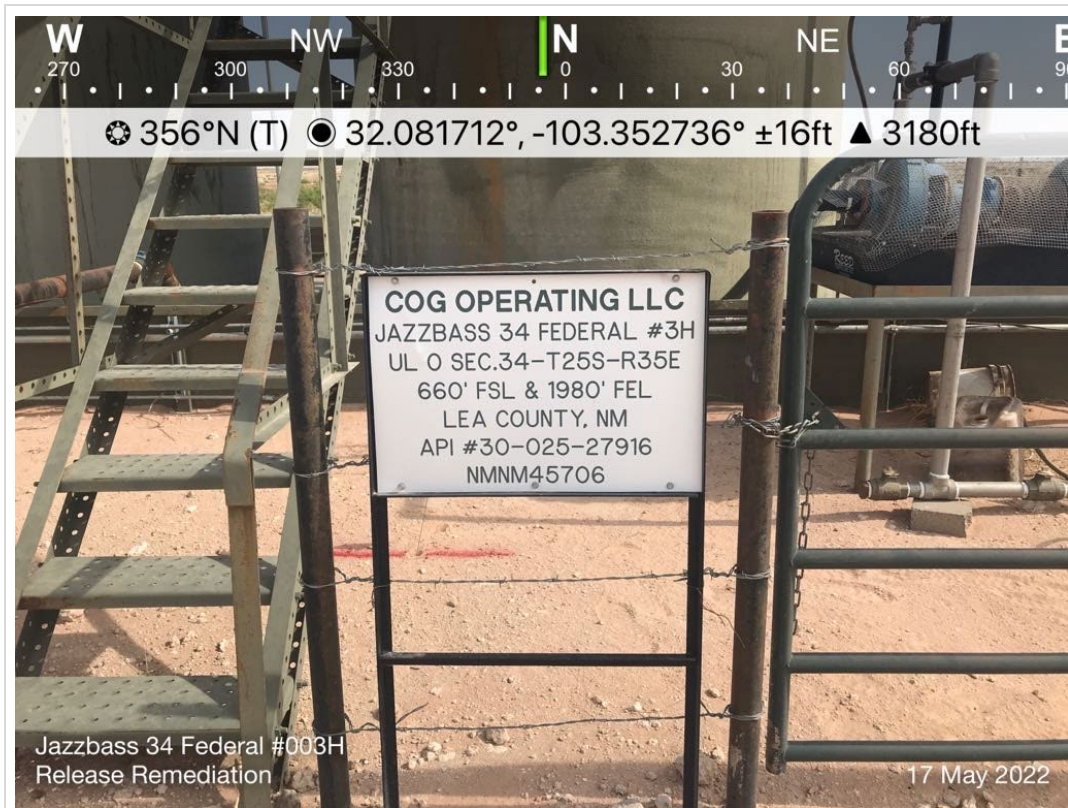
TETRA TECH, INC. PROJECT NO. 212C-MD-02761	DESCRIPTION	View of site signage.	1
	SITE NAME	ConocoPhillips Jazzbass 34 Federal #003H Tank Release	5/17/2022

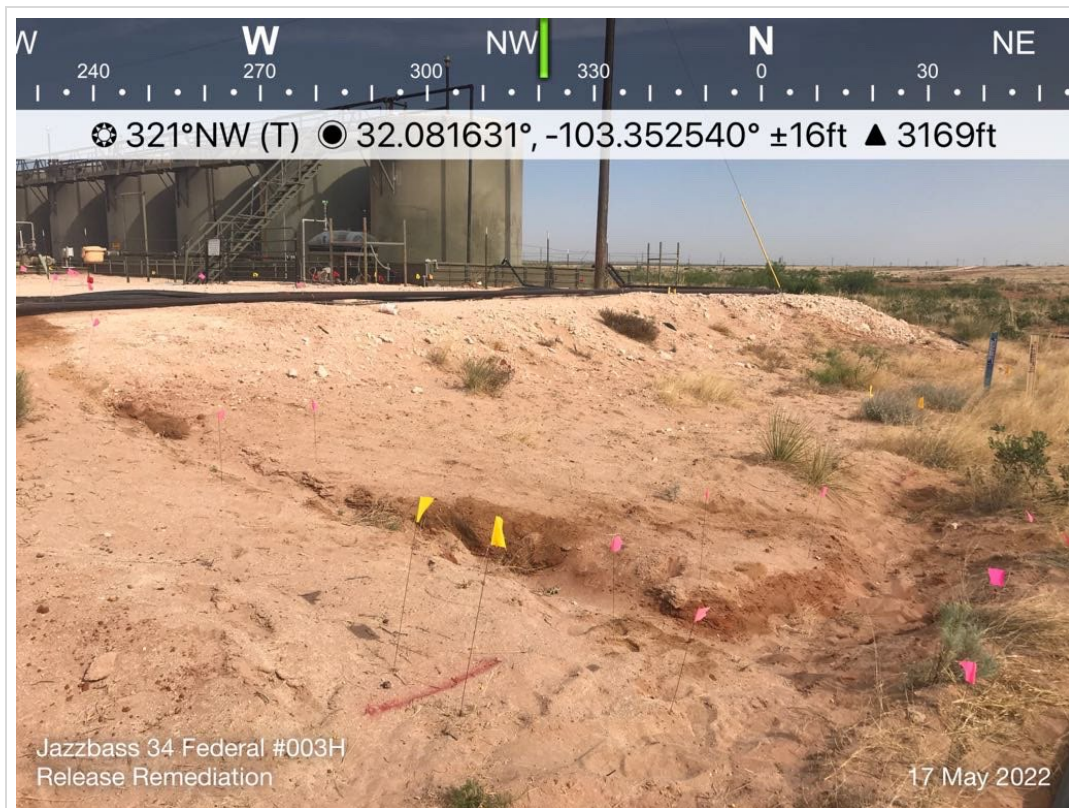
TETRA TECH, INC. PROJECT NO. 212C-MD-02761	DESCRIPTION	View northwest of off-pad release extent.	3
	SITE NAME	ConocoPhillips Jazzbass 34 Federal #003H Tank Release	5/17/2022

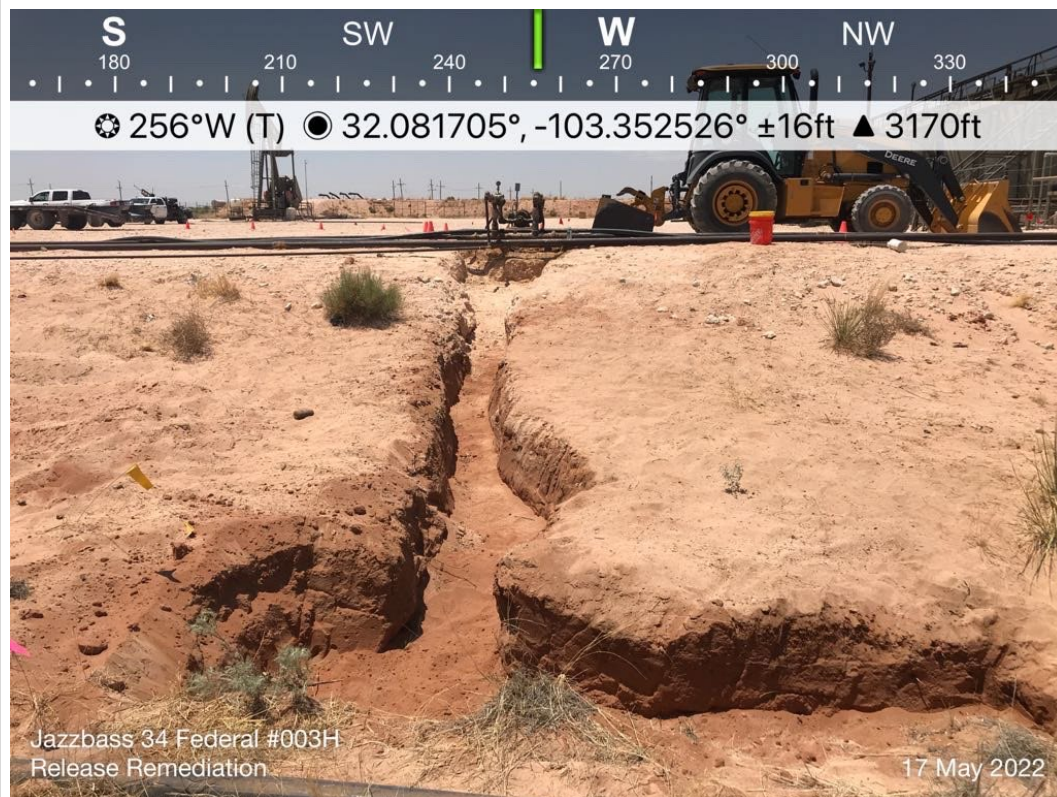
TETRA TECH, INC. PROJECT NO. 212C-MD-02761	DESCRIPTION	View west of excavated remediation extent.	4
	SITE NAME	ConocoPhillips Jazzbass 34 Federal #003H Tank Release	5/17/2022

The total remediated area encompassed a surface area of approximately 180 square feet. Approximately 10 cubic yards of excavated material were transported to the R360 facility in Hobbs, New Mexico. Copies of the waste manifests are included in Appendix E. Photographic documentation of the excavation activities prior to backfilling is presented in Appendix F. The excavated areas were backfilled post-confirmation sample collection and upon receiving analytical results below the applicable RRALs. The impacted surface area occurring on the developed pad at the site was remediated to meet the standards of Table I of 19.15.29.12 NMAC.

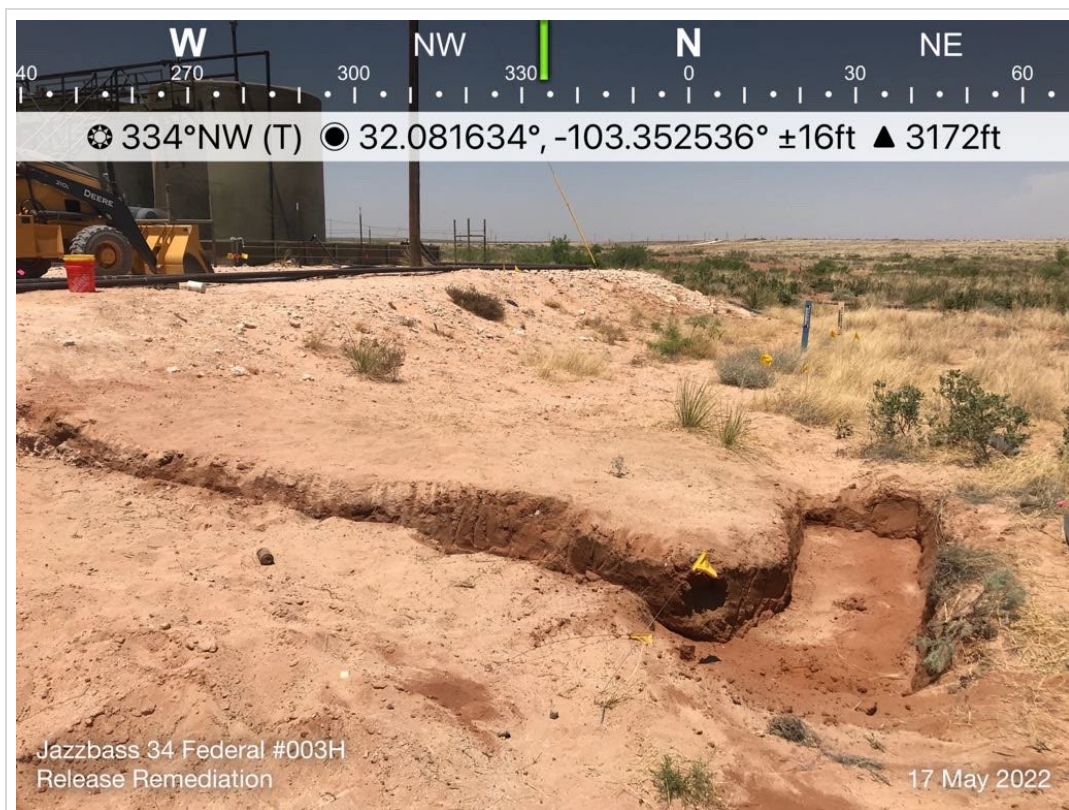
TETRA TECH, INC. PROJECT NO. 212C-MD-02761	DESCRIPTION	View north-northwest of excavated remediation extent.	5
	SITE NAME	ConocoPhillips Jazzbass 34 Federal #003H Tank Release	5/17/2022

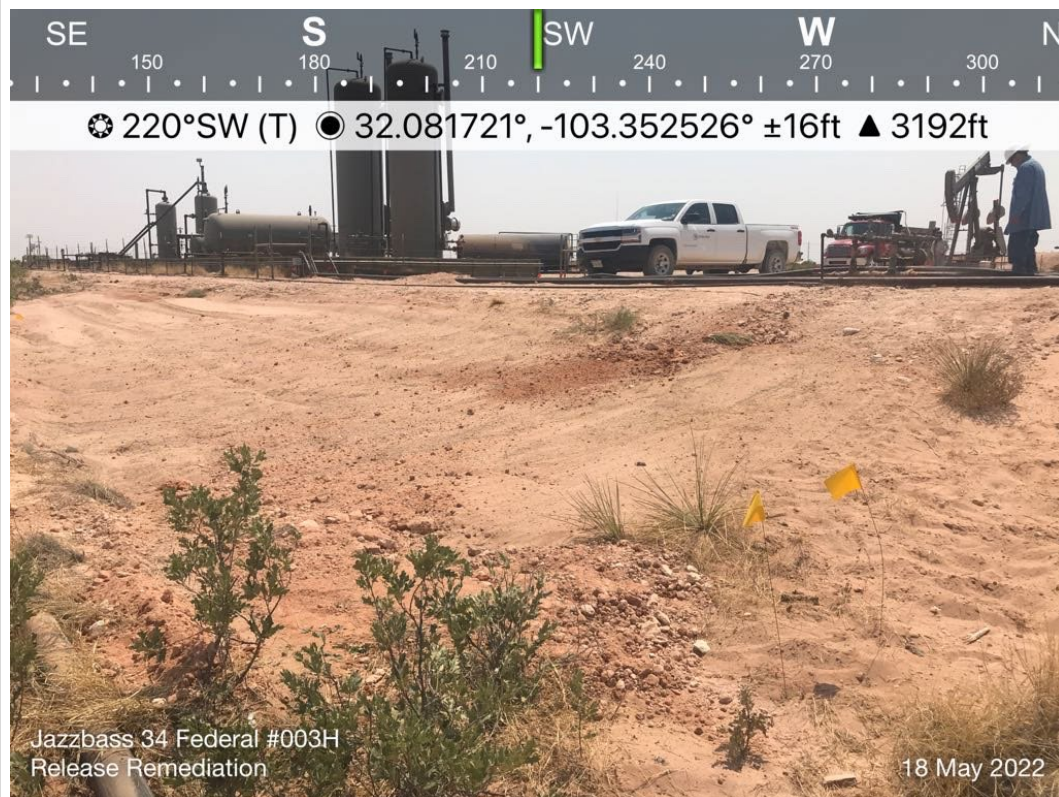
TETRA TECH, INC. PROJECT NO. 212C-MD-02761	DESCRIPTION	View southwest of backfilled release area.	6
	SITE NAME	ConocoPhillips Jazzbass 34 Federal #003H Tank Release	5/17/2022

The backfilled areas in the pasture were seeded to aid in revegetation. The remediated area was seeded in May 2022. Based on the soils at the site, an approved BLM seed mixture was used for seeding and planted in the amount specified in the pounds pure live seed (PLS) per acre.
