Remediation and Closure Report

HollyFrontier Refining & Marketing LLC
Lea County
Incident ID: **nAPP2127734737**

Subject: HollyFrontier Refining & Marketing LLC
Lea County
Incident ID: **nAPP2127734737**

Closure Report
Holly Energy, North Vacuum Abo N. Unit
Transport Incident

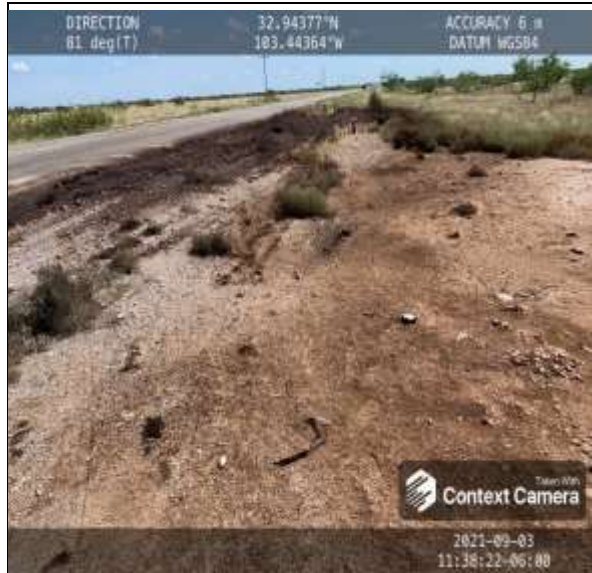
**Photograph No.1 Description:**

Spill Area at accident (source)

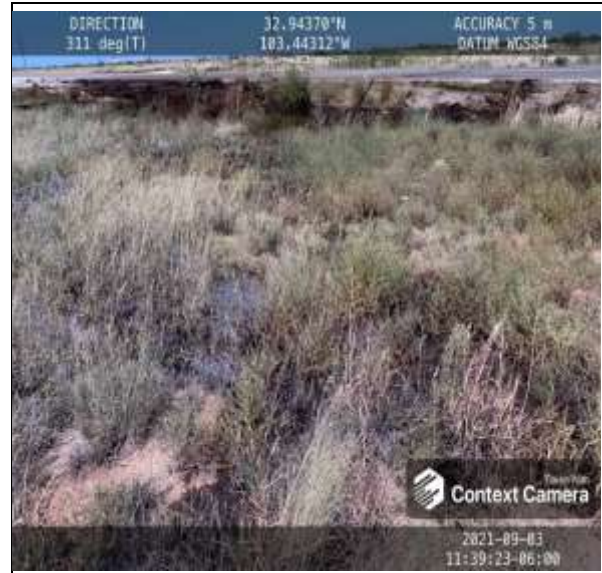
**Photograph No.2 Description:**

Pasture Impact-Standing fluid

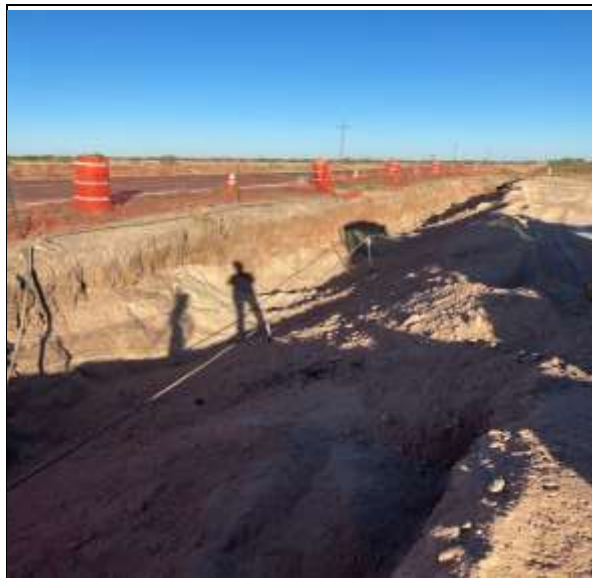
**Photograph No.3 Description:**

Excavation looking East

The impacted area has been excavated from depths of 4' bgs. to 10' bgs. respectively, or to the extent practicable due to highway shoulder, and utility lines. Fiber optic lines were hydro-excavated to remove contamination around the lines. The bottom as well as the sidewalls were advanced and excavated to the extent that, all impacted soils above closure criteria were removed. The crude leached northward impacting the highway sidewall. All contaminated soil has been transported and disposed of at Lea Landfill an NMOCD approved facility. All fluid from the Hydro-excavation was disposed of at R360 and NMOCD approved facility. Excavation and sample area maps are attached in [Appendix I](#).

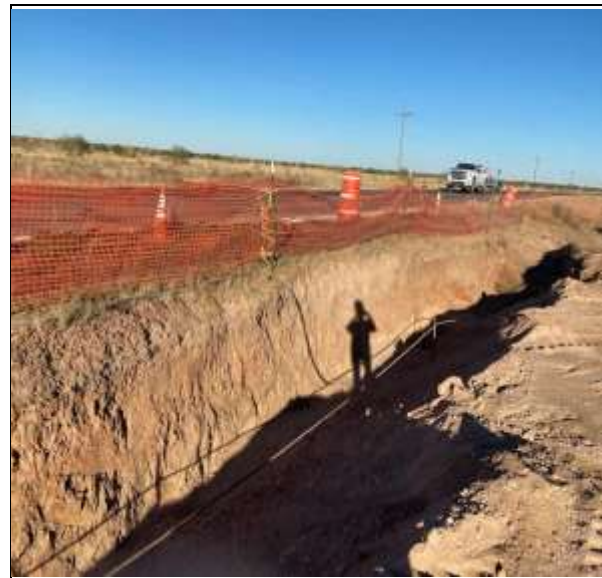
**Photograph No.4 Description:**

Excavation of spill path on right-of-way-exposed utility lines

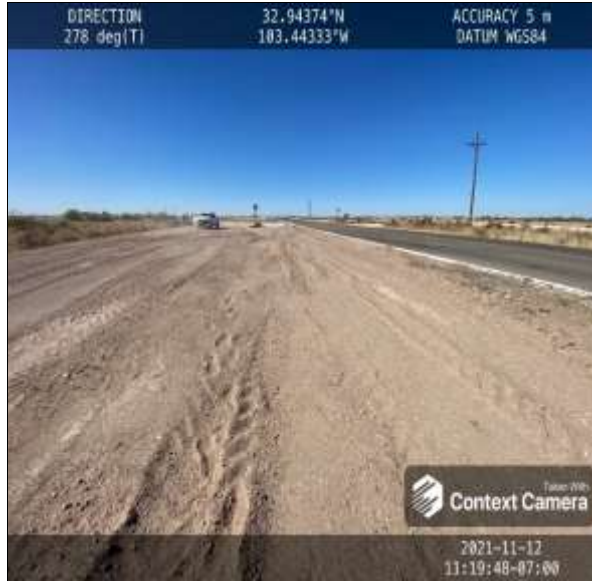
Photograph No.5 Description:

Aerial of backfilled area at source (riser)

Pursuant to NMOCD guidelines the excavation was advanced vertically and horizontally to the extent that the sidewalls and excavation floor tested for chlorides <600 mg/kg, and TPH <100 mg/kg. The north sidewall was advanced to the extent practicable, without compromising the integrity of the highway shoulder. The excavation was backfilled with fresh, clean caliche to within 4 feet of surface. Four feet of clean topsoil mixed with native sand was used to backfill to surface restoring the area to shoulder grade as documented with photo's ([Appendix V](#)).

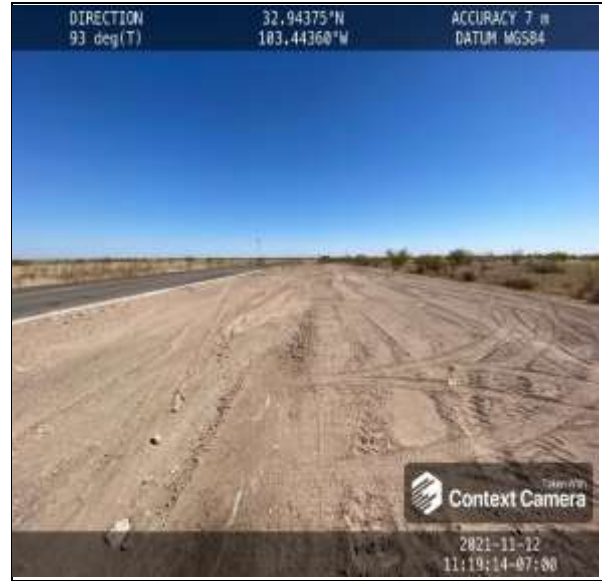
Photograph No.6 Description:

Backfilled to grade on right-of-way
