**Re: Closure Request
Pierce Canyon 32 Tank Battery
Incident Number NAPP2205254615
Eddy County, New Mexico**

Ensolum, LLC (Ensolum) on behalf of XTO Energy, Inc. (XTO), has prepared this Closure Request to document site assessment and soil sampling activities performed at the Pierce Canyon 32 Tank Battery (Site). The purpose of the site assessment and soil sampling activities was to assess for the presence or absence of impacts to soil resulting from a small crude oil flare fire at the Site. Based on the site assessment activities and analytical results from the soil sampling event, XTO is submitting this Closure Request for Incident Number NAPP2205254615.

XTO ENERGY, INC
 PIERCE CANYON 32 TANK BATTERY
 NAPP2205254615
 Unit P, Sec 32, T24S, R30E
 Eddy County, New Mexico

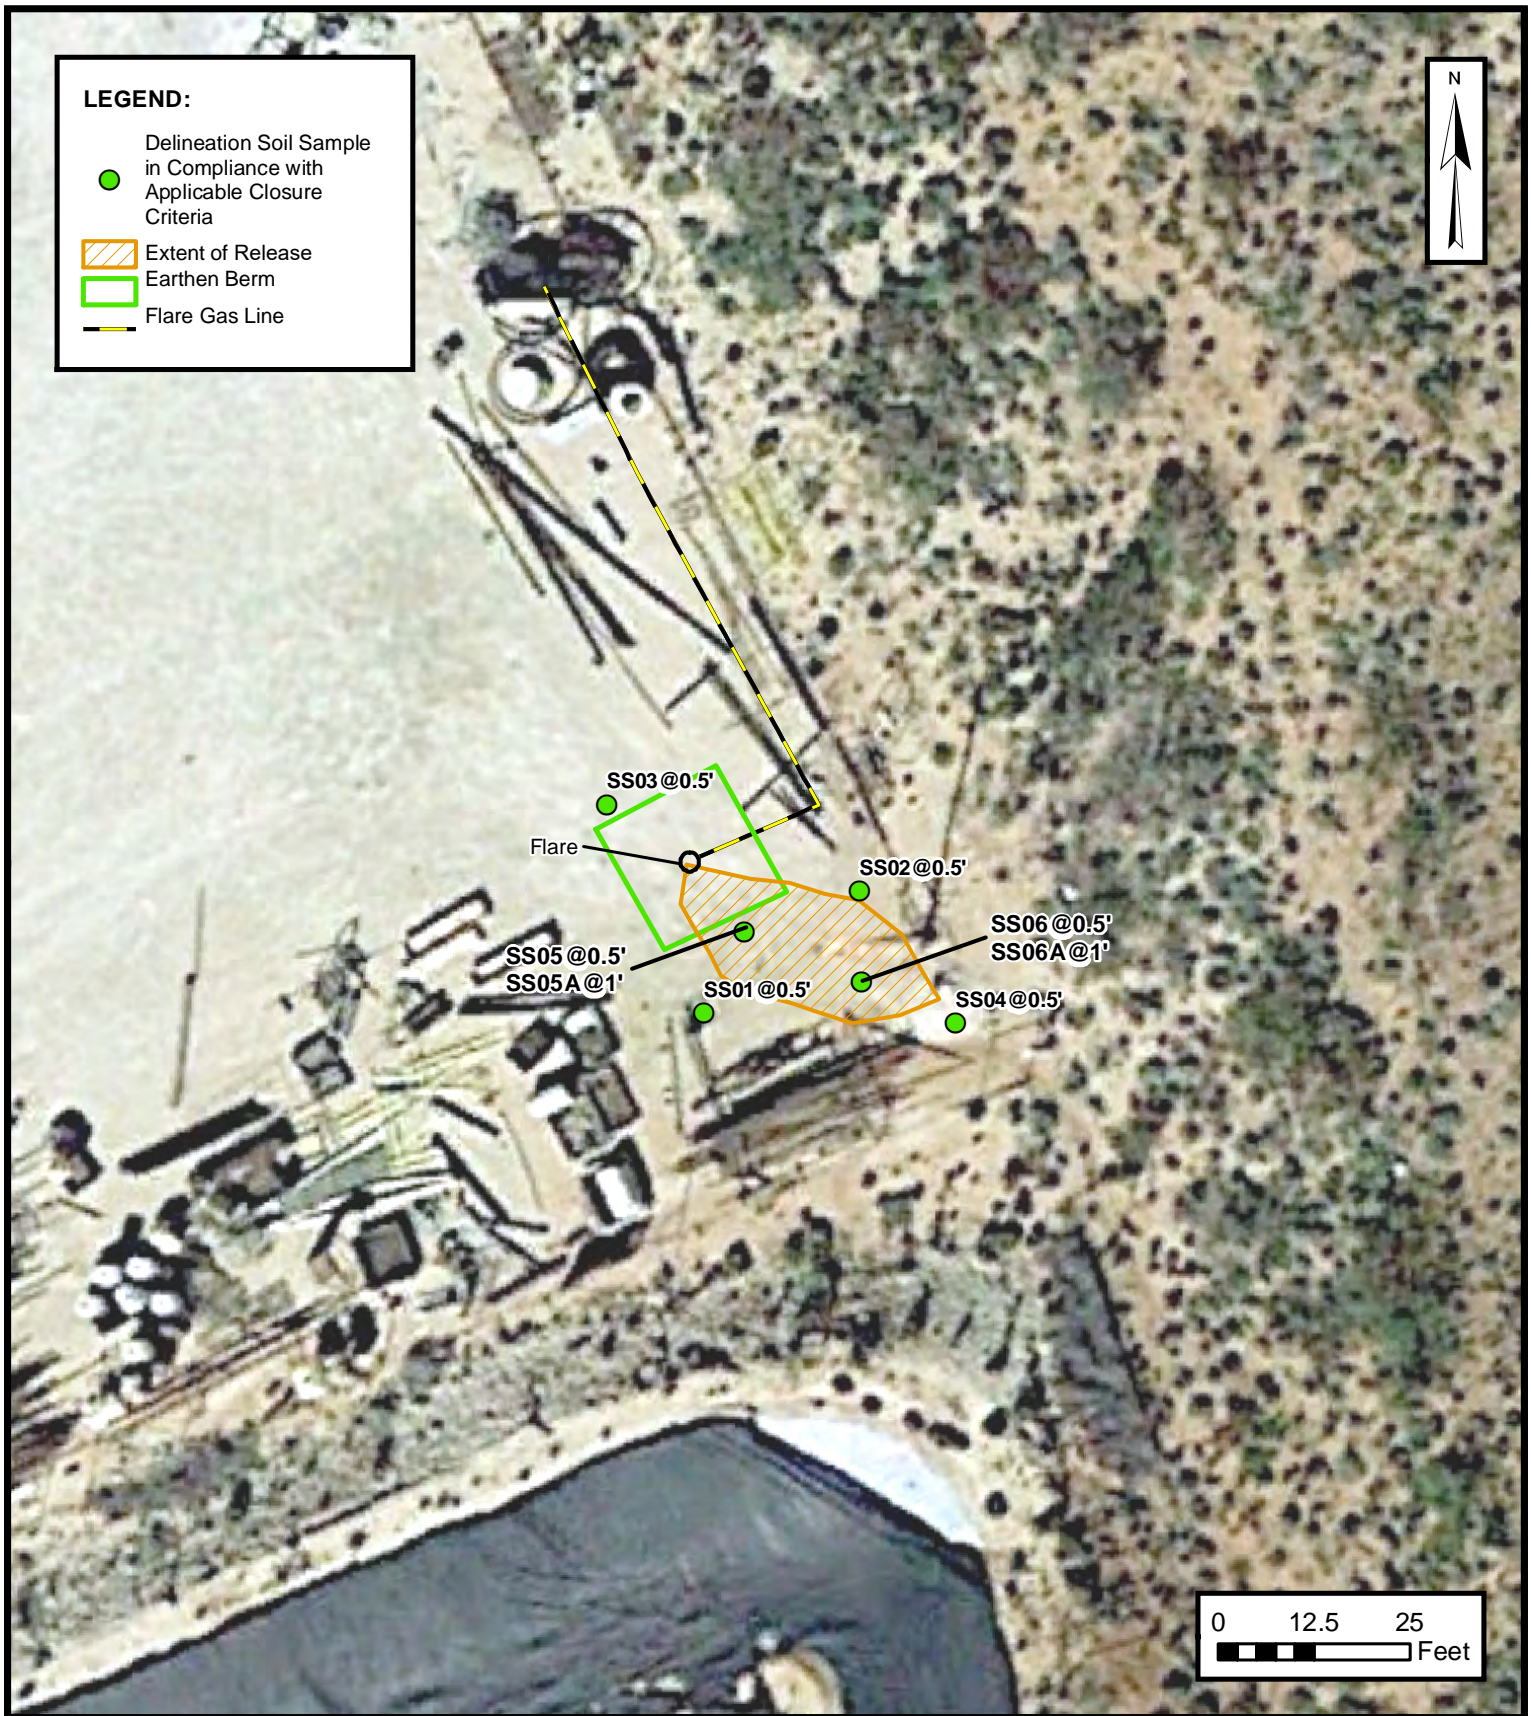
DELINEATION SOIL SAMPLE LOCATIONS

Field screening results indicated no impacts to soil; however, surficial staining from the fire was scraped and removed from the Site. Following the preliminary soil sampling and scraping, additional delineation activities were conducted to confirm the absence of impacted soil. Potholes were advanced via track mounted backhoe within the release extent at the locations of preliminary soil samples SS05 and SS06. The potholes were advanced to a depth of 1 foot bgs. Discrete delineation soil samples SS05A and SS06A were collected from the potholes at a depth 1 foot bgs. Soil from the potholes was field screened for VOCs and chloride utilizing a calibrated PID and Hach® chloride QuanTab® test strips, respectively. Field screening results and observations for the potholes were logged on lithologic/soil sampling logs, which are included in Appendix C. The delineation soil sample locations are depicted on Figure 2.

Laboratory analytical results for preliminary soil samples SS01 through SS06 and delineation soil samples SS05A and SS06A indicated that benzene, BTEX, TPH-GRO/TPH-DRO, TPH, and chloride concentrations were compliant with the Site Closure Criteria and provided lateral and vertical delineation to below the most stringent Table 1 Closure Criteria. Laboratory analytical results are summarized in Table 1 and the complete laboratory analytical reports are included as Appendix D.

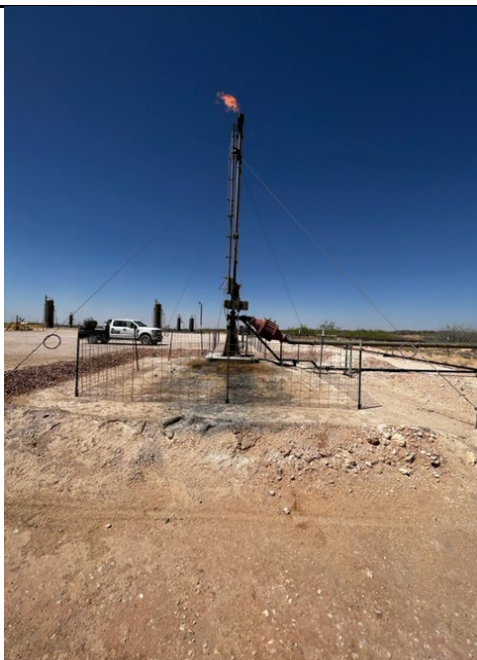
Photograph 1 Date: 04/13/2022

Description: View of staining and release extent facing northwest during the one call.

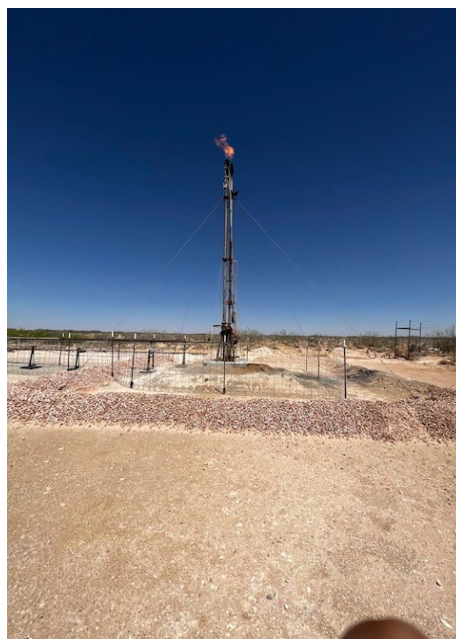
Photograph 2 Date: 04/13/2022

Description: View of staining and release extent facing northeast during the one call.

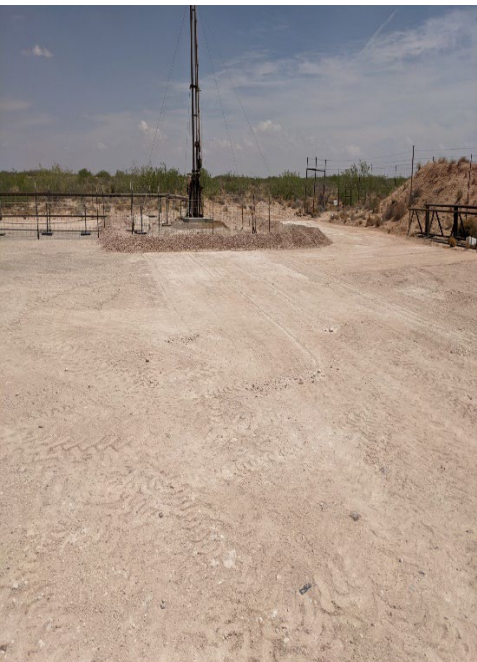
Photograph 3 Date: 04/22/2022

Description: View of release area following a surface scrape of the staining facing east.

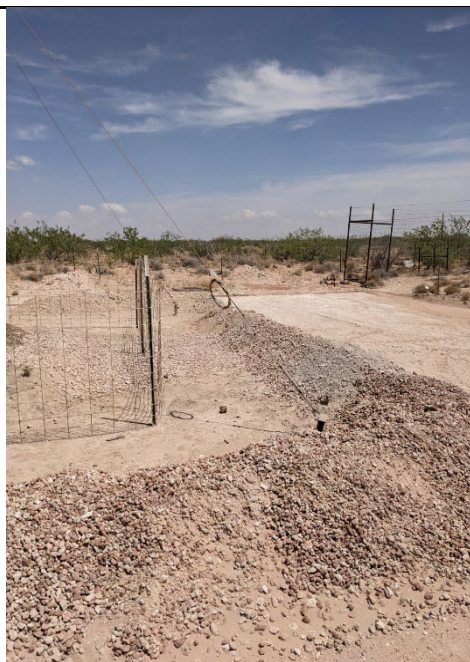
Photograph 3 Date: 04/22/2022

Description: View of release area following a surface scrape of the staining facing southeast.
