Release Notification

Site Name Moore LS 2A	Site Type Well
Date Release Discovered 4/1/2021 @ 11:00am (MT)	API# 30-045-22827

Executive Summary

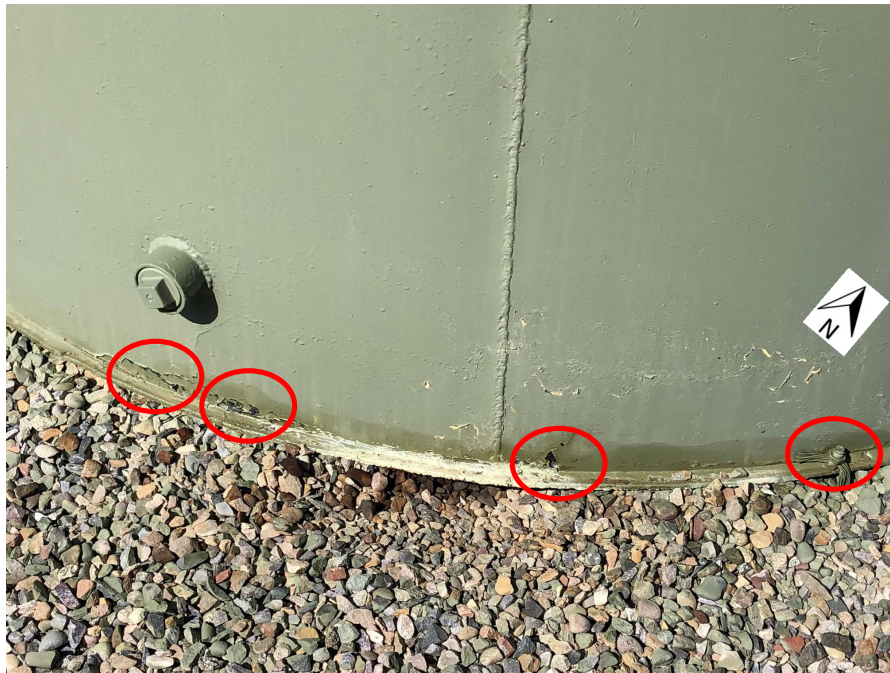
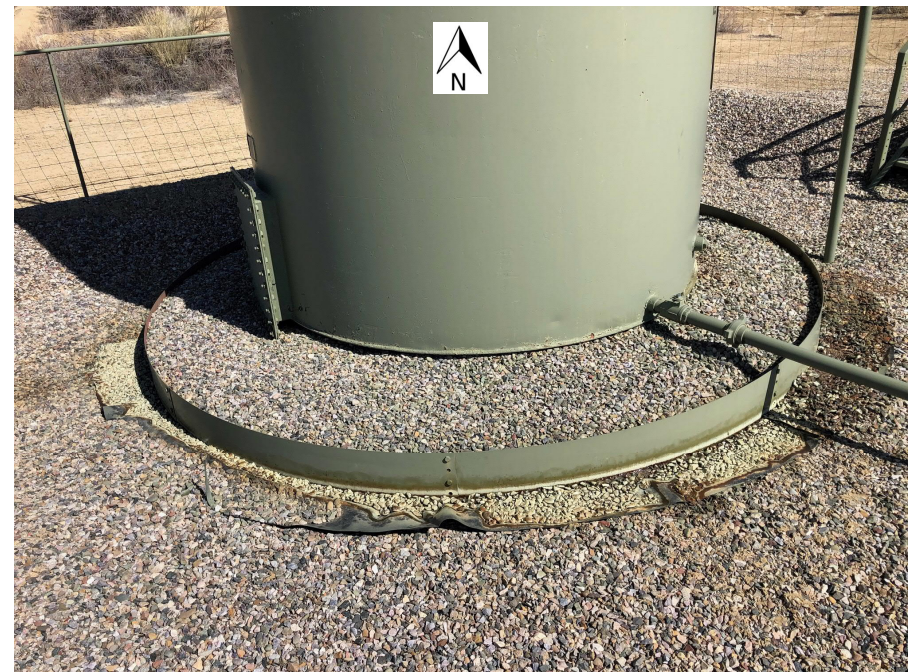
Initial Release Photographs

On April 1, 2021 at 11:00 am MT, Hilcorp Energy Company (Hilcorp) had a release of 20 bbls condensate at the Moore LS 2A (API No. 30-045-22827). The release was due to a hole that had developed in the condensate production storage tank as a result of corrosion. Upon discovery, the oil dump line for the condensate storage tank was shut-in pending an incident investigation. The released fluids remained inside secondary containment and visibly-impacted gravel/soil was observed in the northern portion of the bermed area. The visibly-impacted surface area measured approximately 15 ft x 20 ft (300 ft²) on the surface. No fluids were recovered at the time of the incident.

Following the initial investigation, Hilcorp chose to remediate the site via dig/haul with the use of a backhoe. Prior to commencing any excavation activities, the condensate production storage tank was removed from the bermed area and a one-call was made. A total of two excavation events occurred during the weeks of May 24 and May 31. A total of 56 cubic yards (yd³) was excavated from the release area. However, with expansion, the actual amount hauled to EnviroTech equated to 75 yd³.

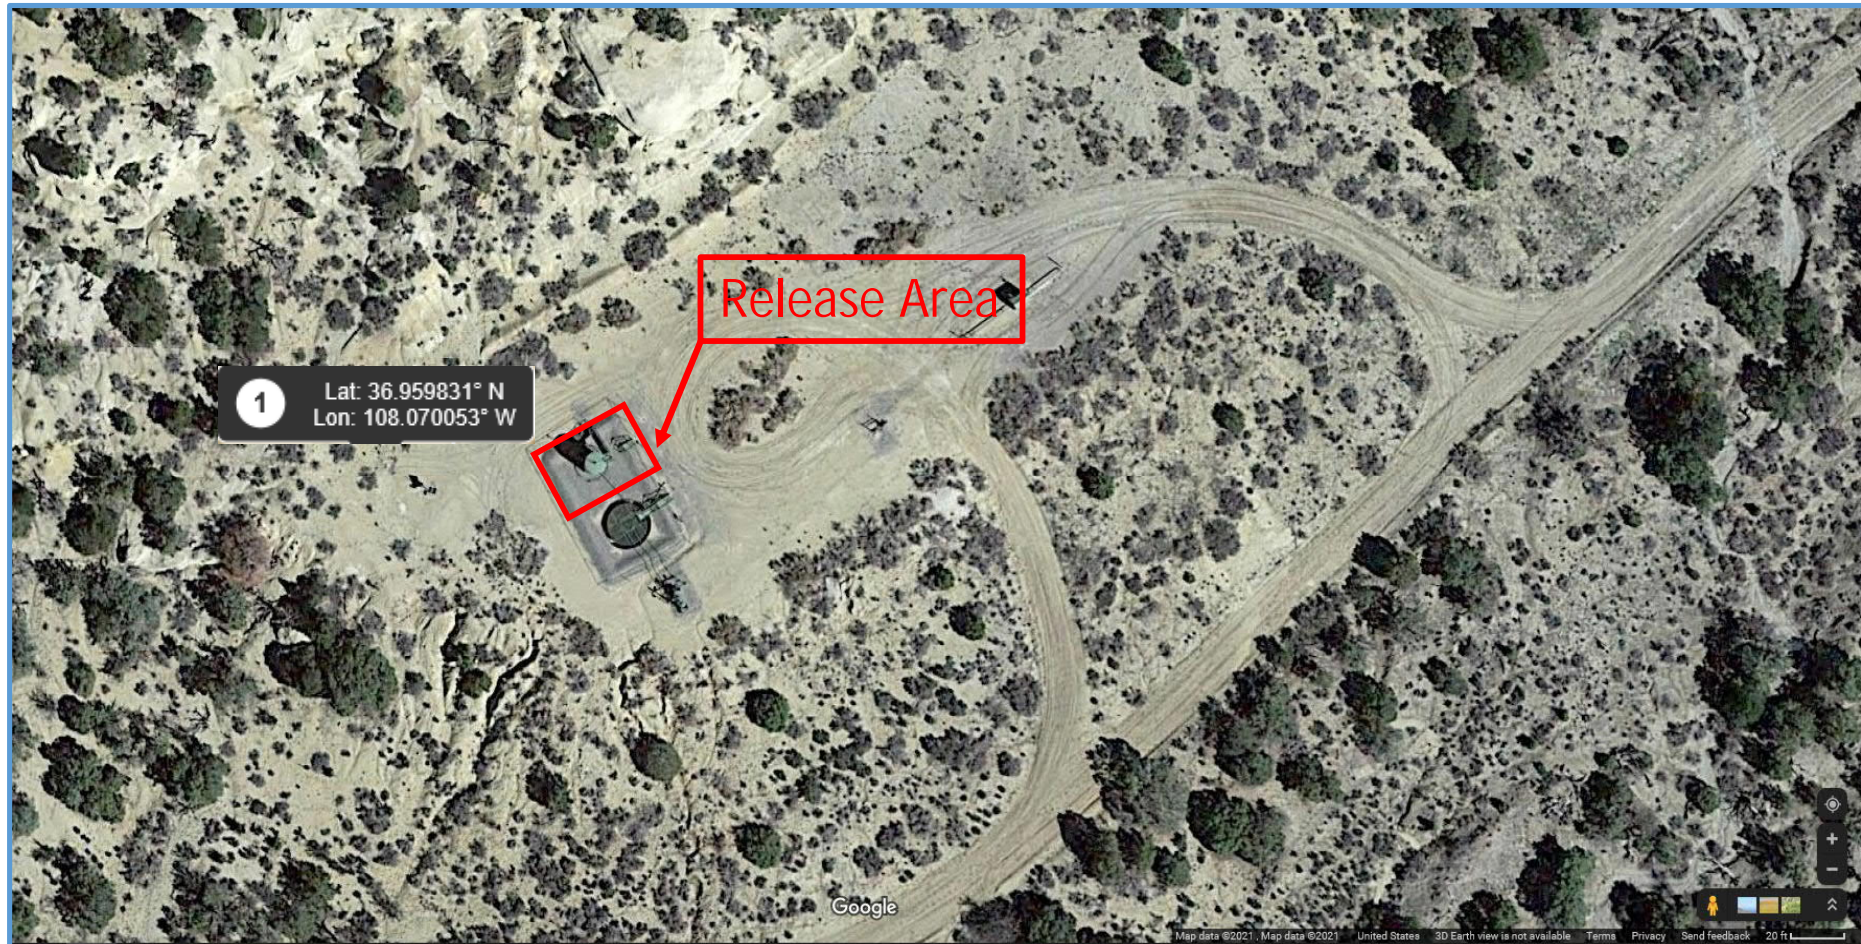
Scaled Map

Note 1: The surface extent of the Moore LS 2A release is represented by the red rectangle shown in image above. Note that all spilled liquids remained within secondary containment.

Note 2: Prior to excavation, the condensate production storage tank was removed at north portion of bermed area.

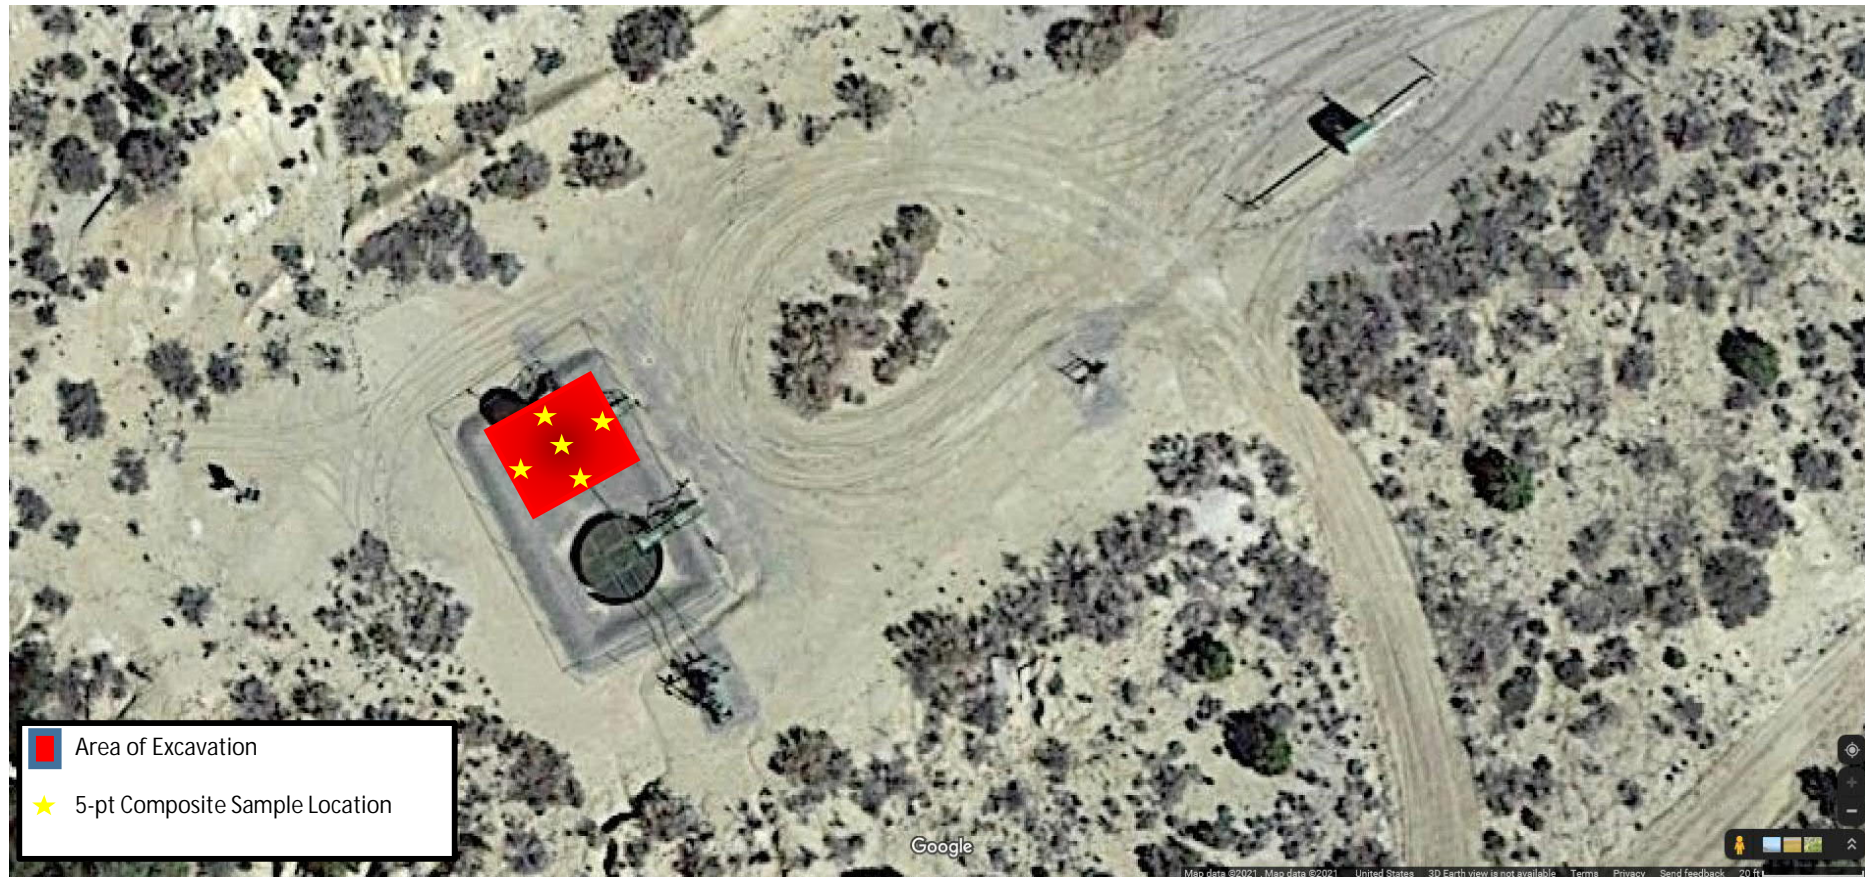
Scaled Map – Close-up

Note 1: The total impacted material excavated was approximately 56 cubic yards (or 75 cubic yards with expansion).

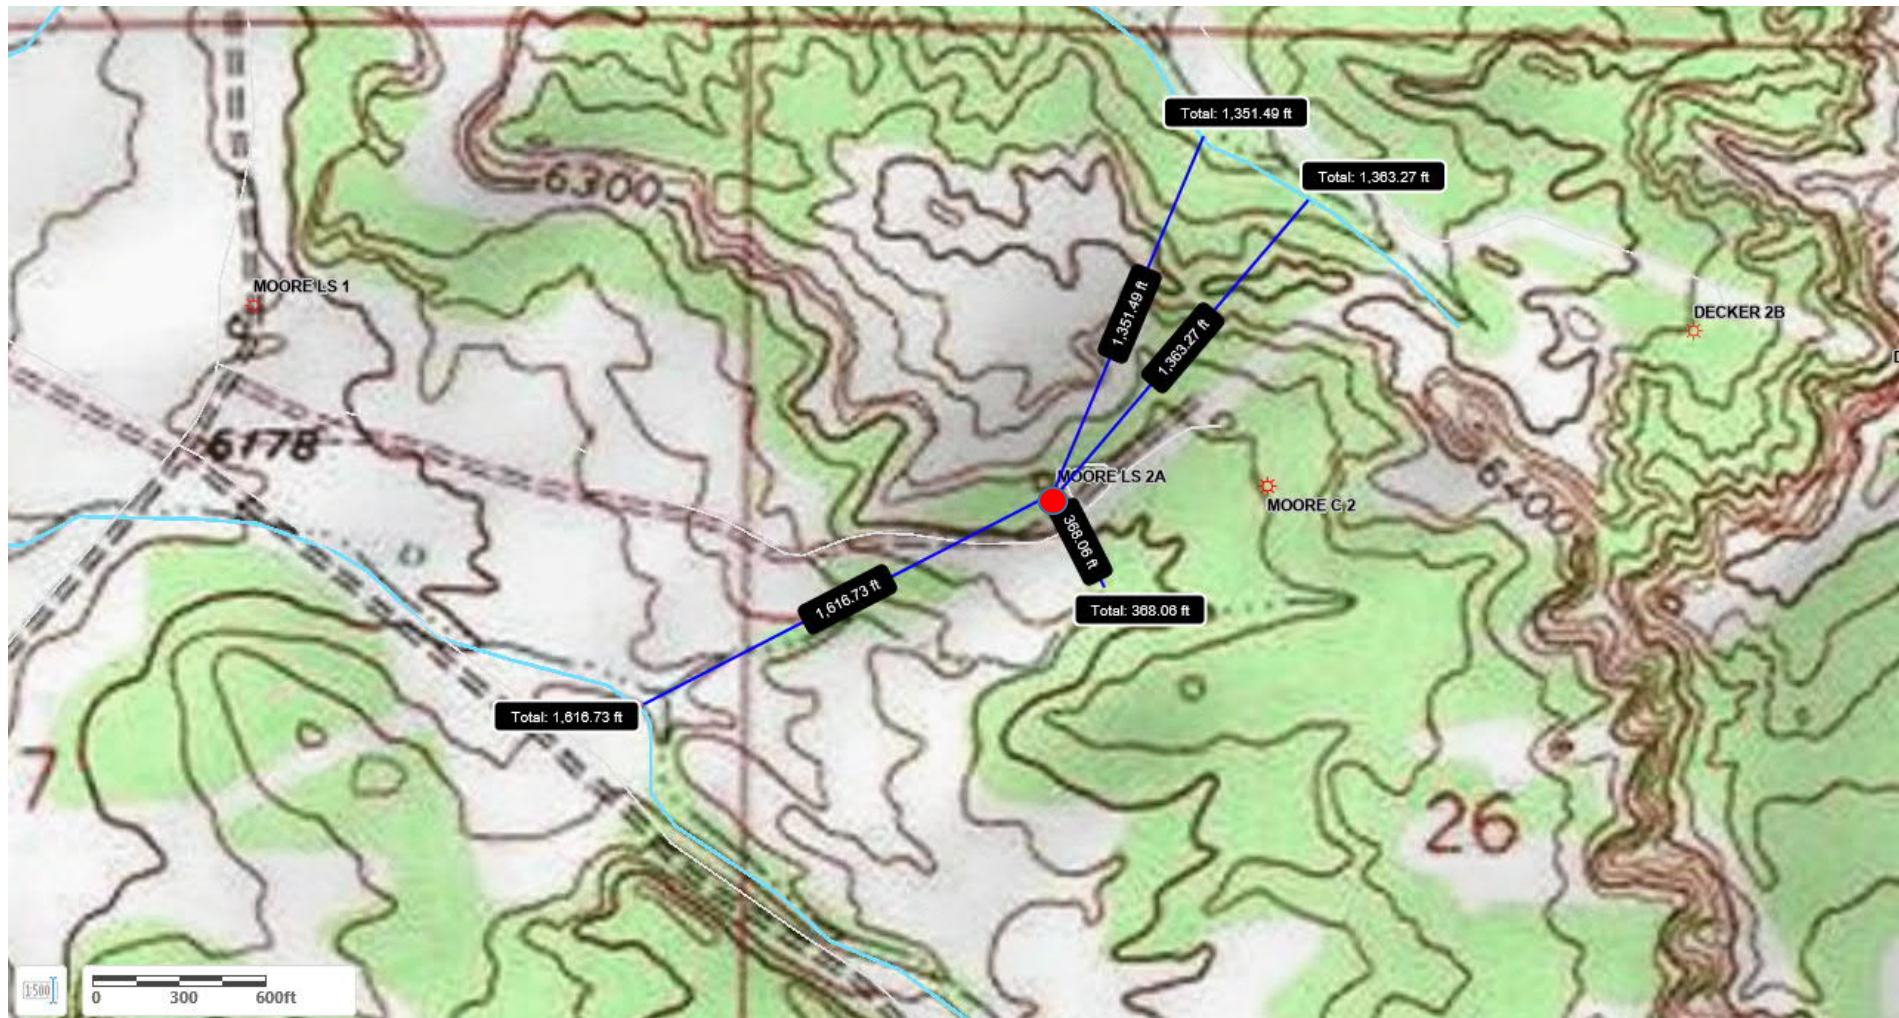
Determination of water sources and significant watercourses within ½ mile of the lateral extent of the release

Note: Release point is not shown to be within 300 ft of any continuously flowing watercourse or any other significant water course. It should also be noted that the water feature denoted on the topographic layer to the southeast is outside of the 300 ft buffer and is not a continuously flowing water feature (also refer to the C-144 BGT Pit Permit discussed further below).

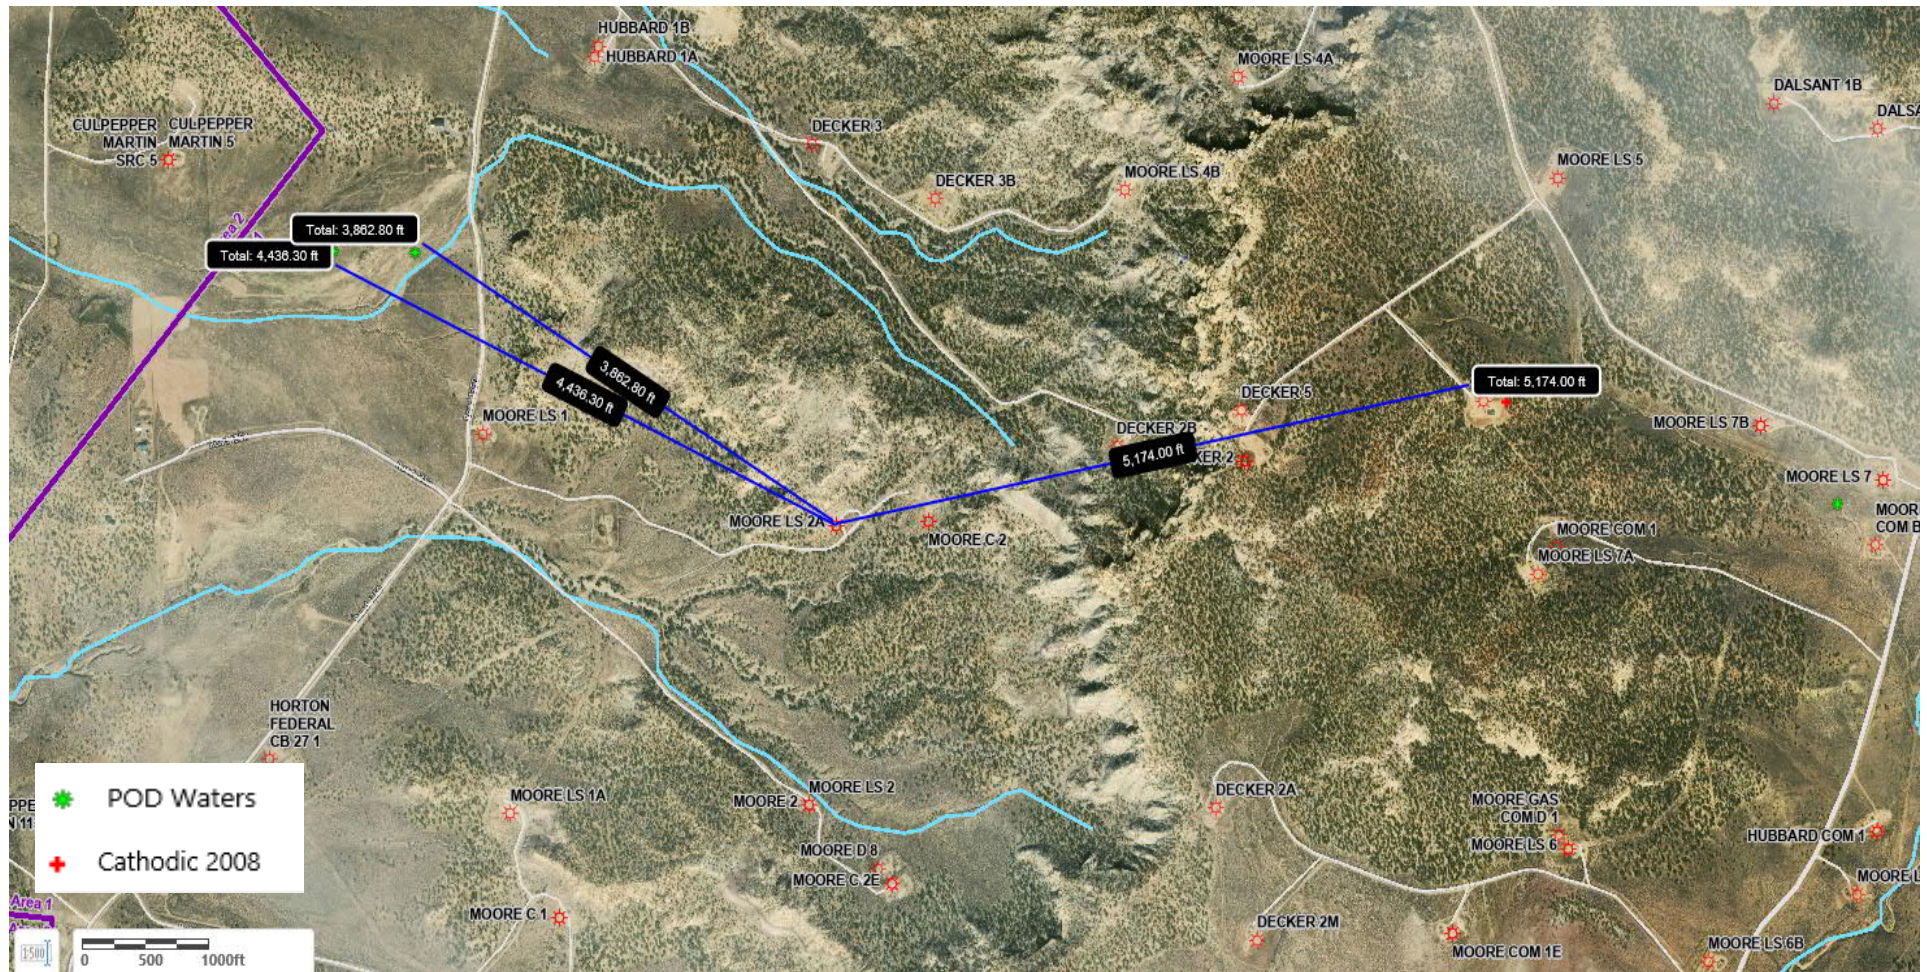
Distance to mapped water wells

Note: The lateral extents of the release point are not shown to be within 500 ft of a spring or domestic freshwater well used by less than 5 households (or stock watering) or within 1,000 ft of any freshwater water well or spring.

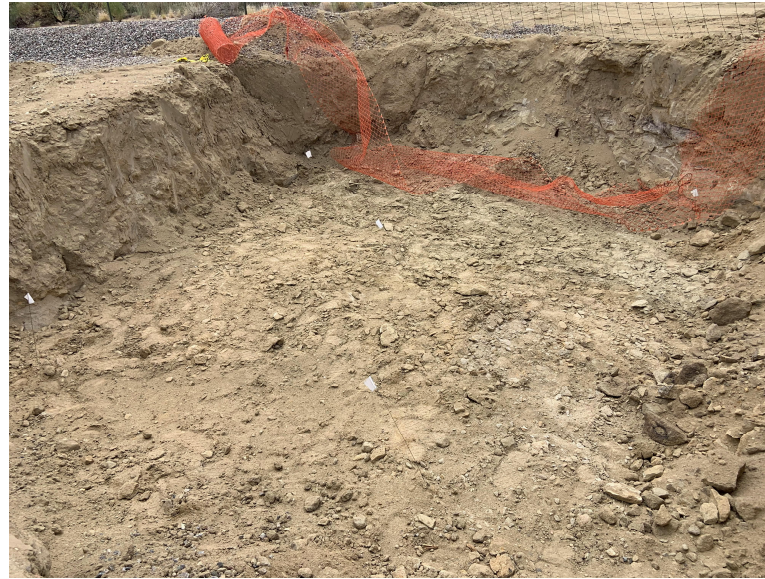
Sample No. 1
Base Composite Point

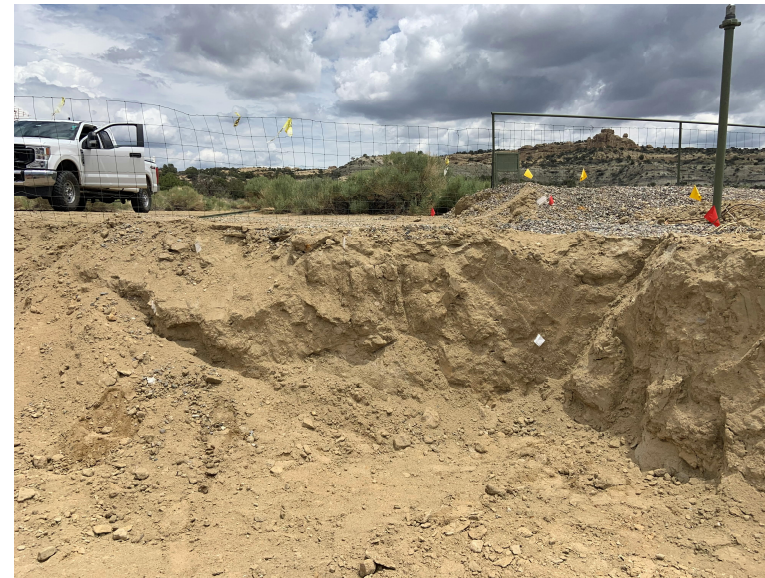
Sample No. 2
East Wall Composite Point

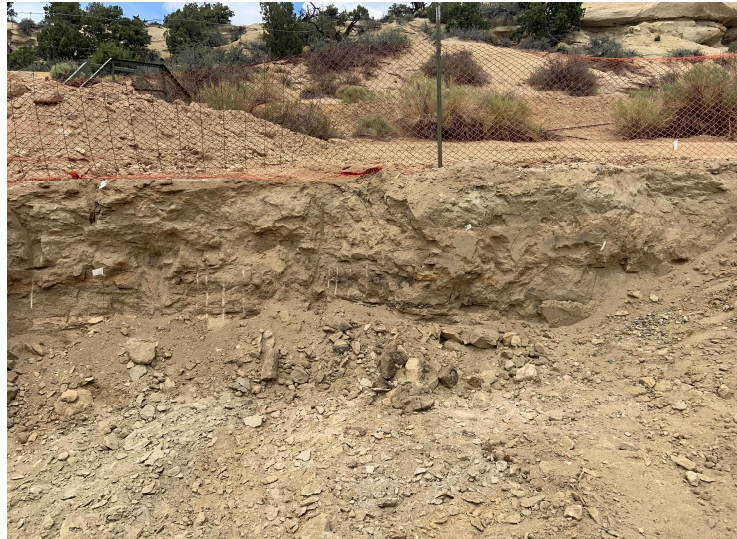
Sample No. 3
North Wall Composite Point

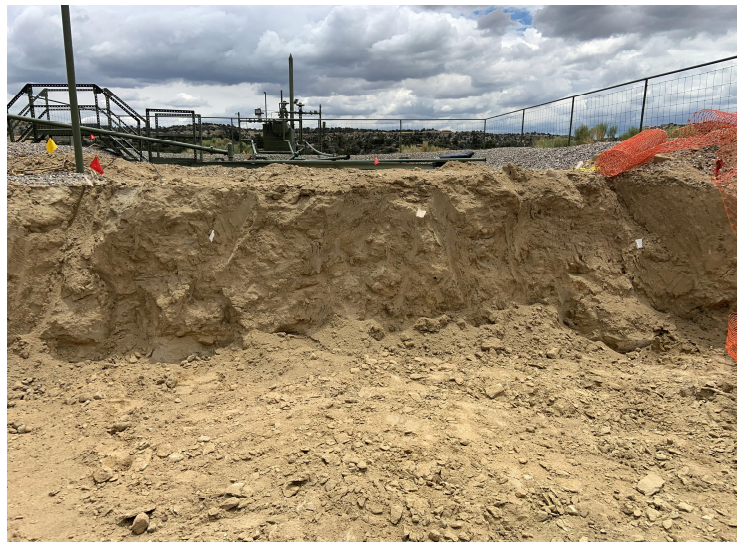
Sample No. 4
South Wall Composite Point

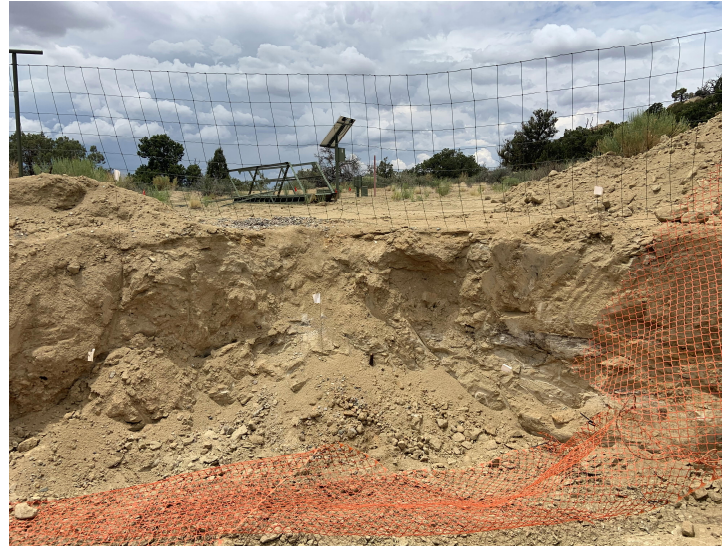
Sample No. 5
West Wall Composite Point
