Site Assessment/Characterization

State of New Mexico
Oil Conservation Division

Based on laboratory analytical results and field activities conducted to date, Etech recommends ConocoPhillips Company provide copies of this *Remediation Summary & Soil Closure Request* to the appropriate agencies and request closure be granted to the Bevo 004H release site.

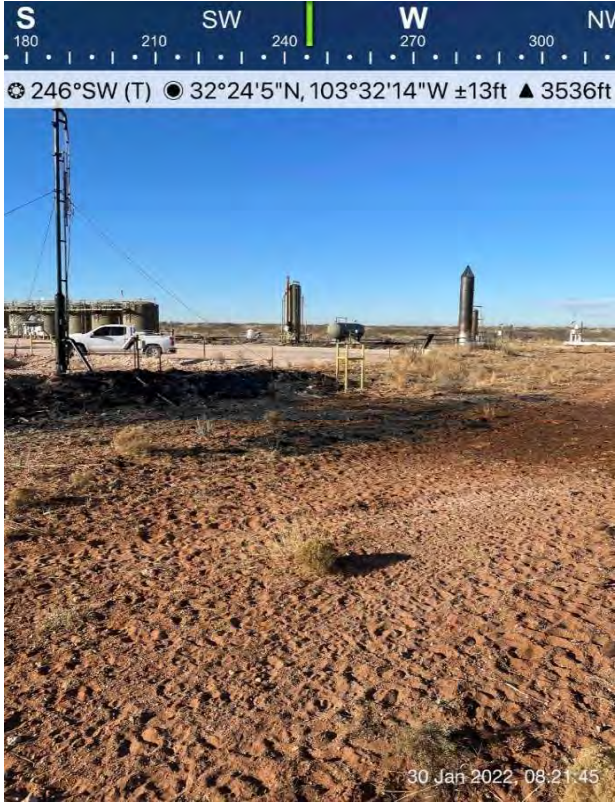
Photo Number: 3

Photo Direction: Southwest	
Photo Description: View of the affected area.

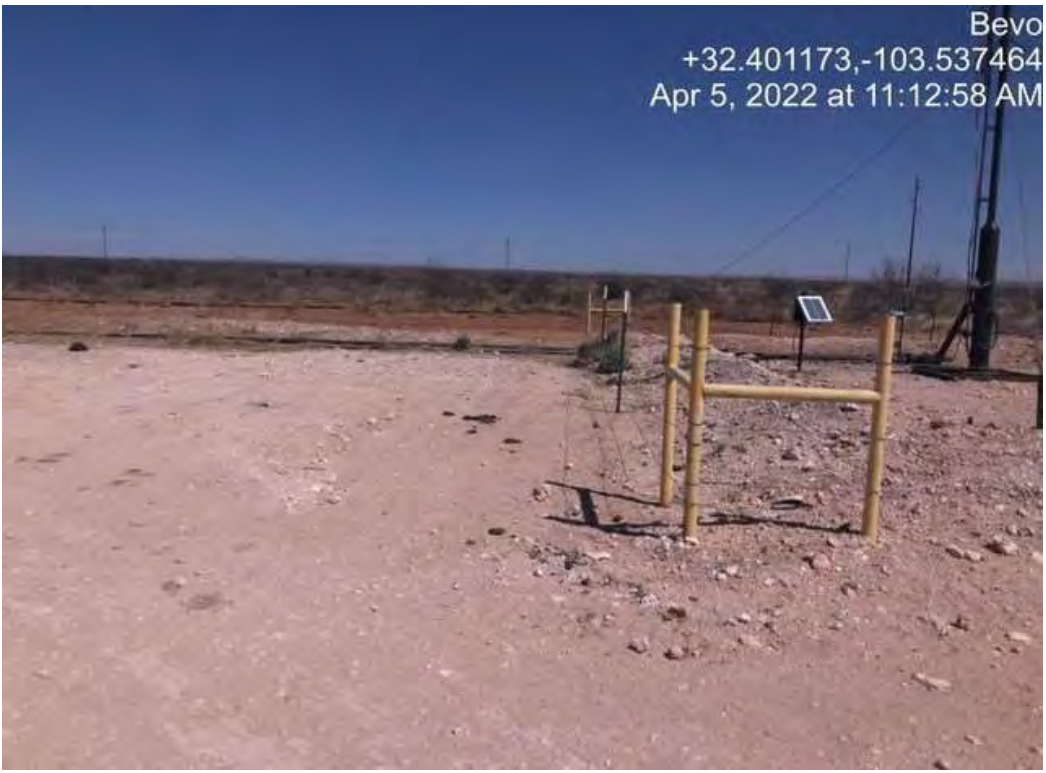
Photo Number: 4

Photo Direction: North	
Photo Description: View of the scraped area.

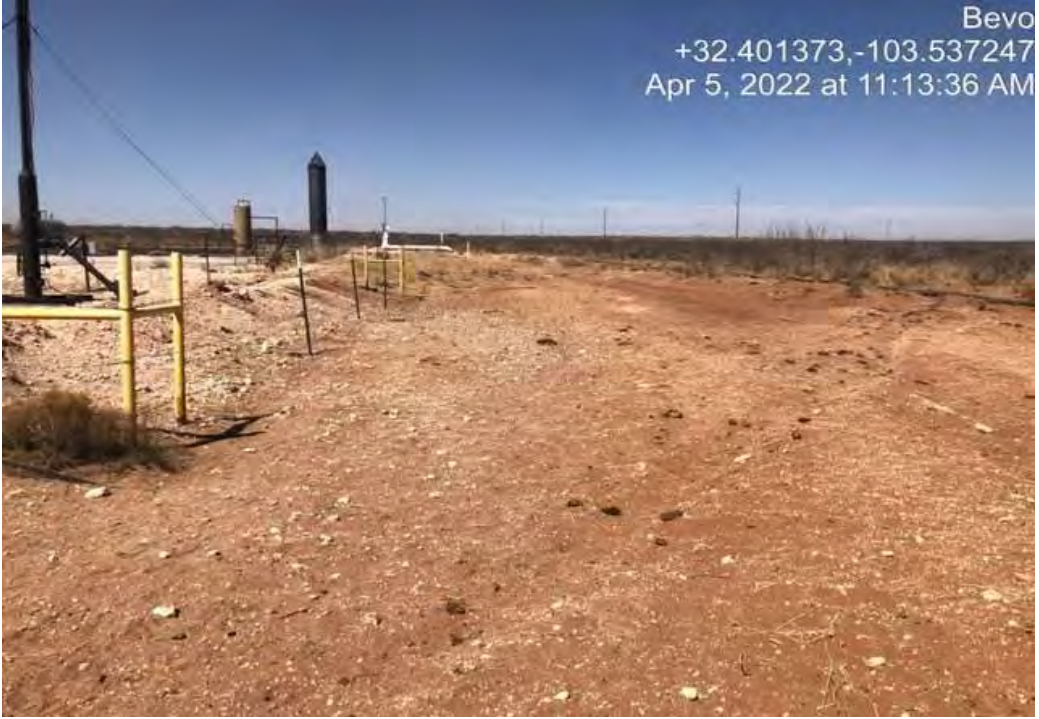
Photo Number: 5

<p>Bevo +32.401373,-103.537247 Apr 5, 2022 at 11:13:36 AM</p>
Photo Direction: West	
Photo Description: View of the scraped area.
