Closure Report
Asio Otus CTB (02.17.22)
Incident #: NAPP2206232853
Eddy County, New Mexico
Unit K Sec 18 T26S R27E
32.039692°, -104.231634°

Produced Water Release
Point of Release: Alarm Failure
Release Date: 02/17/2022
Volume Released: 12.478 Barrels of Produced Water
Volume Recovered: 12 Barrels of Produced Water

**Re: Closure Report
Asio Otus CTB (02.17.22)
Concho Operating, LLC
Incident ID NAPP2206232853
Site Location: Unit K, S18, T26S, R27E
(Lat 32.039692°, Long -104.231634°)
Eddy County, New Mexico**

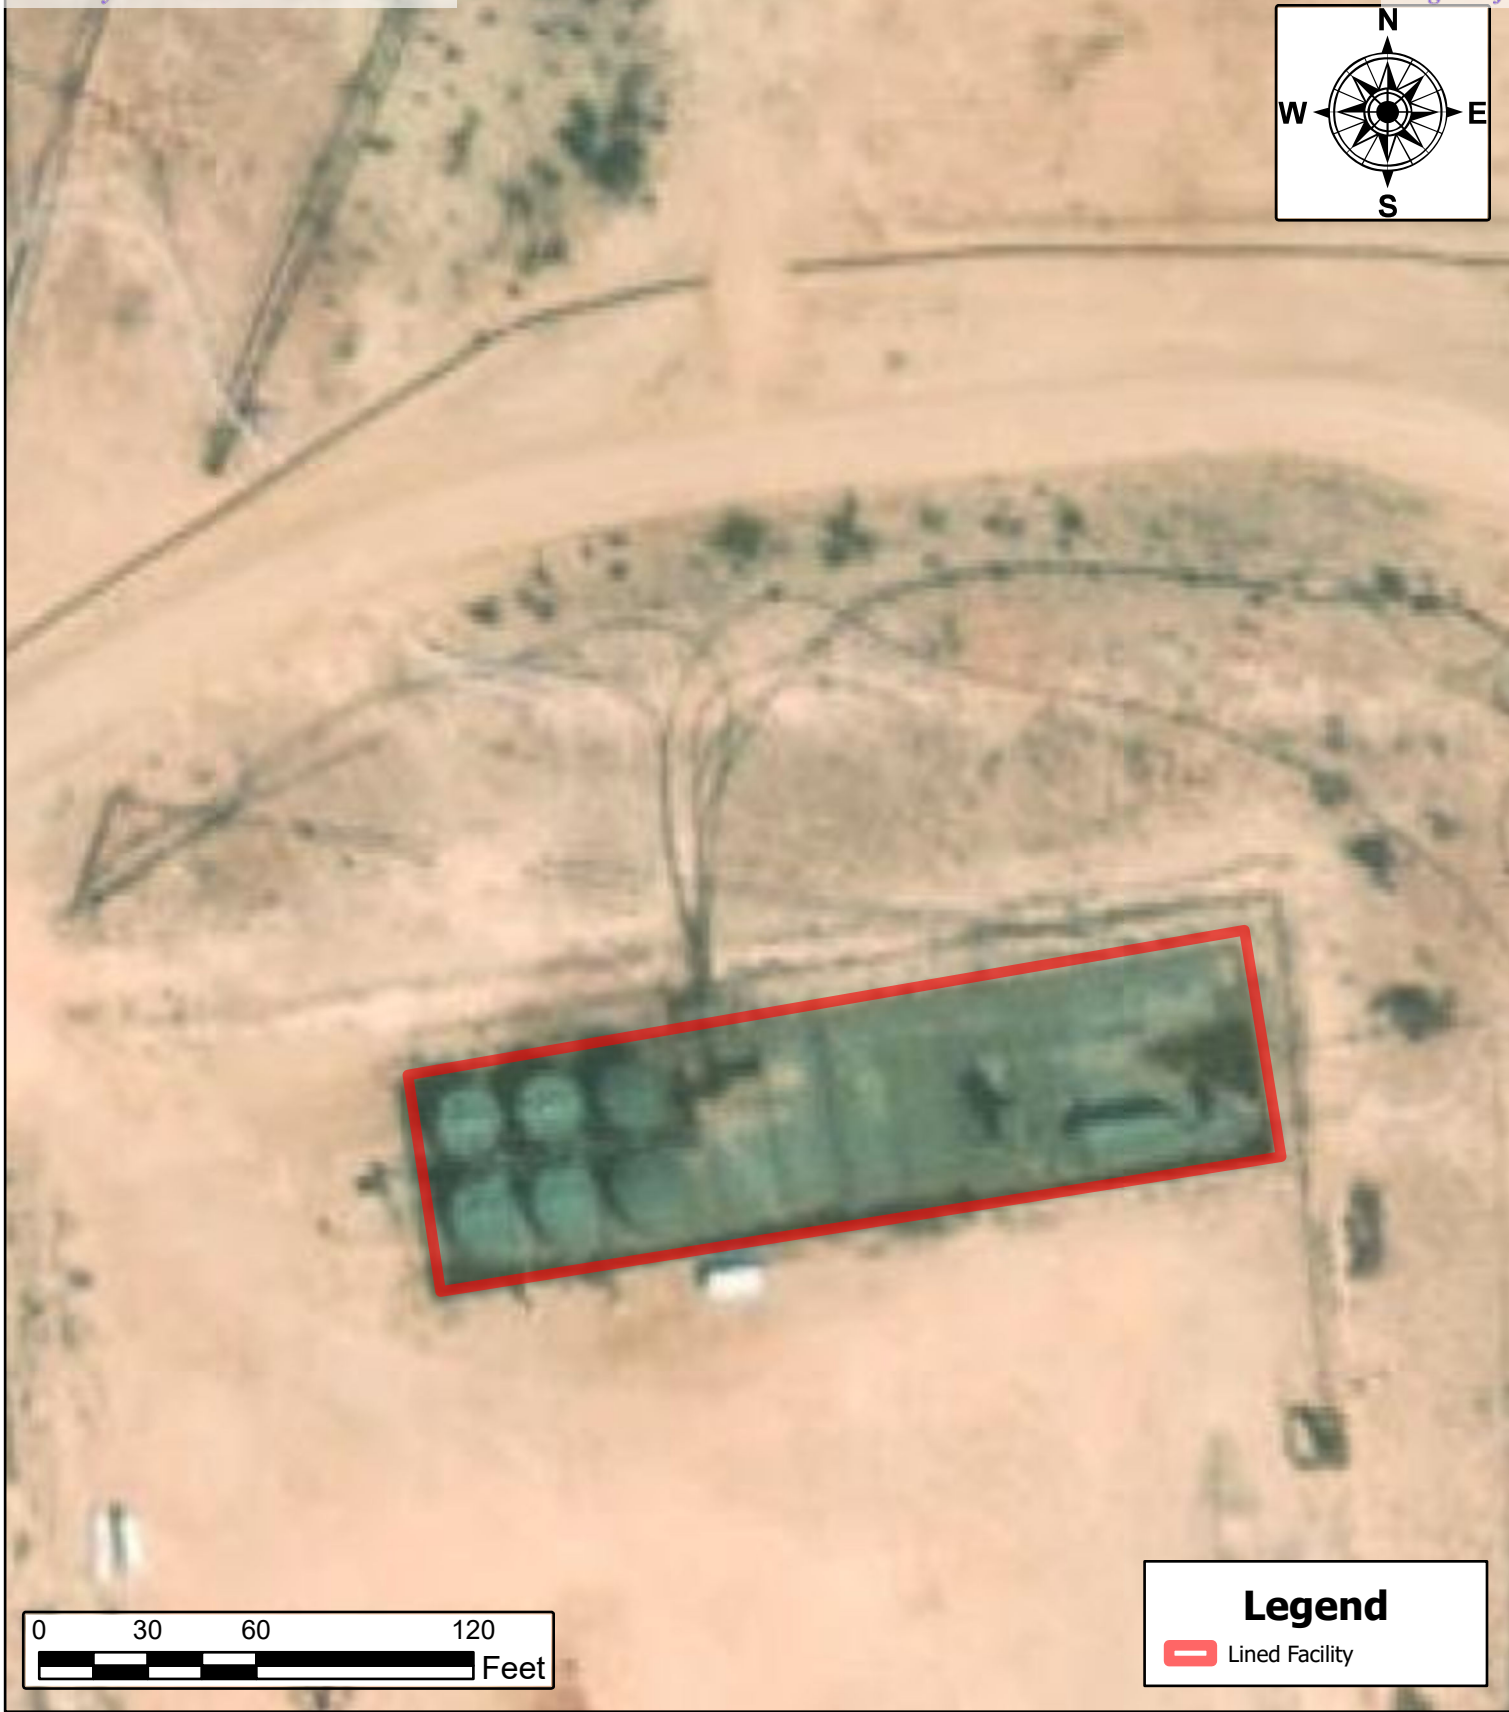
FIGURE 3

Based on the initial C-141 obtained from the New Mexico Oil Conservation Division (NMOCD), the release was discovered on February 17, 2022, due to an alarm failure. It resulted in approximately twelve point four seven eight (12.478) barrels of produced water. Twelve (12) barrels were recovered. See figure 3. The initial C-141 form is attached in Appendix B.

SECONDARY CONTAINMENT MAP
COG OPERATING
ASIO OTUS CTB (02.17.22)
EDDY COUNTY, NEW MEXICO
32.039692, -104.231634

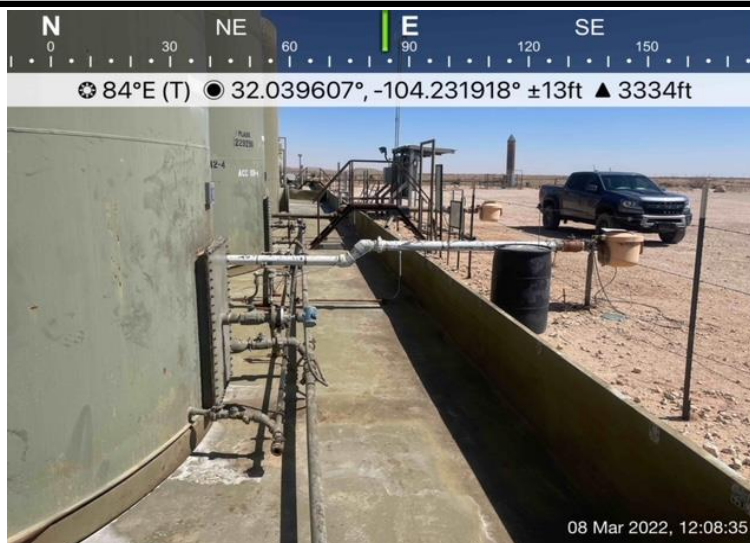
Photograph No. 1

On March 8, 2022, Carmona Resources, LLC conducted liner inspection activities to assess the liner's integrity within the facility. Carmona Resources, LLC personnel proceeded to inspect the liner visually. The liner was found to be intact with no integrity issues. Refer to the Photolog.

View East of lined facility.

Based on the liner inspection throughout the facility, no further actions are required at the site. The final C-141 is attached, and COG formally requests closure of the spill. If you have any questions regarding this report or need additional information, don't hesitate to contact us at 432-813-1992.

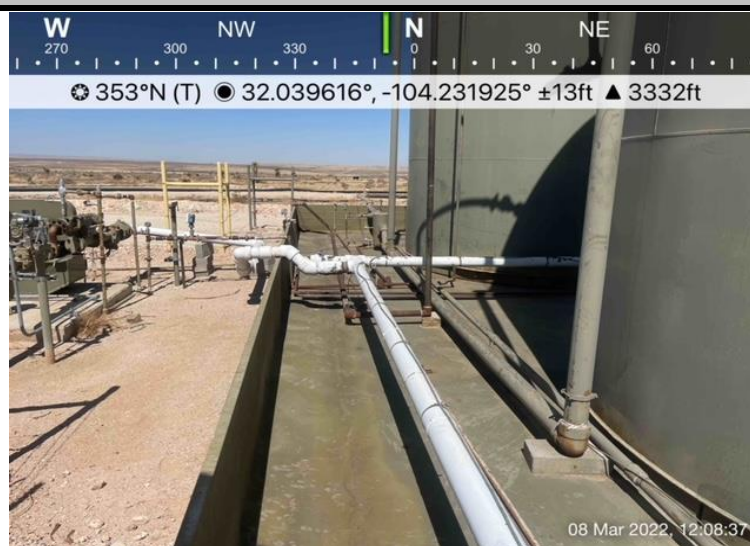
Photograph No. 2

View North of lined facility.

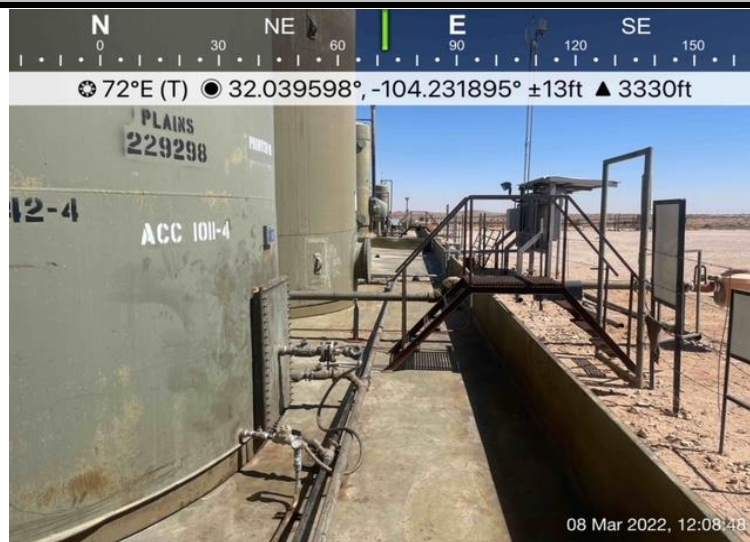
Photograph No. 3

View East of lined facility.

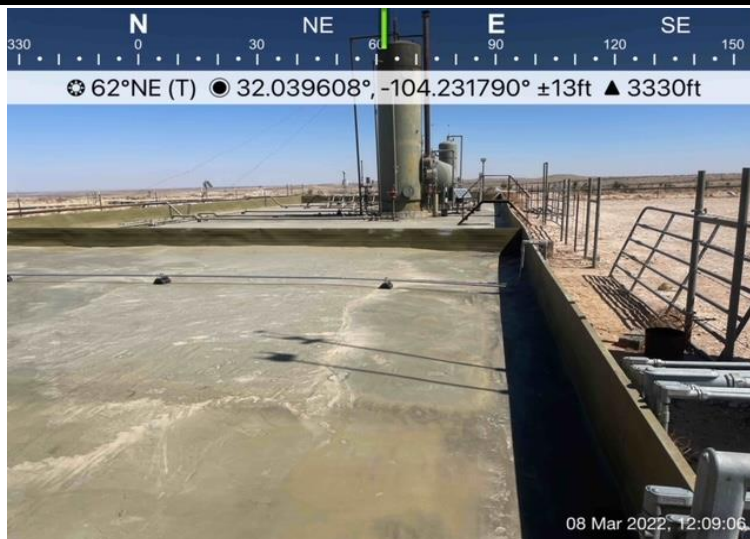
PHOTOGRAPHIC LOG**Concho Operating, LLC****Photograph No. 4****Facility:** Asio Otus CTB (02.17.22)**County:** Eddy County, New Mexico**Description:**

View Northeast of lined facility.

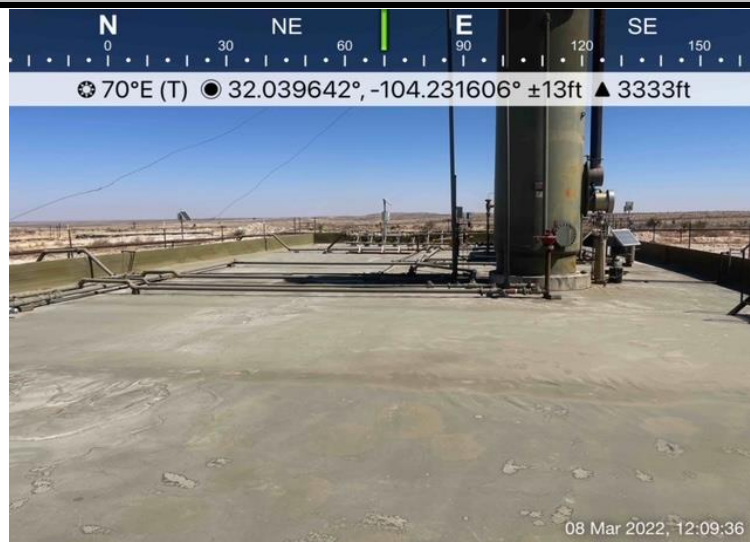
**Photograph No. 6****Facility:** Asio Otus CTB (02.17.22)**County:** Eddy County, New Mexico**Description:**

View East of lined facility.

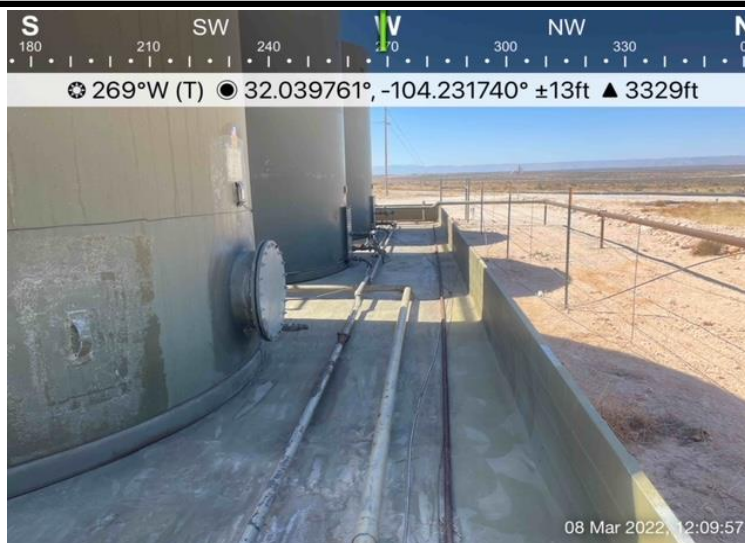
Photograph No. 7

View West of lined facility.

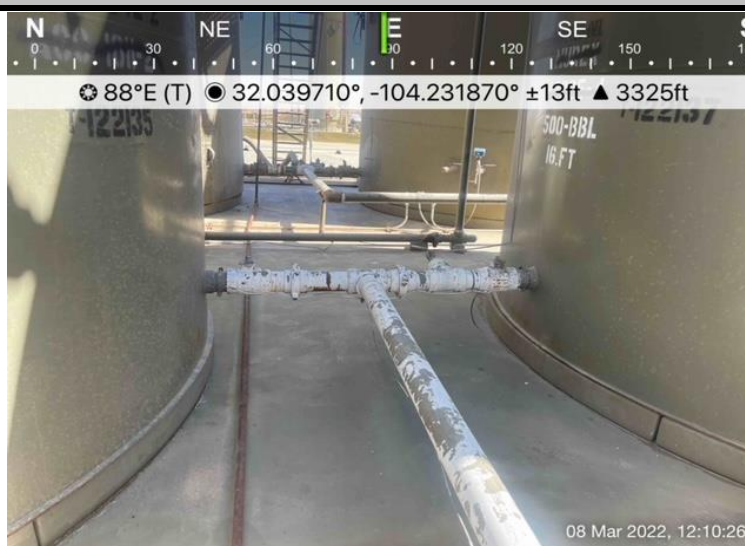
Photograph No. 8

View East of lined facility.

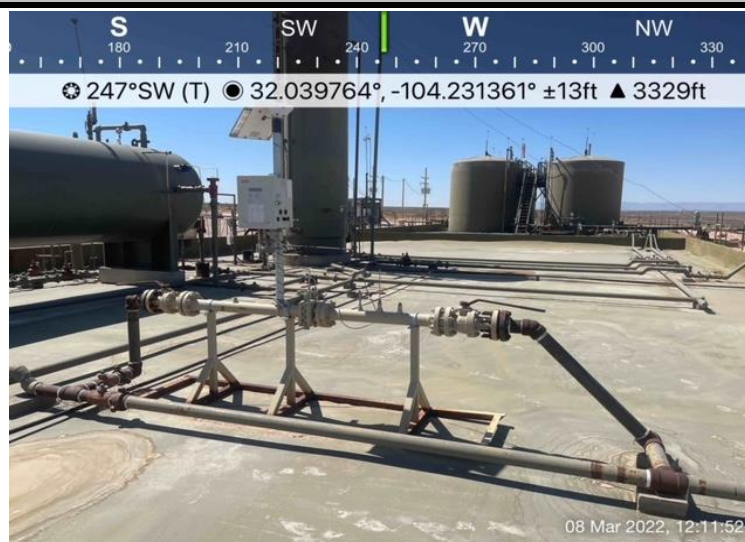
Photograph No. 9

View Southwest of lined facility.
