RE: 1RP-1214 NEDU 704

Company: Apache Corporation Address: 2530 W Marland St., Hobbs, NM 88240 Telephone #: (575) 393 7106  
Site Name: Northeast Drinkard Unit 704 (NEDU 704) NMOCD Reference#: 1RP-1214  
Surface Owner: Millard Deck Estate (rep L.V. "Flap" Sims II) Mineral Owner: BLM  
Unit Letter: M Section: 15 Township: T21S Range: R37E County: Lea  
GPS Coordinates: 32.474528 N, -103.152899 W  
Date/Time of Release: 9/18/2003 Type of Release: Crude Oil ☒ Produced Water  
Volume(s) Released: 500 bbl Volume(s) Recovered: 0.0 bbl  
Closure Criteria for Impacted Soil (mg/kg; See Appendix F, "Closure Criteria Justification"):

### Background Information:

#### **Site Closure Request**

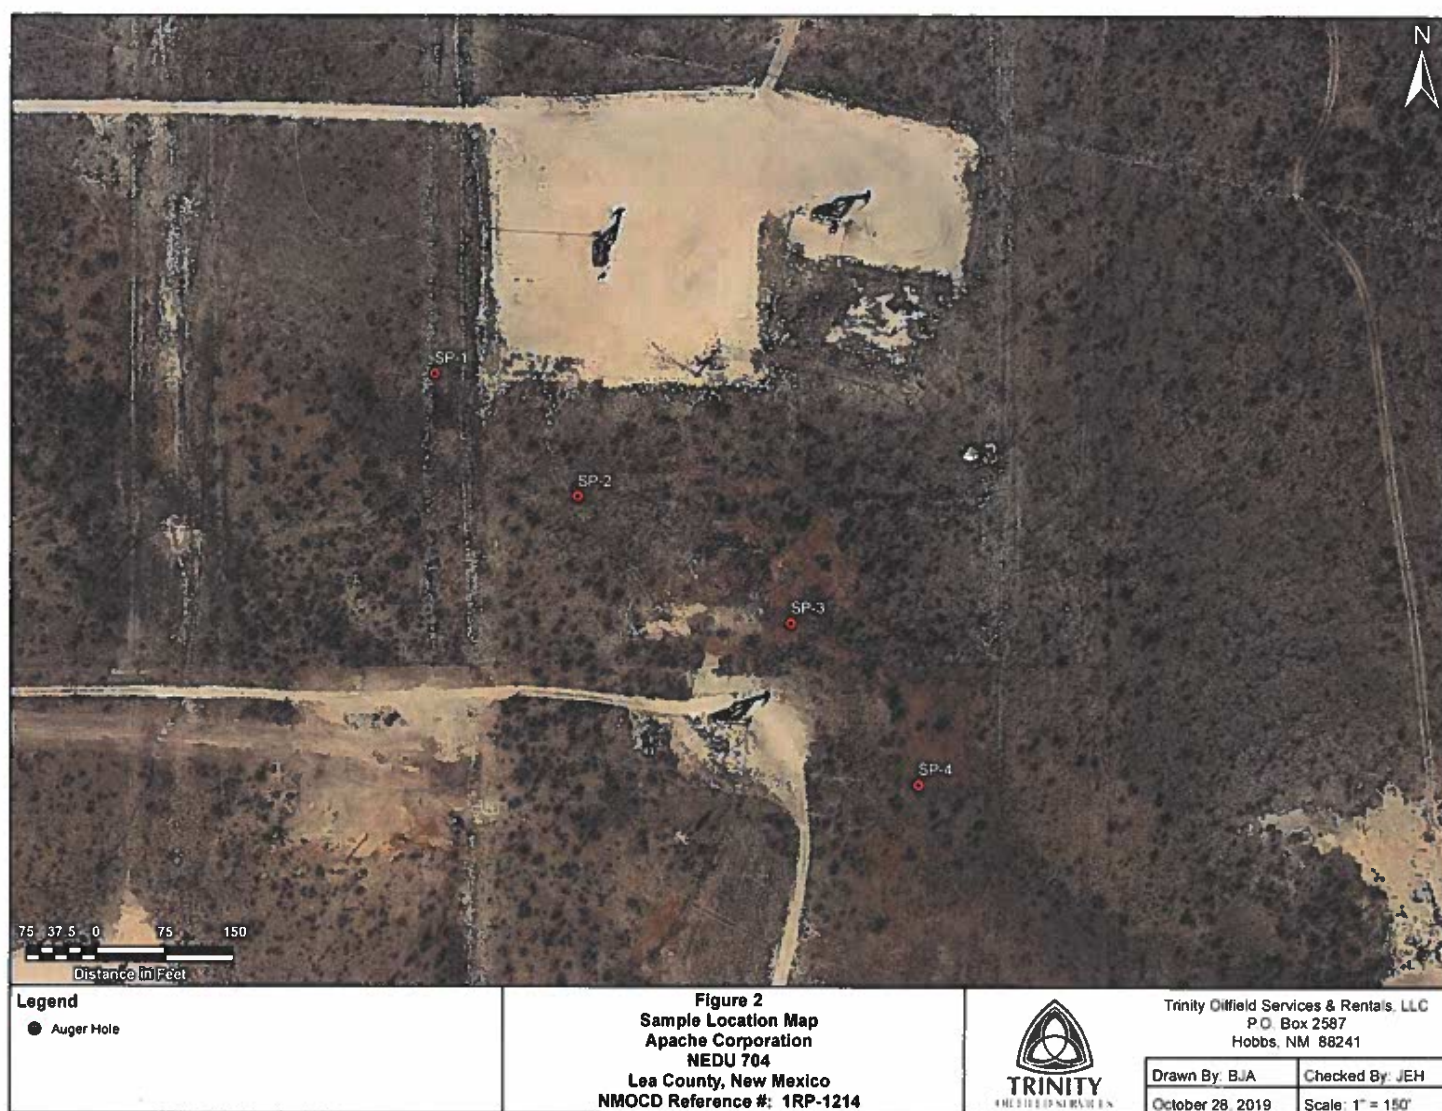
**FIGURE 2**  
**SAMPLE LOCATIONS – TRINITY**

On August 22, 2019, Trinity mobilized a sampling crew to assess the current conditions at the NEDU 704 site. A stainless-steel spatula was utilized to collect surface samples while a hand auger was utilized to collect soil samples to refusal at a depth of one-foot at locations SP-1 through SP-3. A surface sample and samples at 1-foot intervals to a depth of three feet bgs were collected at SP-4 using the same tools. A total of 10 samples were collected from four sampling locations. The location of the four sample points is shown on Figures 2 and 3. Samples were placed on ice in a cooler following sampling and a chain of custody was written and used to convey the samples to the laboratory. All sample locations appear to be at approximately the same points at the chloride sampling points tested by others in 2008.

Soil Samples collected from the inferred impacted area were analyzed by a NMOCD approved laboratory. Concentrations of Chloride, TPH and BTEX from sample points SP-1, SP-2 and SP-4 were below the closure criteria parameters listed in Table 1 of Section 19.15.29.12 of the New Mexico Administrative Code (NMAC) for a site where the depth to groundwater is between 0 and 50 feet bgs. At sample point SP-3 at one-foot bgs, DRO (C10-C28) and EXT DRO (C28-C36) yielded lab analytical values of 138 mg/kg and 95.9 mg/kg respectively. TPH for this sample is 233.9 mg/kg which is over double the allowable value for TPH where the depth to groundwater is less than 50 feet bgs. The depth to groundwater averages 39.8 feet bgs within a one-half mile radius of the site. (See Appendix F, "Closure Criteria Justification" for more information). Lab results for all samples yielded results that were below the MDL for all BTEX constituents. Based on these laboratory analytical results, the initial response and subsequent actions conducted at the site during the period between 2008 and 2019 were largely effective in remediating the release.

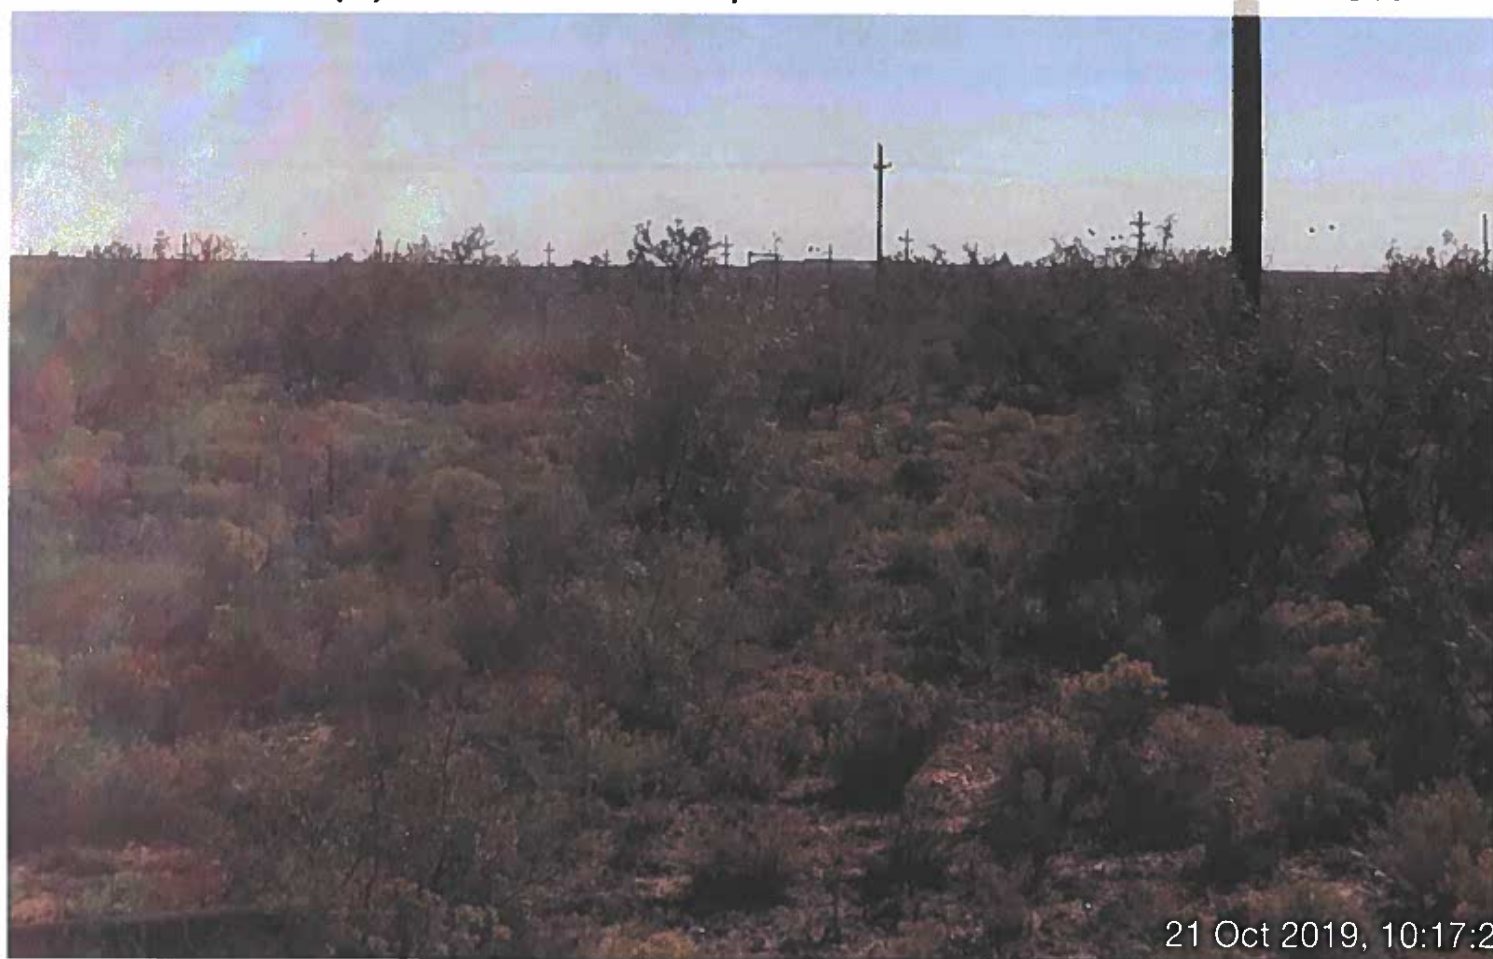
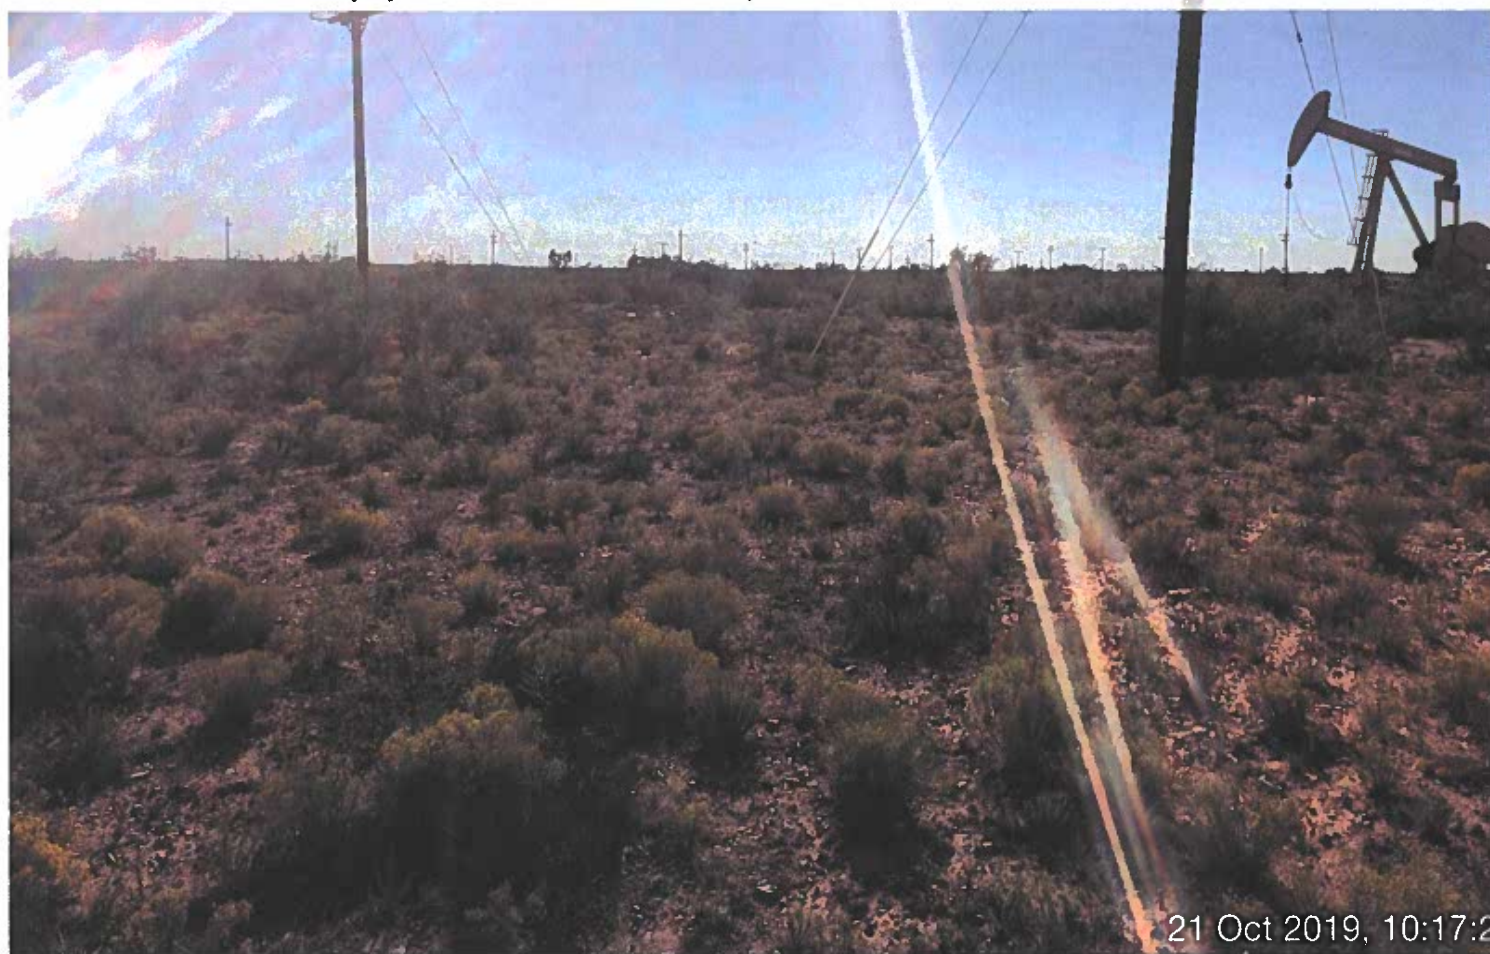
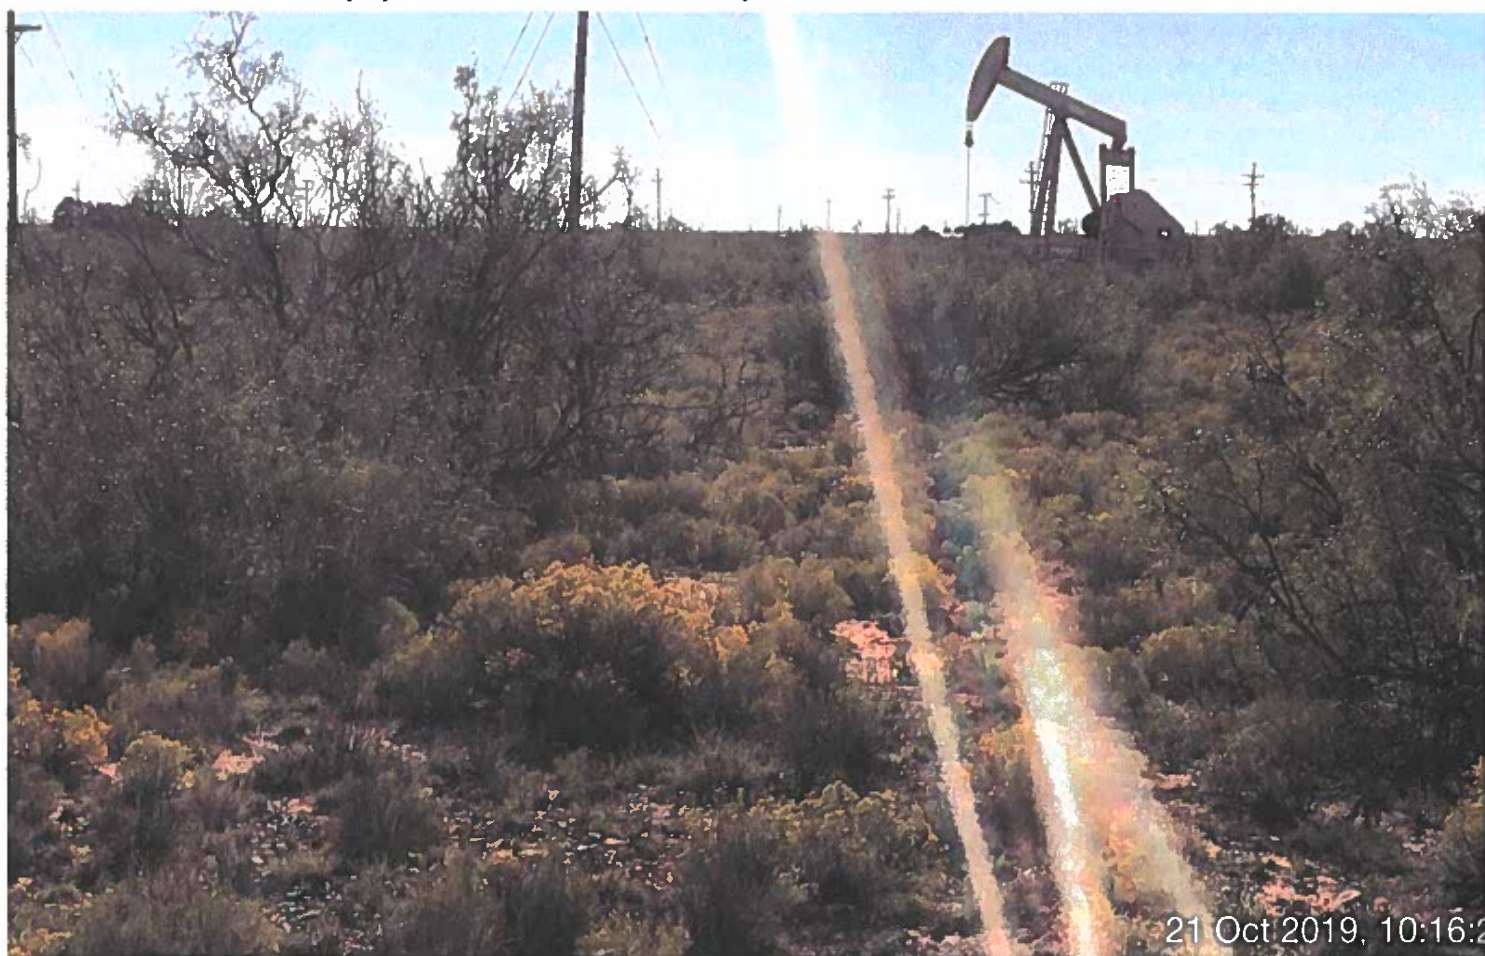
### **CURRENT SITE PHOTOGRAPHY**

Photographic documentation of the site shows that native vegetation has re-established over much of the site even though the surface soil is rather rocky. The dominant vegetation species appear to be mesquite, rabbit brush and sparse assorted grasses.

*Due to the rocky nature of the soil in the area, Apache is requesting a variance for the area identified as having elevated TPH at SP-3 at refusal at one-foot bgs due to the fact that native vegetation has re-established or is still re-establishing on the rocky soils in the area. Any excavation disturbance in the area would likely upset a delicate balance for the local vegetative ecosystem. Trinity on behalf of Apache requests that no further delineation of the elevated TPH at SP-3 be performed due to hand auger sampling refusal at one-foot in the subsurface and the potential for upsetting the ecosystem.*

*It is likely that the hard-native rock in-situ in the shallow subsurface will preclude the migration of TPH deeper into the subsurface to a level that would affect groundwater. It is also likely that natural attenuation will reduce the TPH values in the soil at the SP-3 over time to background levels. Trinity on behalf of Apache recommends no further action at the site.*
