## CLOSURE REPORT

**Lateral 10A-5 (3/14/22)  
Unit Letter F, S33 T26N R12W  
San Juan County, New Mexico**

**NM EMNRD OCD Incident ID No. NAPP2207346984**

April 26, 2022  
Ensolum Project No. 05A1226187

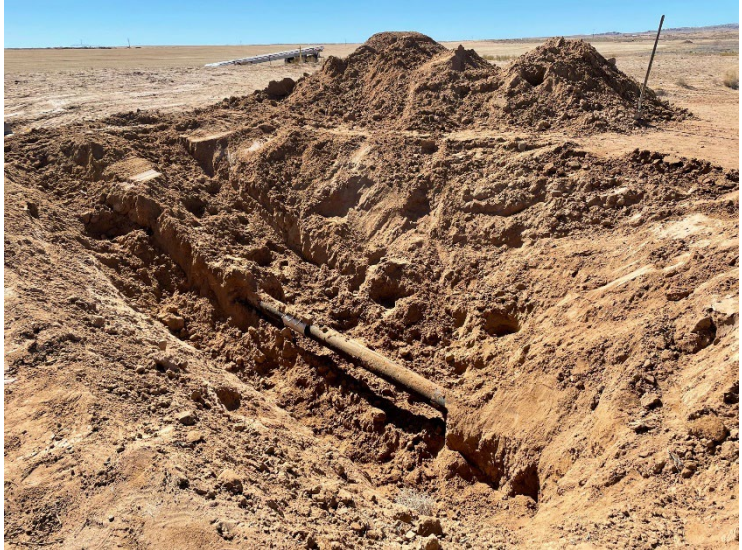
**Photograph 1**

Photograph Description: View of in-process excavation activities.

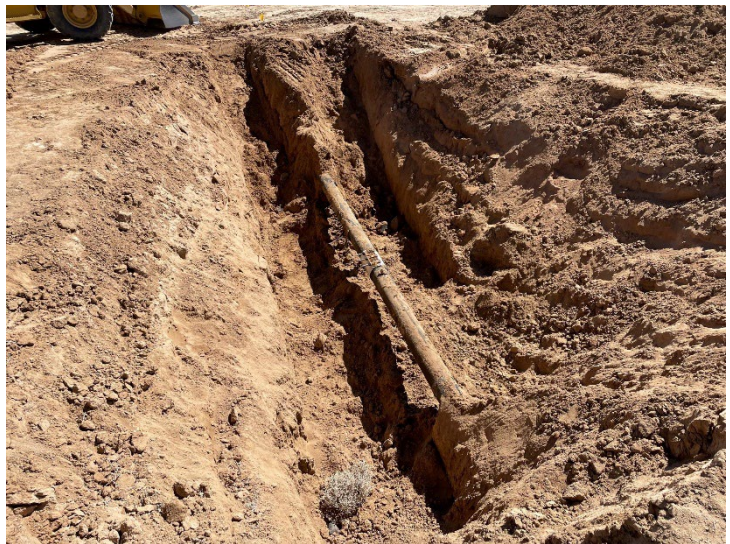
**Photograph 2**

The final excavation measured approximately 22 feet long and 18 feet wide at the maximum extents. The maximum depth of the excavation measured approximately six feet bgs. The lithology encountered during the completion of remediation activities consisted primarily of unconsolidated silty sand.

Photograph Description: View of the final excavation.

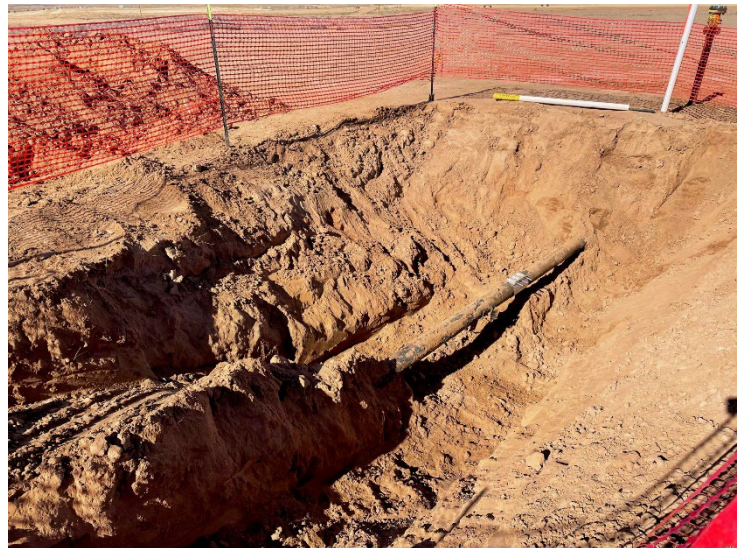
**Photograph 3**

Photograph Description: View of the final excavation.

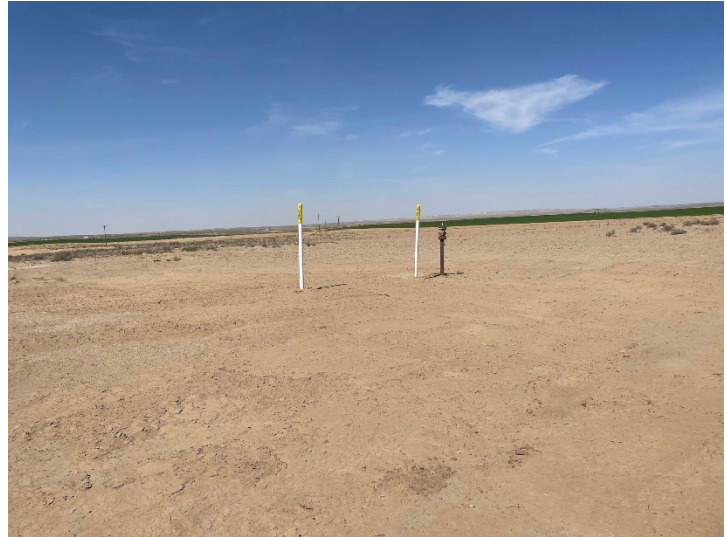
### Photograph 4

Photograph Description: View of the site after initial restoration.

The excavation was backfilled with imported fill and laboratory-confirmed stockpiled soil and was then contoured to surrounding grade.

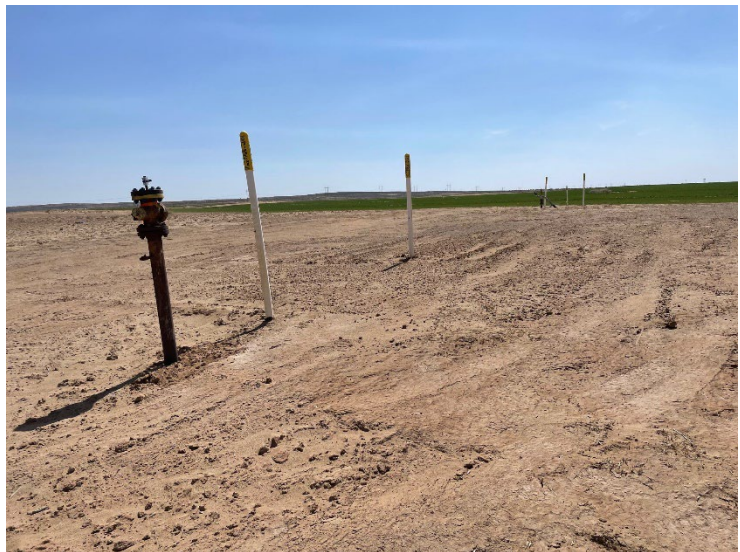
### Photograph 5

Photograph Description: View of the site after initial restoration.
