**Subject: Liner Inspection and Closure Report**  
**Cotton Draw Unit 172H**  
**Eddy County, New Mexico**

Devon Energy Production Company (Devon) (Client) retained HRL Compliance Solutions, Inc. (HRL) to conduct a liner inspection and prepare this closure report for the release at the Cotton Draw Unit 172H well pad (Site). The Site is located in Eddy County, New Mexico (Figure 1).

**Subject: Liner Inspection and Closure Report  
Cotton Draw Unit 172H  
Eddy County, New Mexico**

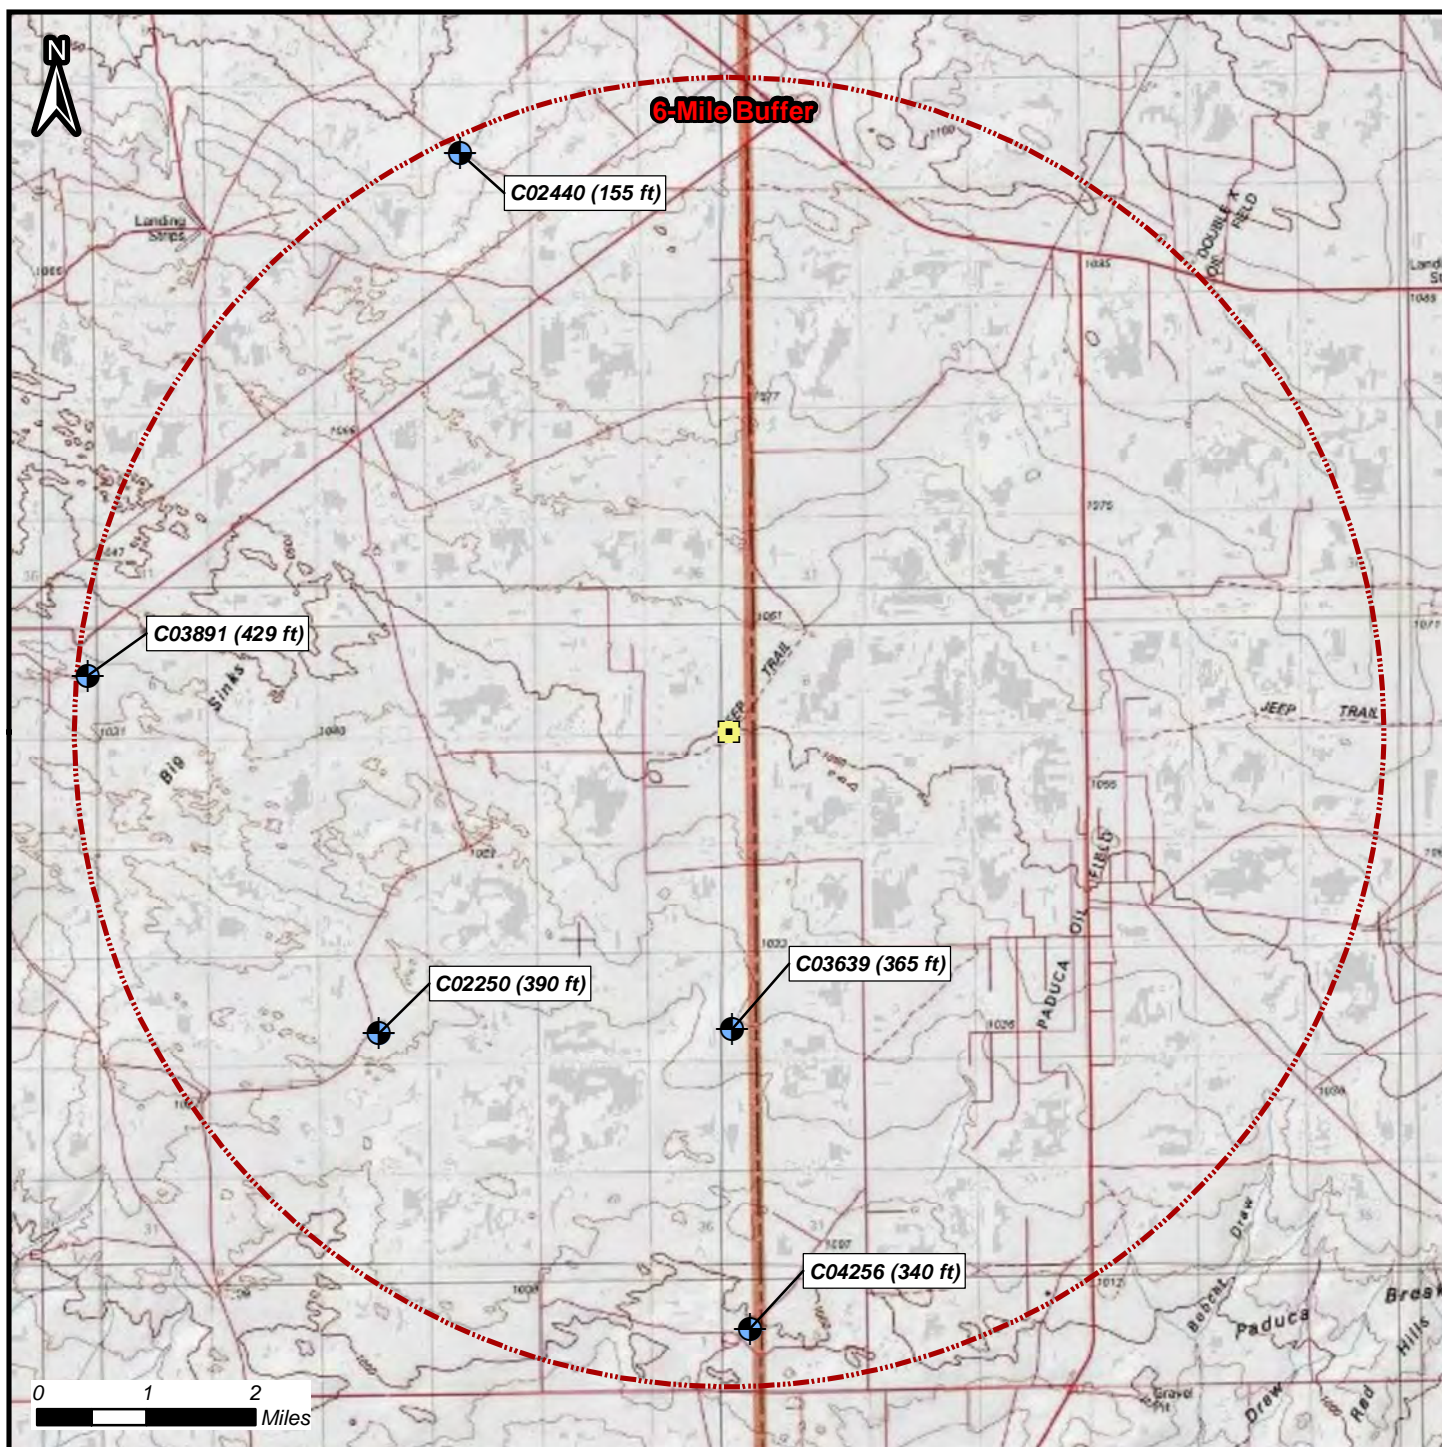
**Figure 2: Depth to Groundwater Map**

Based on research from the New Mexico Office of the State Engineer (NMOSE) and United States Geological Survey (USGS), depth to groundwater is estimated to be between 155 and 429 feet below ground surface (bgs) (Figure 2).

Well Number	Water Level Below Ground Surface (ft)	Distance from Source (mi)
C02250	390	4.23
C03639	365	2.72
C04256	340	5.48
C02440	155	5.85
C03891	429	5.90

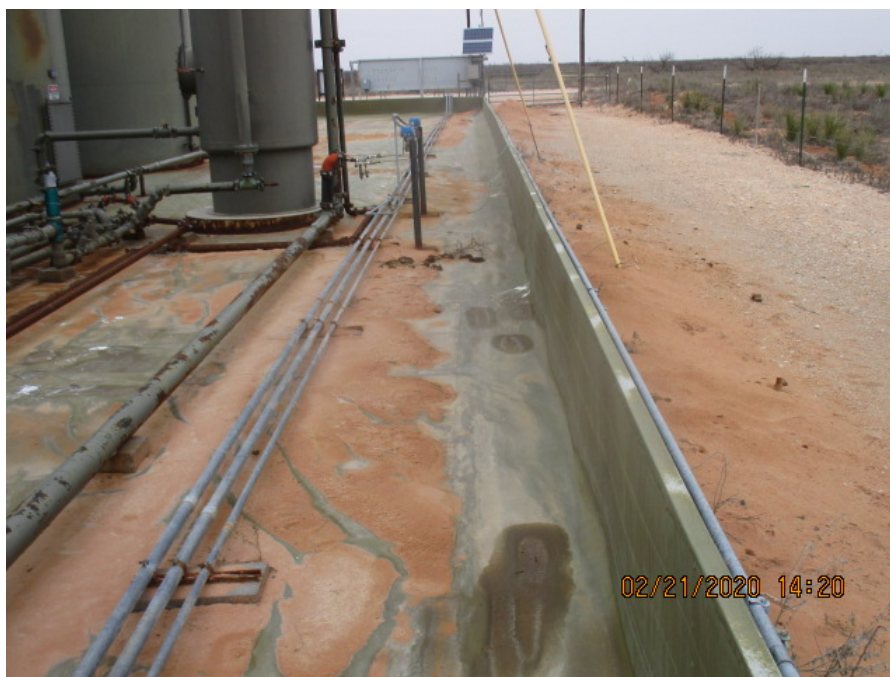
On February 21, 2020, after the released fluid was removed, HRL conducted an inspection to evaluate the integrity of the liner (Attachment B, Photographs). No tears or holes were observed in the liner and the liner was retaining precipitation. Based on this inspection, HRL has determined that the liner remains intact and had the ability to contain the release (Attachment C, Liner Inspection Field Form).

View of sediment buildup within lined secondary containment

The August 13, 2019 release of 10 barrels of produced water at the Site remained within the lined containment area. HRL has determined that the liner integrity remains intact and had the ability to contain the release; therefore, additional characterization of the soil and/or groundwater at the Site is not necessary. HRL recommends closure of this release.

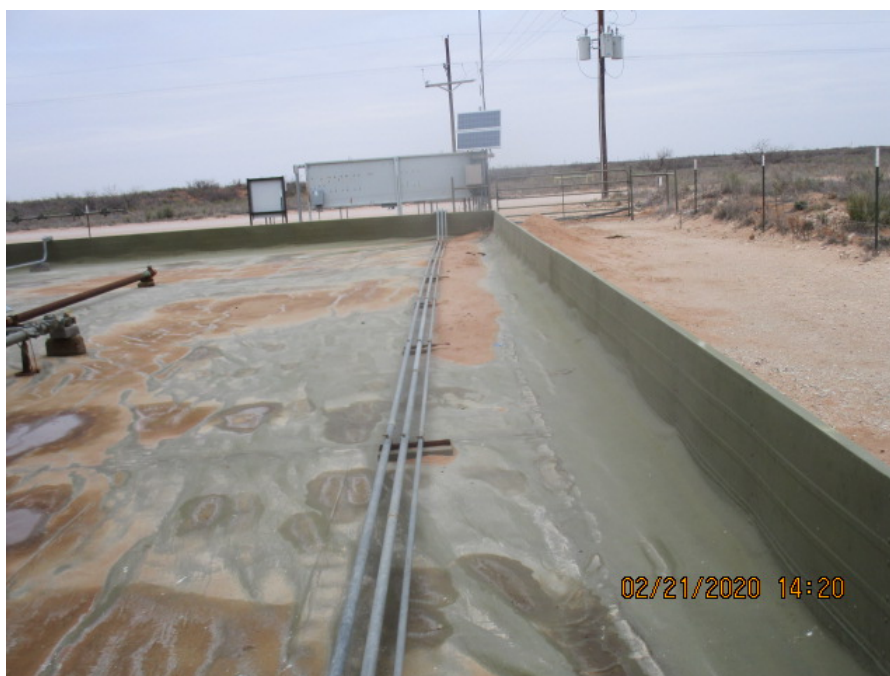
View of sediment and minor pooling within lined secondary containment

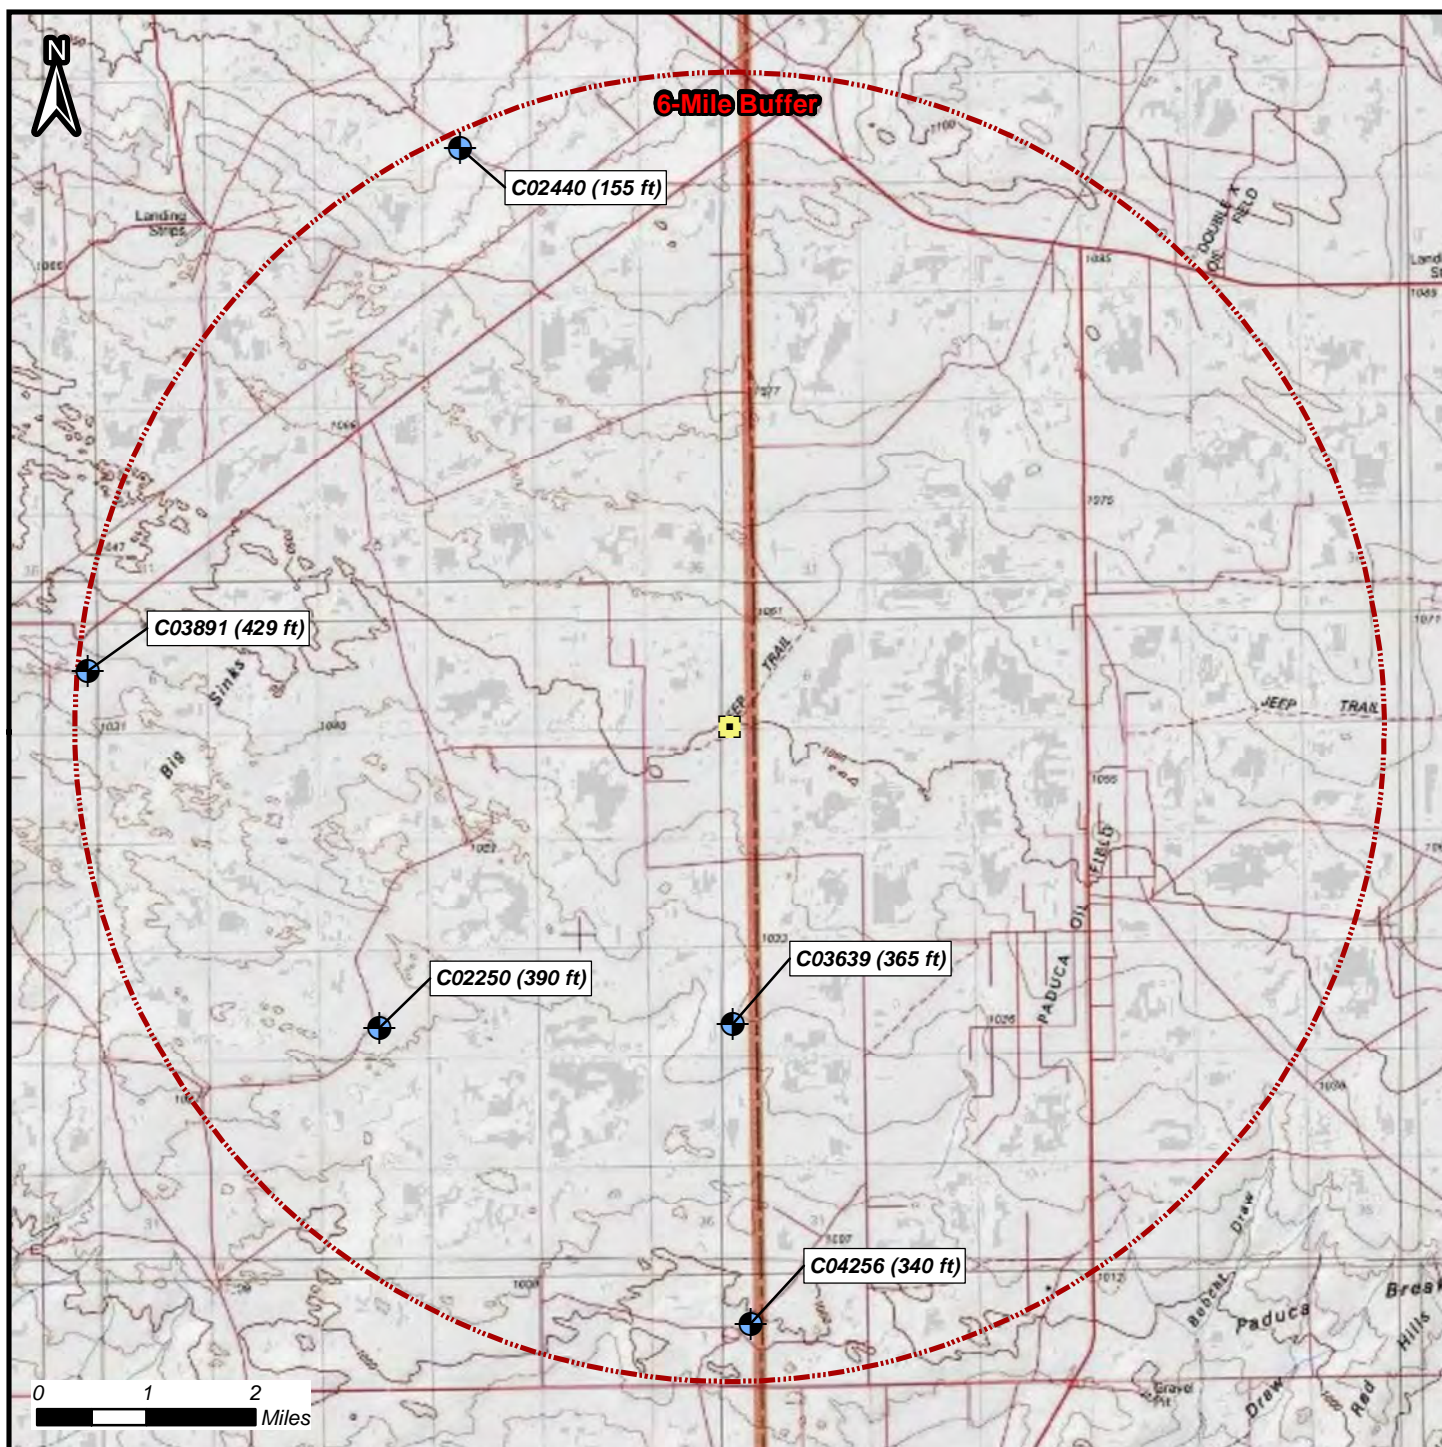
Figure 2: Depth to Groundwater Map

Based on research from the New Mexico Office of the State Engineer (NMOSE) and United States Geological Survey (USGS), depth to groundwater is estimated to be between 155 and 429 feet below ground surface (bgs) (Figure 2).

Well Number	Water Level Below Ground Surface (ft)	Distance from Source (mi)
C02250	390	4.23
C03639	365	2.72
C04256	340	5.47
C02440	155	5.85
C03891	429	5.90

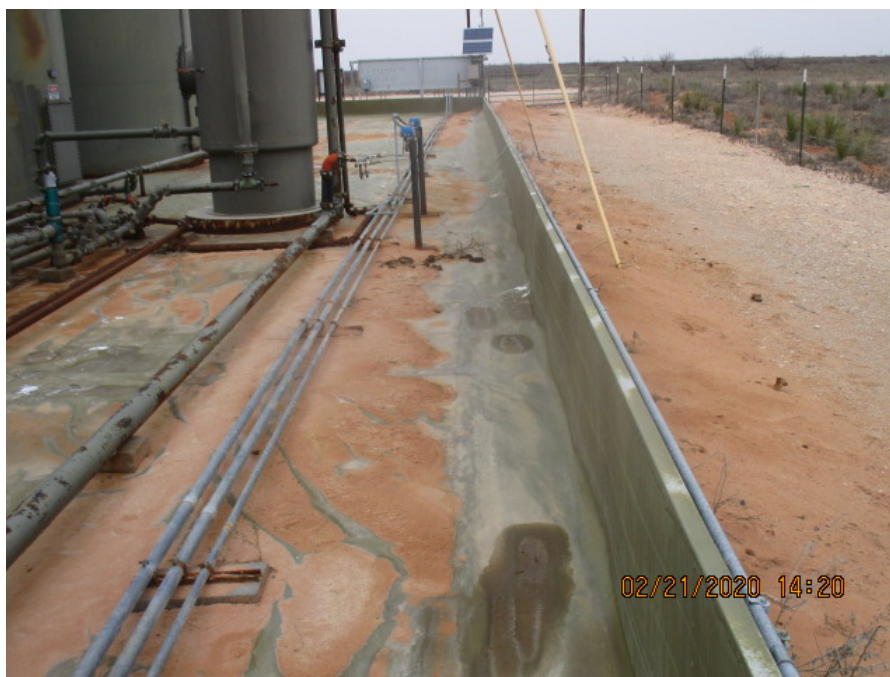
On February 21, 2020, after the released fluid was removed, HRL conducted an inspection to evaluate the integrity of the liner (Attachment B, Photographs). No tears or holes were observed in the liner and the liner was retaining precipitation. Based on this inspection, HRL has determined that the liner remains intact and had the ability to contain the release (Attachment C, Liner Inspection Field Form).

View of sediment buildup within lined secondary containment

The January 7, 2016 release of 15 barrels of produced water and 10 barrels of oil at the Site remained within the lined containment area. HRL has determined that the liner integrity remains intact and had the ability to contain the release; therefore, additional characterization of the soil and/or groundwater at the Site is not necessary. HRL recommends closure of this release.

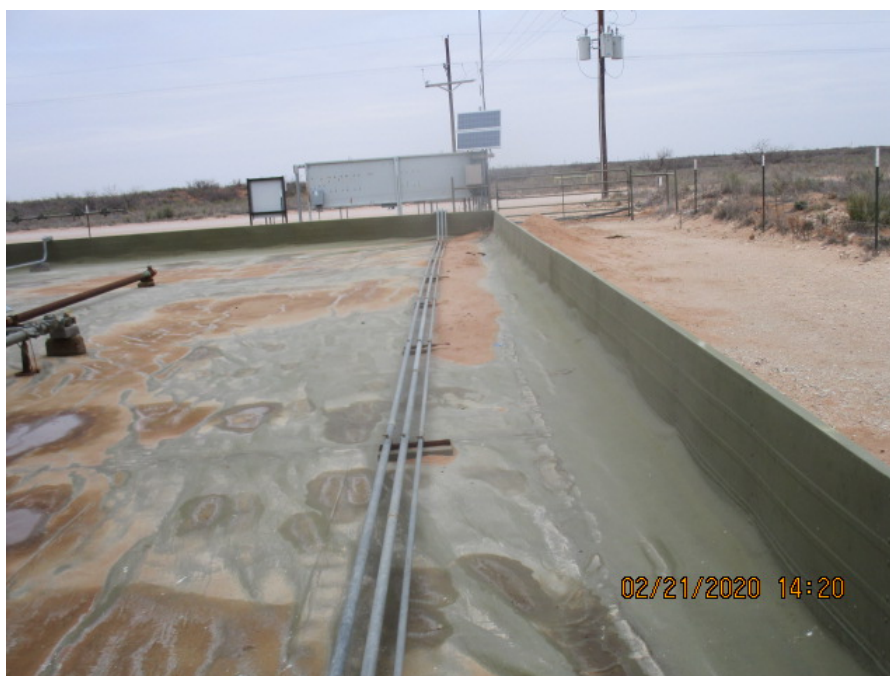
View of sediment and minor pooling within lined secondary containment
