Produced Water Spill Remediation Plan

Chaco Plant

36.484021, -108.11705
Unit E, Section 16, T26N, R12W
San Juan County, New Mexico

Enterprise Products
Remediation Excavation Report
Chaco Plant
San Juan County, New Mexico
36.483783°, -108.117059°
Incident # nAPP2202747264
Project #04061-0040

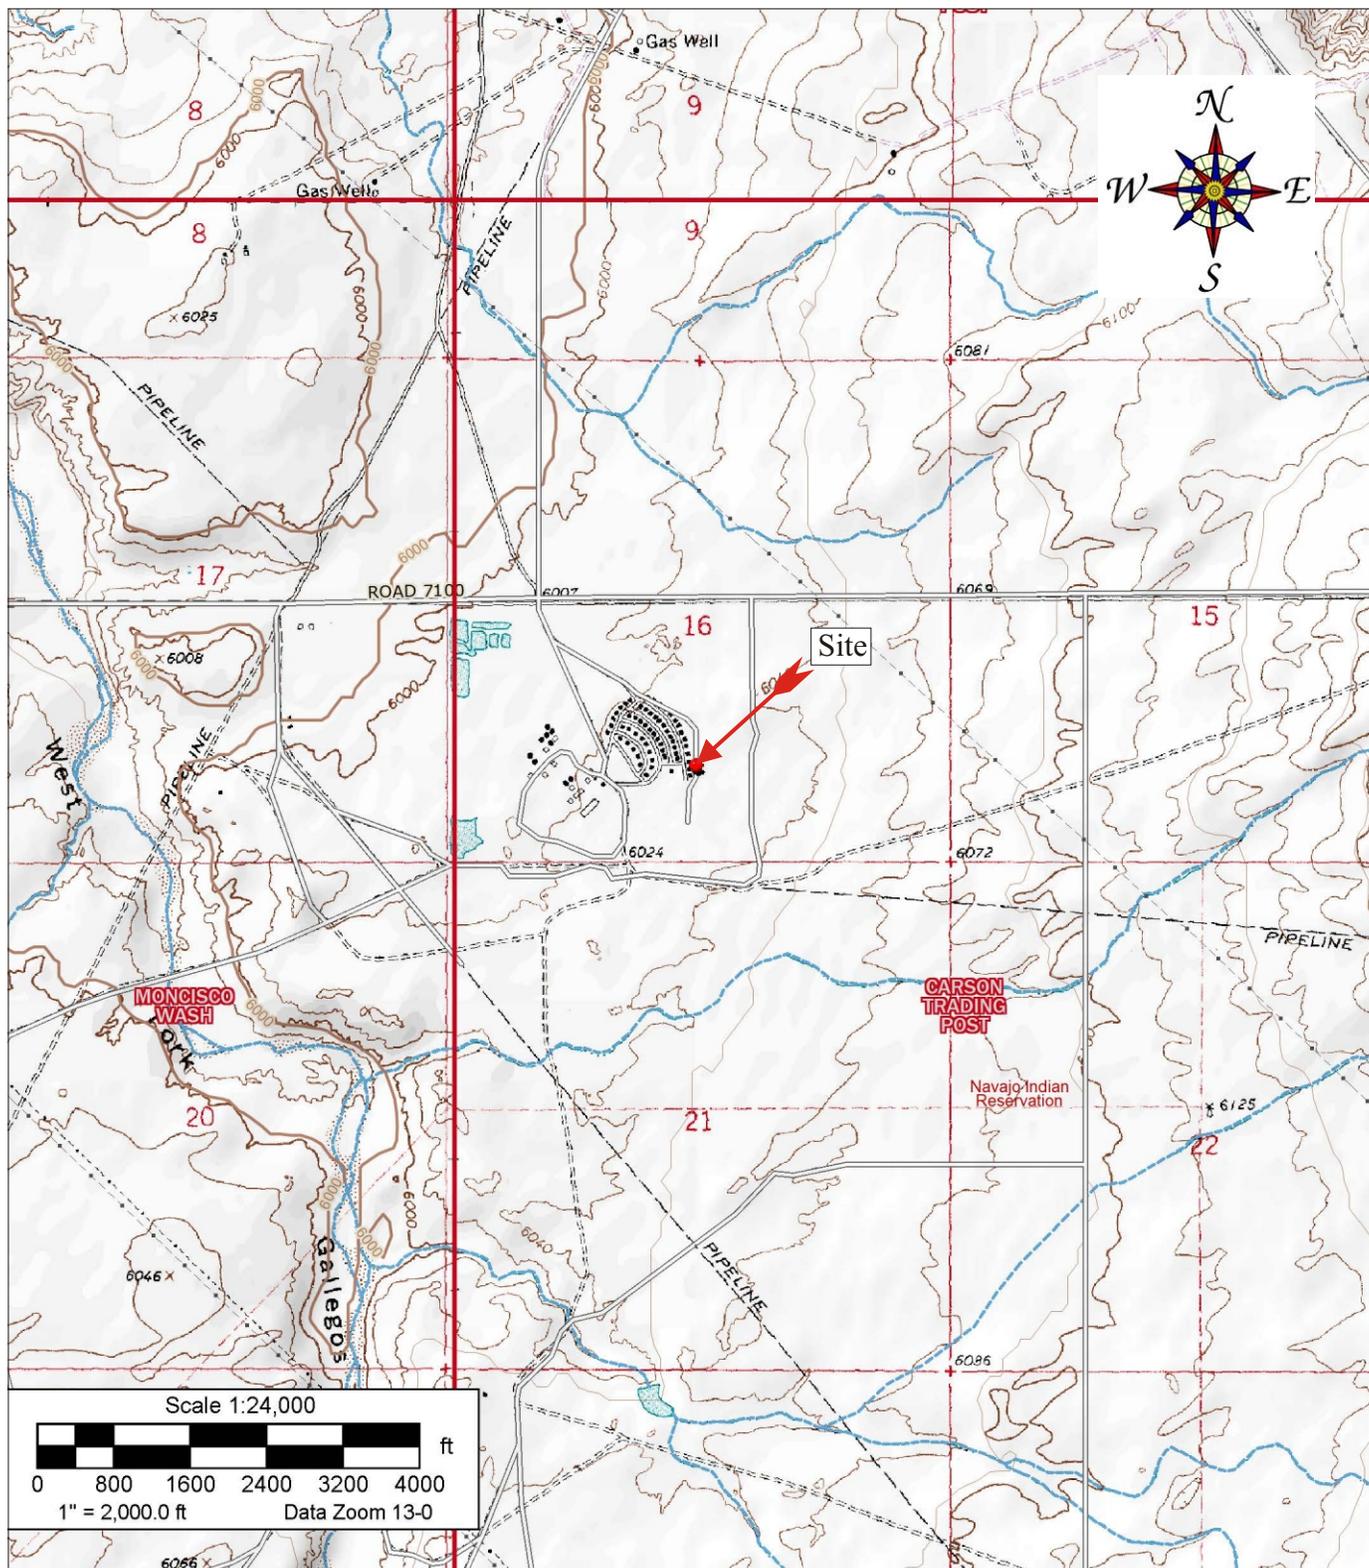
ENVIRONMENTAL SCIENTISTS & ENGINEERS	Vicinity Map	
Project Number: 04061-0040 Date Drawn: 05/23/2022			Figure #1	
		5796 U.S. HIGHWAY 64 Farmington, New Mexico 87401 505.632.0615	DRAWN BY: Brittany Hall	PROJECT MANAGER: Greg Crabtree

Source: 7.5 Minute, Carson Trading Post, New Mexico U.S.G.S. Topographic Quadrangle Map
 Scale: 1:24,000 1" = 2,000

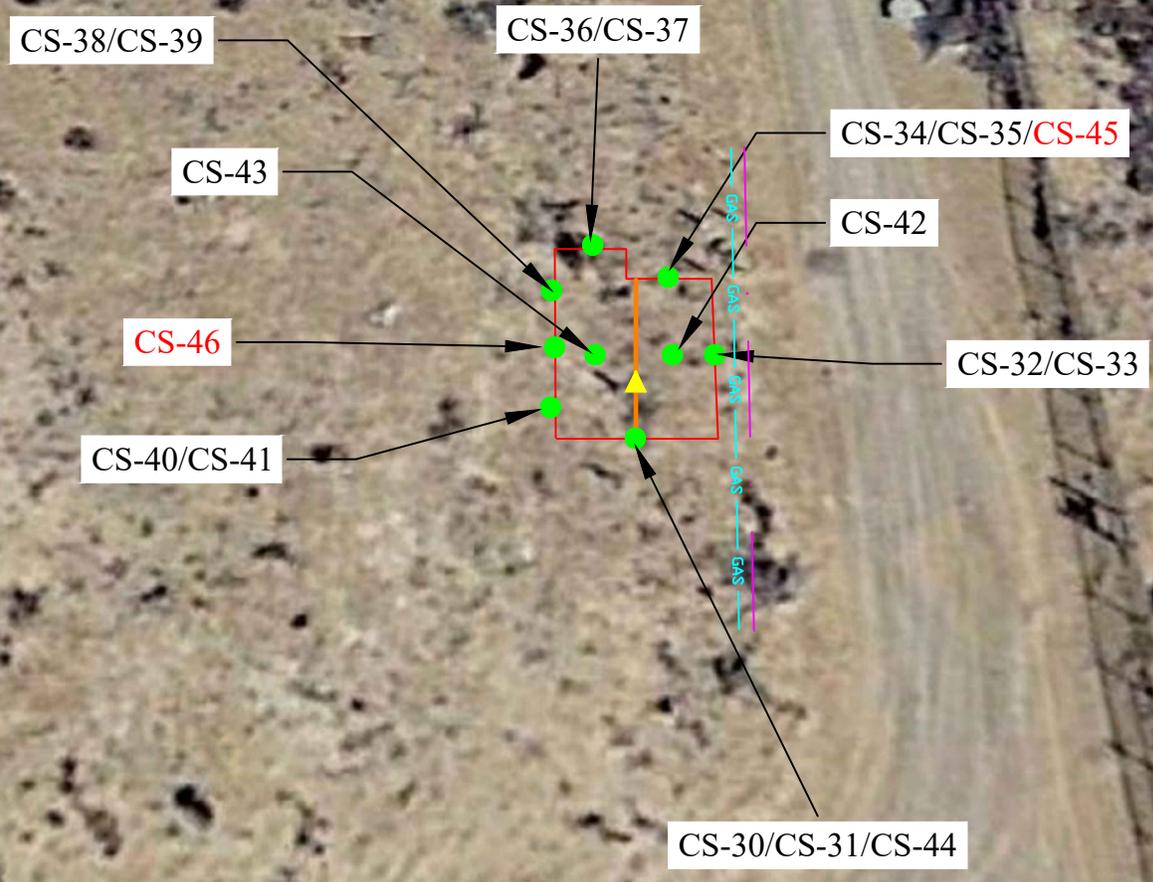
Overall Excavation Dimensions 25 ft (west wall) x 20 ft x 26 ft BGS

Red sample names depict results above regulatory limits

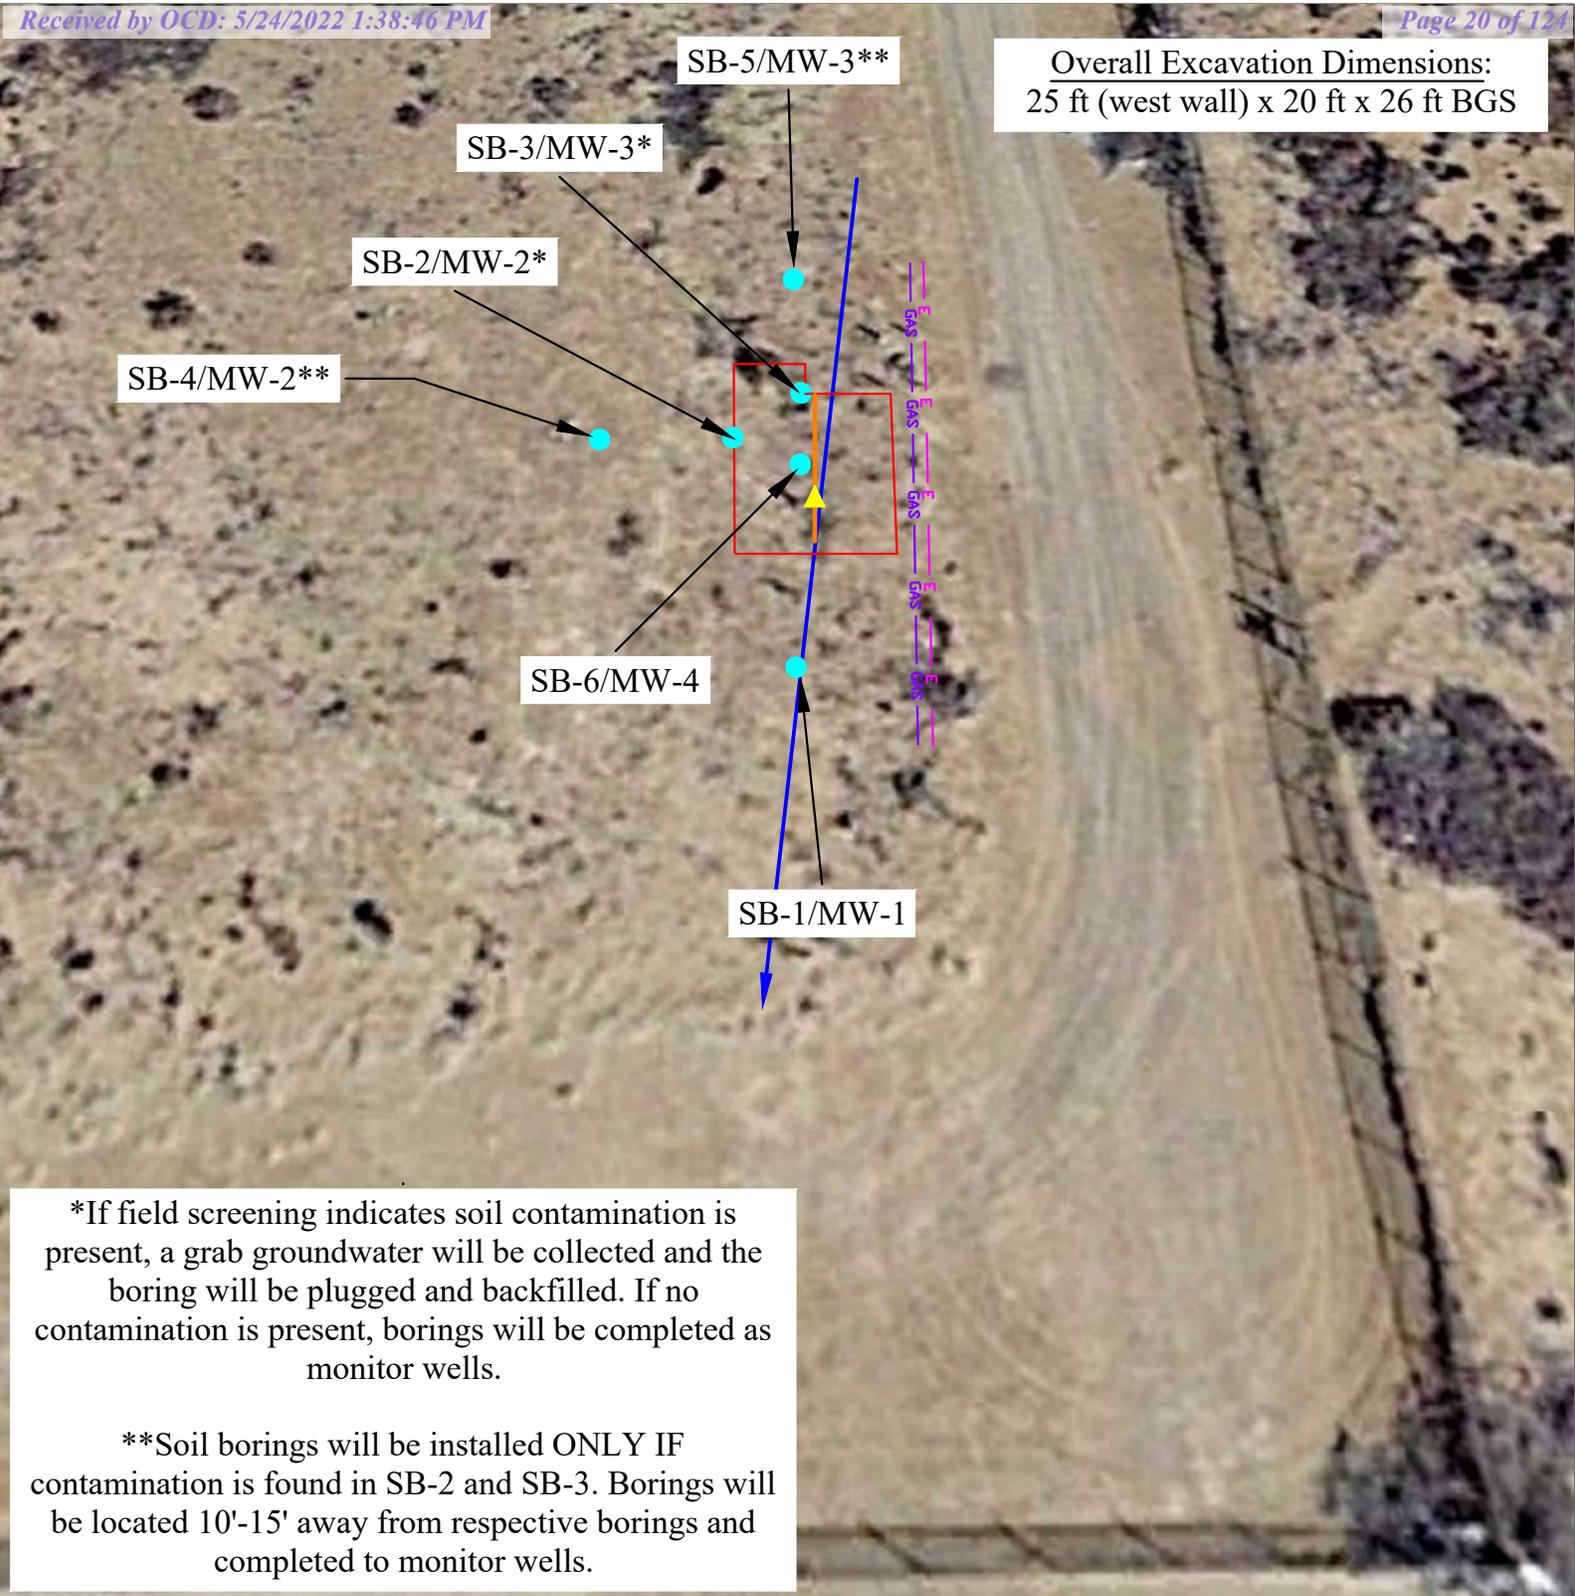
*If field screening indicates soil contamination is present, a grab groundwater will be collected and the boring will be plugged and backfilled. If no contamination is present, borings will be completed as monitor wells.

**Soil borings will be installed ONLY IF contamination is found in SB-2 and SB-3. Borings will be located 10'-15' away from respective borings and completed to monitor wells.

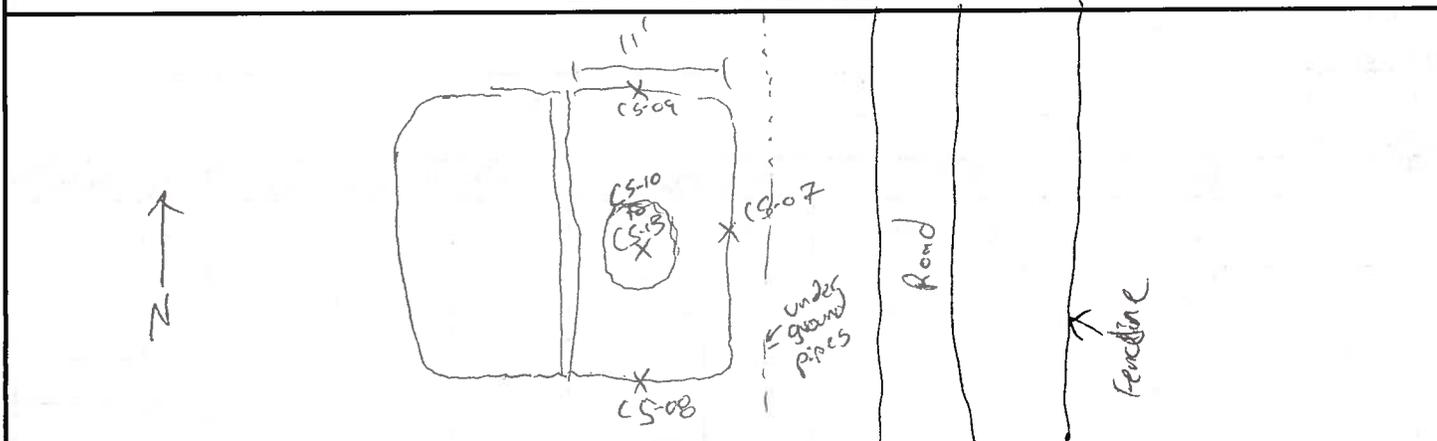
CS-COMPOSITE SAMPLE GS-GRAB SAMPLE SB-SOIL BORING TP-TEST PIT DU-DECISION UNIT ST-STATION	Field screening for new excavation east side of pipeline, sampled CS-13 for TPH, BTEX, and chlorides.
--	---

<p>Sample Name: <i>underground pipes</i></p> <p>12'</p> <p>Sampled CS-13 hole</p> <p>W →</p>	<p>Sample Name:</p>
<p>Sample Name:</p>	<p>Sample Name:</p>

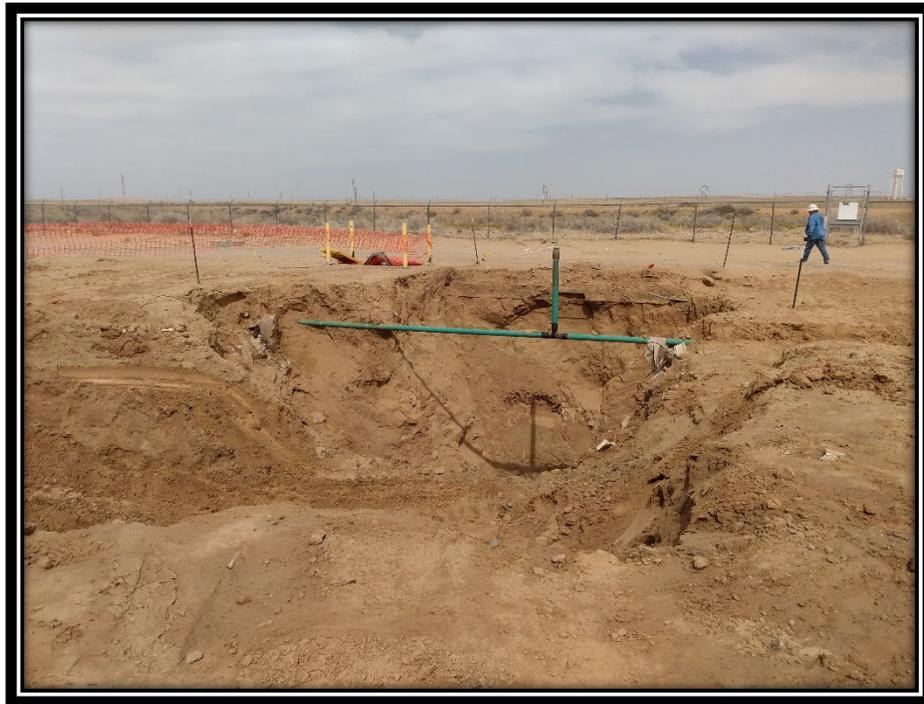
Picture 1: Excavation (View 1)

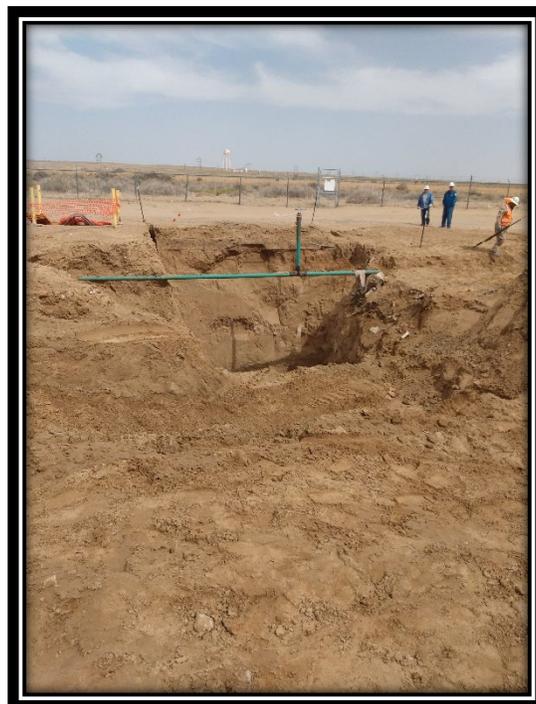
Picture 2: Excavation (View 2)

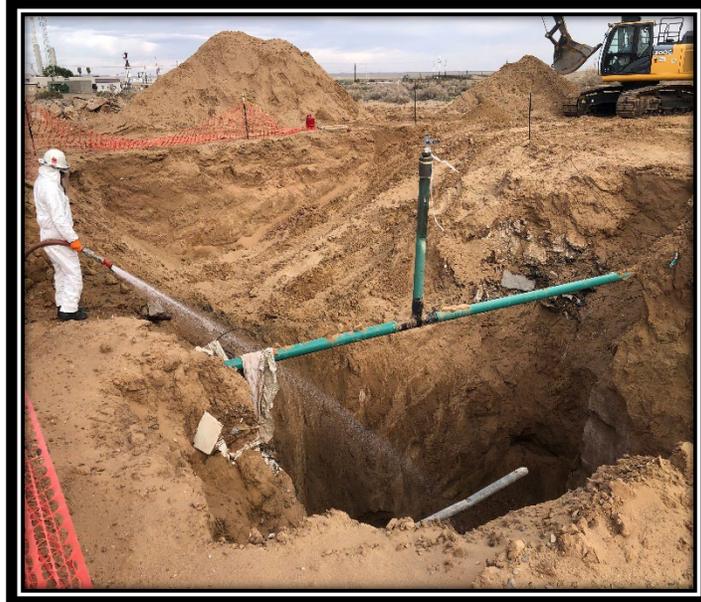
Picture 3: Hydrogen Peroxide Application (View 1)

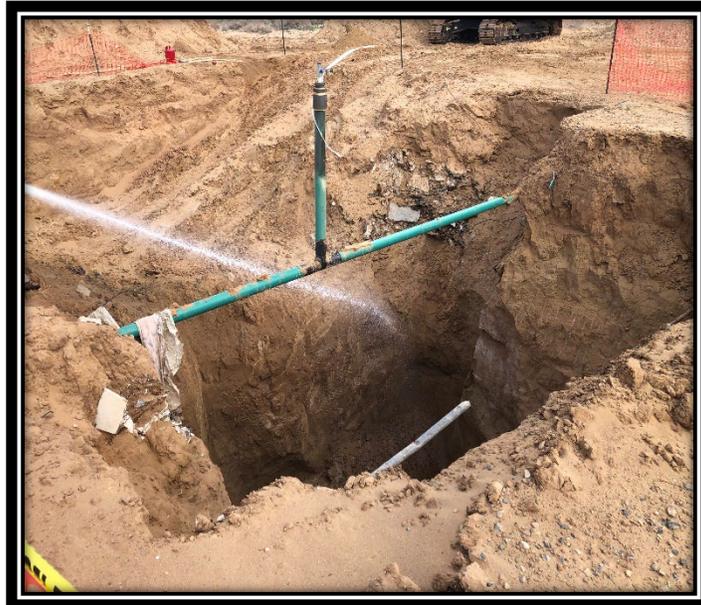
Picture 4: Hydrogen Peroxide Application (View 2)

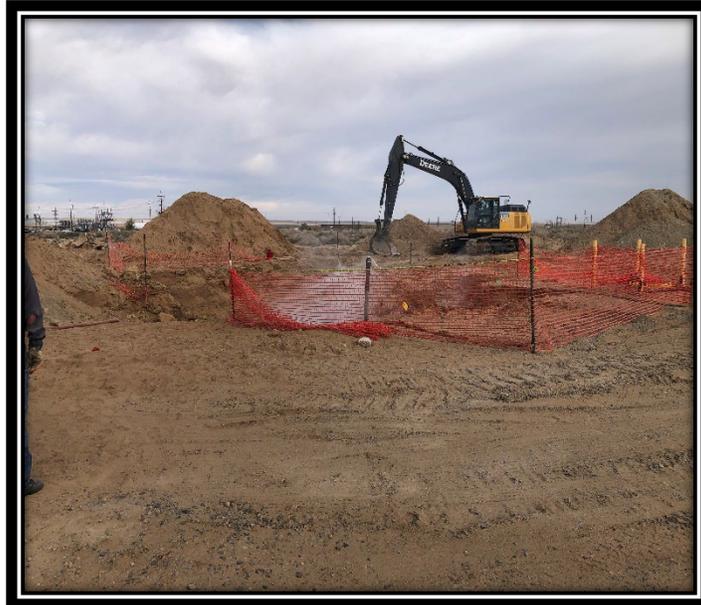
Picture 5: Hydrogen Peroxide Application (View 3)

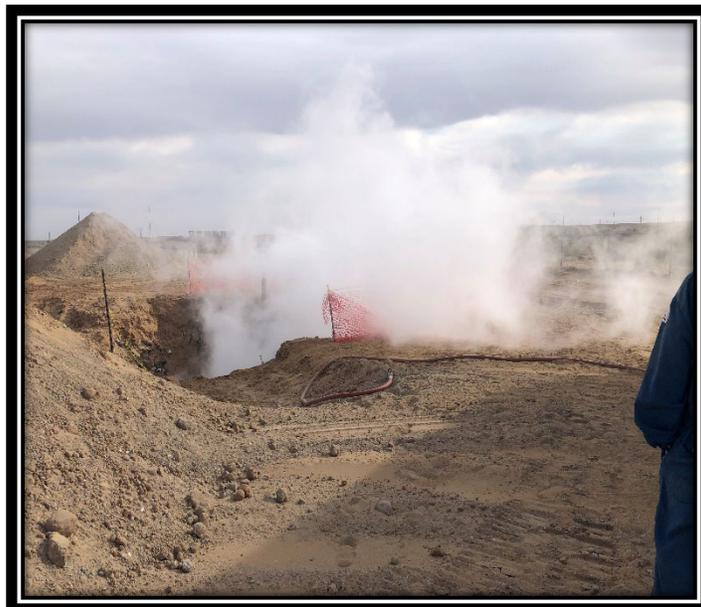
Picture 6: Hydrogen Peroxide Application (View 4)
