Vertex Project #: 20E-00141-010

Spill Closure Report: Arena Roja Fed Unit 15H-16H and Unit 2 CTB
Unit A, Section 28, Township 26 South, Range 35 East
County: Lea
API: 30-025-42671, 42672
Tracking Number(s): nJXK1532330117, TBD

Devon Energy Production Company
Arena Roja Fed Unit 15H-16H and Unit 2 CTB

2020 Spill Assessment and Closure
April 2020

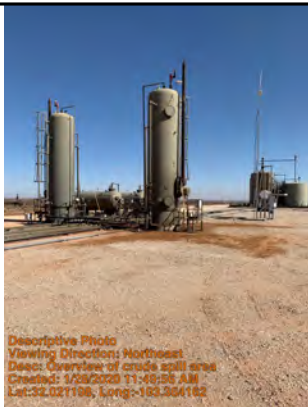
Viewing Direction: Northeast

Overview of crude spill area

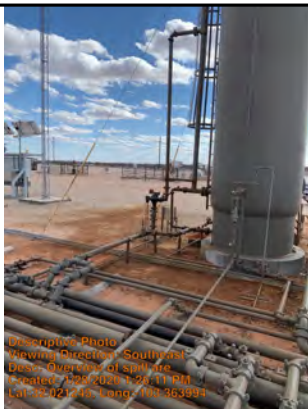
Viewing Direction: Southeast

Overview of spill are

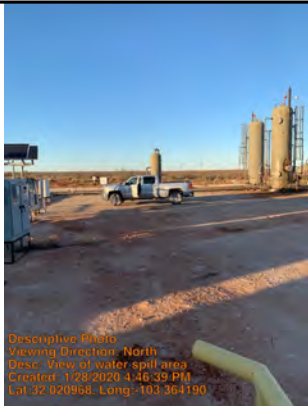
Viewing Direction: North

View of water spill area

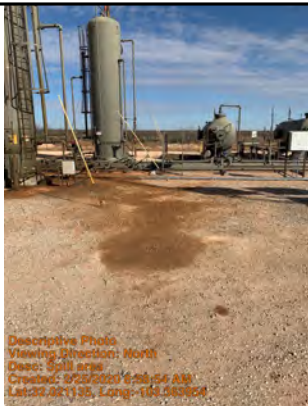
Viewing Direction: North

Spill area

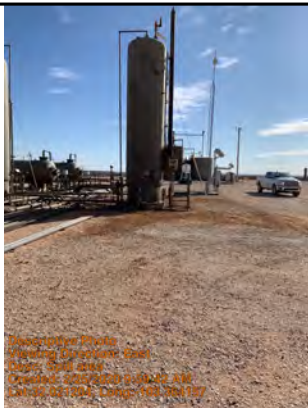
Viewing Direction: East

Spill area

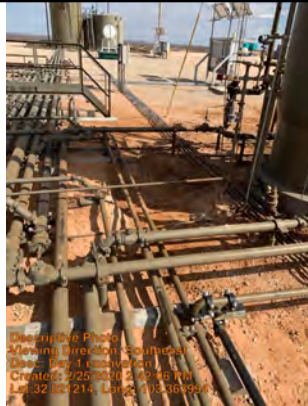
<p>Descriptive Photo Viewing Direction: Southeast Date: Day 1 excavation Created: 2/25/2020 10:43 AM Lat: 32.021204, Long: -103.363954</p>	<p>Viewing Direction: Southeast</p>

<p>Descriptive Photo Viewing Direction: Southeast Date: Day 1 excavation Created: 2/25/2020 2:42:05 PM Lat: 32.021214, Long: -103.363954</p>
Water spill area	Day 1 excavation
<p>Viewing Direction: Southeast</p>

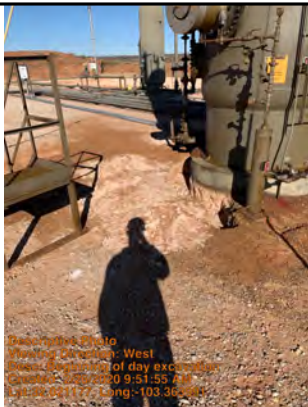
Viewing Direction: West

Beginning of day excavation

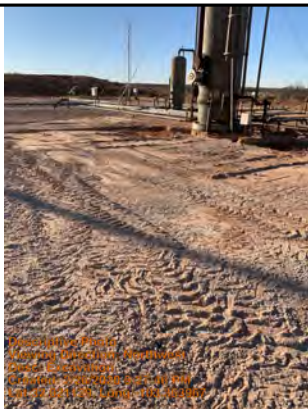
Viewing Direction: Northwest

Excavation

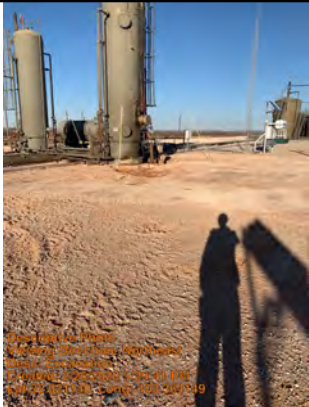
<p>Viewing Direction: Northeast</p>

<p>Descriptive Photo Viewing Direction: Northeast Topic: Excavation Created: 2/27/2020 5:34:09 PM Lat: 32.03223, Long: -103.364115</p> <p>Excavation</p>	<p>Viewing Direction: Southeast</p>

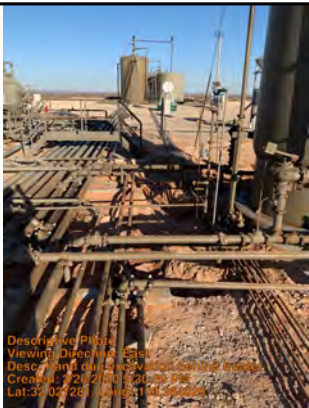
<p>Descriptive Photo Viewing Direction: East Topic: Hand dug excavation behind treater Created: 2/26/2020 5:34:16 PM Lat: 32.03223, Long: -103.364115</p> <p>Hand dug excavation behind treater</p>	<p>Viewing Direction: South</p>

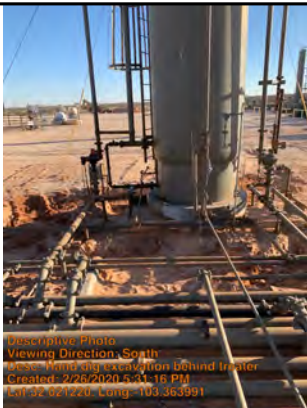
<p>Descriptive Photo Viewing Direction: South Topic: Hand dug excavation behind treater Created: 2/26/2020 5:34:16 PM Lat: 32.021250, Long: -103.364115</p> <p>Hand dig excavation behind treater</p>
