# **Devon Energy Production Co LP Todd 22B Fed 2 Closure Report**

2RP-1671  
2RP-3640

**Unit Letter B, Section 22, T23S, R31E  
Eddy County, New Mexico**

**February 23, 2017**

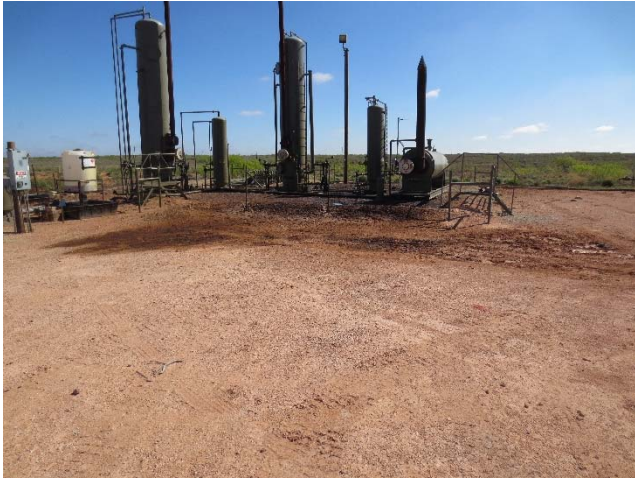
Looking North at impacted pad area

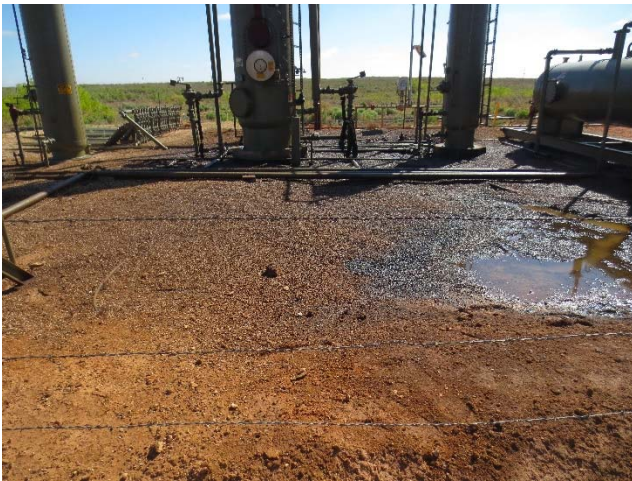
Standing Fluid inside berm SW corner

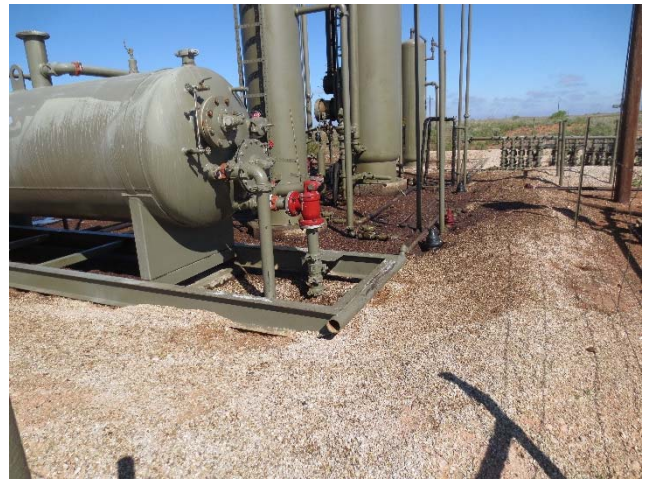
Impacted area inside berm NE Corner

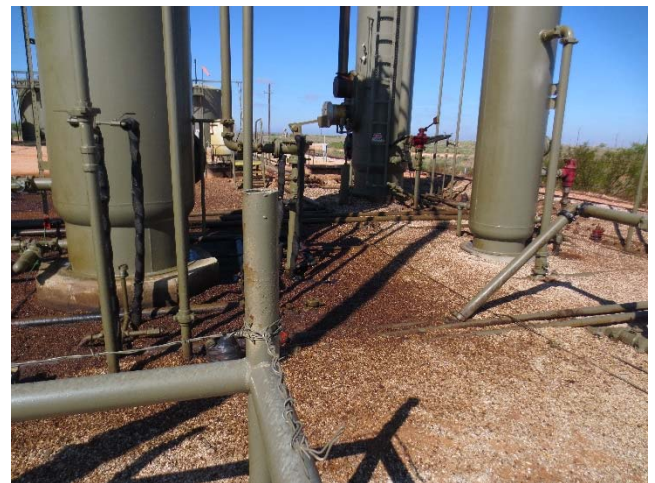
Looking SW from NE corner of bermed area

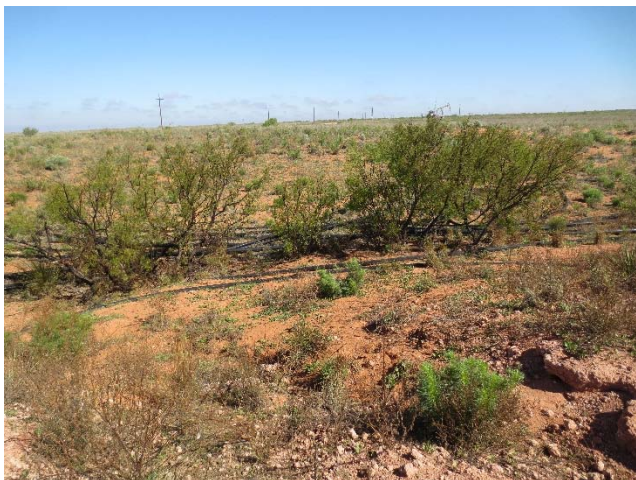
Over-spray area looking West

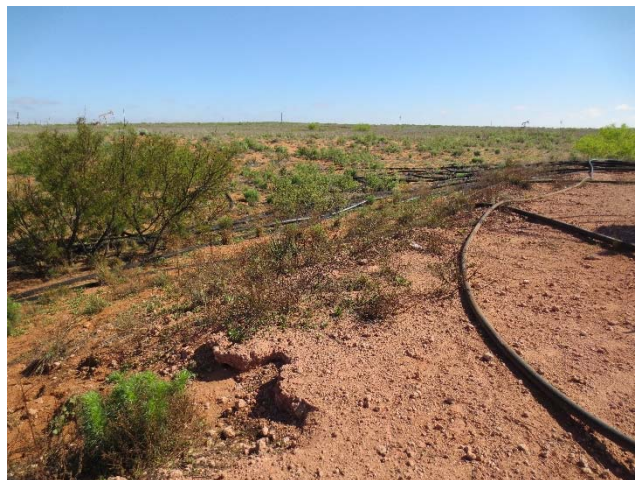
Sprayed area looking Northwest

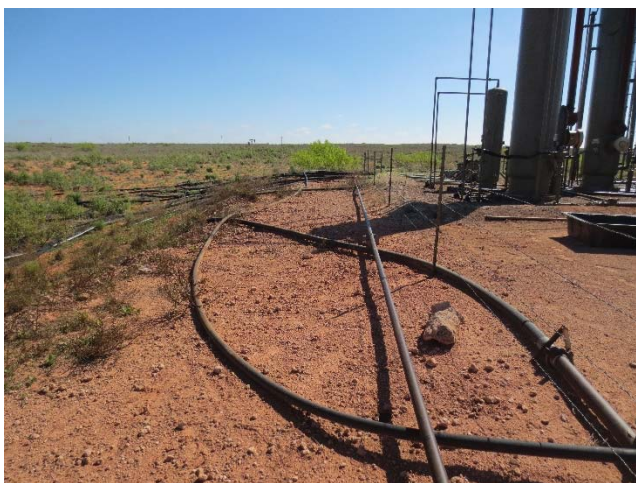
Sprayed area looking North

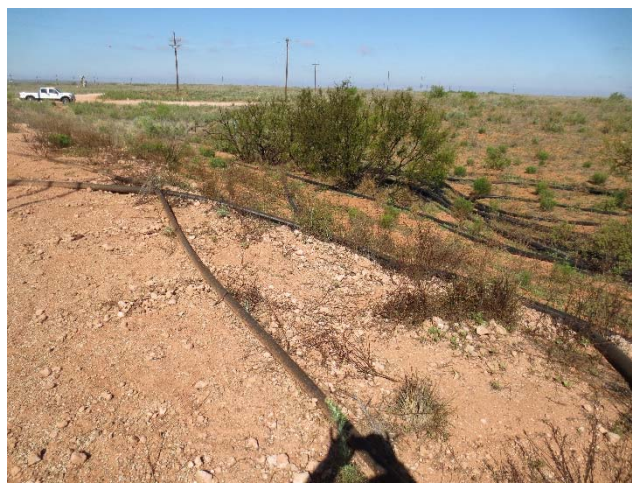
Spray area looking Southwest

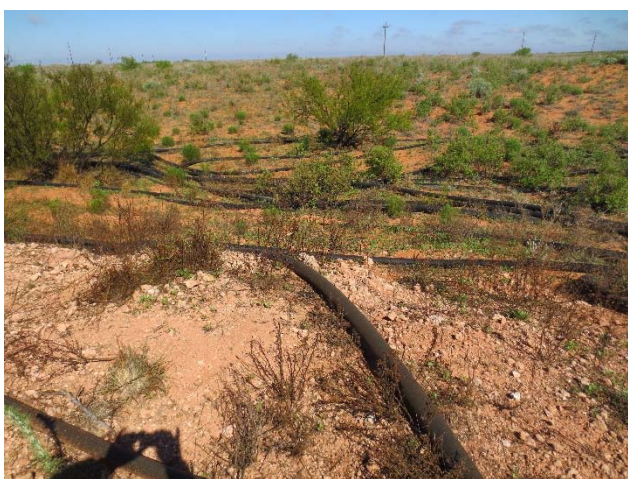
Spray are looking West

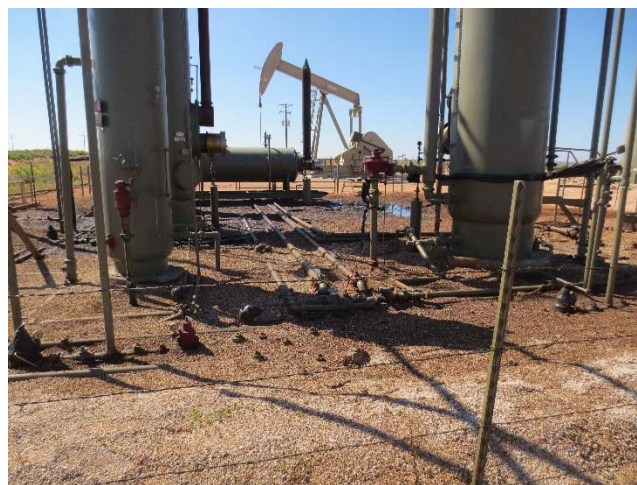
Looking SE at impacted area inside berm

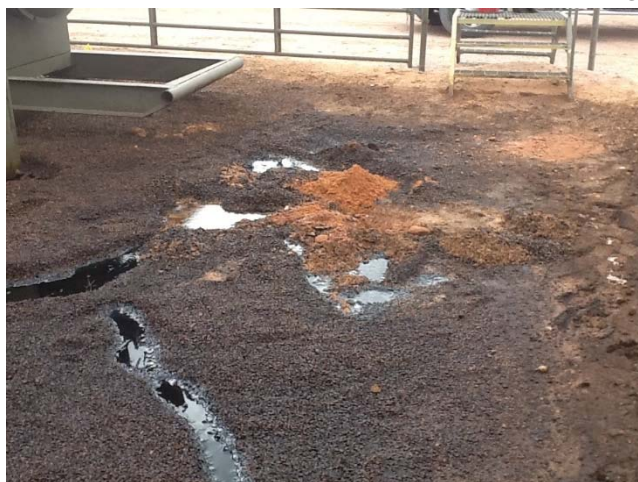
Area of Auger hole 1

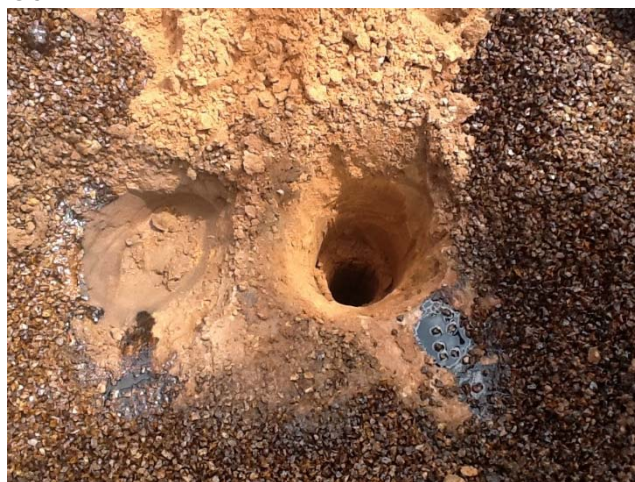
Auger hole 2

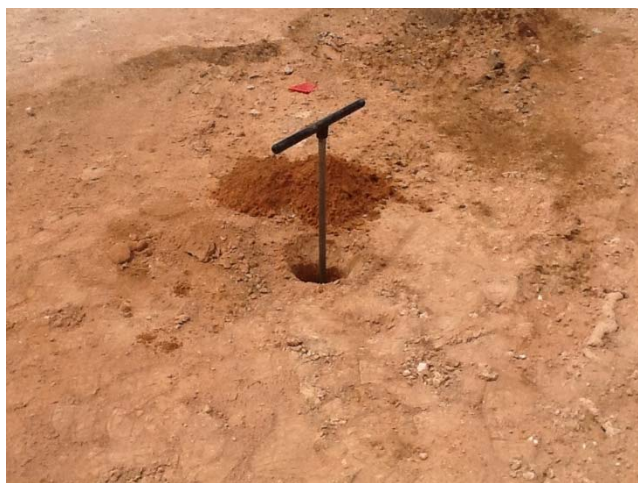
Auger hole 3 verification of depth

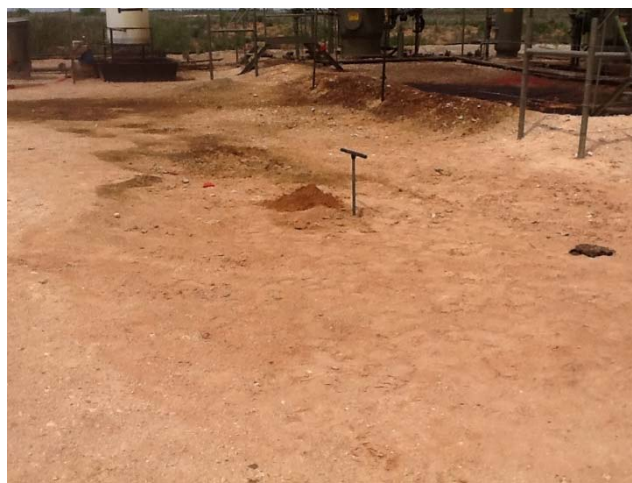
Indicating pooling area of Auger Hole 3

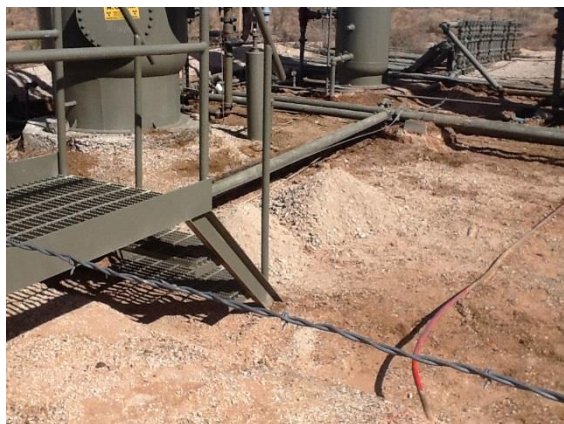
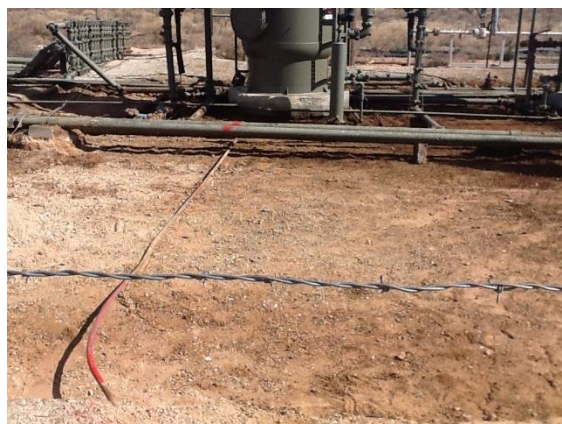
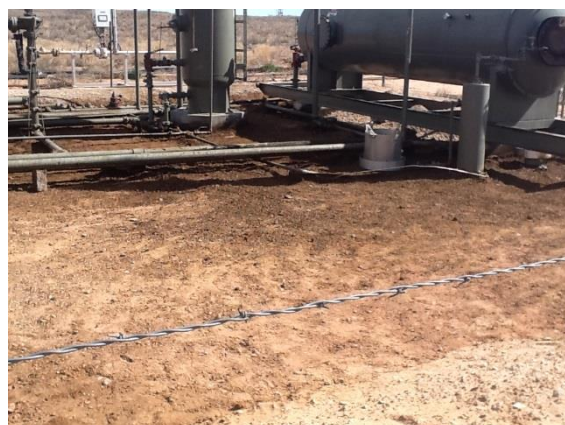
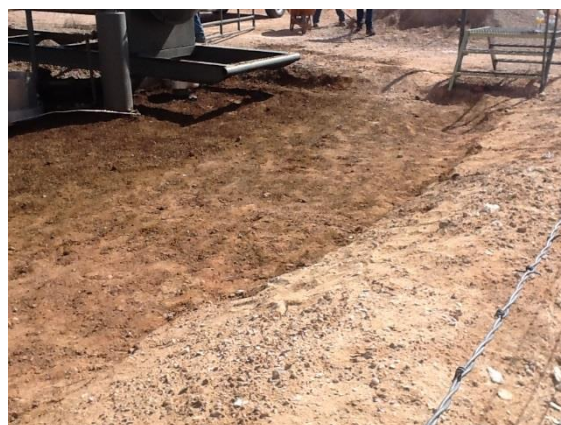
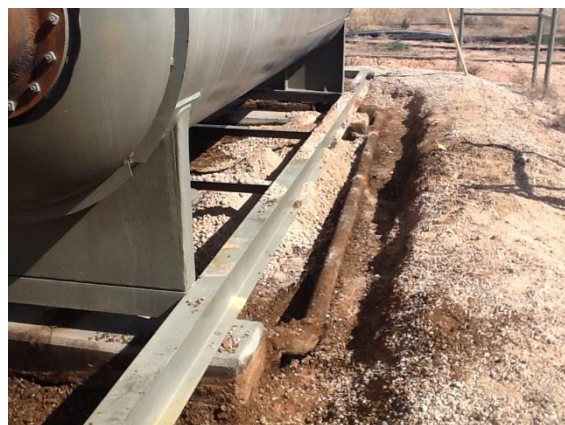
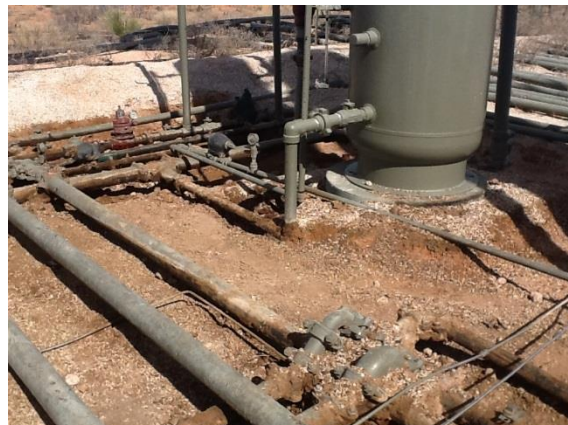
### Bermed Area Excavated

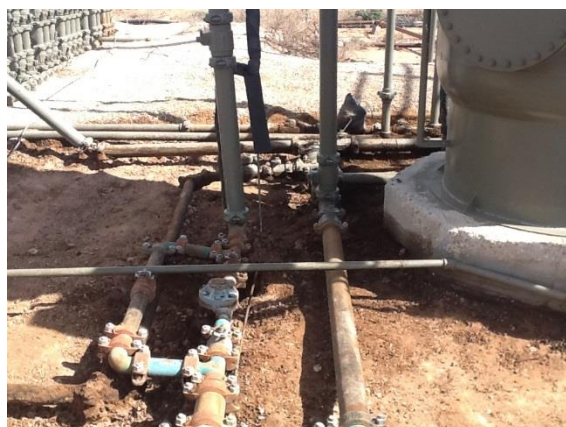
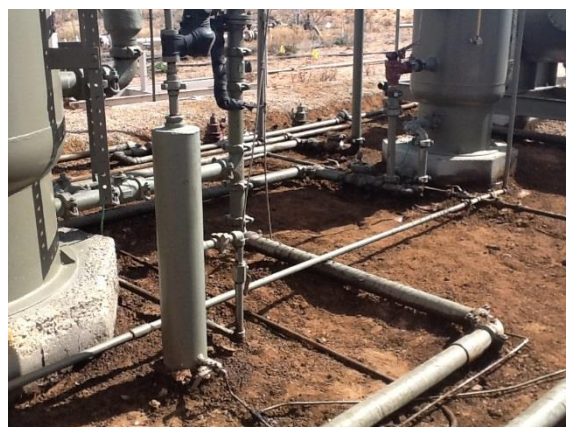
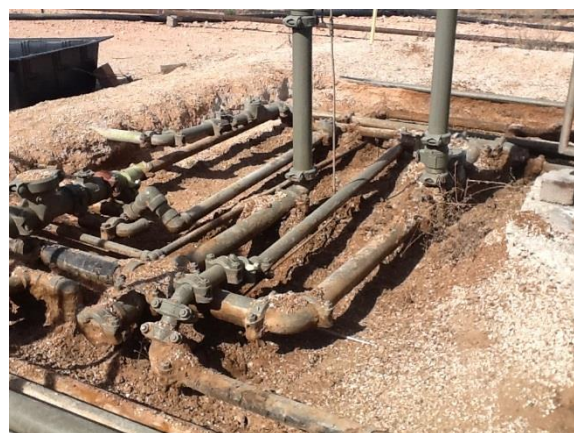
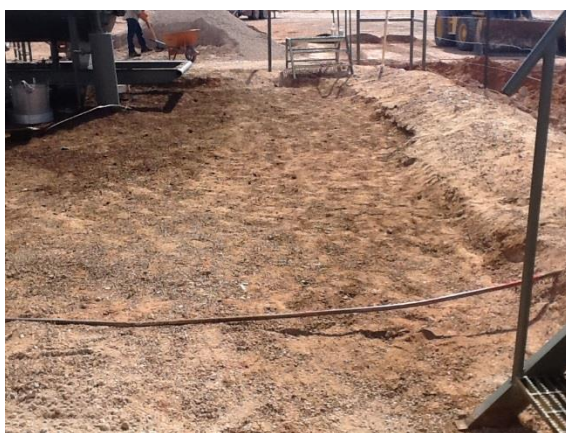
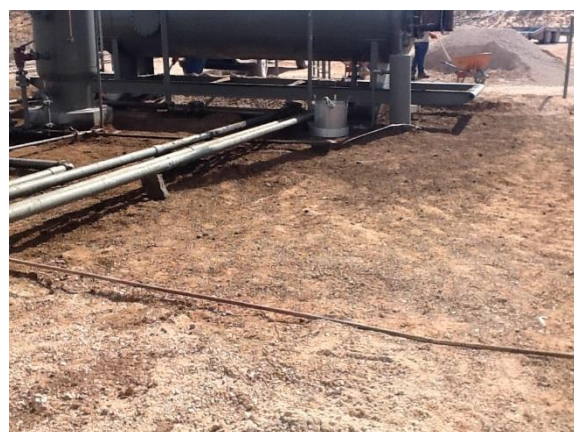
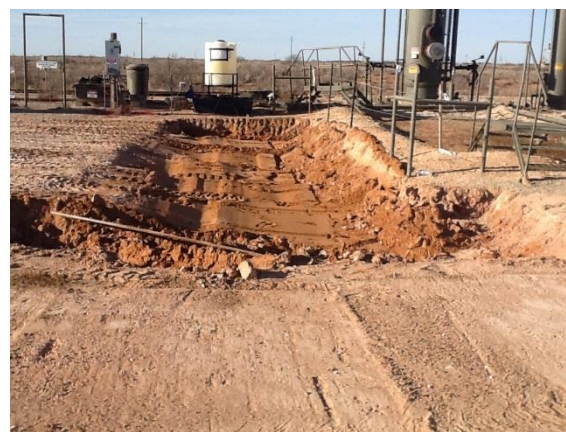
## Bermed Area Excavated

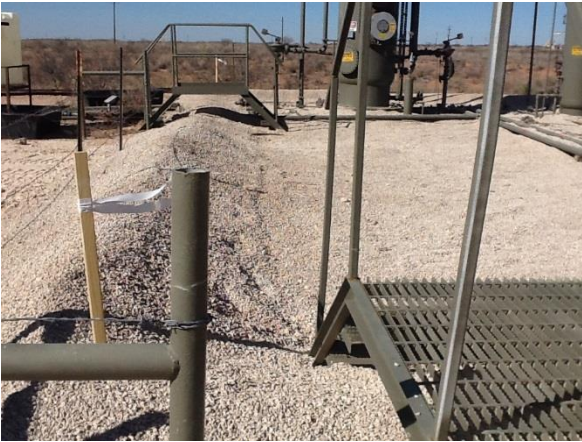
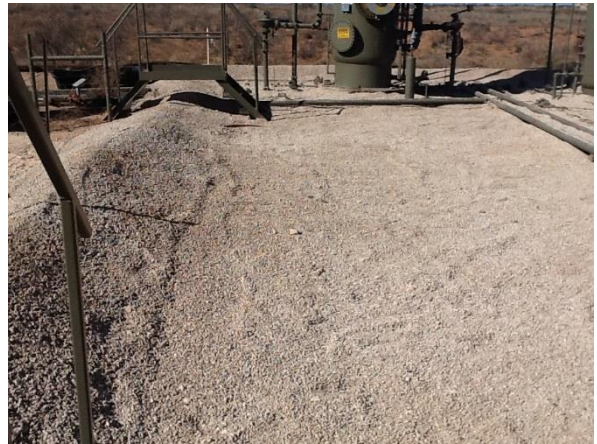
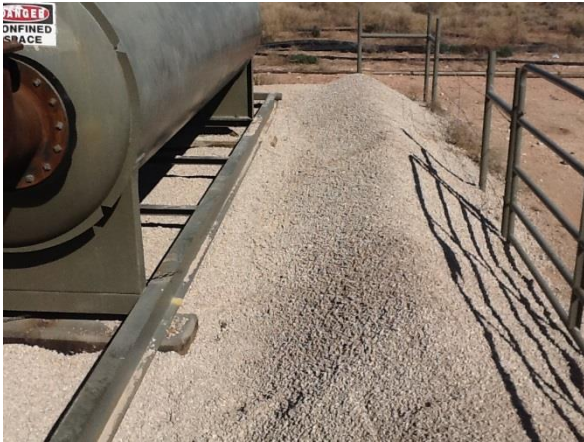
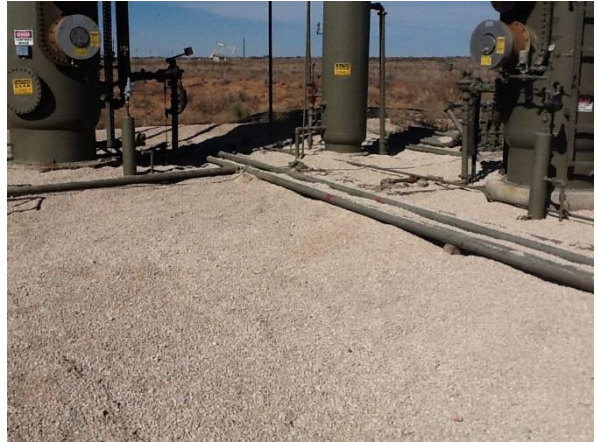
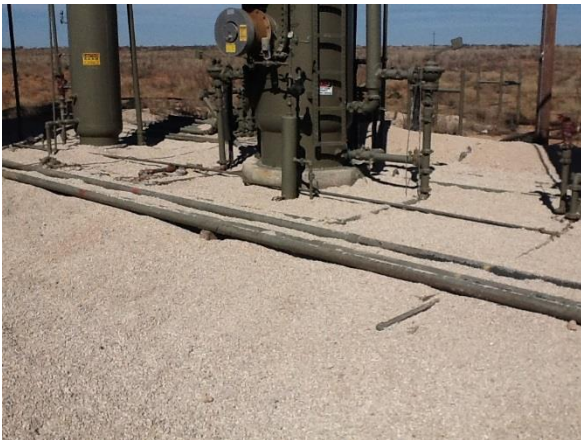
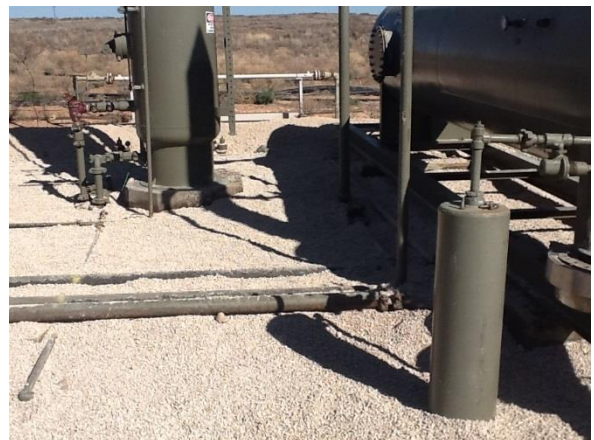
## Bermed Area Backfilled

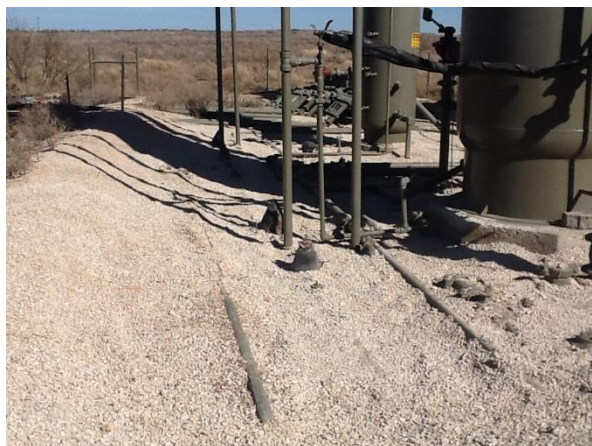
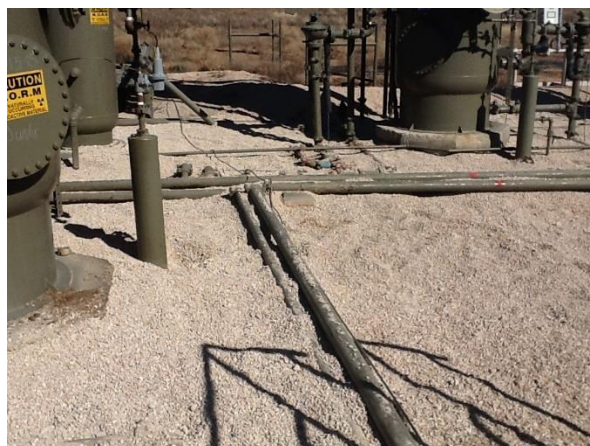
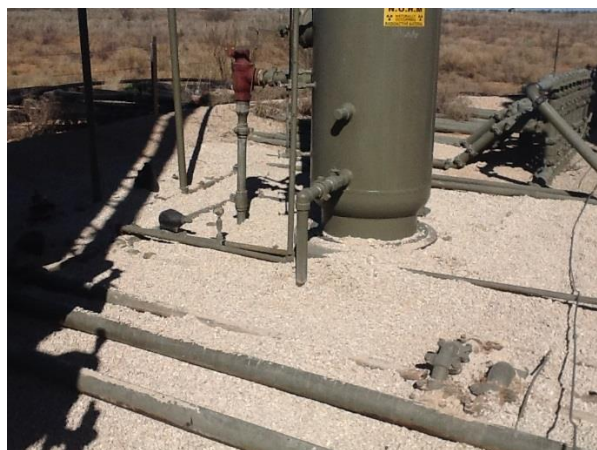
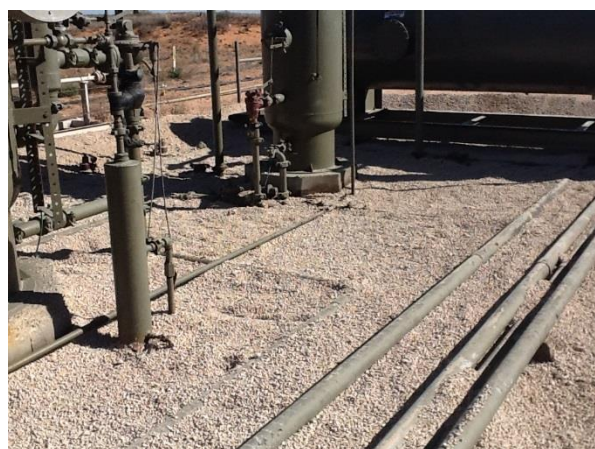
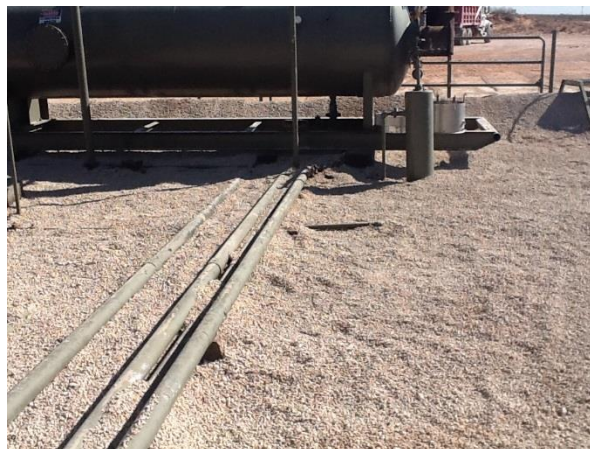
## Bermed Area Backfilled

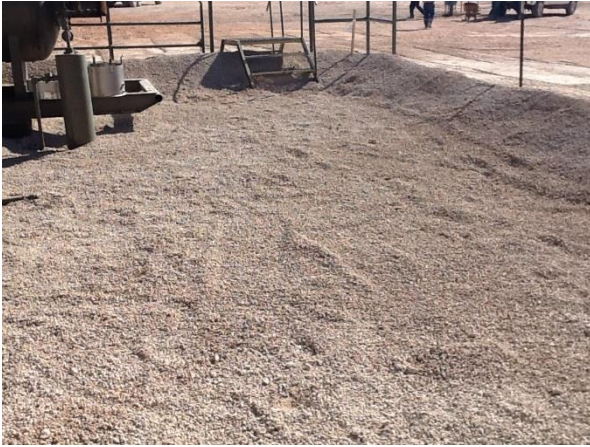
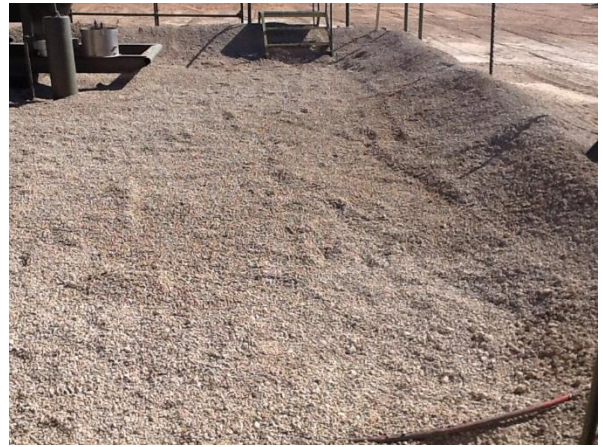
## Bermed Area Backfilled

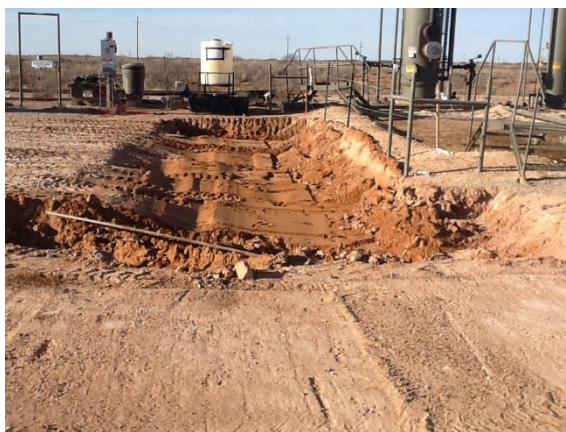
### Outside Pad Area Excavated

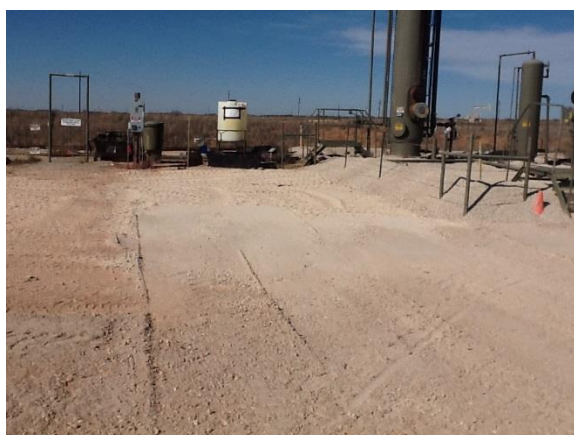
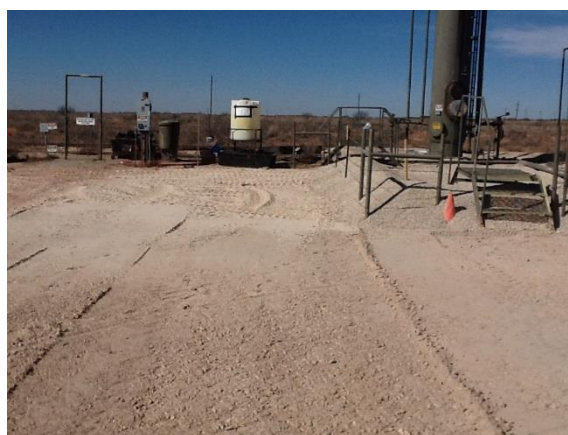
### Outside Pad Area Backfilled
